# National Register of Historic Places Registration Form

historic name Enterprise Mercantile & Milling Company Building (EM&M Building)  
other names/site number Courtney Apartments, Berland Apartments

street & number 115 E Main Street  not for publication  
city or town Enterprise  vicinity  
state Oregon code OR county Wallowa code 063 zip code 97828-1383

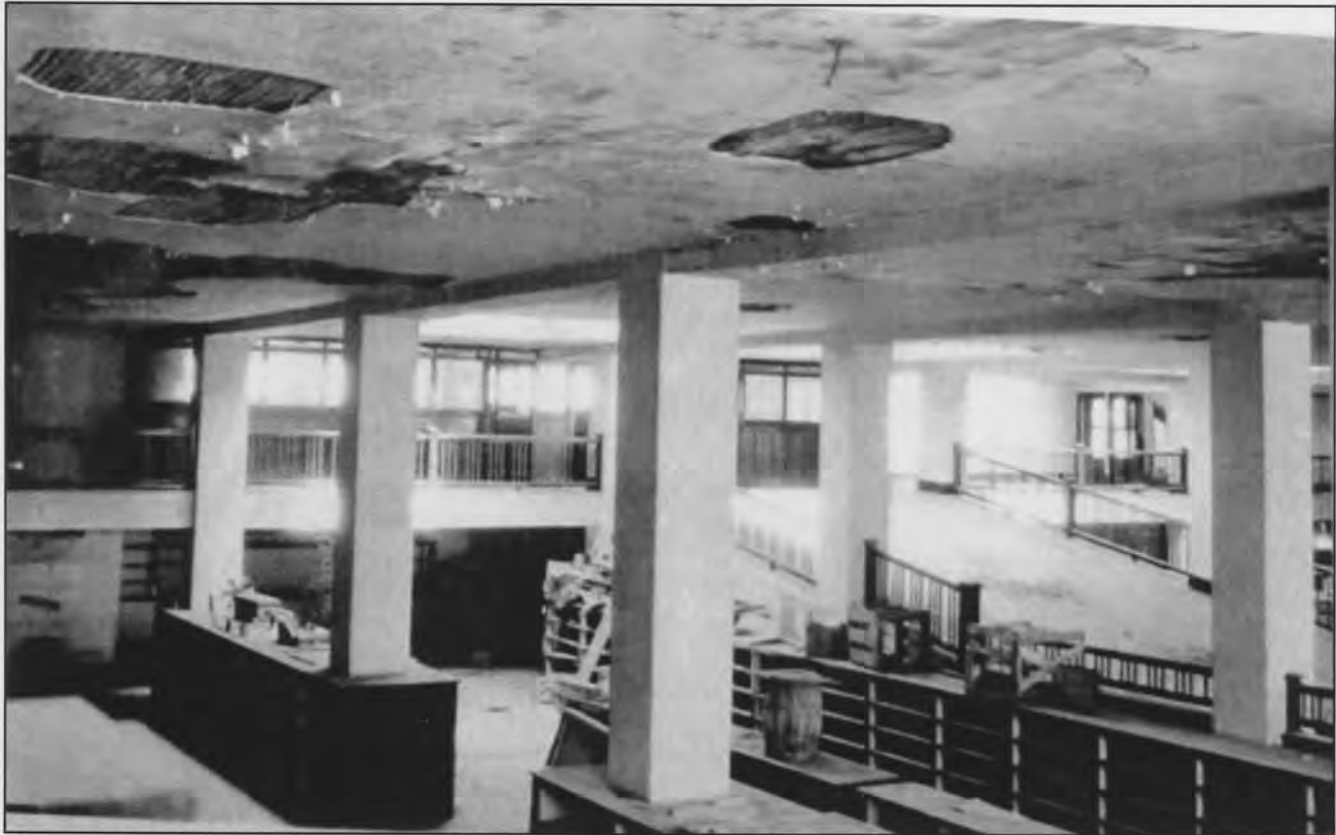
Figure 9a: Historic view of the ground floor of the EM&M Building. Picture No.8 on Page 129, *City of Enterprise, Survey of the Financial Situation of the City of Enterprise, Oregon, League of Oregon Cities, 1934.*

← First Floor. Conjectural drawing of first floor open plan in 1920s showing mezzanine level (dashed line).  
Dot and dotted lines indicate position of photographer and field of vision depicted in photograph.

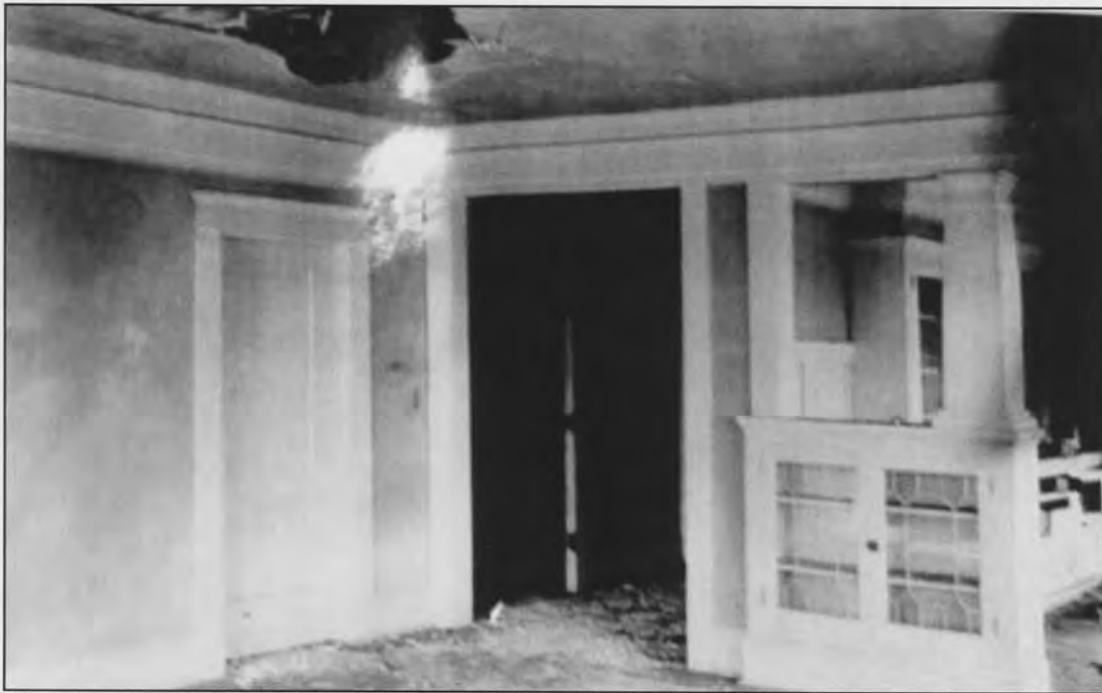
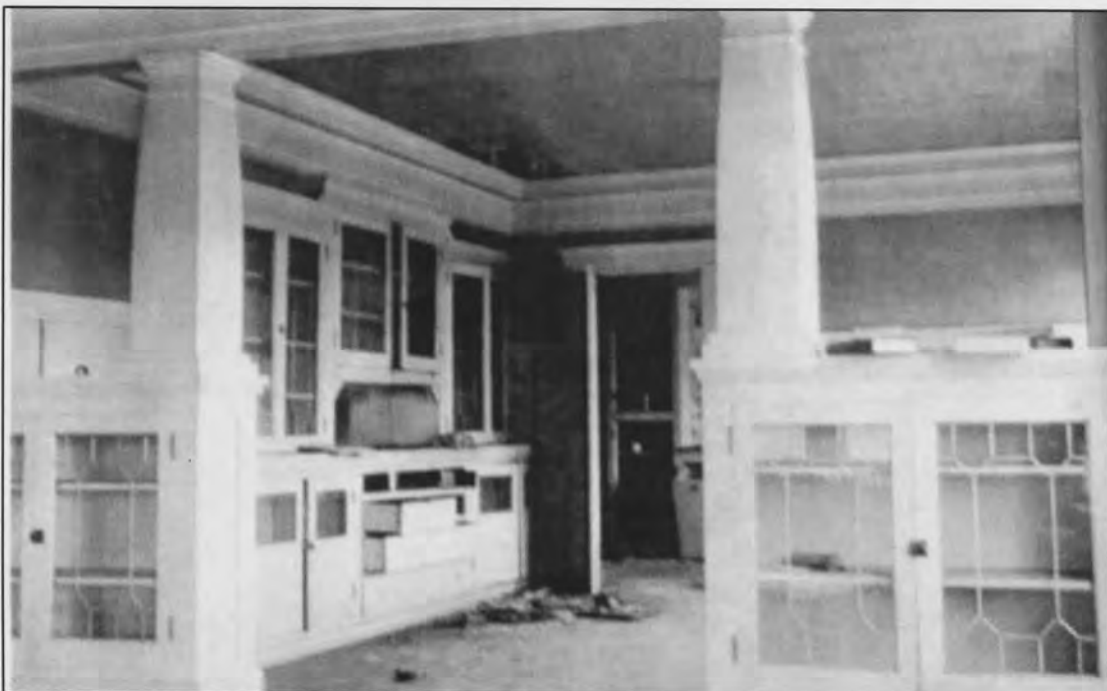
Figure 9b and 9c: Historic interior photographs of a apartment of the EM&M Building Historic view of the manager's apartment of the EM&M Building. Picture No.11 and No.12 on Page 131, *City of Enterprise, Survey of the Financial Situation of the City of Enterprise, Oregon, League of Oregon Cities, 1934.*

A 1934 report titled, "*Survey of the Financial Situation of the City of Enterprise, Oregon*" chronicled the conditions of the downtown, residential areas, and various industries in the Wallowa Valley and Enterprise. The report declared the EM&M in terrible disrepair (Figure 9a-c). At this time, the mezzanine level was still open to the ground level department store, which had only empty shelves and vacant retail spaces. The plaster ceilings of the mezzanine and store levels were falling off in large patches (Figure 9a). The roof was practically non-existent and the interior of the building was "a wreck."<sup>23</sup> The manager's apartment, which had been finished with leaded glass bookcases and cupboard doors, hardwood floors, and a corner fireplace, was covered in ceiling plaster and the hardwood floors were ruined by moisture from the failing roof (Figure 9b-c). Other apartments were in worse condition.
