KENTUCKY HISTORIC RESOURCES INVENTORY

Site No. Sc 270

1. Historic Name(s) <u>Charles Whitaker house</u>		22. ADD/County <u>Bluegrass Scott</u> 105	
Original Owner <u>Charles Whitaker</u>		23. U.S.G.S. Quadrant (15'/75') <u>Georgetown v. 5</u> G.I.S. Mod.

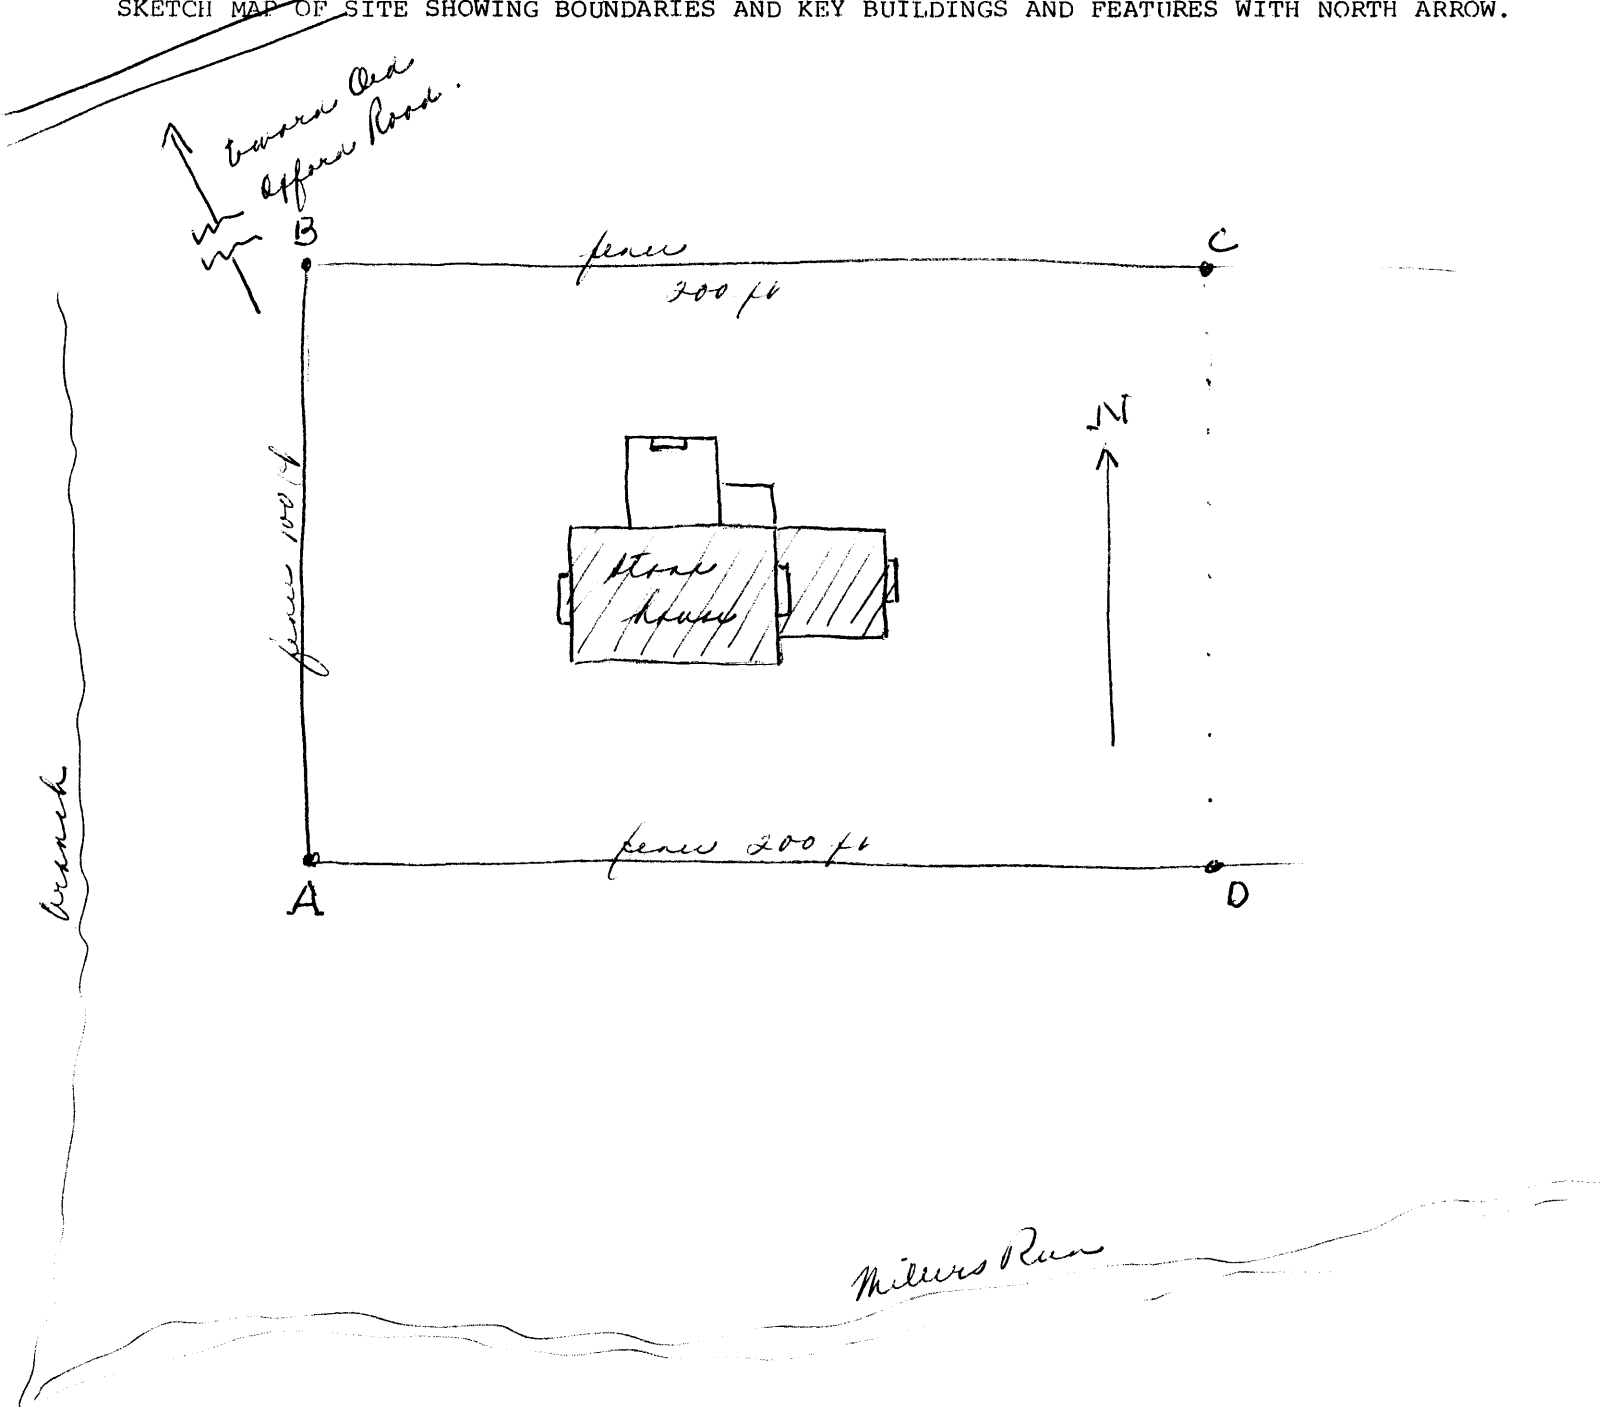
SKETCH MAP OF SITE SHOWING BOUNDARIES AND KEY BUILDINGS AND FEATURES WITH NORTH ARROW.

Beginning at A at the SW fence corner of the yard, thence N 100 ft to B, E 200 ft to C, leaving fence at right angle, 100 ft S to D, and with fence 200 ft W to the beginning containing the stone house, about 1 acre. (Does not show; see sketch) about orientation. C. W.
