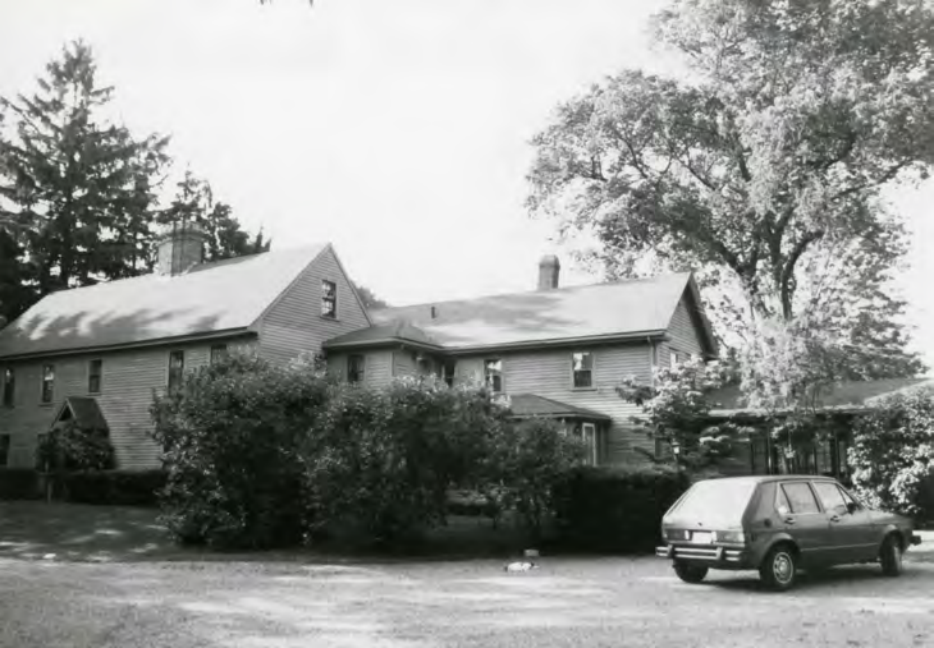
85:04

Brown House  
76 Bridge Street  
extension

The Brown House is 5 bays wide, 2 1/2 stories in height and one room deep. There are 19th century additions to the rear and east (right) side. The front right-hand rooms and chimney bay comprise the original single cell structure constructed between 1662 and 1673. By the 1680s or 1690s, a second cell was added to the west and a lean-to extended behind the addition and possibly behind the earlier end of the house as well. The west end of the house preserves a framed overhang with cyma molded exposed overhanging girt and original large

pendants. A smaller overhang trims the gable end. The lean-to has been removed. The clapboarded exterior is vernacular Second Period, evidenced by fenestration of small, simply enframed sash windows, symmetrically placed across the facade. The small entrance porch, reminiscent of a medieval flitch gate, and the elaborately pilastered chimney date from a restoration of the house c. 1920.

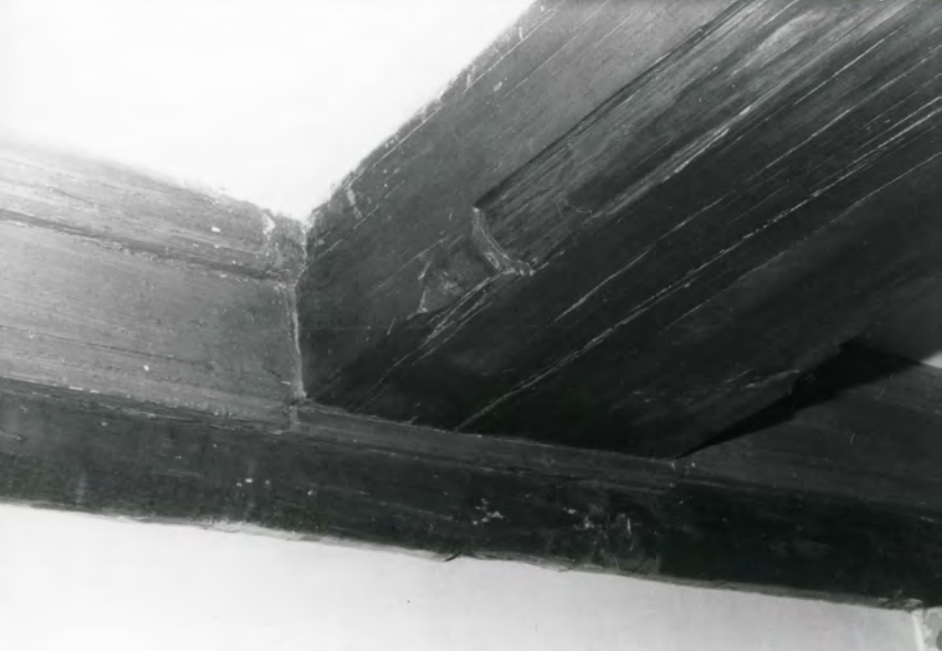
19:32

detail: summer to  
1985

In the right-hand chamber, the 11 inch wide transverse summer tie beam has quarter-round chamfers, flat collars and triangular stops.

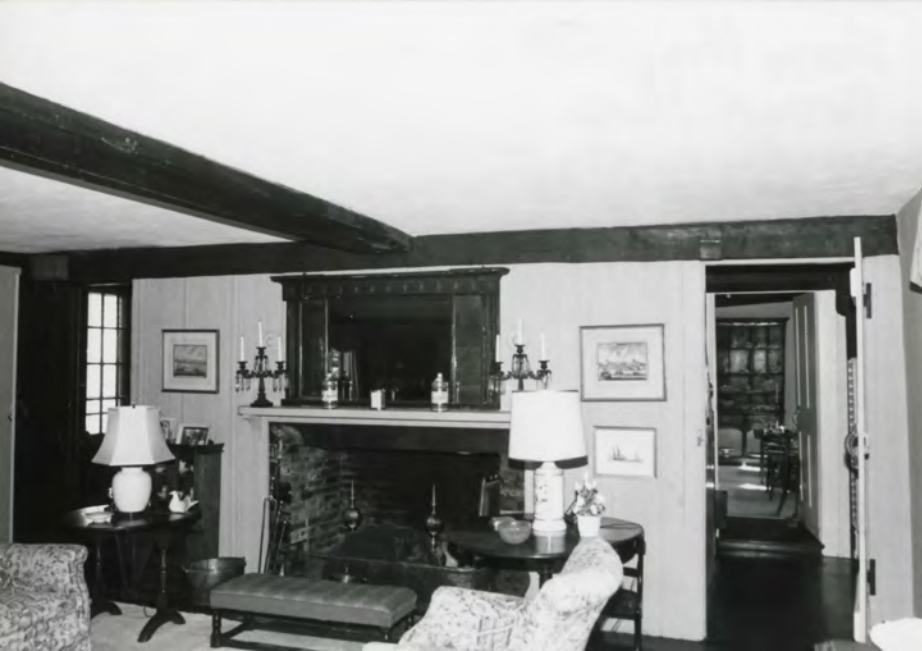
19:29

Hamilton, TIA  
Brown House  
76 Bridge Street  
Left-hand room  
1985

The left-hand room of 1680s or 1690s construction date is 20 feet deep by 21 feet wide. The 14 1/2 inch wide longitudinal summer beam has wide quarter-round chamfers and lamb's tongue stops. On the fireplace wall is a replica of the shadow-molded sheathing now in SPNEA's architectural museum which was found in a reused position in the house.

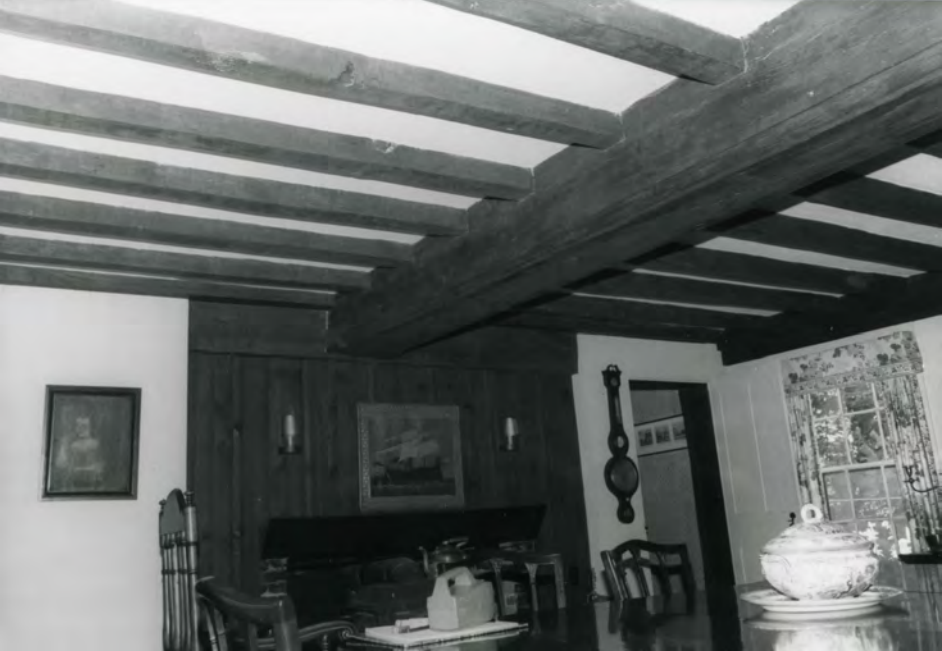
19:31

Hamilton, TVA  
Brown House  
76 Bridge Street  
right hand room

First Period features are found in all four front rooms and on the exterior. The right-hand room is a little over 19 feet wide and 21 feet deep. The longitudinal oak summer beam in that room is 12" wide by 15" deep and is decorated with broad quarter-round chamfers and lamb's tongue stops, except on the south face at the right-hand end. Here the stop just peters out. Joists are tusk tenoned and are spaced 18 inches on centers.

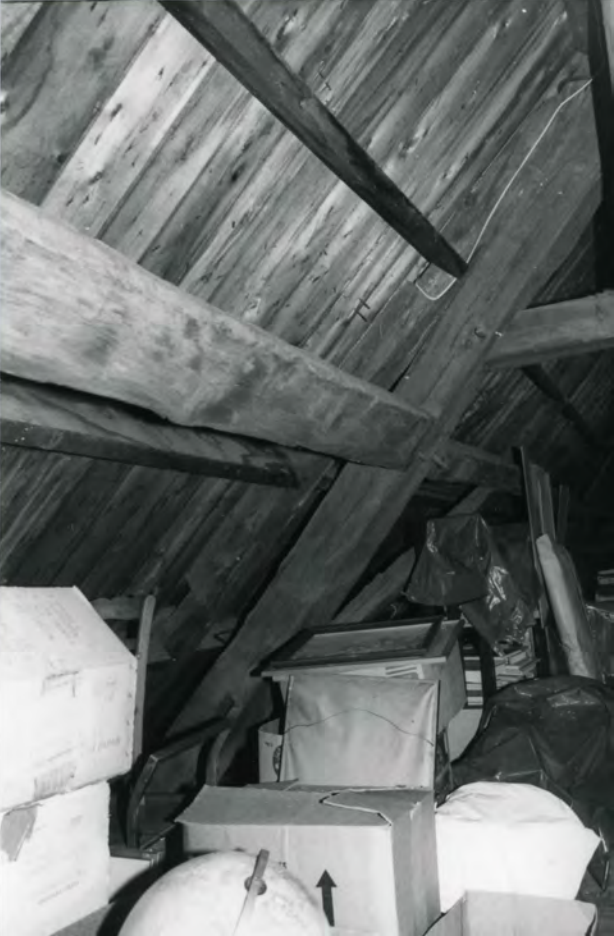
19:26

Hamilton, TN  
Brown House  
76 Bridge Street  
attic  
1985

The attic preserves clear evidence of two separate roof framing systems. Over the original right-hand rooms are the remaining

principal rafters of a principal rafter/common rafter/principal purlin roof system. The frame is of oak and is chamfered. In the newer part of the attic, the pine rafters of a principal rafter/common purlin roof system are visible. There are collar beams in all rafters except those in the east end wall. There is a diagonal brace between the purlin and a rafter in the older part of the roof. When the lean-to was added, new rafters were inserted along the rear slope of the original roof. Their ends resting near the ridge on top of the earlier rafters. The front slope of the roof was set out at a later date so as to create an overhanging eave. New narrow deep purlins were inserted in all parts of the roof at some point.
