NATIONAL REGISTER OF HISTORIC PLACES  
REGISTRATION FORM

historic name: **Delorme-Anduze House (Casa Delorme-Anduze)**

street & number: **361 Antonio Mellado St., corner of Muñoz Rivera St.**

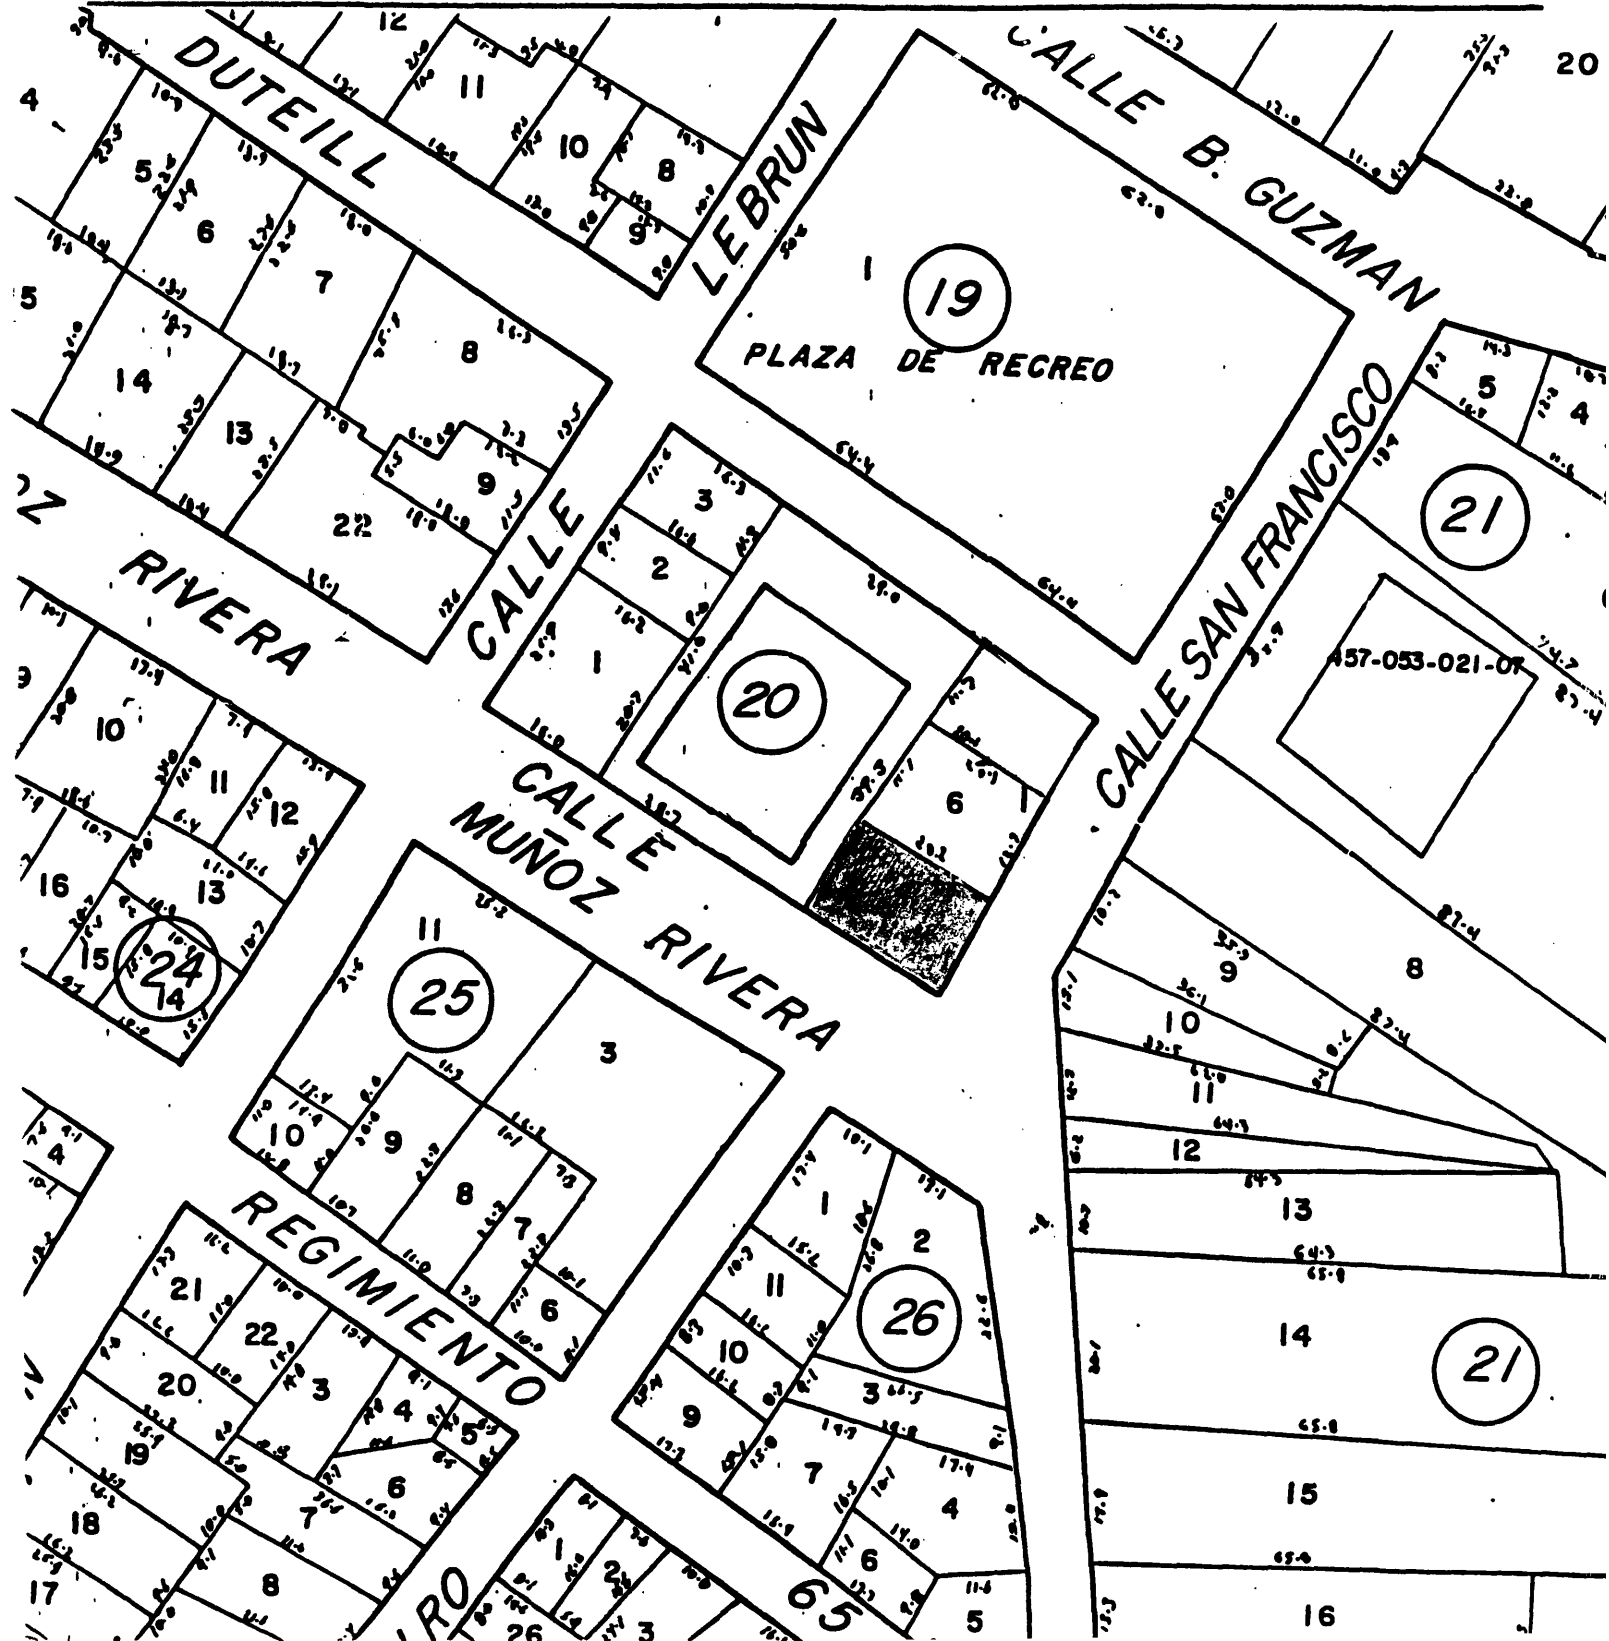
SITE PLAN  
Casa Delerme-Anduze  
Isabel Segunda  
Vieques, P.R.

The Delorme-Anduze House is situated on an urban lot, located on the northwest corner of Muñoz Rivera and Antonio Mellado Streets, in the town of Isabel Segunda, on the Island of Vieques, Puerto Rico. It is a ground-level, one-story, wooden-frame, vernacular dwelling, with a gallery-type balcony. It has an L-shaped plan, with an intersecting, corrugated sheet-metal hipped roof, and an open balcony running the length of both façades. There is a single dormer window at the center of the Muñoz Rivera façade. The house is slightly raised from the ground-level, leaving narrow side passageways and an interior courtyard, enclosed by a masonry wall that runs along the west and north property lines.

The third commercial space occupies the remaining section of the house, facing Antonio Mellado Street, and consists of two deep, narrow rooms, divided by a wood-frame wall and interconnected by a single wooden door. These rooms, in a poor state of conservation, are arranged in a shotgun fashion regarding the main room of the house. The lot is defined to the west and north by a fence of varying heights, composed of mixed materials. Portions of an older, brick-masonry garden wall remain along the length of the fence. This wall has been continuously repaired, with portions of concrete block, wood and corrugated metal. The fence lies along the lot lines and provides for narrow alleys at the west and north extremes of the house.
