NATIONAL REGISTER OF HISTORIC PLACES
REGISTRATION FORM

historic name: Foster, C. E., House

other name/site number: "Wonder House"

Constructed c. 1931 by Carlos Hill and Phil Lance, the C. E. Foster House is an irregular-plan, two-section stone structure originally constructed as a vacation residence. The two sections, connected by a gable-roof breezeway, are constructed of uncoursed, uncut stone collected near the site and consequently have a heavy, yet organic feel that was typical of the building style generally known as "Rustic." Both sections are covered by composition-shingled, gable roofs of saltbox configuration. The interior, consisting of two levels on the front section and seven levels on the rear section, has been modified somewhat since construction. The C. E. Foster House is located on the top of Rich Mountain on the north side of State Highway 88 in the current Queen Wilhelmina State Park, which is approximately 13 miles northwest of Mena. There are no extant outbuildings or site features associated with this property.

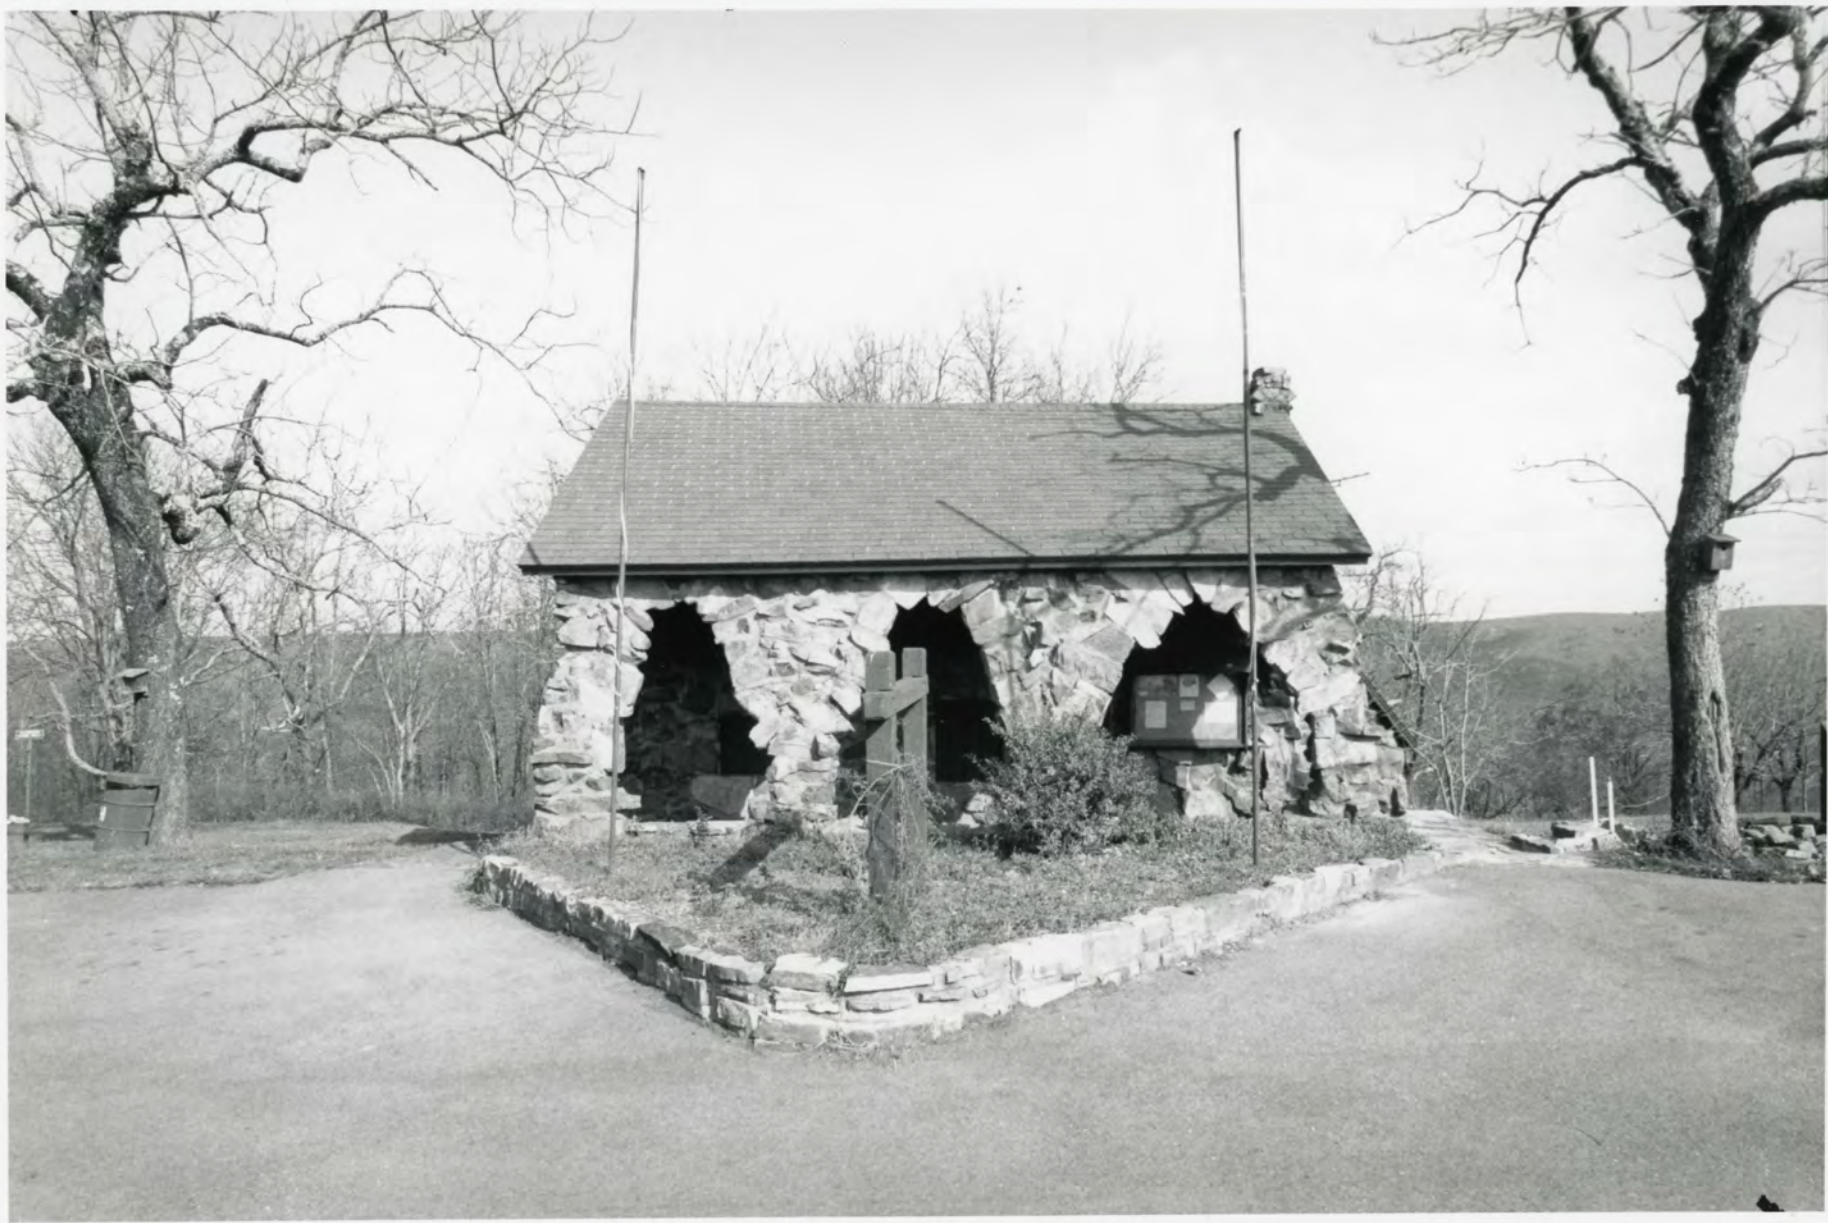
View from the south

The front, or southern, section has an inset porch on the front facade supported by three jagged stone arches. Underneath, a single-leaf door (not original) allows entry into the first floor, which consists of a single room that was used mostly for a living room, though people often slept there. An exterior chimney is located on the eastern elevation of this section and features stone stairs built around the chimney as they ascend to the second-story single-leaf entrance, which is to the north of the chimney. This elevation contains a large window opening on the first-story that has been boarded over, a smaller window to the north of the second-story entrance, and a diamond-shaped window (boarded over) to the south of the chimney. The opposing western elevation contains two different-sized window openings on each floor. In addition to the single-leaf entrance underneath the breezeway, there are two flanking window openings of different dimensions on the rear, or northern, elevation of the southern section. The second-story consists of one very narrow room with an unusual built-in bed, which was designed to sleep three children head to toe, along the entire length of the southern wall.

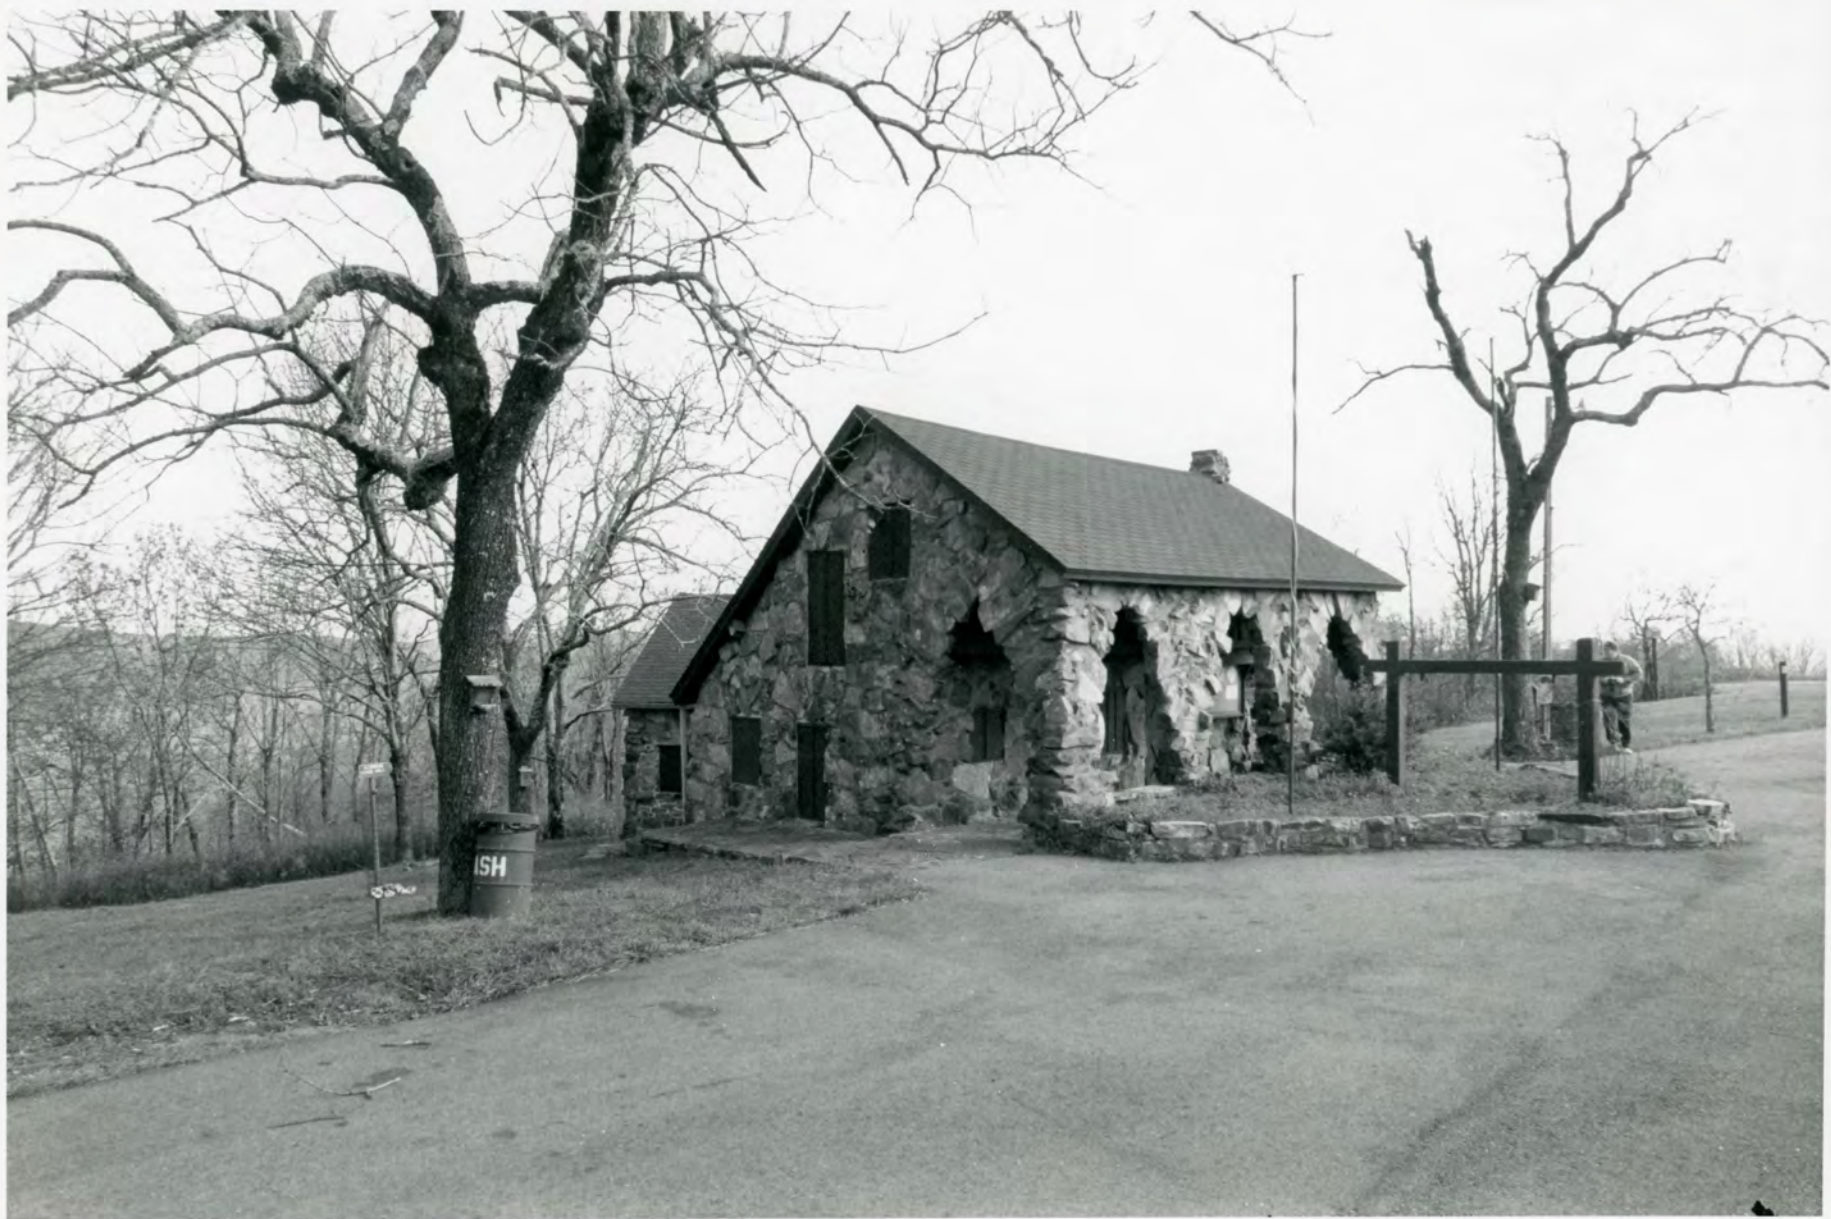
C. E. Foster House
Polk Co., Arkansas
Photograph by Patrick Zollner
November 1992
Negative on file at AHPP
View from the southwest

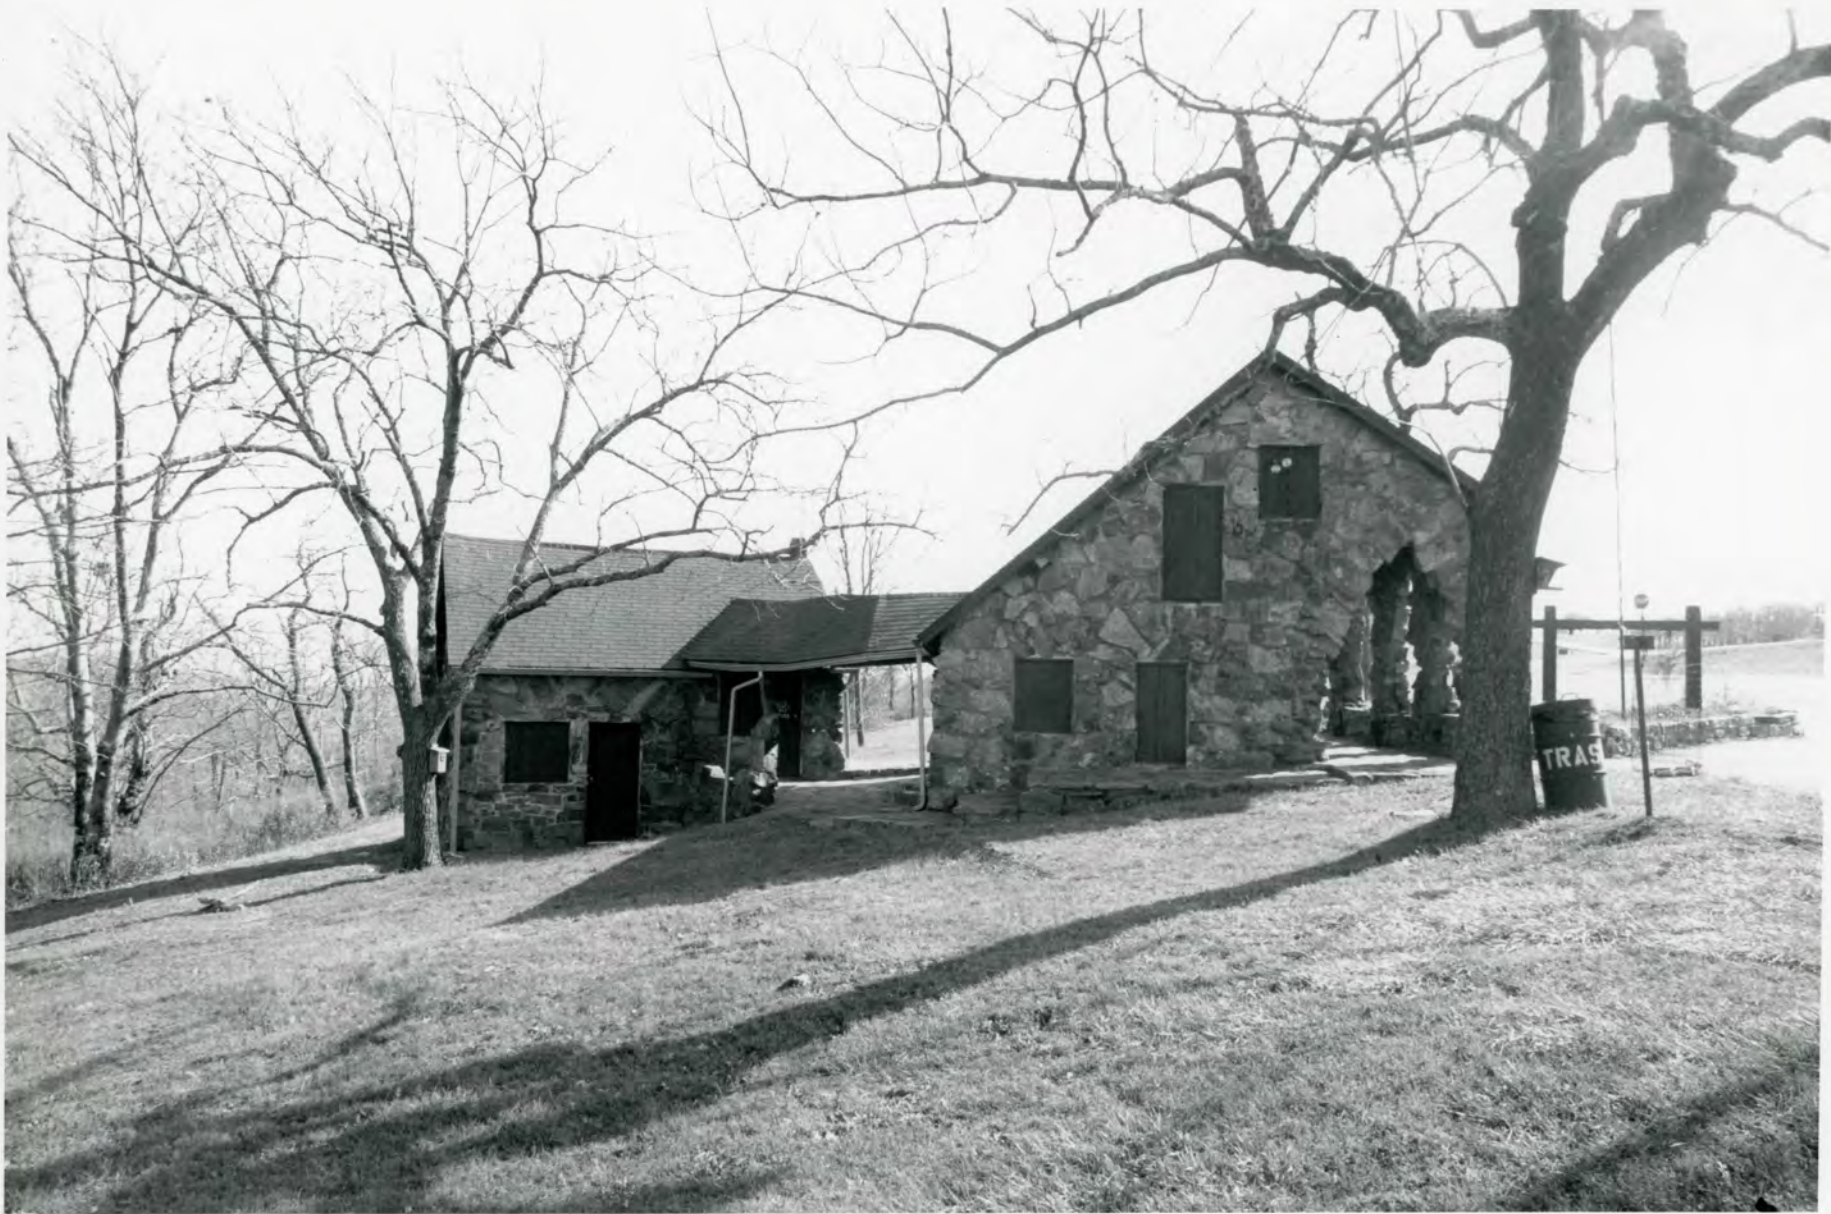
C. E. Foster House
Polk Co., Arkansas
Photograph by Patrick Zollner
November 1992
Negative on file at AHPP
View from the west

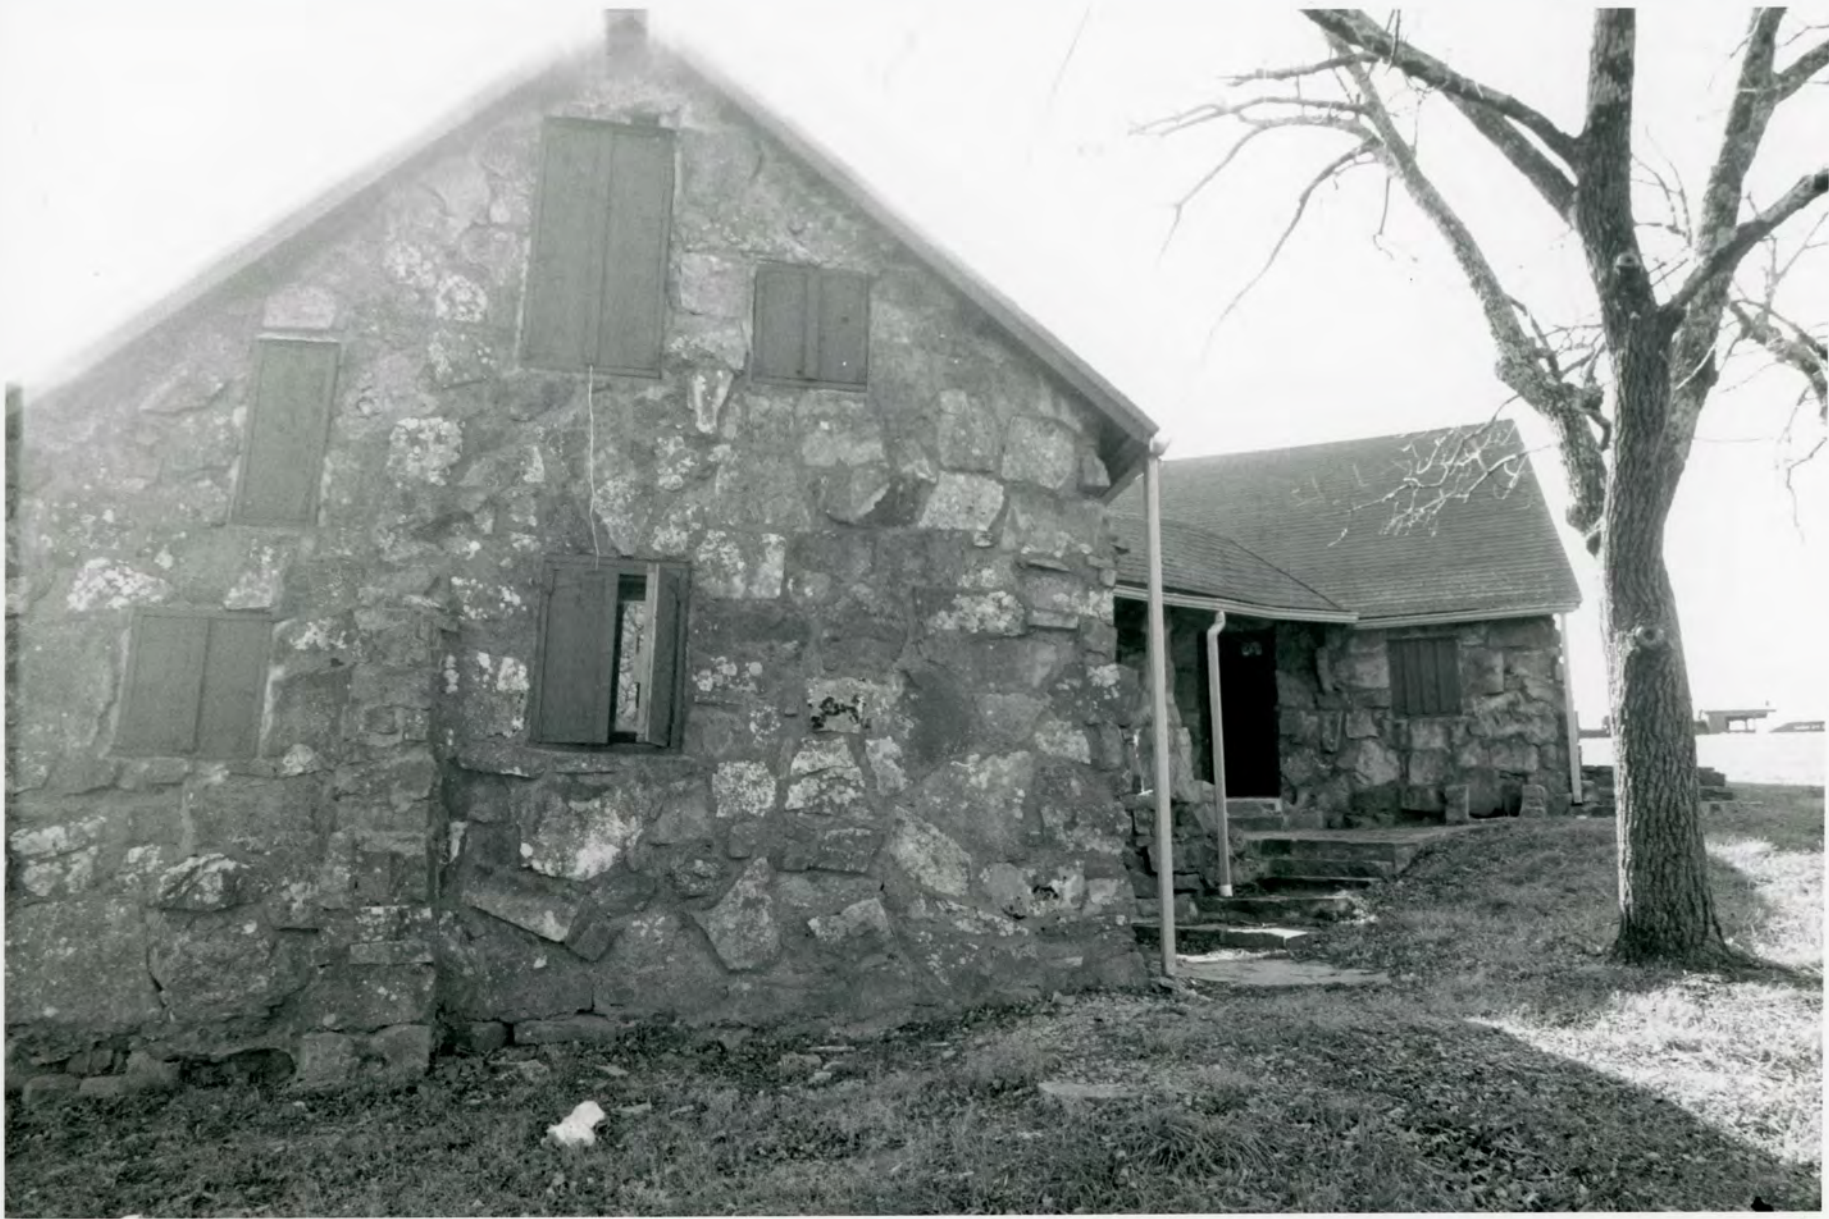
C.E. Foster House
Polk Co., Arkansas
Photograph by Patrick Zolher
November 1992
Negative on file at AHPP
View from the north

The rear, or northern, section is located on the down slope of the mountain and is situated at an angle with the gable end facing southeast. This southeastern elevation contains a central chimney flanked by a single-leaf entry and a window to the right and a large window opening to the left that has been boarded over with a window-unit air conditioner installed. There is a small window opening on each side of the chimney near the gable-end peak. The southwestern elevation contains a single-leaf doorway underneath the breezeway, which is supported by a single piled-rock post. Northwest of the breezeway on this elevation, there is a single-leaf entrance on a different level and a boarded-over window. The rear, or northwestern, elevation contains a partial chimney extending

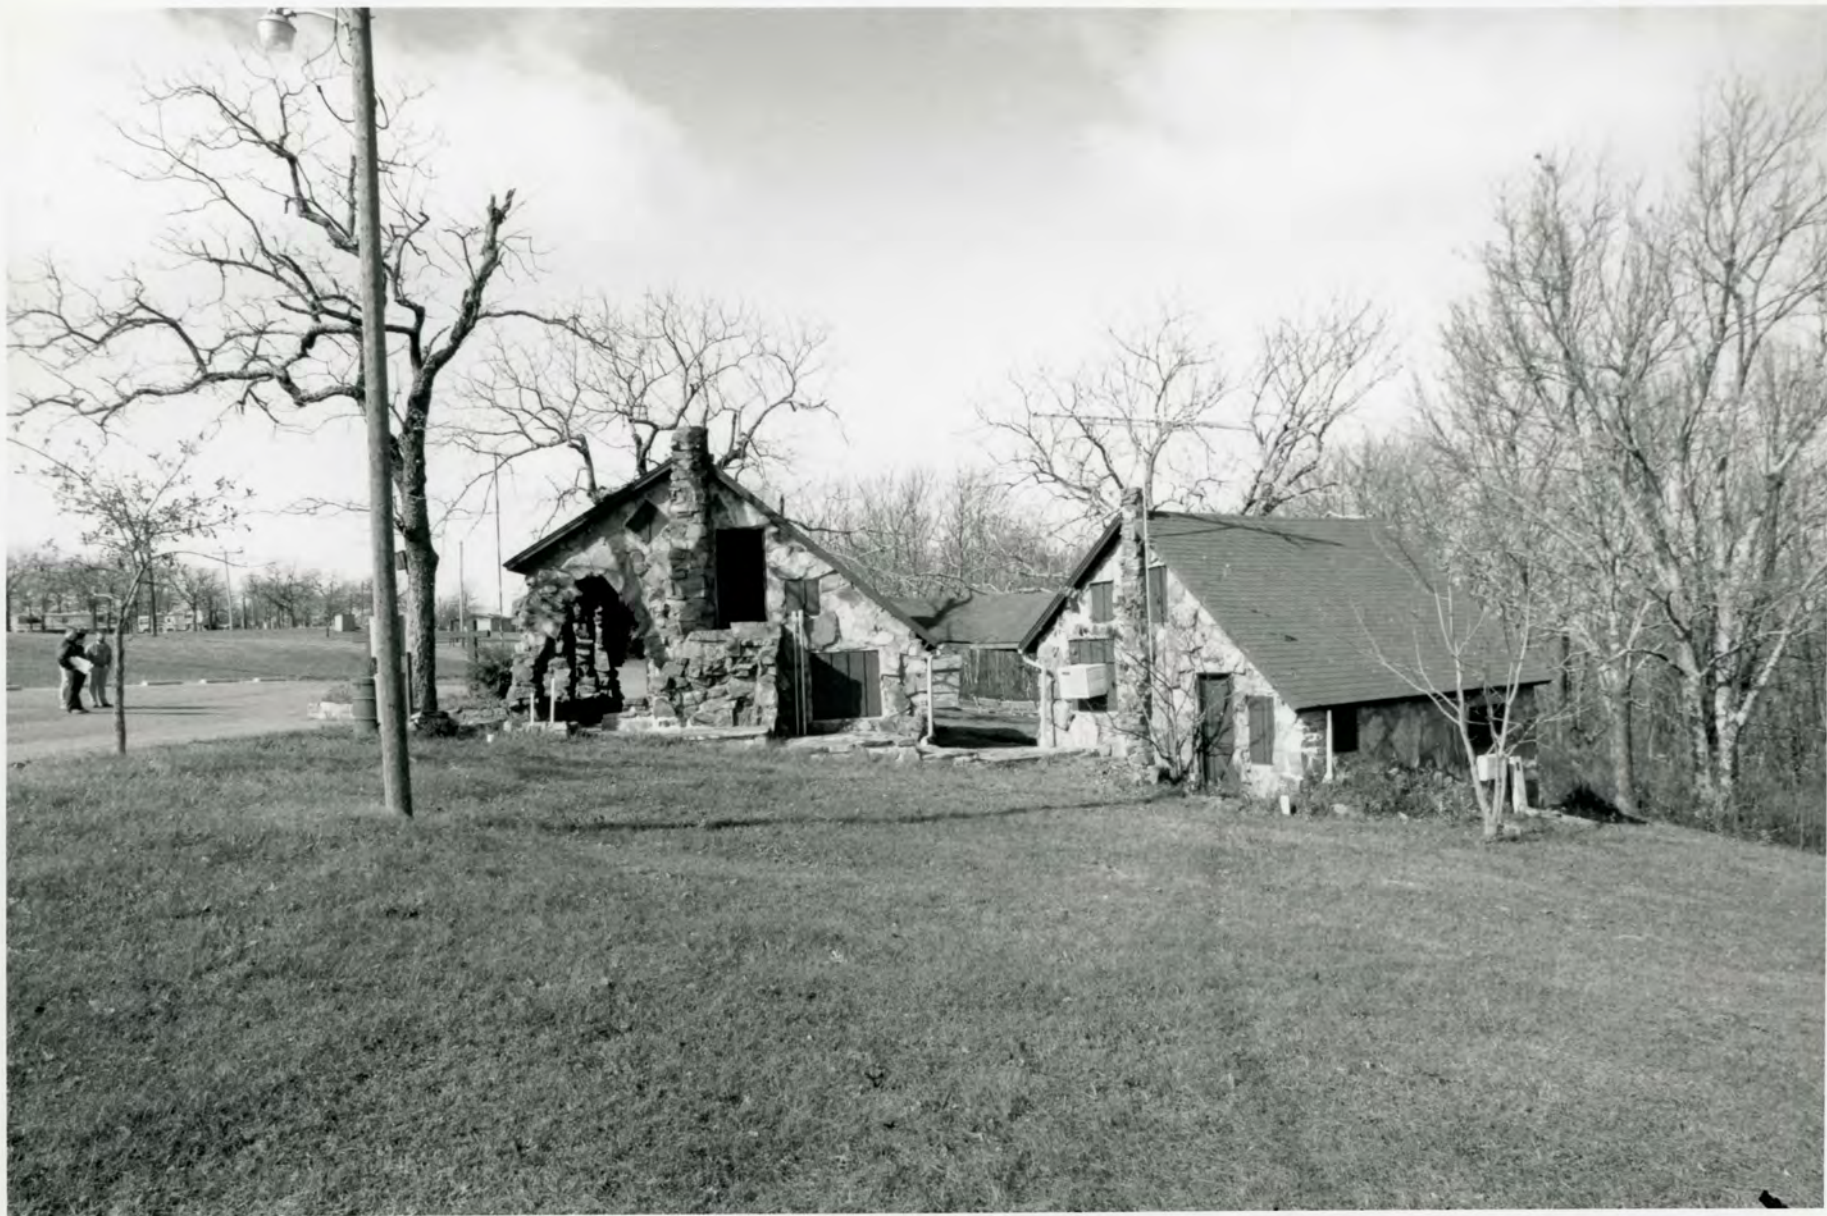
View from the east

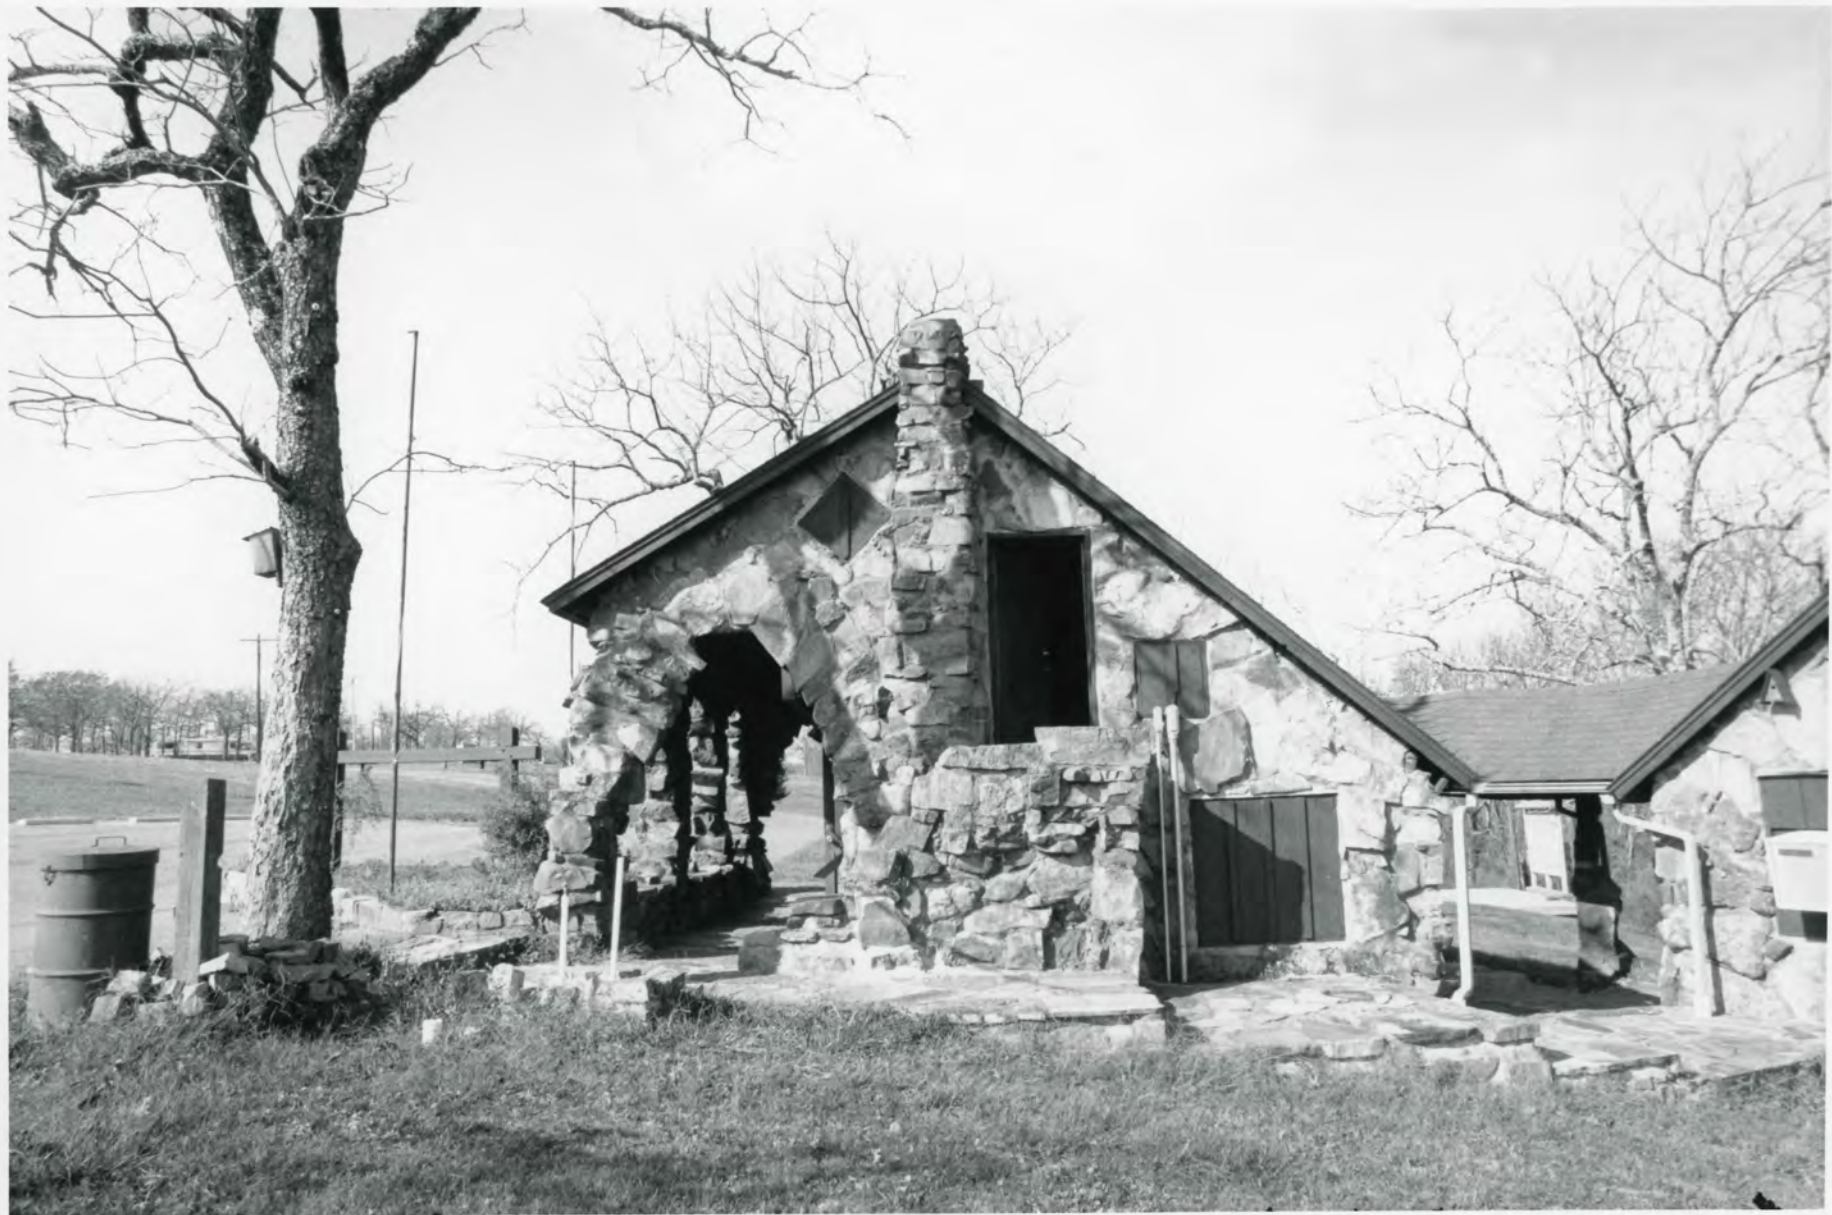
C.E. Foster House
Polk Co., Arkansas
Photograph by Patrick Zoller
November 1992
Negative on file at AHPP
View of front section from
the east

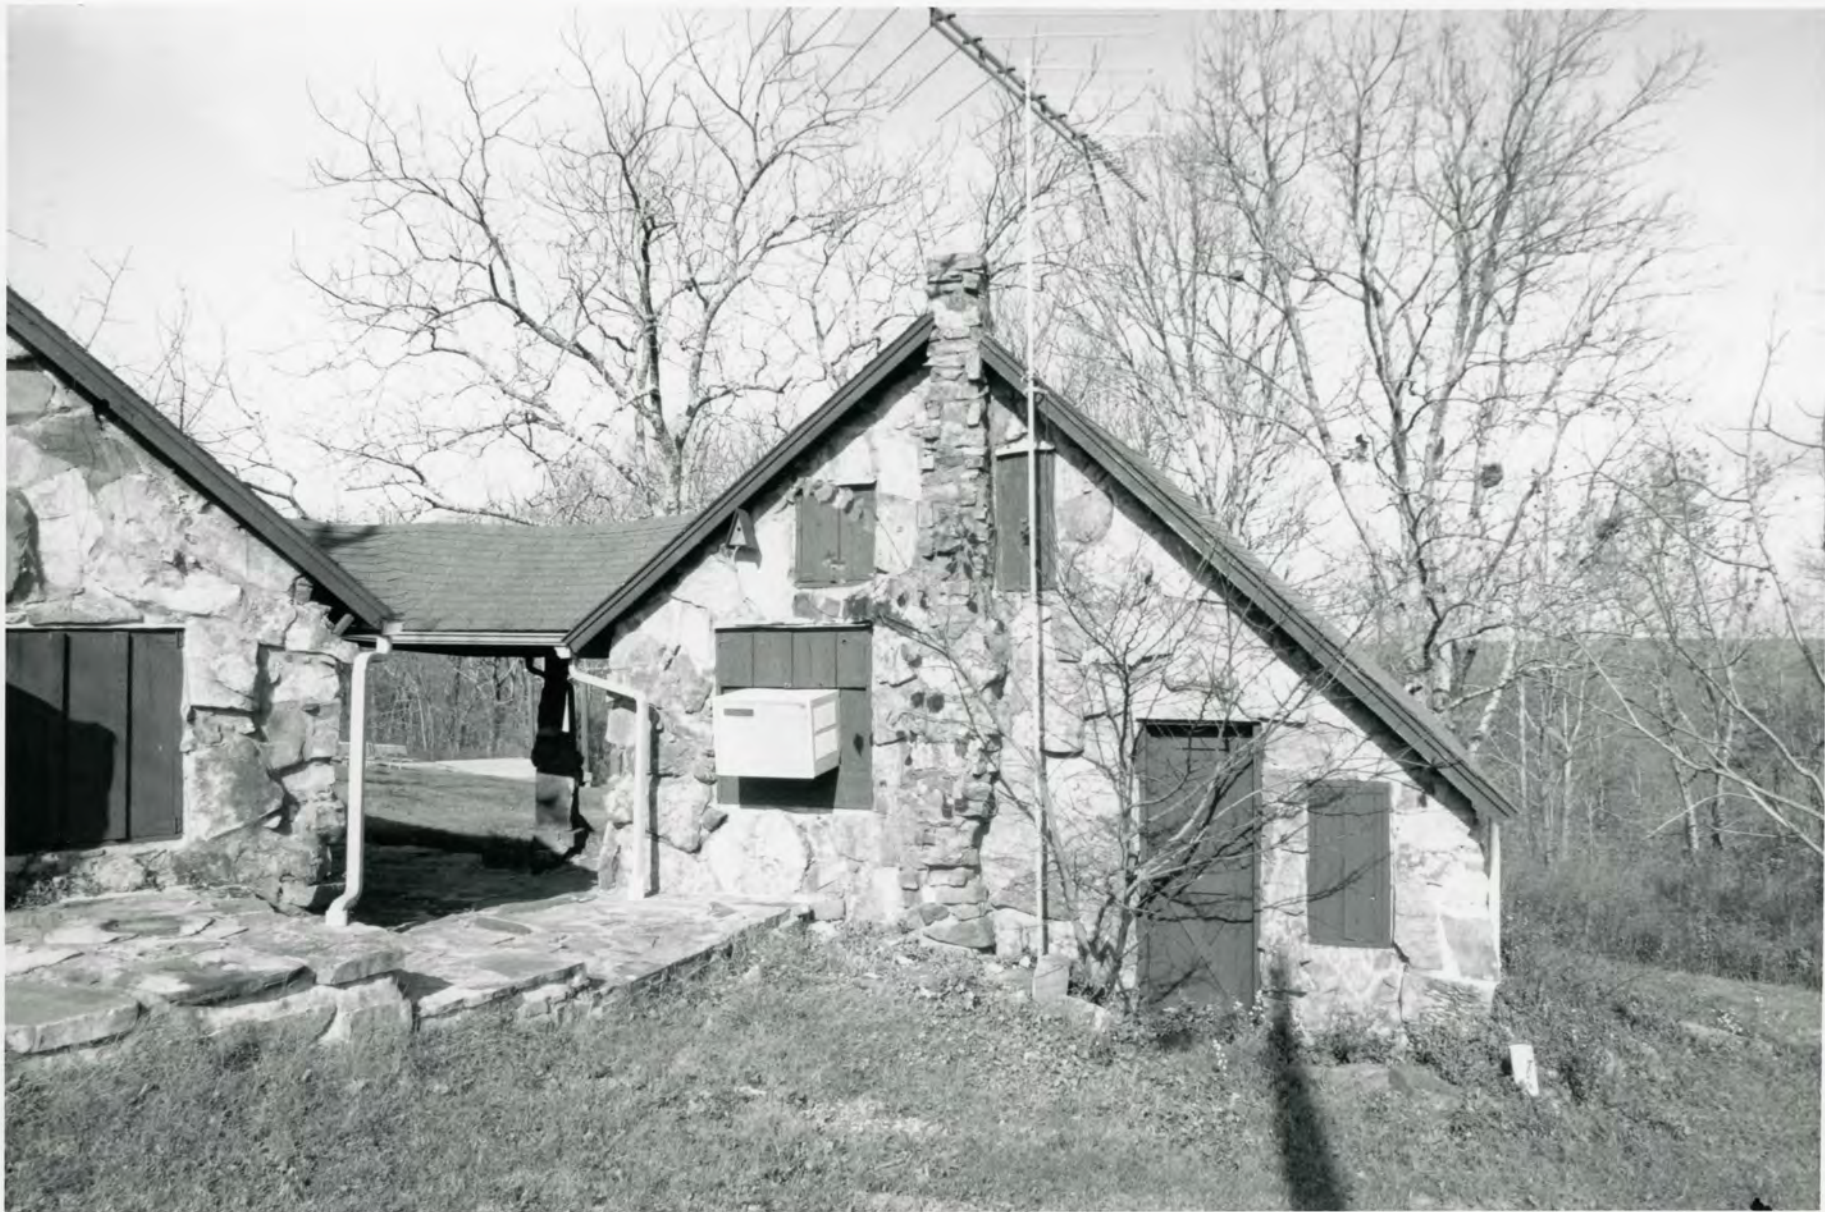
C. E. Foster House
Polk Co., Arkansas
Photograph by Patrick Zollner
November 1992
Negative on file at AAPP
View of rear section
from the south

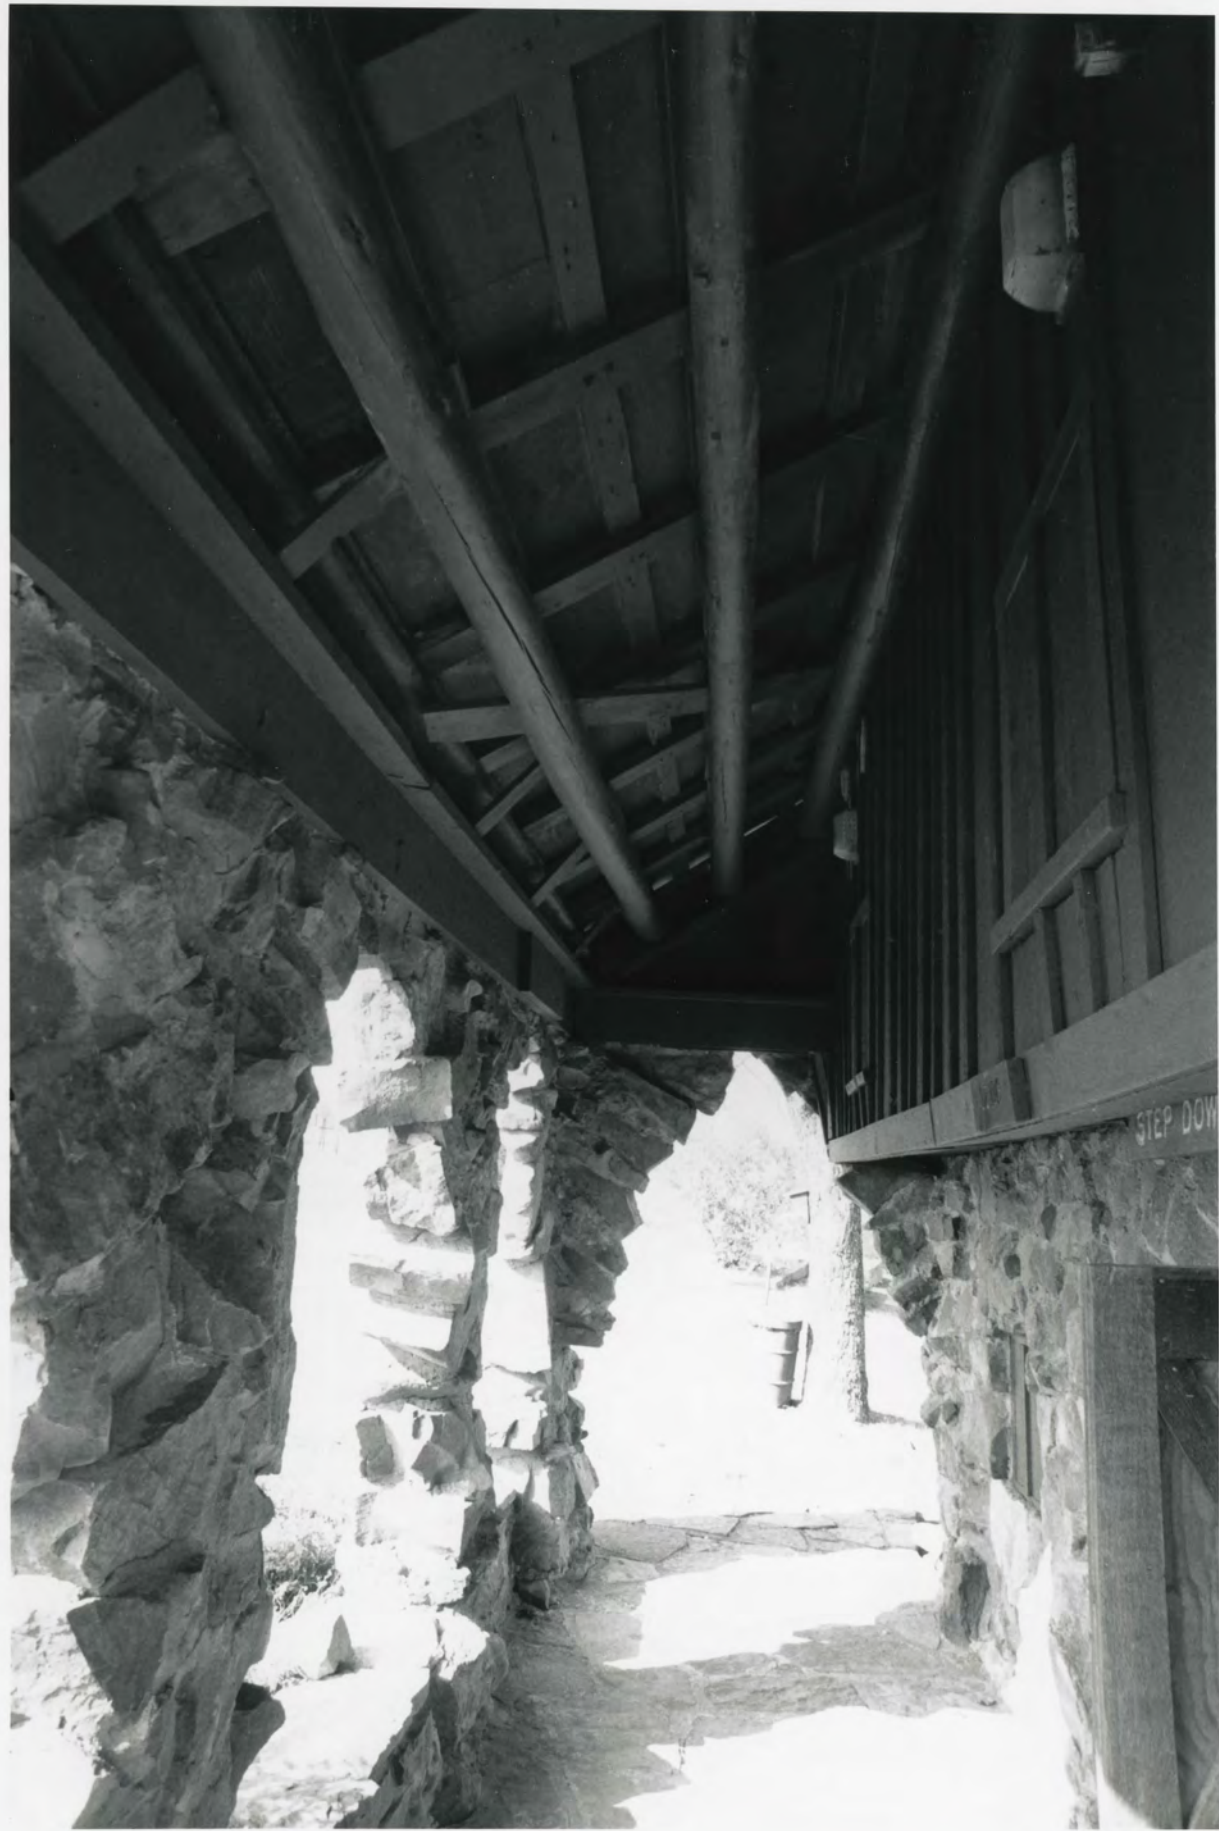
C. E. Foster House
Polk Co., Arkansas
Photograph by Patrick Zollner
November 1992
Negative on file at AHPP
View underneath front porch
from the east

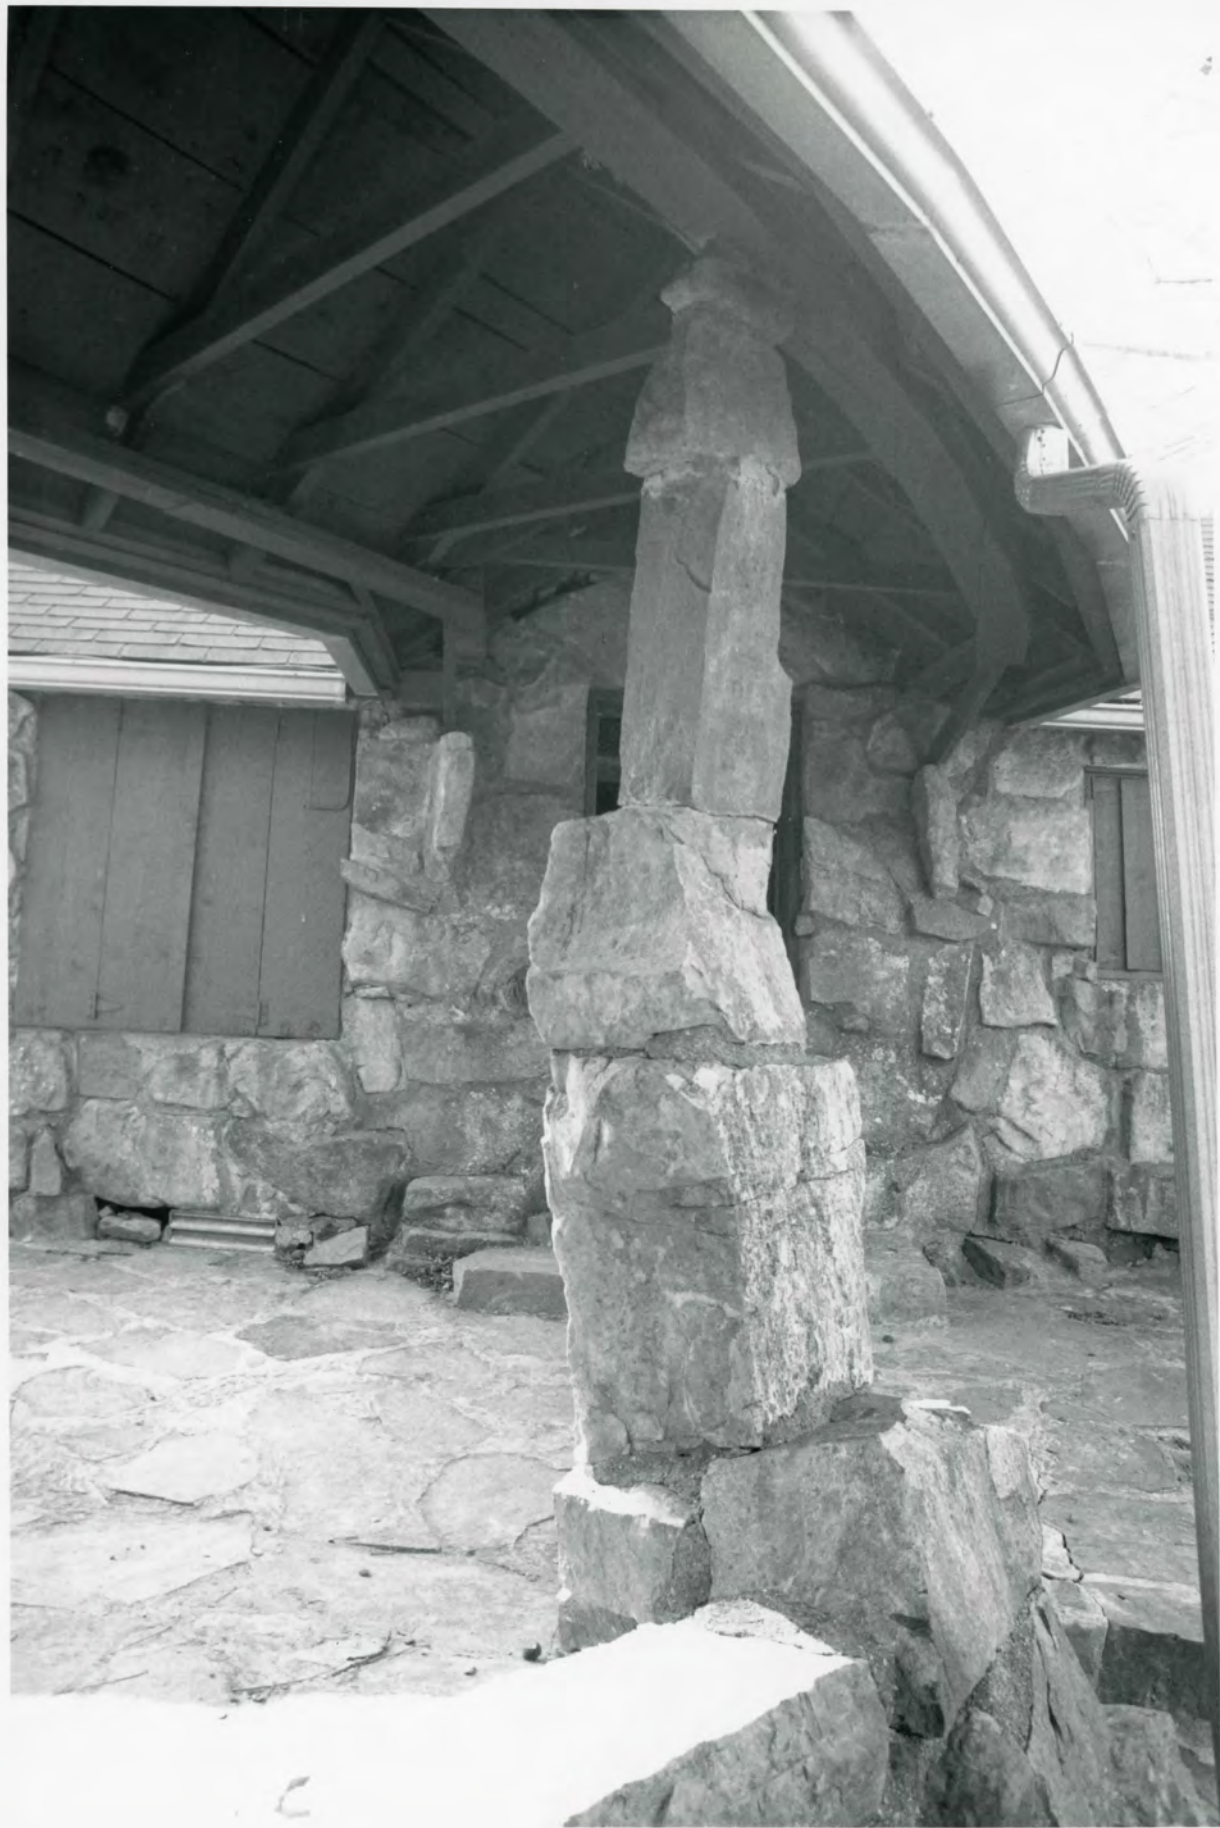
View of connecting "breezeway" porch
support from the north
