NATIONAL REGISTER OF HISTORIC PLACES
REGISTRATION FORM

historic name: Foster, C. E., House

other name/site number: "Wonder House"

Constructed c. 1931 by Carlos Hill and Phil Lance, the C. E. Foster House is an irregular-plan, two-section stone structure originally constructed as a vacation residence. The two sections, connected by a gable-roof breezeway, are constructed of uncoursed, uncut stone collected near the site and consequently have a heavy, yet organic feel that was typical of the building style generally known as "Rustic." Both sections are covered by composition-shingled, gable roofs of saltbox configuration. The interior, consisting of two levels on the front section and seven levels on the rear section, has been modified somewhat since construction. The C. E. Foster House is located on the top of Rich Mountain on the north side of State Highway 88 in the current Queen Wilhelmina State Park, which is approximately 13 miles northwest of Mena. There are no extant outbuildings or site features associated with this property.

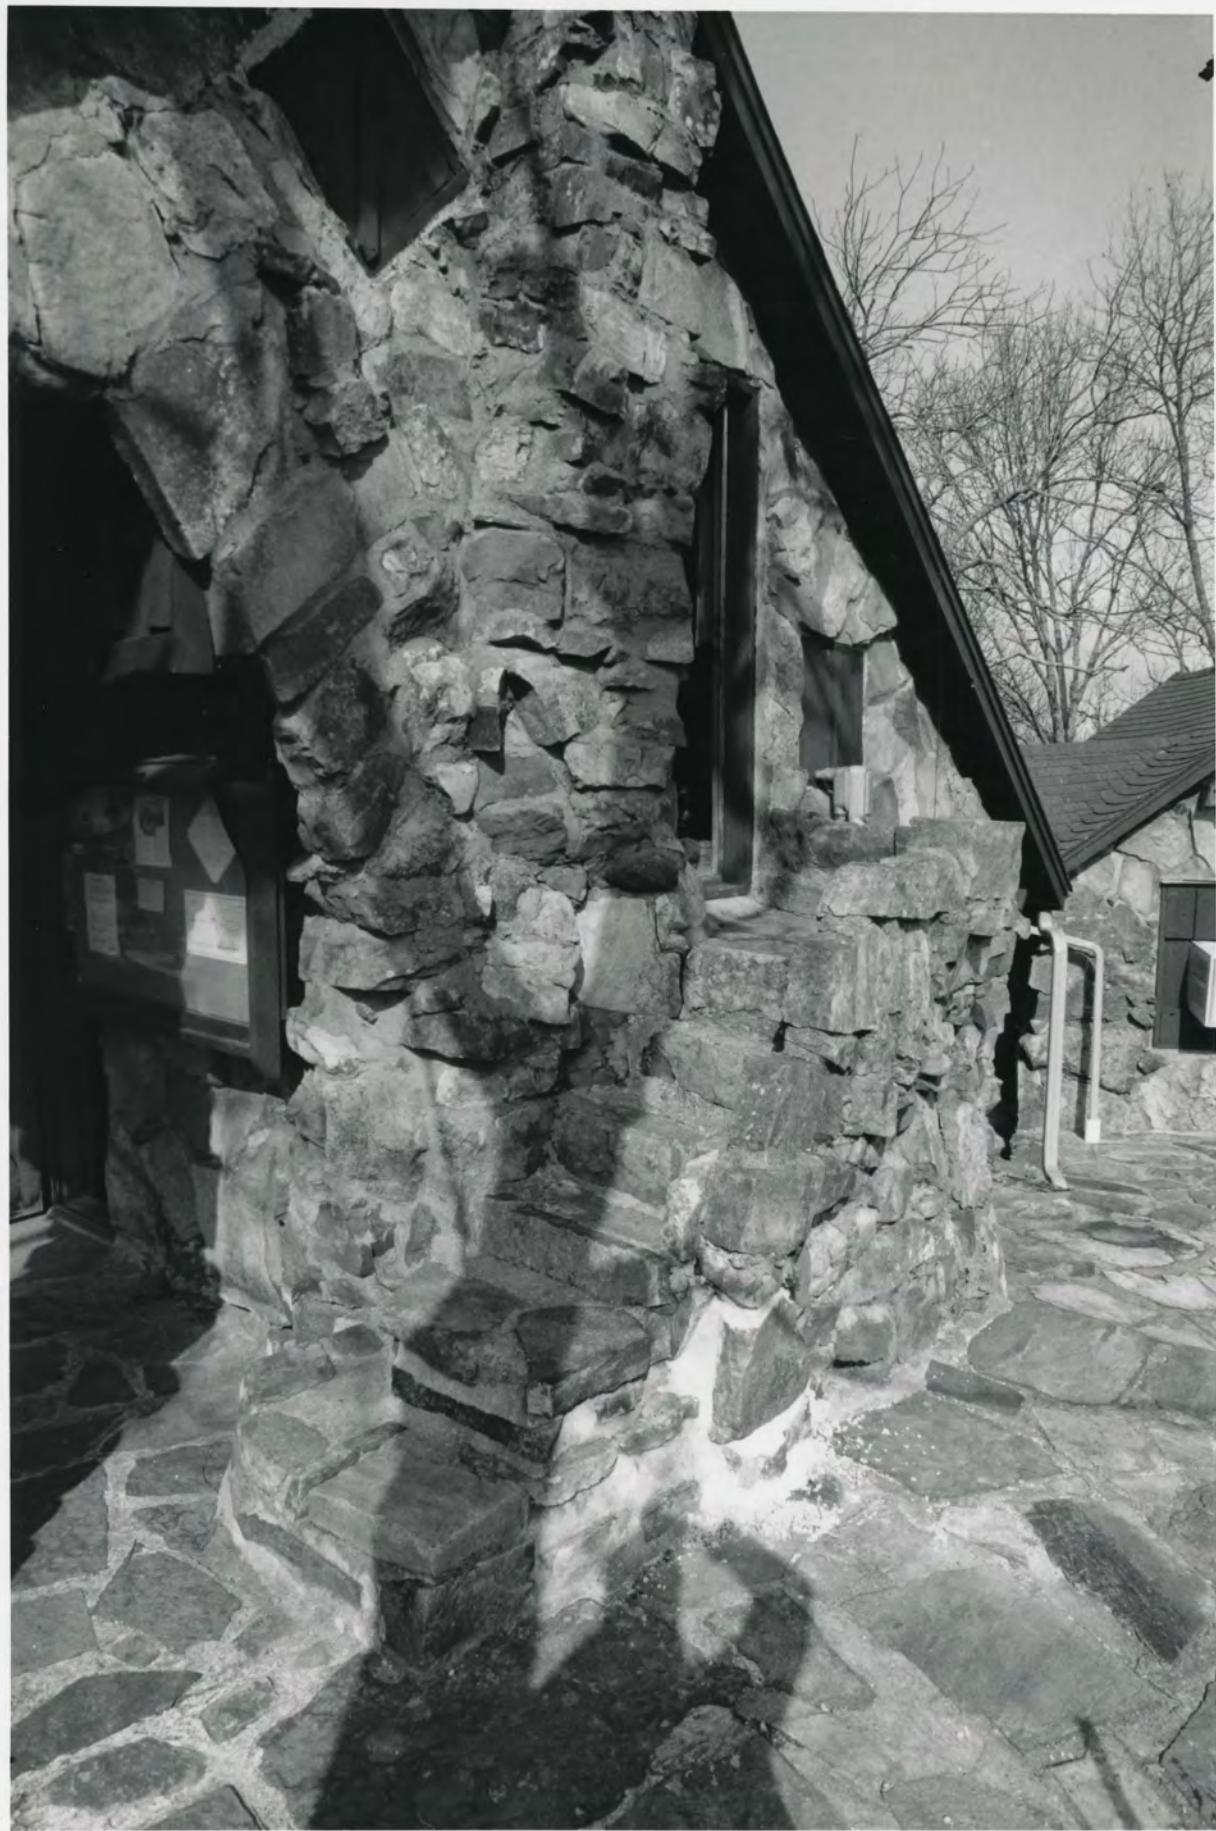
C. E. Foster House
Polk Co., Arkansas
Photograph by Patrick Zolner
November 1992
Negative on file at AHPP
View of exterior staircase
from the south

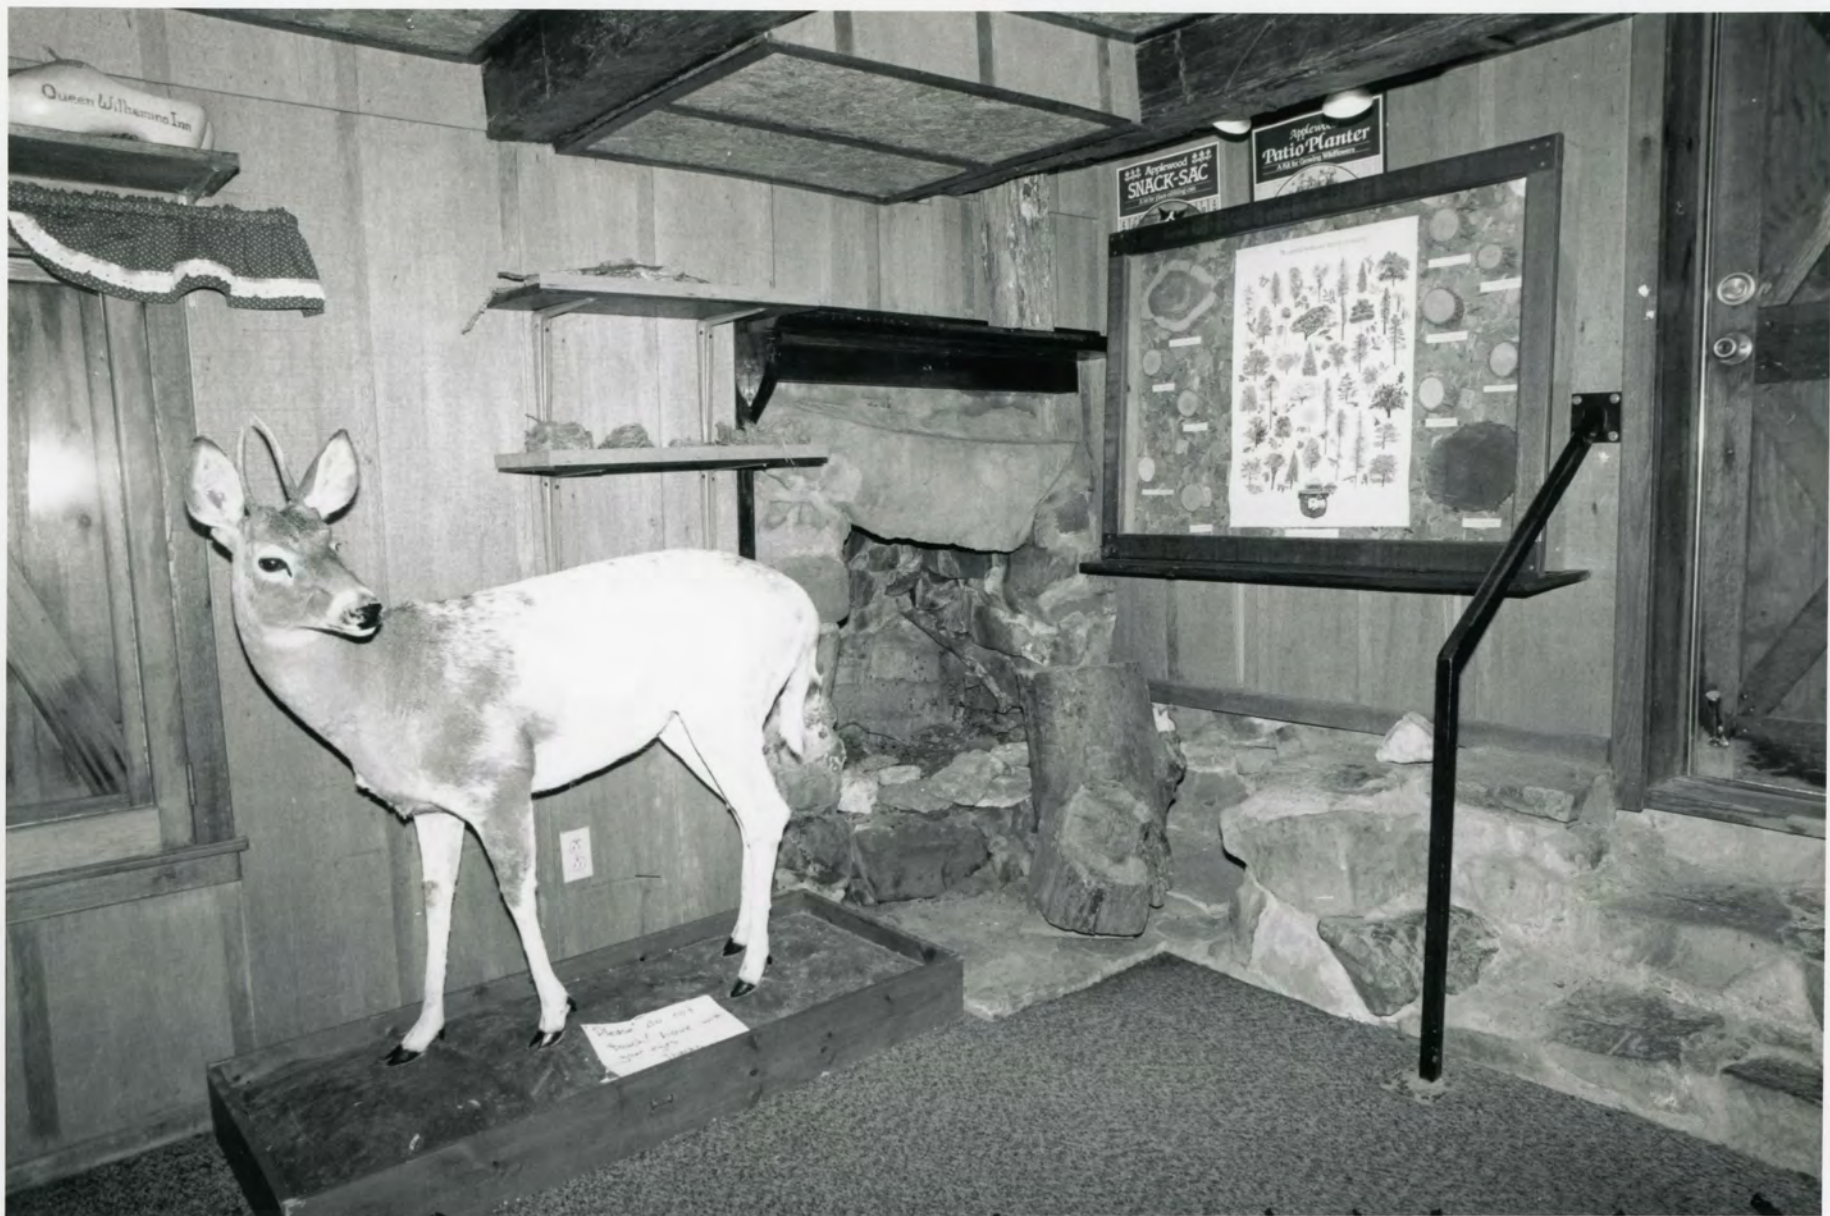
C. E. Foster House
Polk Co., Arkansas
Photograph by Patrick Zollner
November 1992
Negative on file at AHPP
View of first story of
front section

More serious changes have occurred to the interior of both sections. After acquisition by the state park, the ground floor of the front section was remodeled into an exhibit room (it had also been a gift shop previously), but is not currently being utilized for that purpose. An interior ladder to the second-story on this section was removed and the opening sealed, however, the upstairs room is virtually unaltered. Imitation-wood paneling was added to much of the interior of the rear section during a nonhistoric remodeling that also included walling off the cellar, which removed one set of stairs and left only an outside entry for the ground floor. The bathroom floor was raised level with that of the kitchen floor, and the outside entry to it was sealed. All of the small passage openings were closed during this remodeling, though one, between the ground floor and kitchen, has recently been reopened. The fireplace on the ground floor of the rear section was closed, and a heat pump was added to both sections. Although these alterations appear extensive, the basic structure and floor plan remains intact, and all of the changes are reversible.

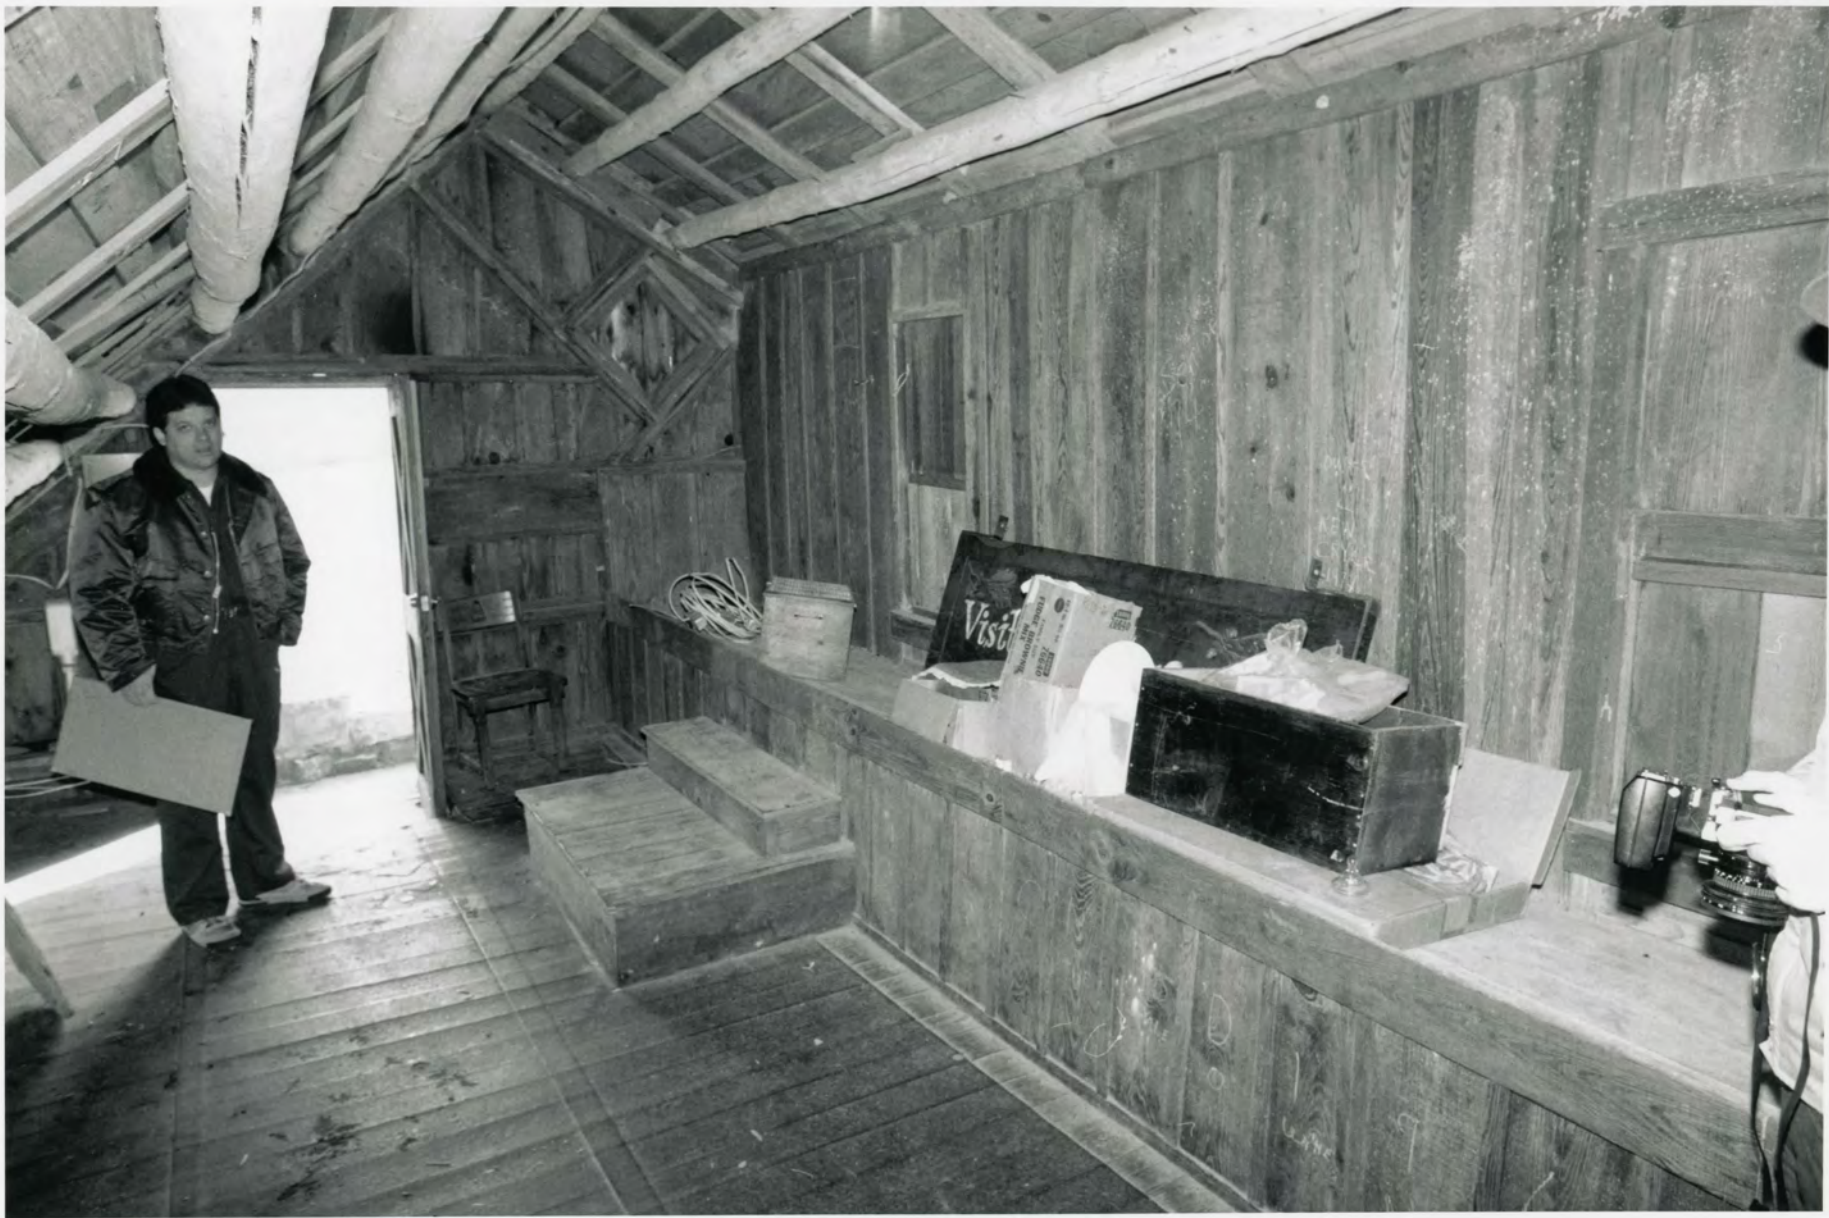
C. E. Foster House
Polk Co., Arkansas
Photograph by Patrick Zolher
November 1992
Negative on file at AHPP
View of upper story of
front, or southern, section
Note "head-to-toe" bed

The front, or southern, section has an inset porch on the front facade supported by three jagged stone arches. Underneath, a single-leaf door (not original) allows entry into the first floor, which consists of a single room that was used mostly for a living room, though people often slept there. An exterior chimney is located on the eastern elevation of this section and features stone stairs built around the chimney as they ascend to the second-story single-leaf entrance, which is to the north of the chimney. This elevation contains a large window opening on the first-story that has been boarded over, a smaller window to the north of the second-story entrance, and a diamond-shaped window (boarded over) to the south of the chimney. The opposing western elevation contains two different-sized window openings on each floor. In addition to the single-leaf entrance underneath the breezeway, there are two flanking window openings of different dimensions on the rear, or northern, elevation of the southern section. The second-story consists of one very narrow room with an unusual built-in bed, which was designed to sleep three children head to toe, along the entire length of the southern wall.

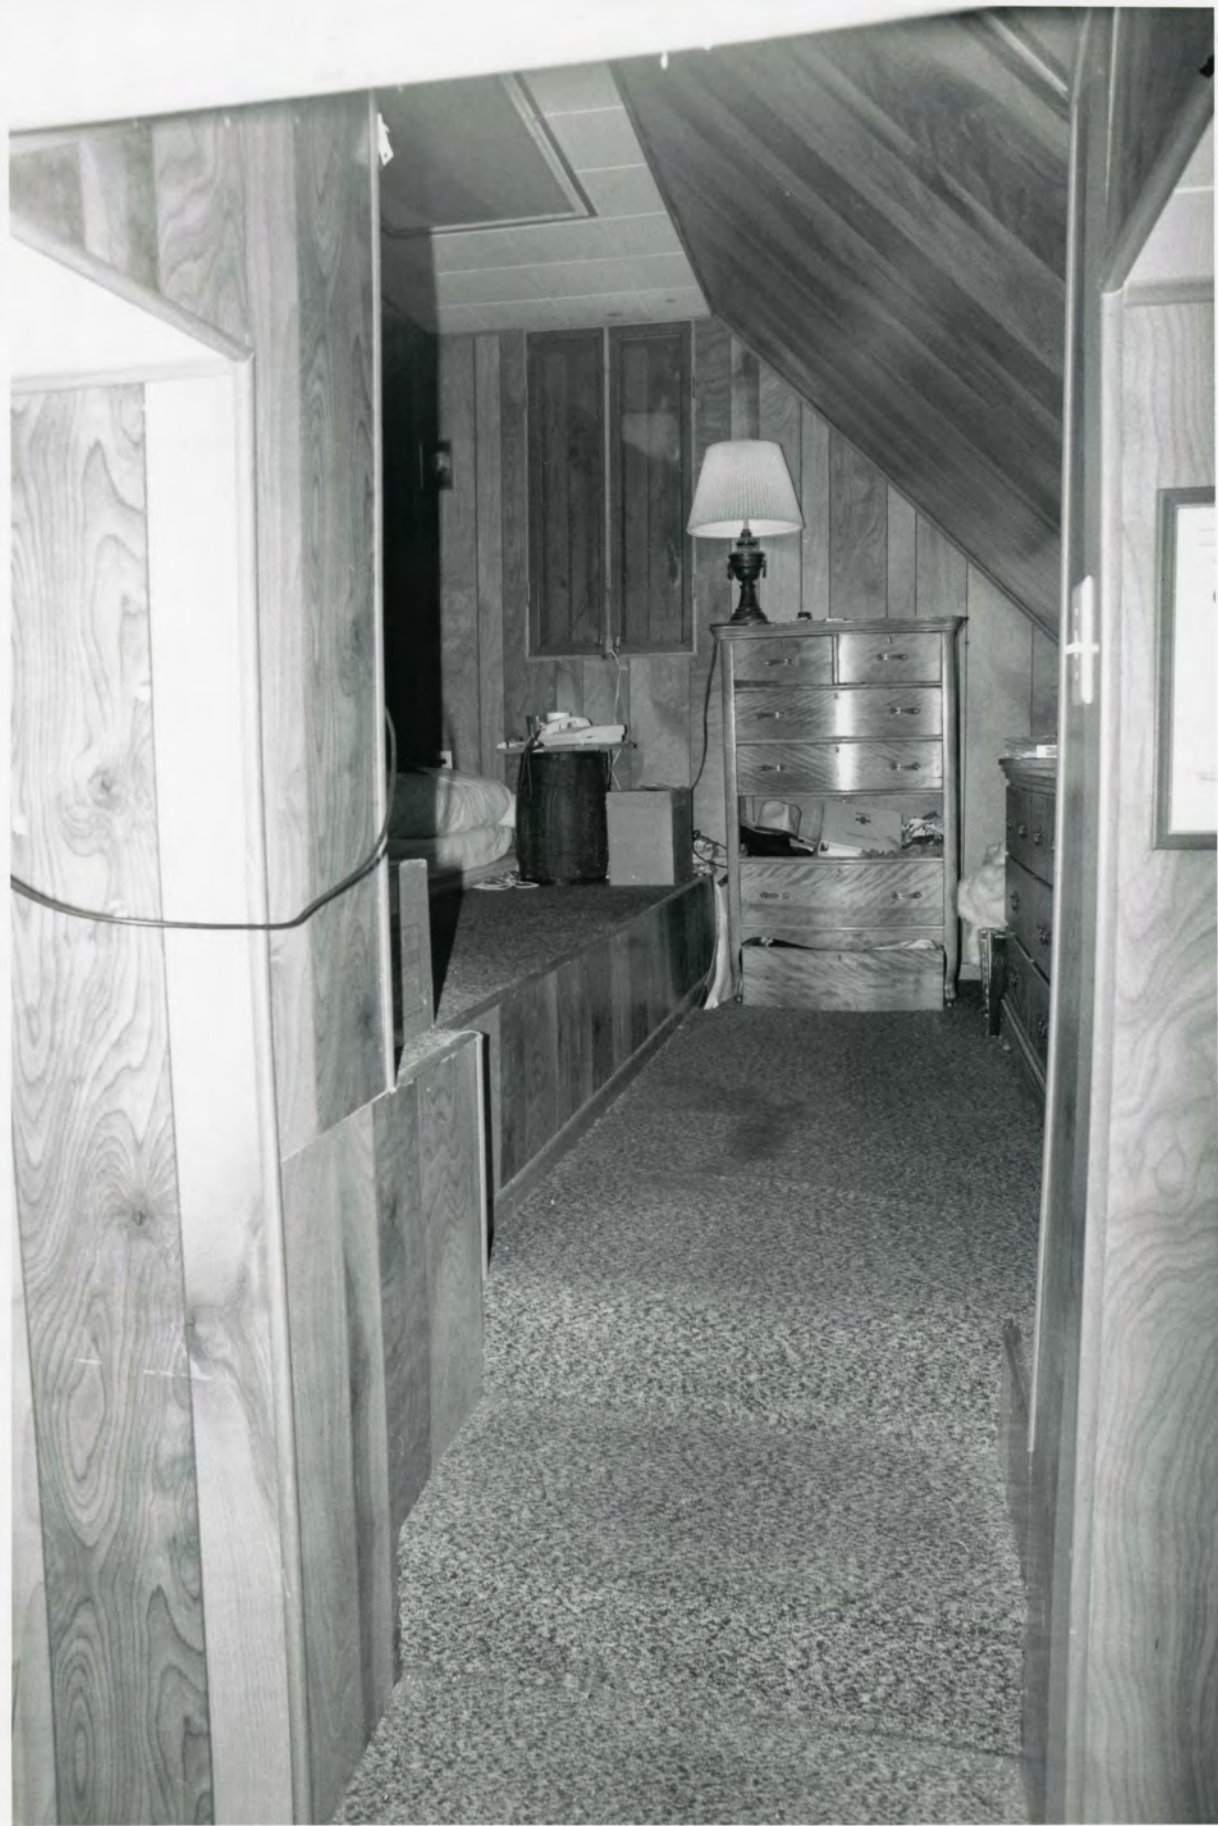
View of bedroom levels 5 & 6
of rear section

Perhaps the interior of this section is the most interesting feature of an already unusual house. Seven different levels were incorporated into the design in this order from bottom to top: cellar, ground floor, kitchen, bathroom, and three upper levels, each uneven with the other. Although all three levels were reputedly used as sleeping spaces, one level is more like a landing for the actual level that is big enough for a bed, and the uppermost level is really more of an attic space. Separate interior staircases of short length ascended clockwise to all of the rooms. In an apparent effort to reduce the amount of stair climbing, each level had small openings so as to pass things through.

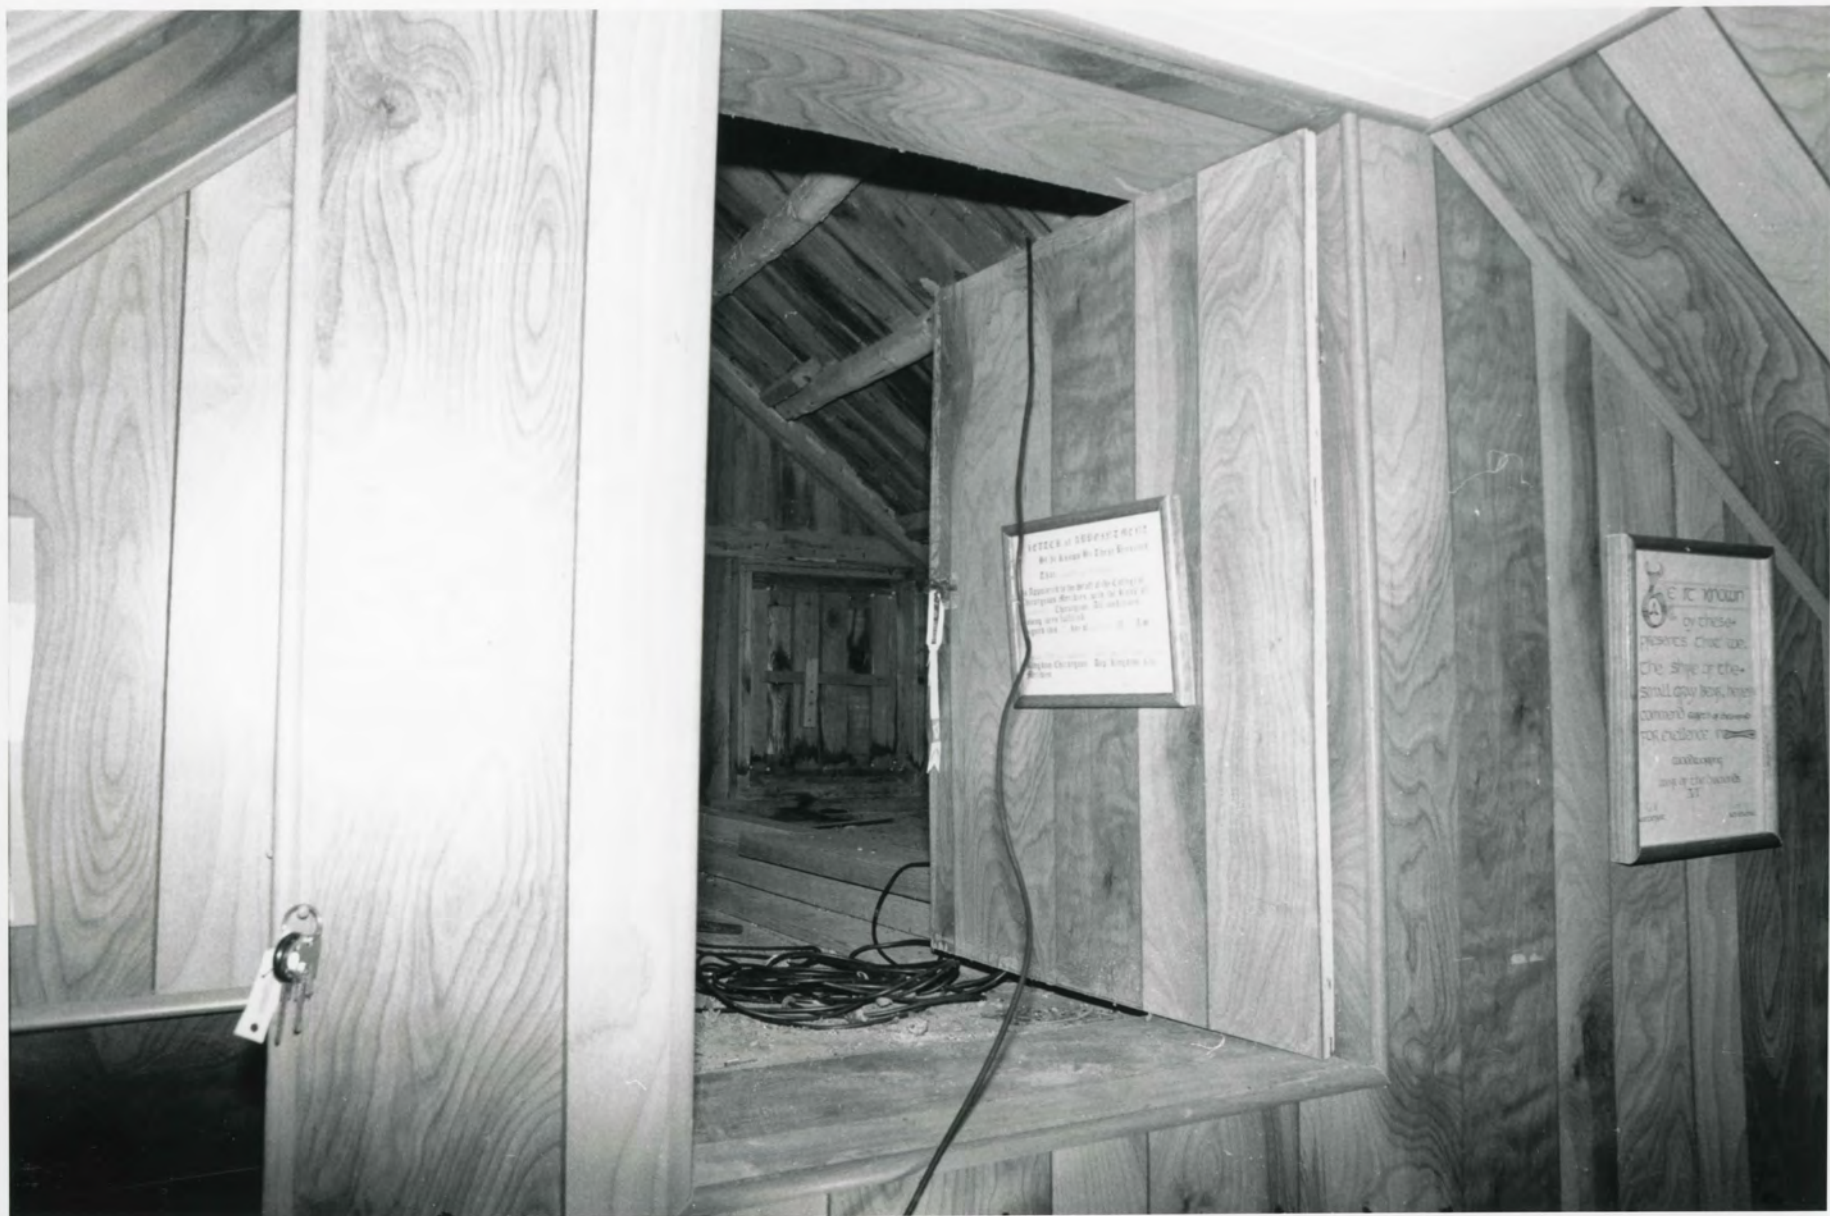
View of entrance into attic/bedroom
in rear, or northern, section
