KENTUCKY HISTORIC RESOURCES INVENTORY

Site No. Mr 82

1. Historic Name(s) <u>Smith house</u>		22. ADD/County <u>Bluegrass / Harrison</u> <input type="checkbox"/> <u>049</u>	
Original Owner <u>Smith</u>		23. U.S.G.S. Quadrant (15'/75') <u>Shawhan vic</u> G.I.S. Mod. <u>138</u>

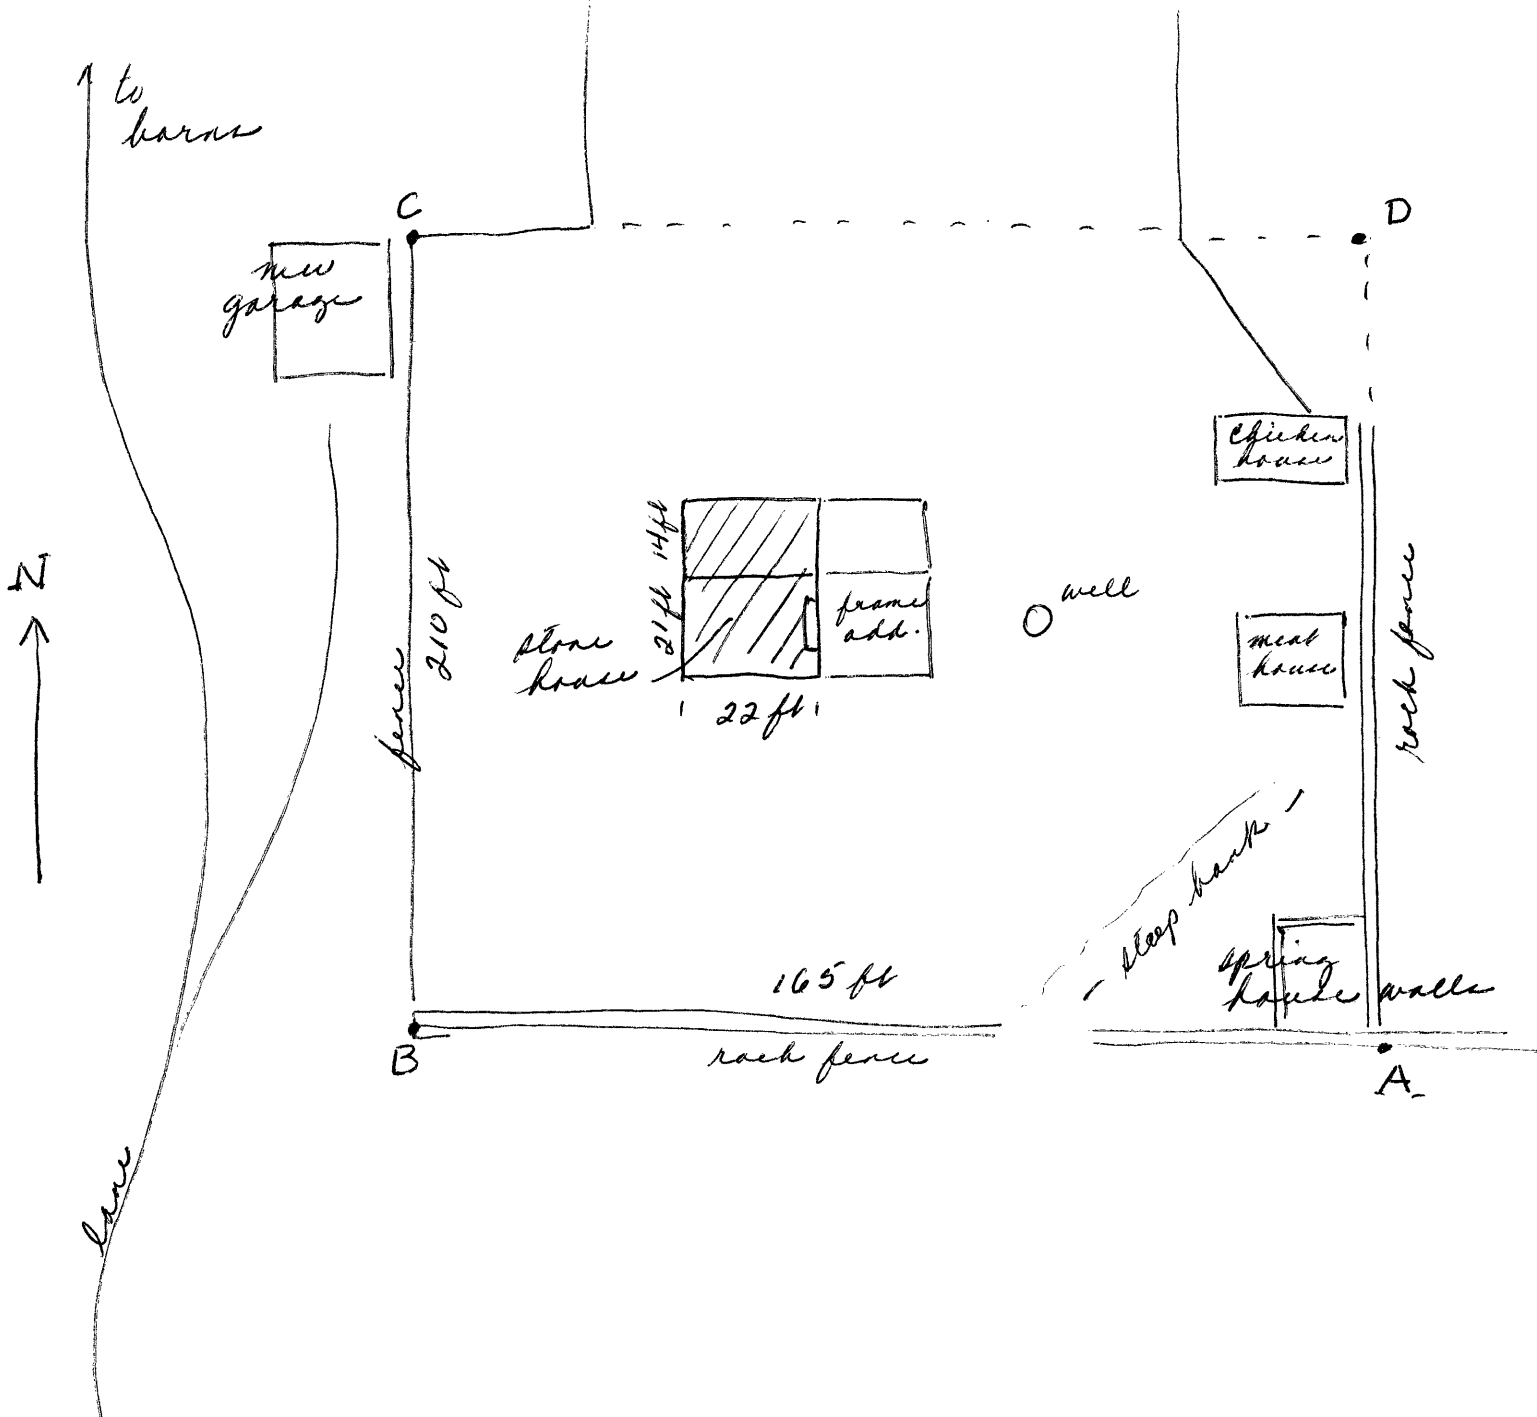
SKETCH MAP OF SITE SHOWING BOUNDARIES AND KEY BUILDINGS AND FEATURES WITH NORTH ARROW.

Beginning at A at the SE corner of the spring house, thence with rock fence W 165 ft to B, thence N 210 ft along wire fence to C, thence E across yard, past fence row ^{165 ft} to D, thence S with rock fence 210 ft to the beginning, containing the stone house, meat house and stone spring house - about .8 acre.
 (Probably showing govt. land records for town.)
