• The Champion School
Collings and Lynne Aves.
Haddon Township, Camden Co, NJ

• October 1987

• Margaret Westfield
401 Bellmawr Ave.
Haddon Hts, NJ 08035

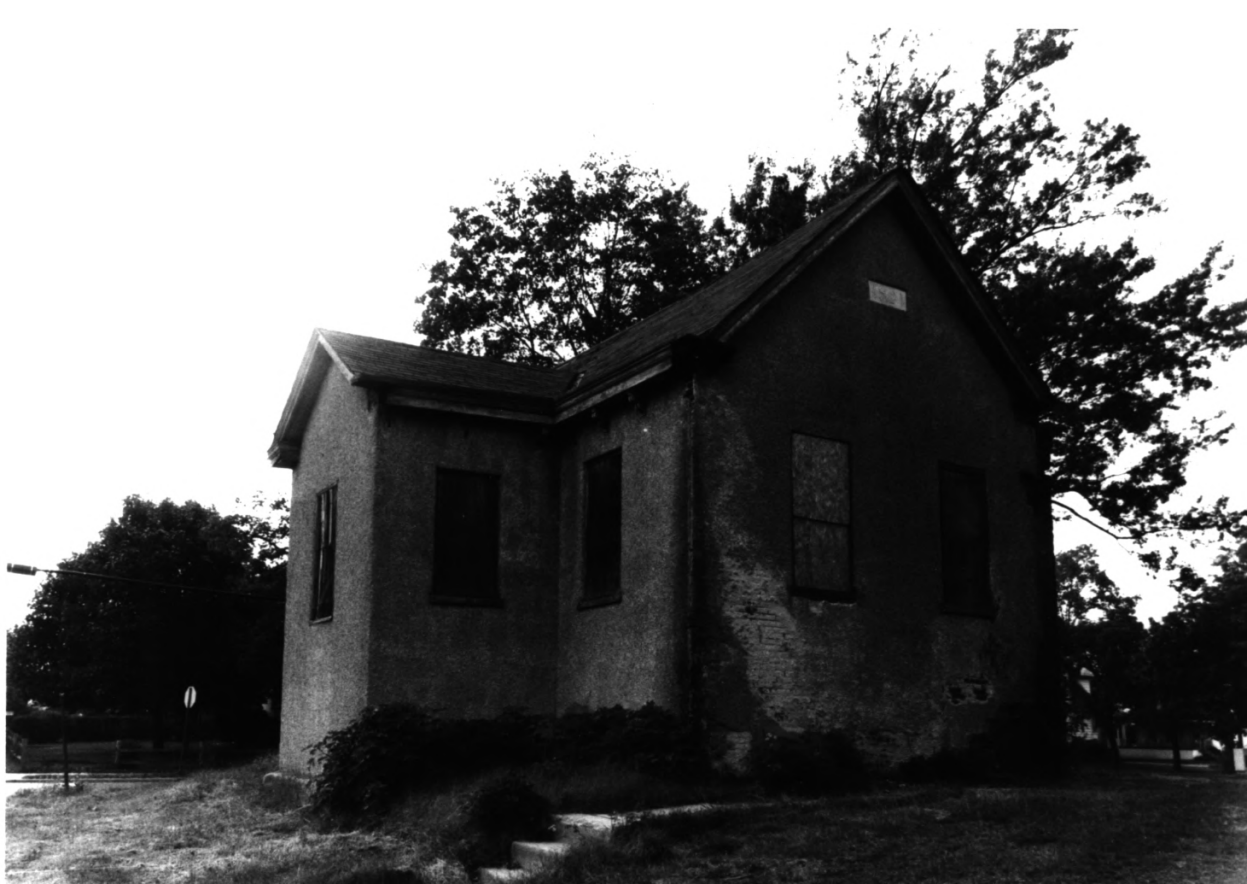
- The Champion School
Collings and Lynne Aves.
Haddon Township, Camden Co., NJ
- October 1987
- Margaret Westfield 401 Bellmawr Ave.
Haddon Hts, NJ 08035
- View of the east elevation of the Champion School from the southeast, showing date stone in gable end, brickwork beneath deteriorating later stucco, bracketed box cornice, window openings with show sills, and altered front vestibule opening (originally a doorway).
- Photograph 1 of 11

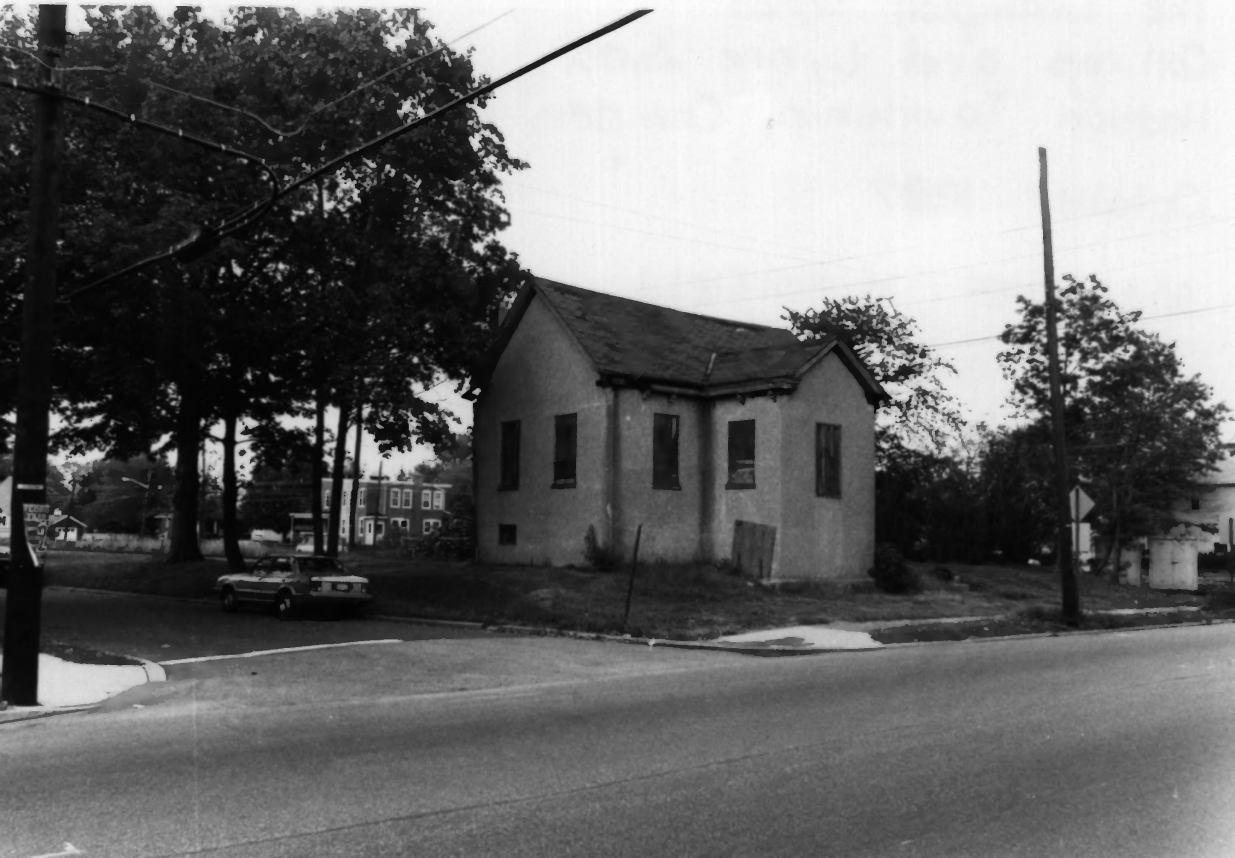
- The Champion School
Collings and Lynne Aves.
Haddon Township, Camden Co., NJ
- October 1987
- Margaret Westfield 401 Bellmawr Ave.
Haddon Hts, NJ
08035
- View of the Champion School from the southwest showing front (Collings Ave) and side (Lynne Ave) elevations. Note front window opening on vestibule (originally a doorway) and added cellar opening on side elevation.
- Photograph 2 of 11

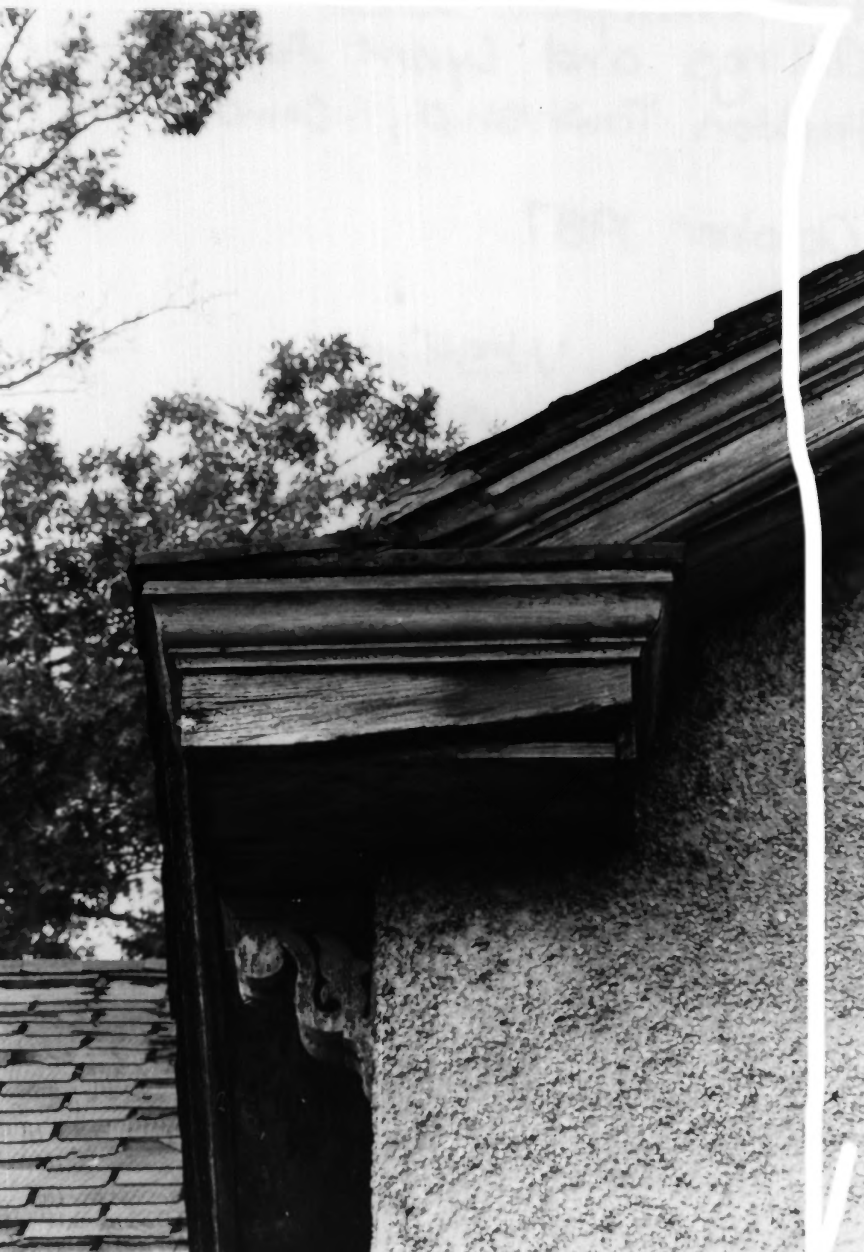
- The Champion School
Collings and Lynne Aves.
Haddon Township, Camden Co., NJ
- October 1987
- Margaret Westfield
401 Bellmawr Ave.
Haddon Hts, NJ 08035
- Detail of vestibule cornice,
facing north, showing
ogee/cove box cornice with
scrolled cornice brackets.
- Photograph 4 of 11

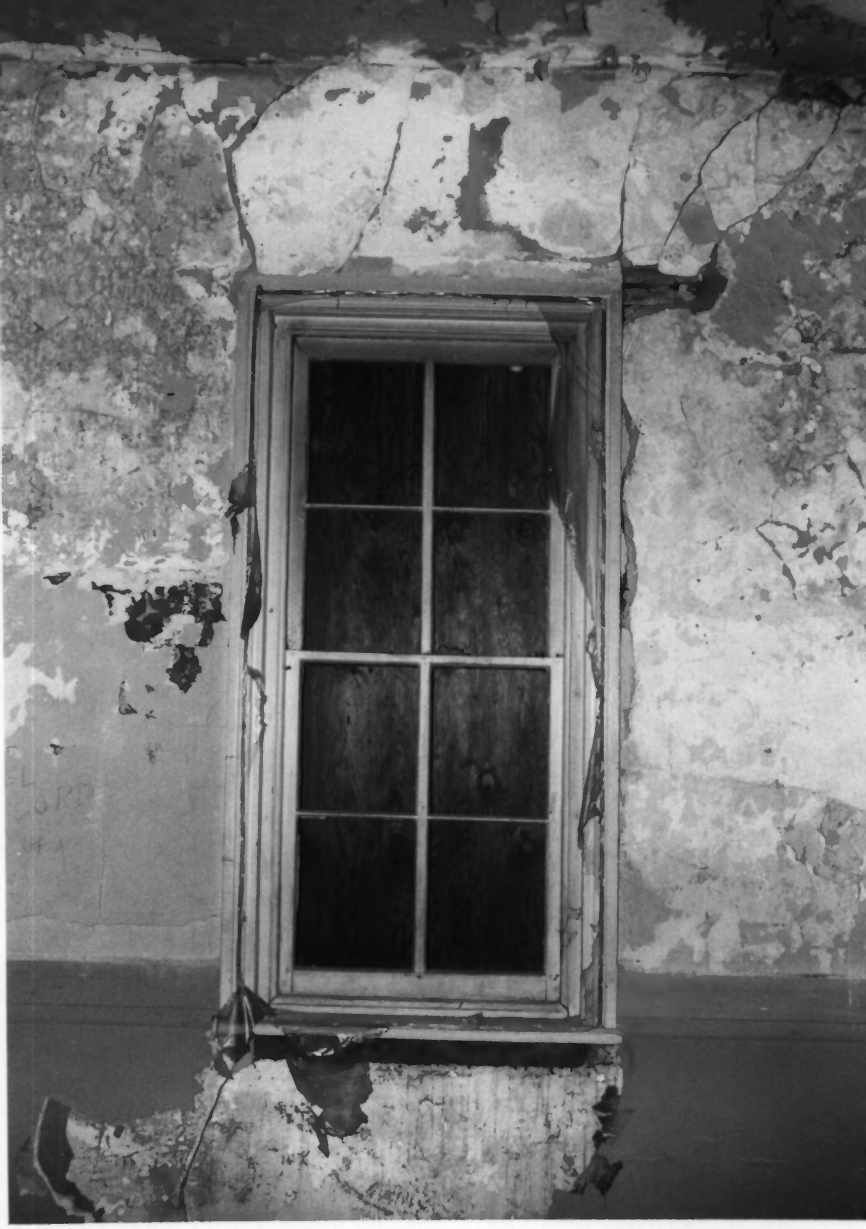
- The Champion School
Collings and Lynne Aves.
Haddon Township, Camden Co., NJ
- October 1987
- Margaret Westfield
401 Bellmawr Ave.
Haddon Hts, NJ 08035
- Detail of four-over-four sash simulated casement double-hung school room window from the interior, facing south. Note evidence of original sill apron beneath 20th c. plaster board wainscotting (partially removed).
- Photograph 5 of 11

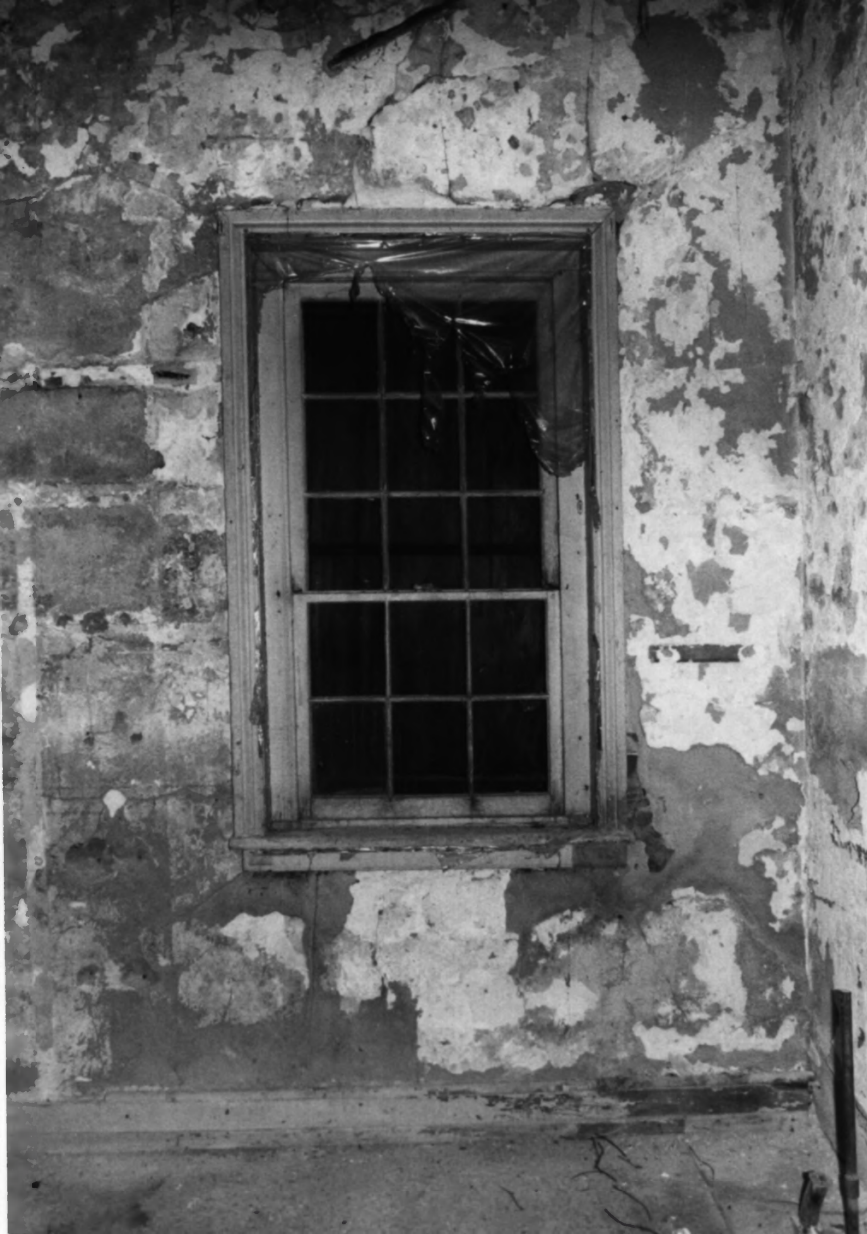
• Photograph 6 of 11

• Detail of nine-over-six
sash vestibule window
from the interior facing
west. Note wooden trim
of both window and
original baseboard.

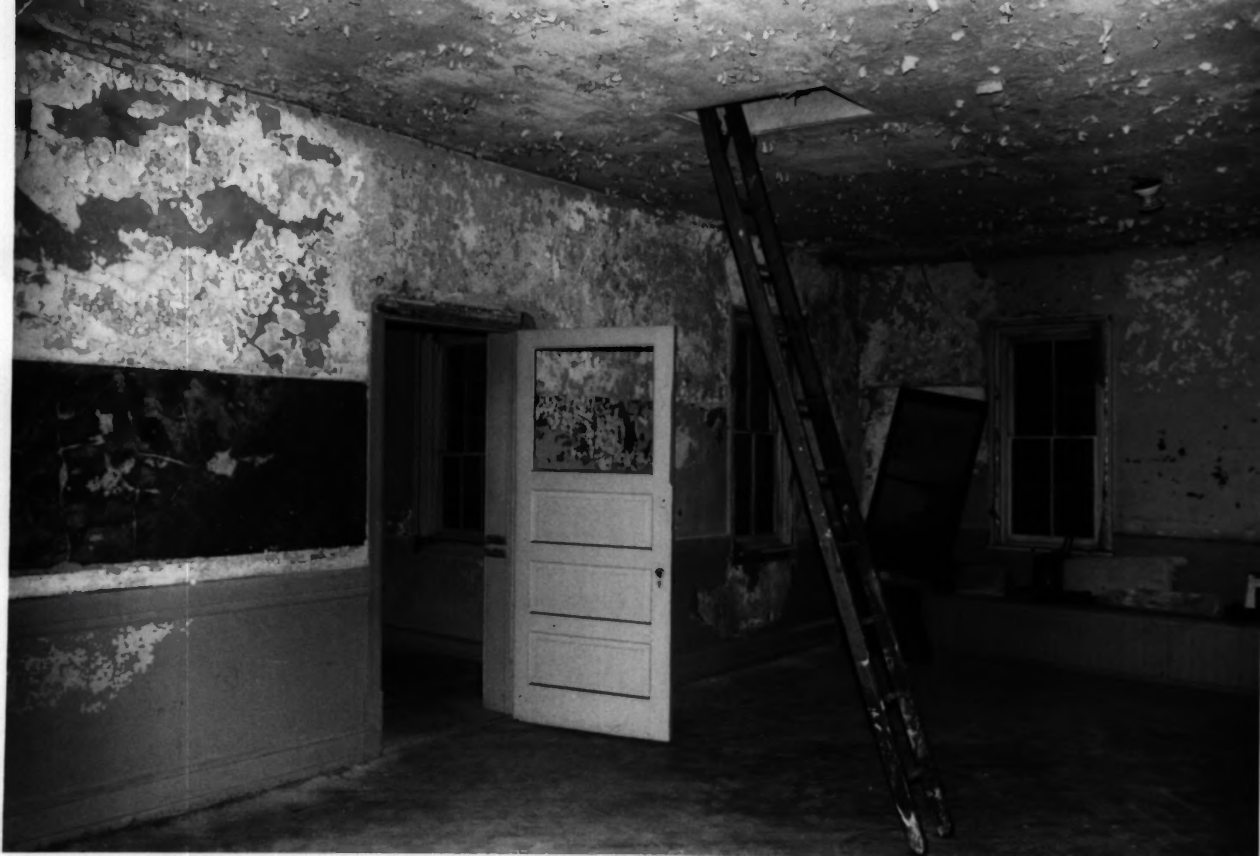
- The Champion School
Collings and Lynne Aves.
Haddon Township, NJ, Camden Co.
- October 1987
- Margaret Westfield 401 Bellmawr Ave.
Haddon Hts, NJ 08035
- View of the south and west walls of
the school room from the northeast
showing plaster walls with integral
blackboard, plaster ceiling with hatch
to attic, plaster board, wainscoting,
wood baseboard and floor, and west
wall of vestibule.
- Photograph 8 of 11

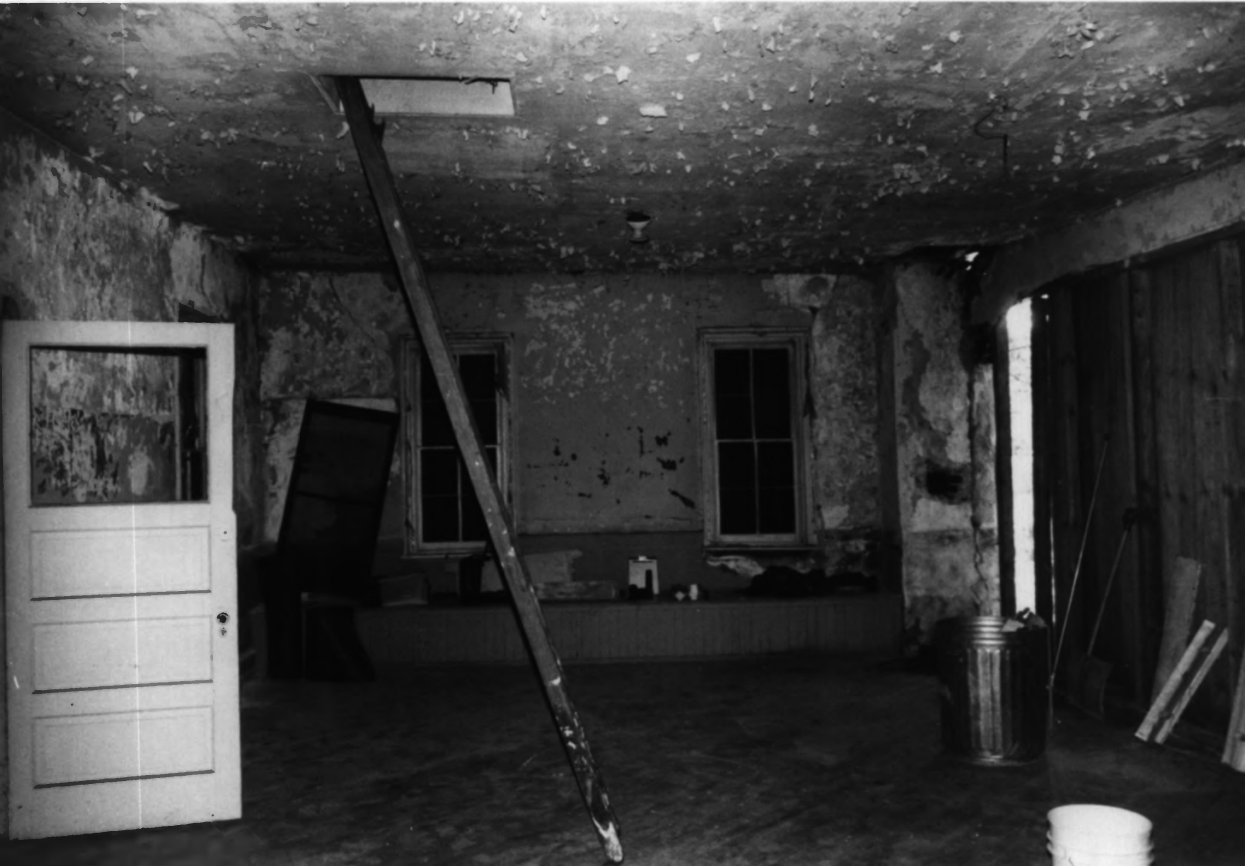
- The Champion School
Collings and Lynne Aves.
Haddon Township, Camden Co., NJ
- October 1987
- Margaret Westfield 401 Bellmawr Ave.
Haddon Hts, NJ 08035
- View of the west wall of the
school room showing plaster walls and
ceiling, wood floor, 4/4 simulated case-
ment DH windows, plaster board wain-
scotting above wood storage bench,
added furnace chimney, door to vest-
ibule, and altered rear wall.
- Photograph 9 of 11

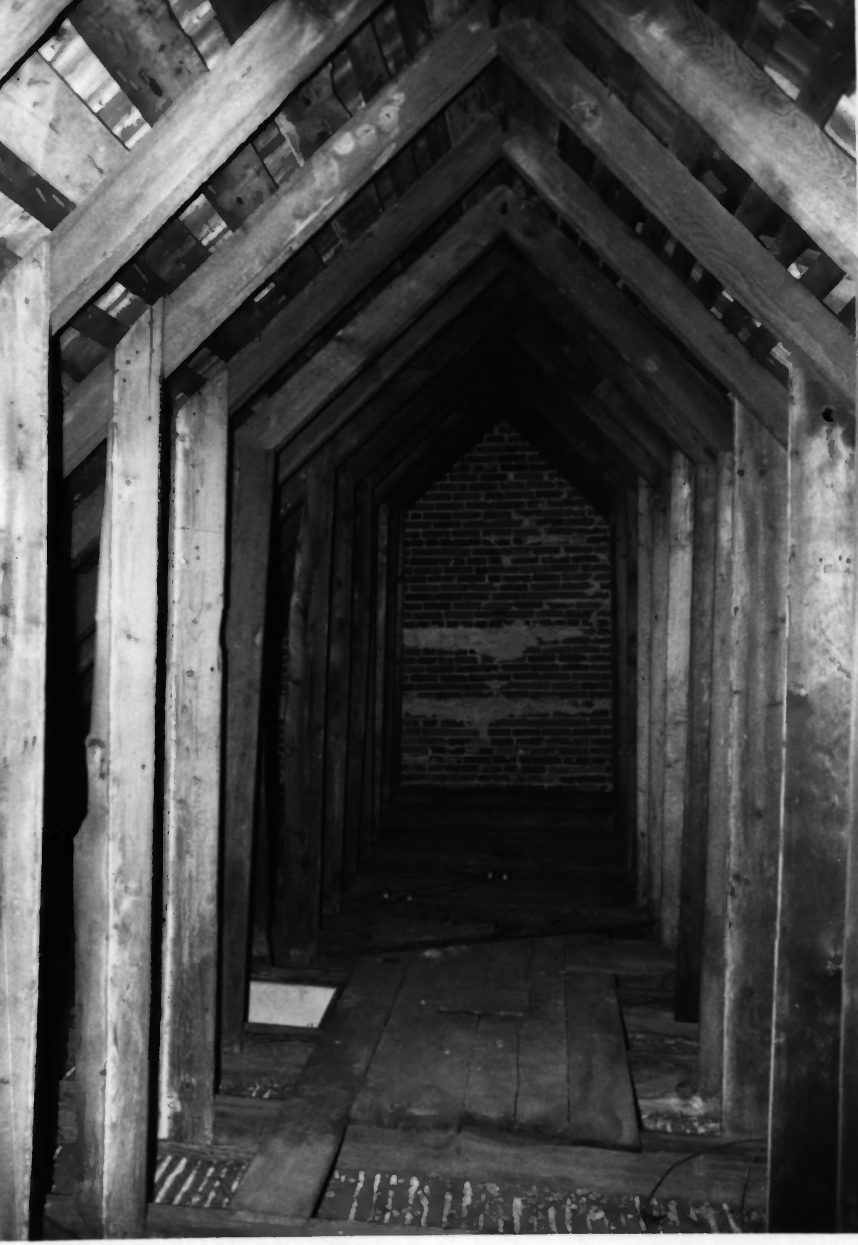
• Photograph 10 of 11

- The Champion School
Collings and Lynne Aves.
Haddon Township, Camden Co., NJ
- October 1987
- Margaret Westfield
401 Bellmawr Ave.
Haddon Hts, NJ 08035
- View from the east of the
attic showing pegged,
mortised-and-tenoned rafters,
wood shingle roof on spaced
sheathing, brick end wall,
and first floor ceiling lath.

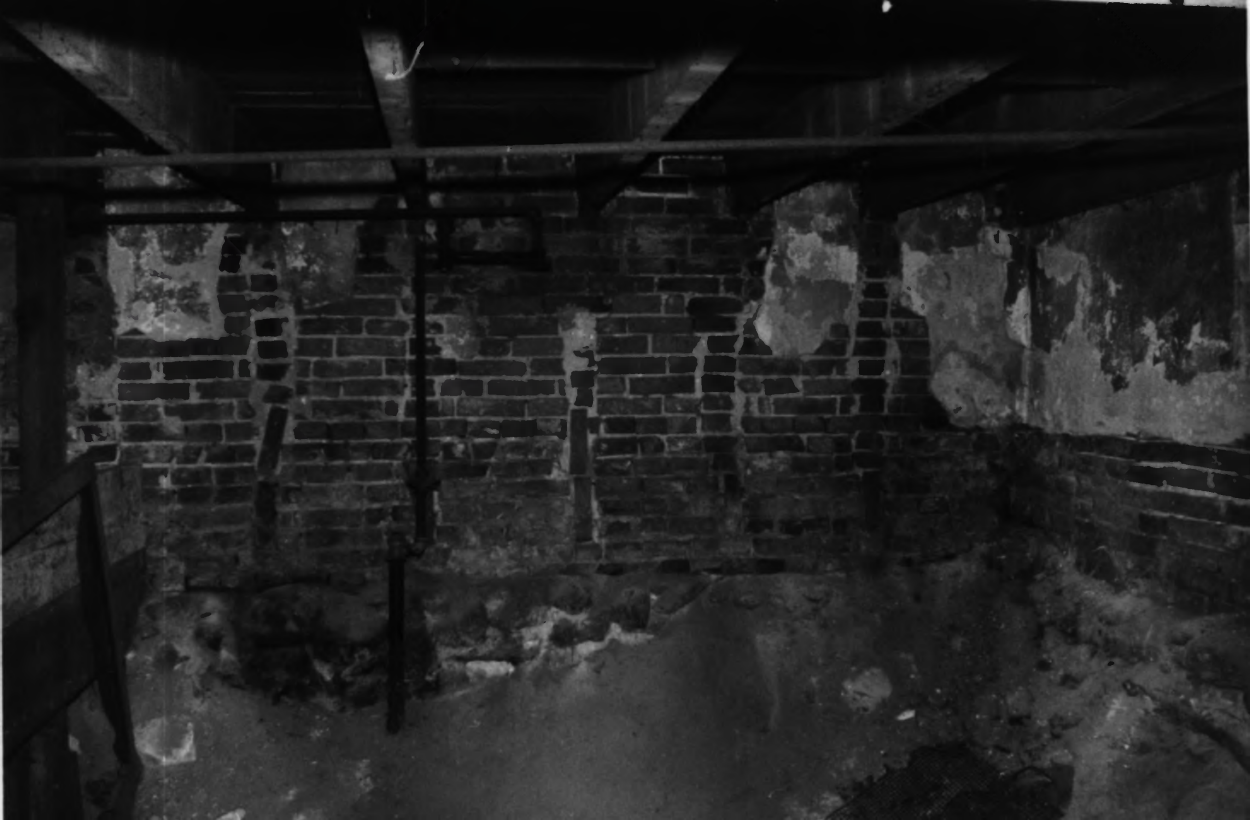
- The Champion School
Collings and Lynne Aves.
Haddon Township, Camden Co, NJ
- October 1987
- Margaret Westfield 401 Bellmawr Ave.
Haddon Hts, NJ 08035
- View of the southwest corner of the cellar from the north, showing infilled brick channels, excavated dirt floor, and portions of painted original plaster, all evidence of the floor's mid-19th c. raising.
- Photograph 11 of 11
