NATIONAL HISTORIC LANDMARK NOMINATION

KENWORTHY HALL

Other Name/Site Number: Carlisle Hall, Edward Kenworthy Carlisle House

**Describe Present and Historic Physical Appearance.****Setting And General Description**

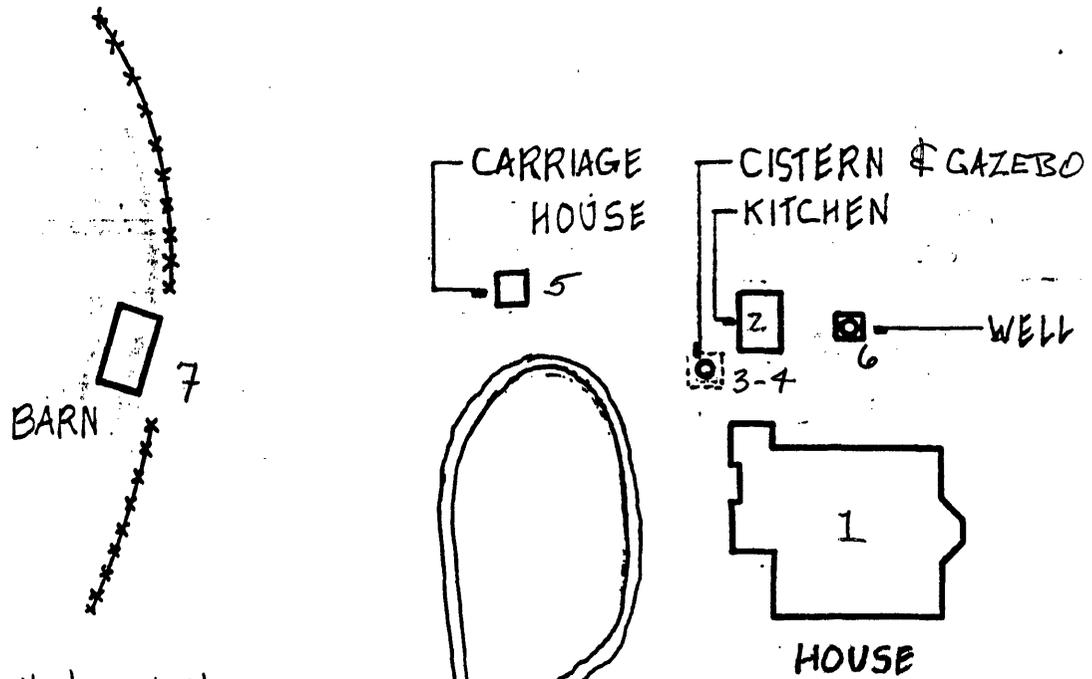
Contributing & Non-Contributing Structures

1. MAIN HOUSE
2. KITCHEN-LAUNDRY
3. CISTERN
4. GAZEBO (NON-CONTRIBUTING)
5. CARRIAGE HOUSE / SMOKE HOUSE
6. WELL HOUSE
7. BARN (NON-CONTRIBUTING)
