Charles Wiedemann House
1102 Park Avenue
Newport, Campbell County, Ky.

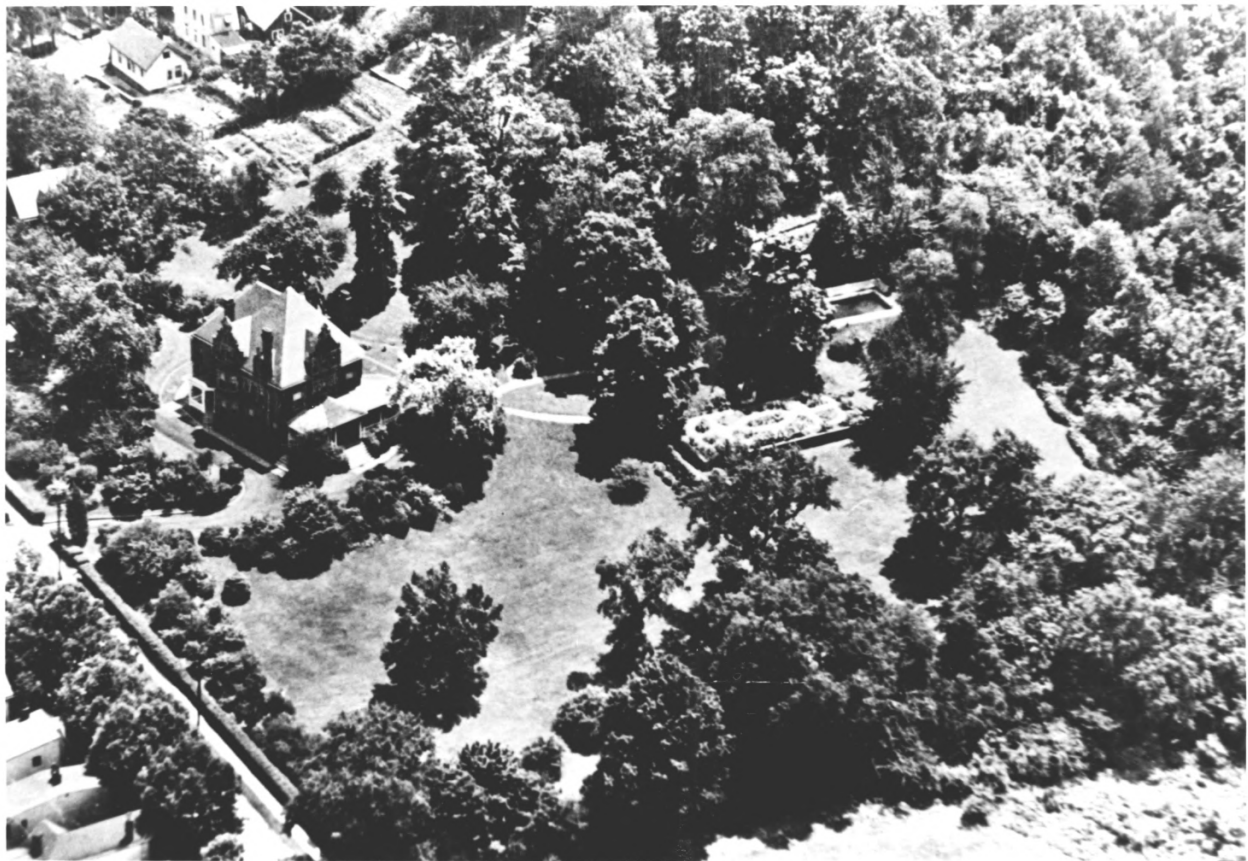
Photo 1

Ca. 1930 airview of property from approximately northeast. Park Avenue crosses view at lower left; Miller Street is at upper left. The Wiedemann House is at left center, with its one-story front porch facing north toward Cincinnati. The rose-garden terrace and swimming pool show at right center, against the wooded hillside at upper right. The railroad crosses under the trees at lower right.

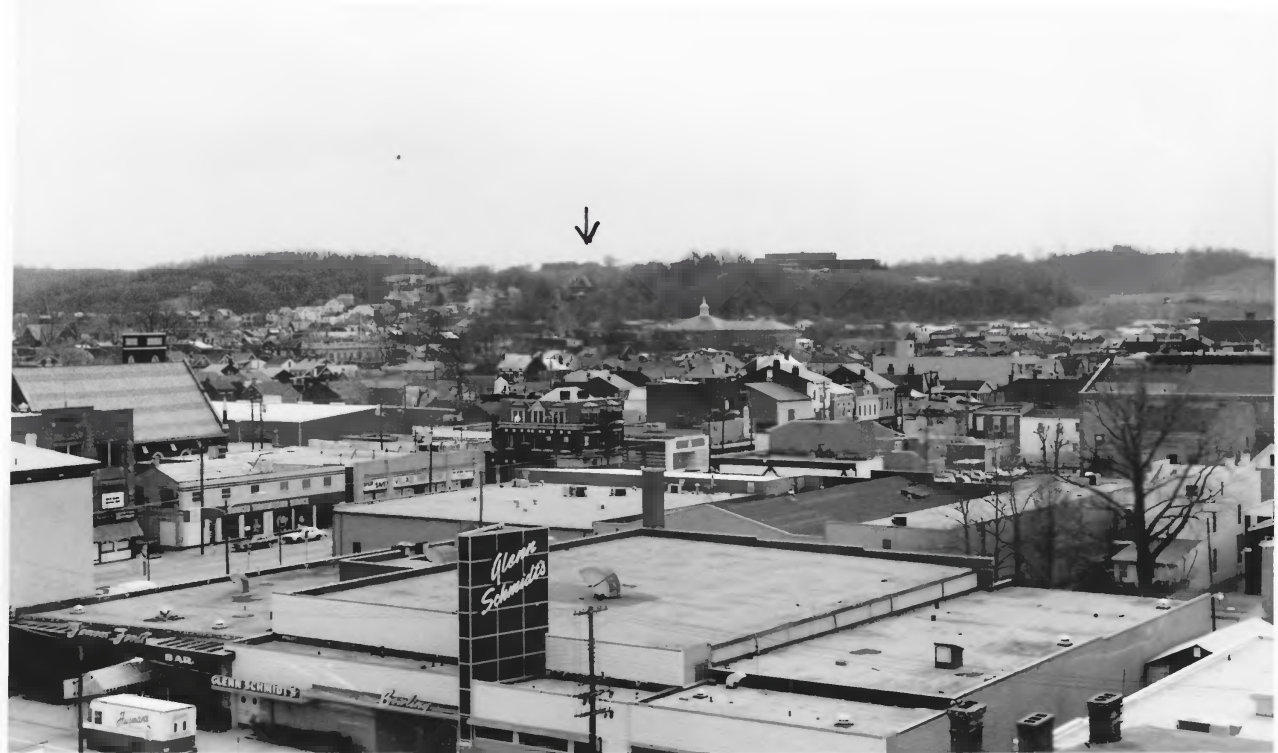
Photo 2

View of hills southeast of Newport, looking southeast from southeast corner of 4th and York Streets in downtown Covington (opposite the Courthouse). The Wiedemann House, with its triangular gable and roof shape, is centered in the photograph, just under the brow

of the hill, with the more modest residential development along the Park Avenue dip shown just to the left of it. The High School is the long low structure at the crest of the hill to the right.

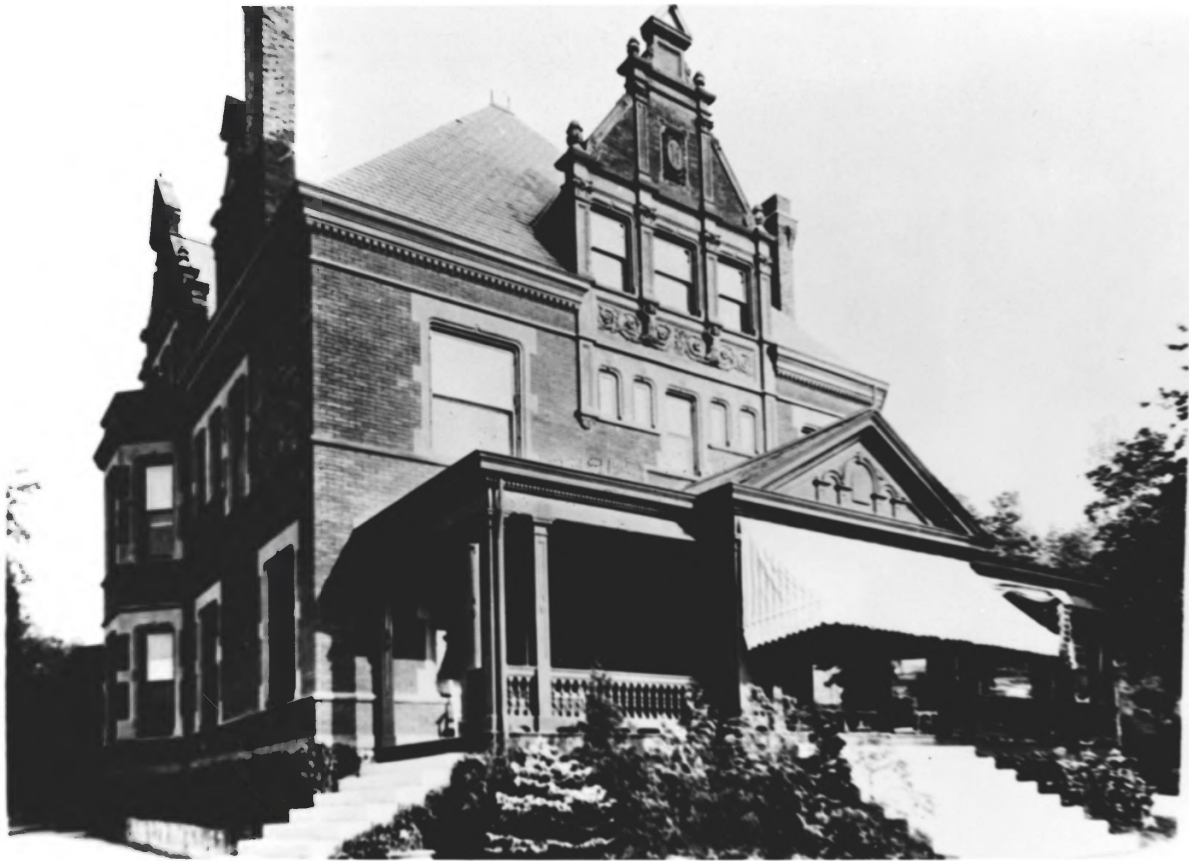
Photo 3

View of north front (right) and east side from the northeast, ca. 1930. The dark coloring is probably original, with the woodwork harmonizing with the red brick and sandstone, whose details show particularly clearly in this view. The small missing gable abut-

ting the northeast corner chimney also shows here.

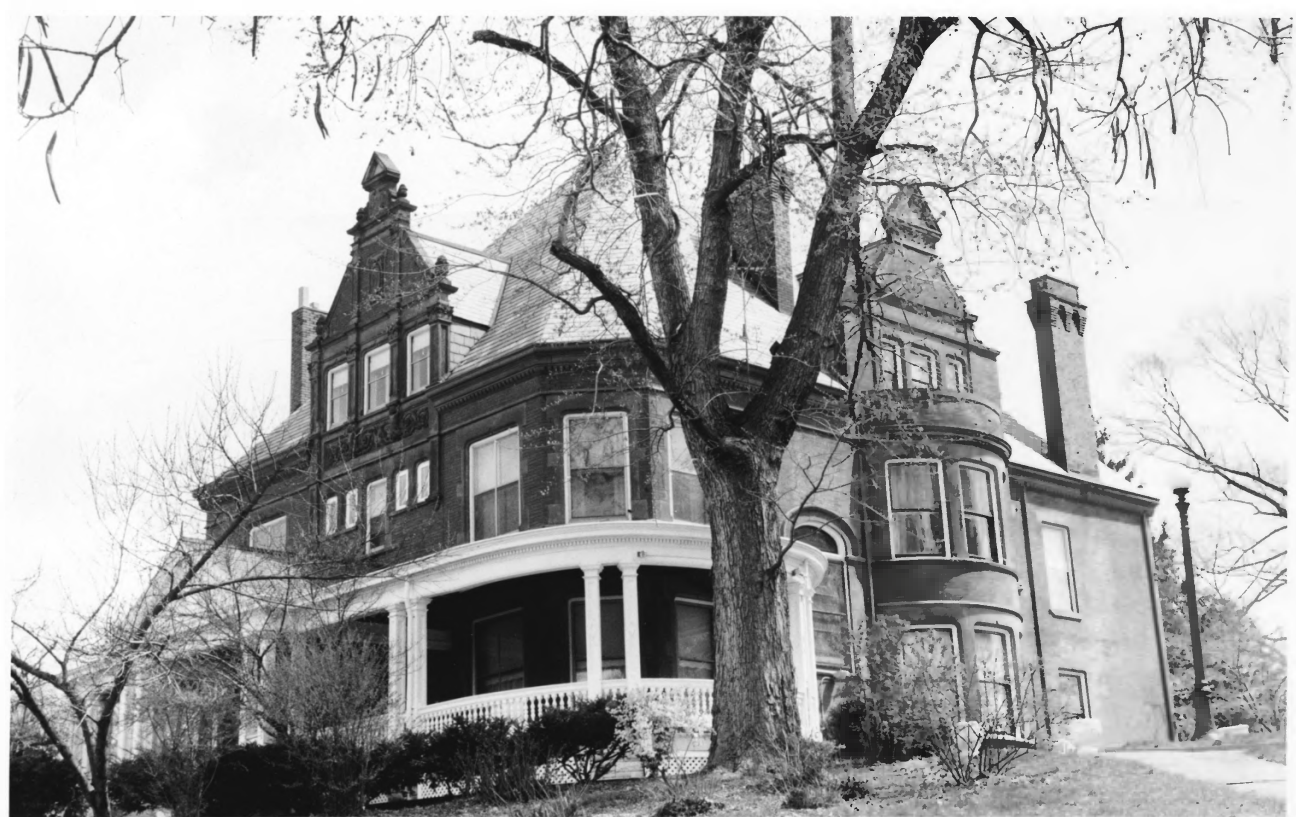
Photo 4

View from northwest showing north front (left) and west side from below.

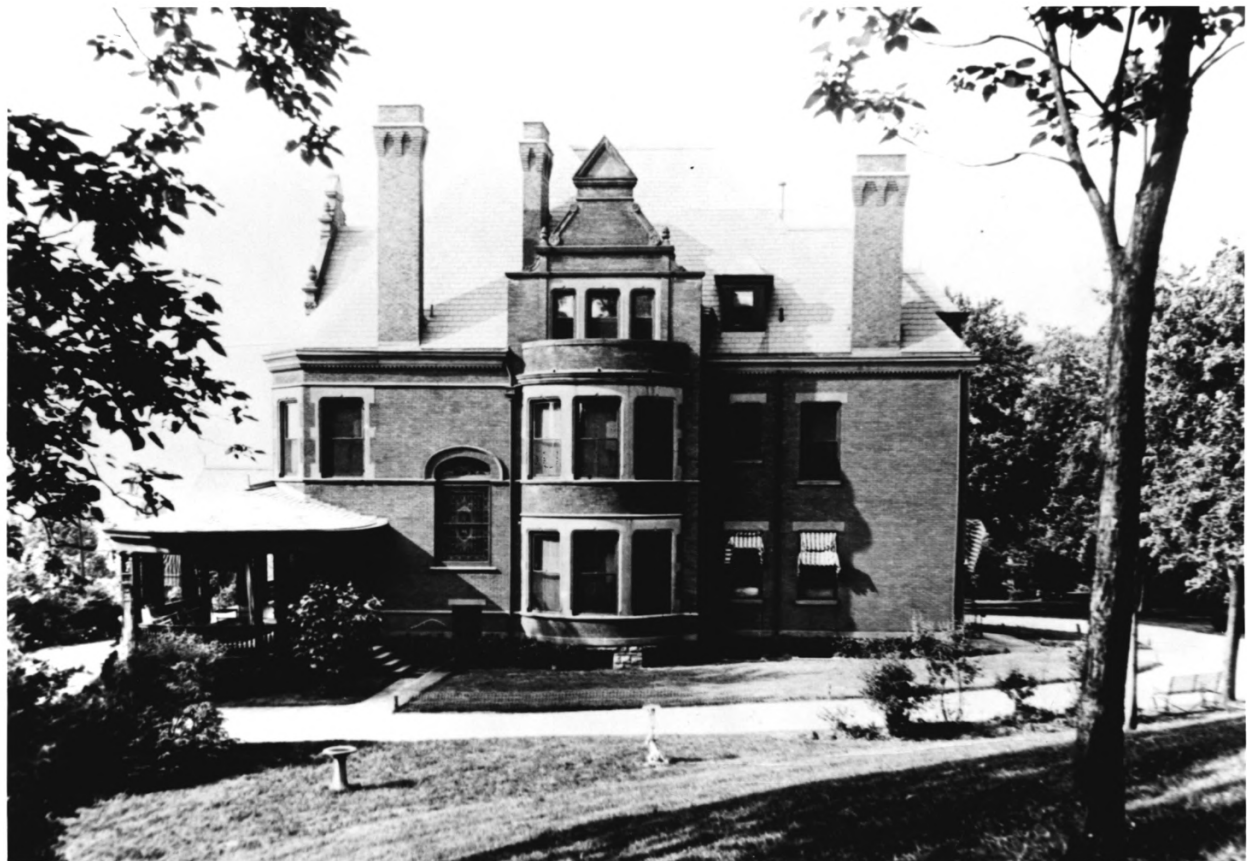
Photo 5

View of west side ca. 1930, showing original chimney of stair-hall and master bedroom now missing, at left.

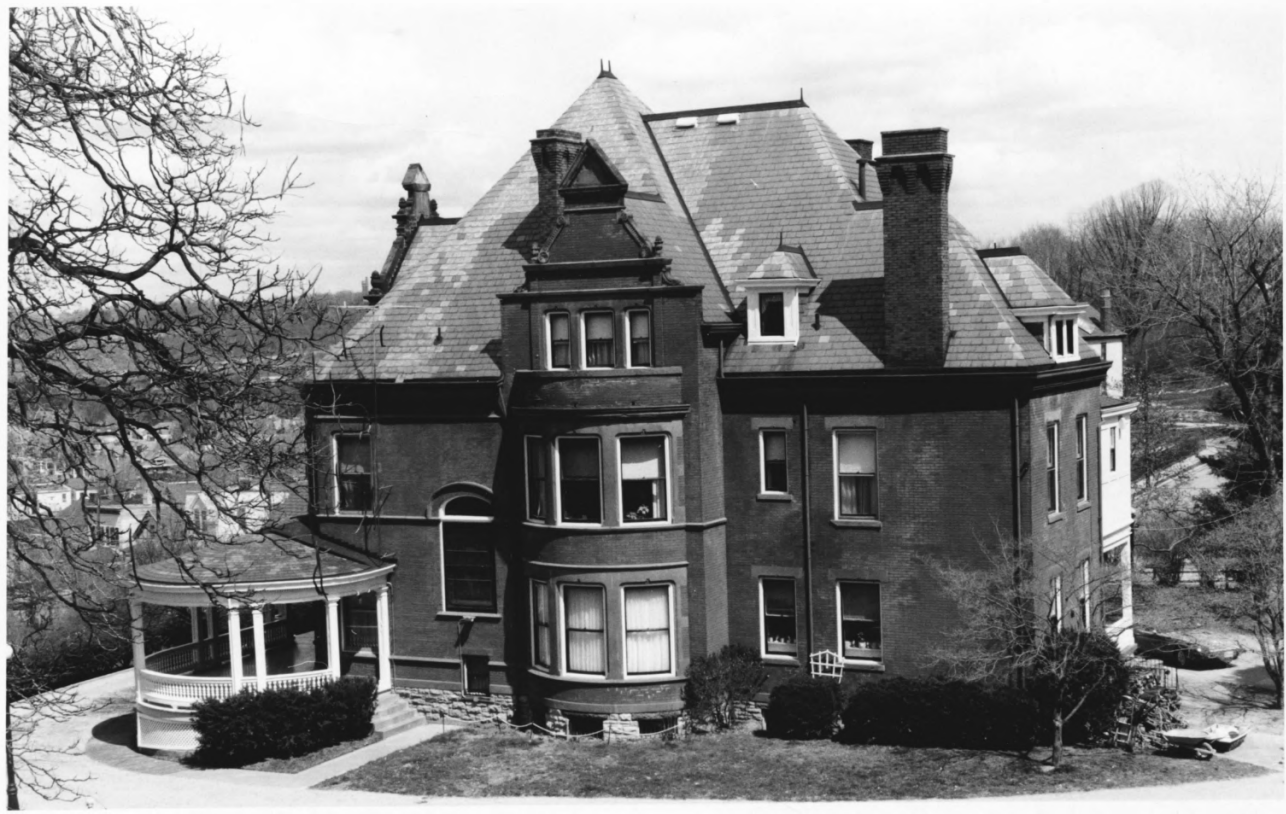
Photo 6

View of west side and part of rear (at right) from hillside to southwest, with glimpse of Park Avenue descent to downtown Newport at left.

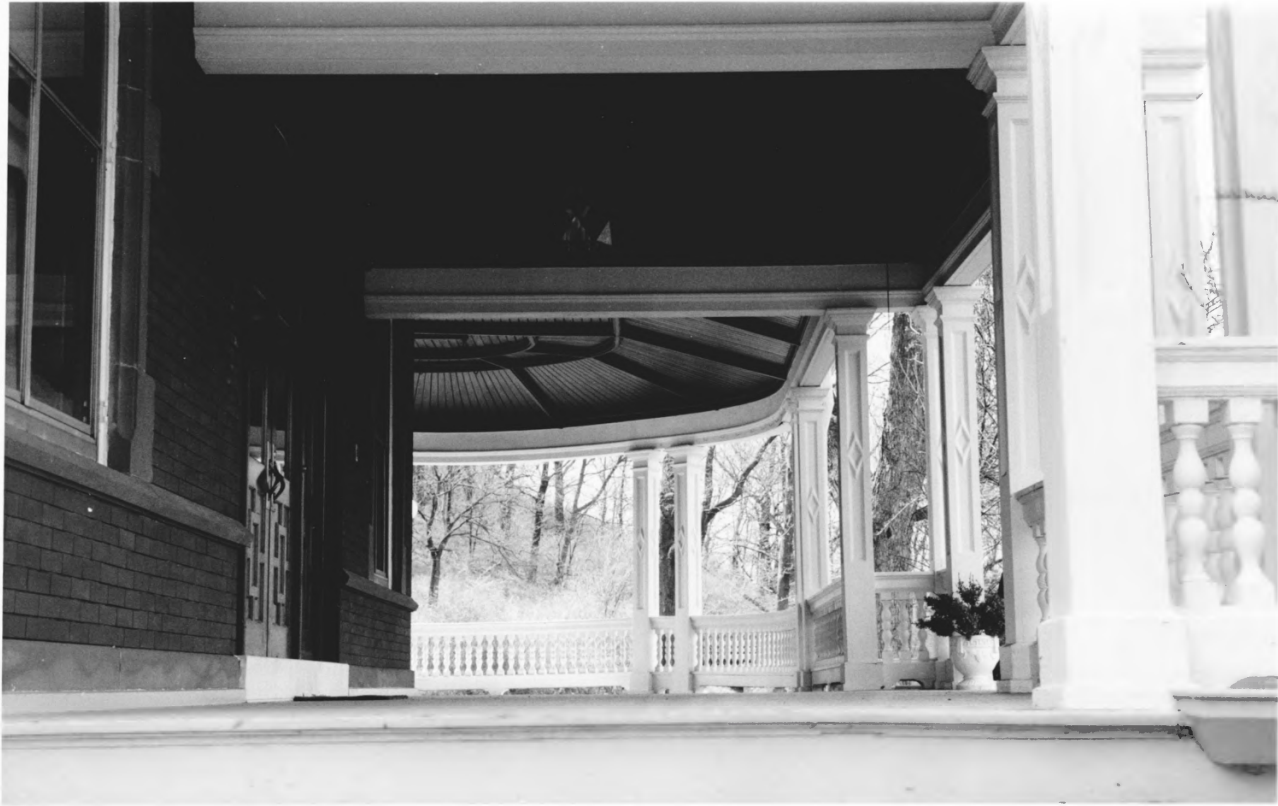
Photo 7

View of front porch from east, showing double front stormdoors at left, detail of railing at far right.

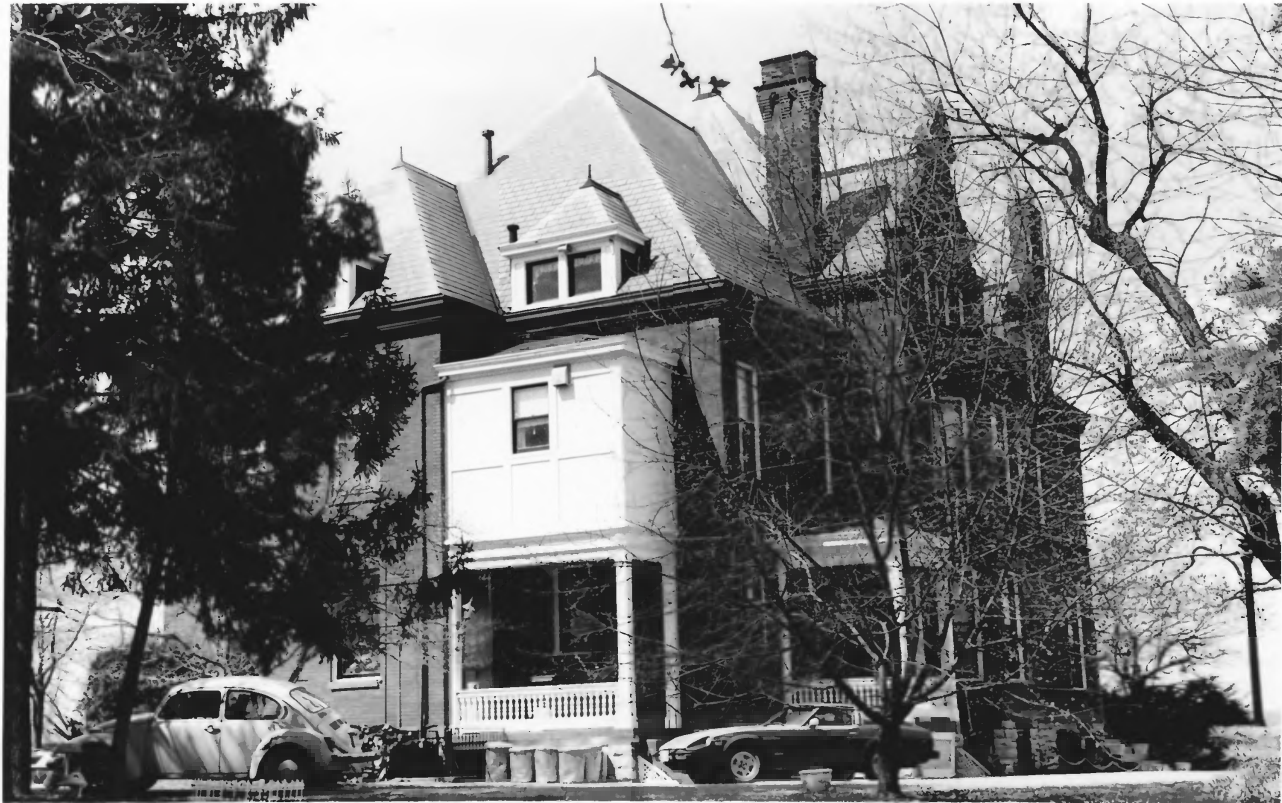
Photo 9

View of rear of house, looking northwest, with family (right) and servants' (center) porches; gables of east side at right. Enclosed second-story porch is one of few alterations to house.

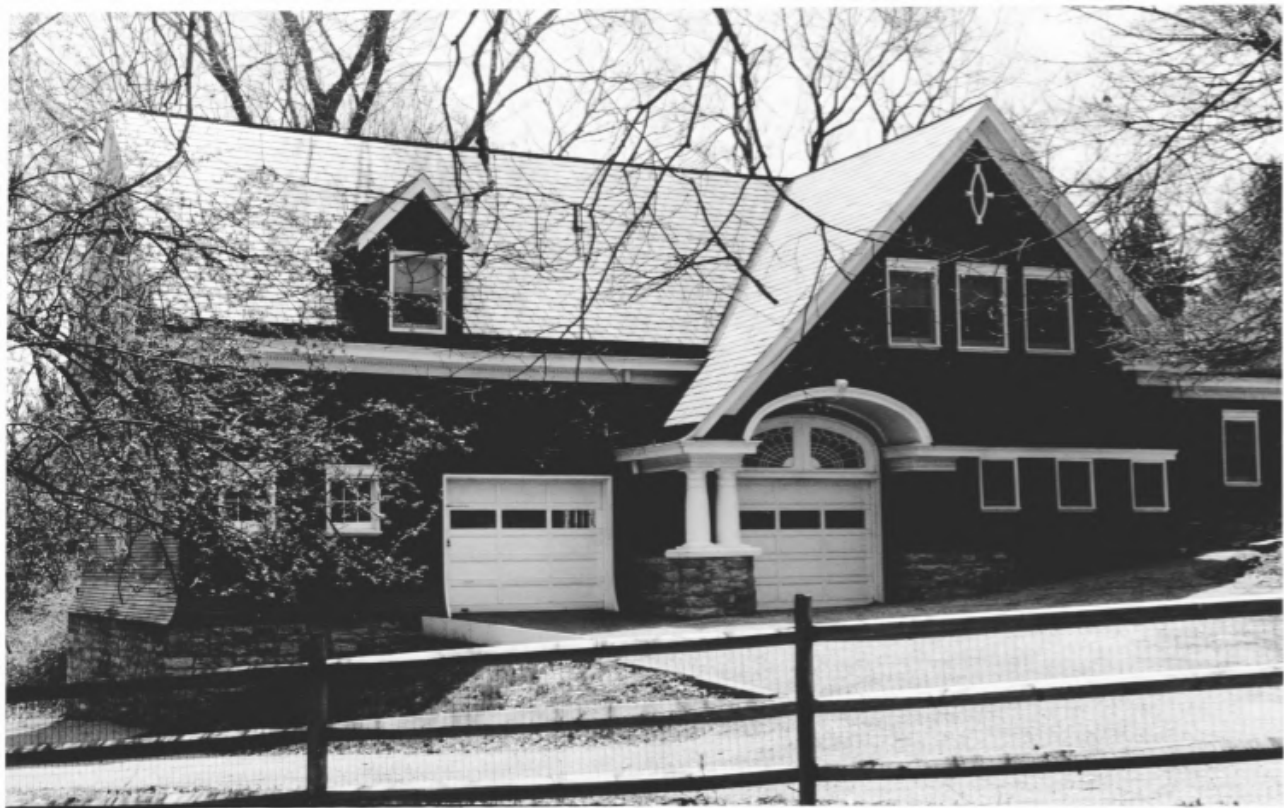
Photo 10

View of carriage-house looking south (west) from direction of main house; slope of hill and site of former greenhouse off to right, beyond small one-story addition; left garage door is also not

original.

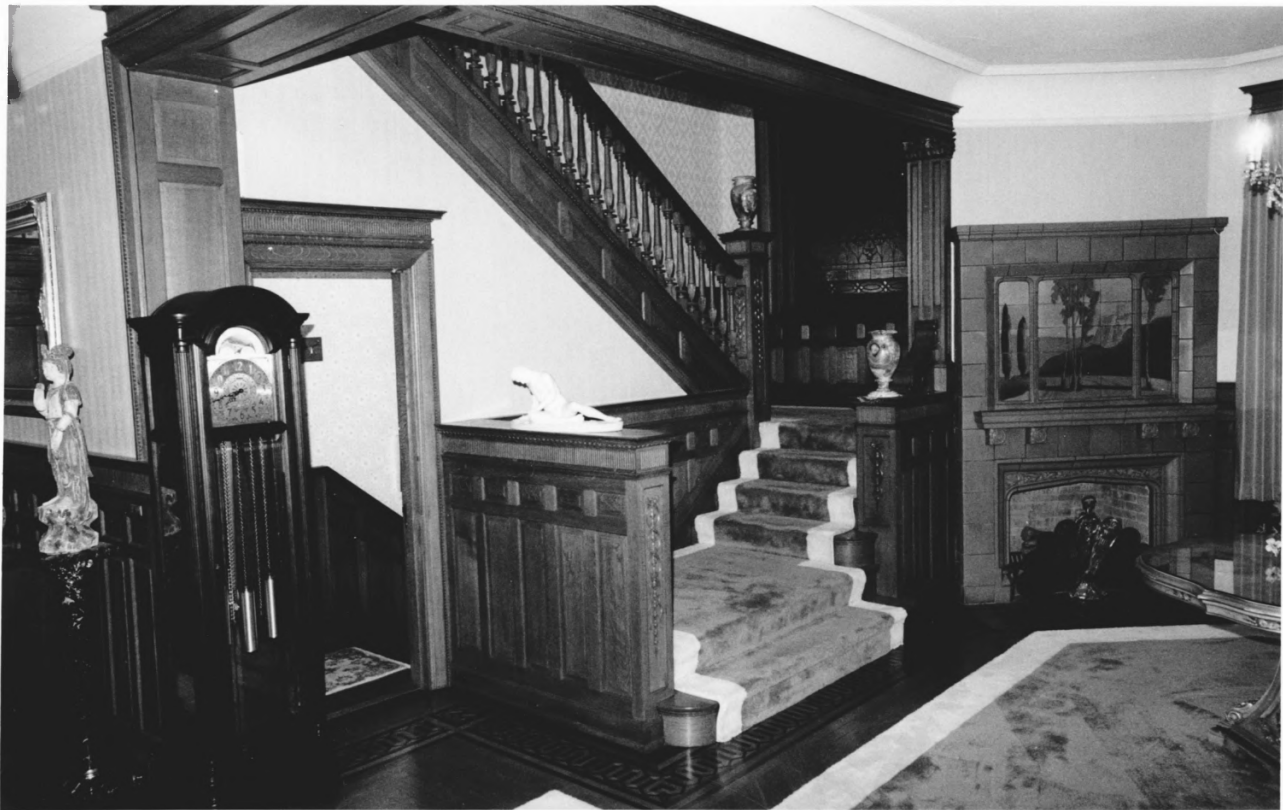
Photo 13

View southwestward from front entrance, showing stairhall (right) main staircase with window on landing, and open door leading down stairs to lavatory; the central hall is glimpsed at left.

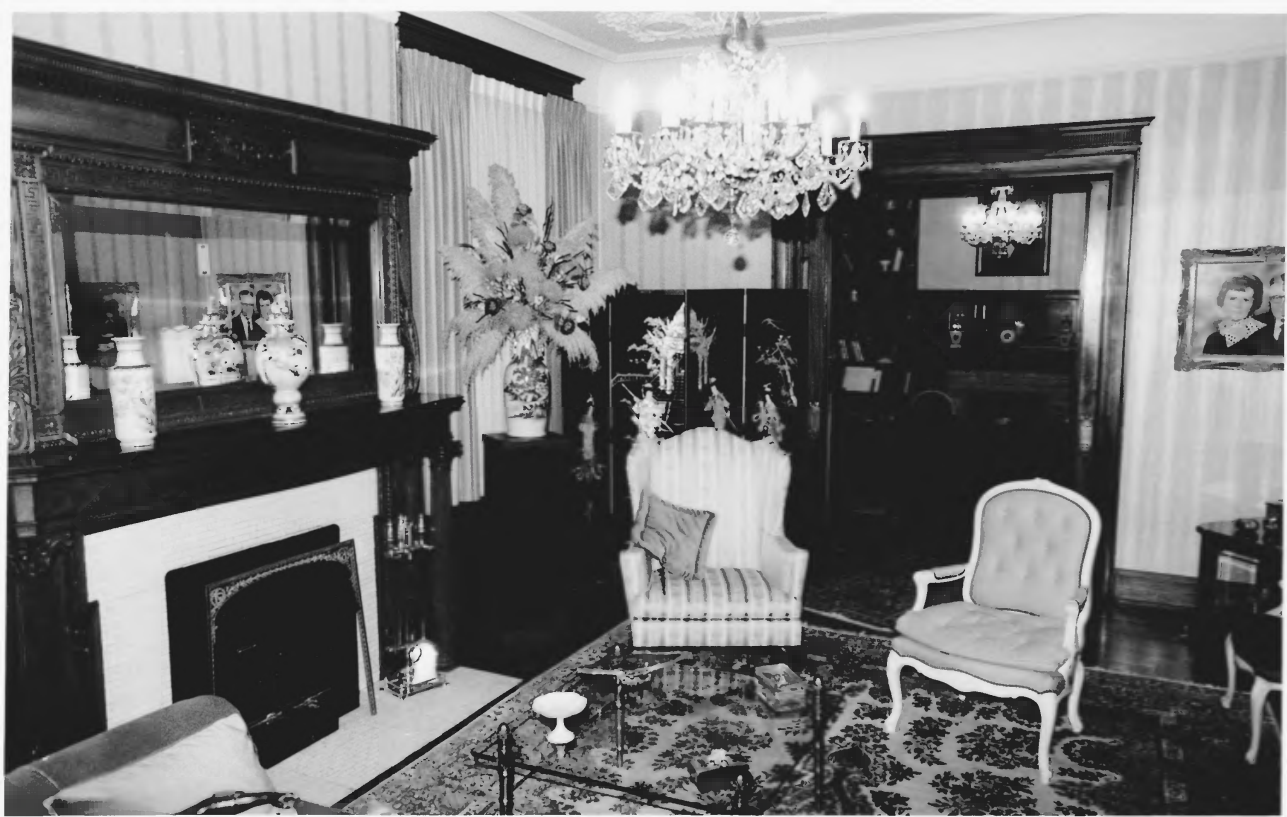
Photo 14

View southeast from parlor into library, showing both mantels.

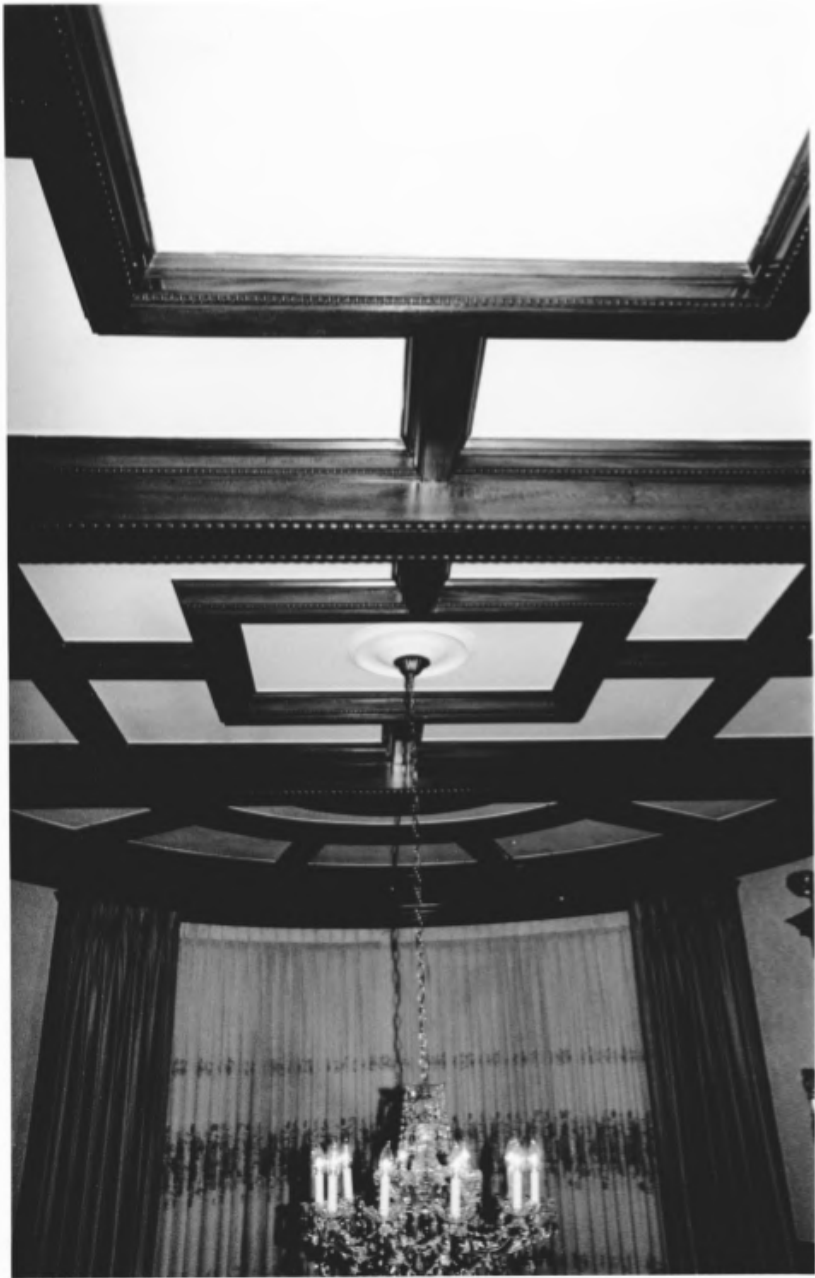
Photo 15

View of dining-room ceiling from entrance, looking west; delicate beading on beams is visible. Compare Illustration IV.

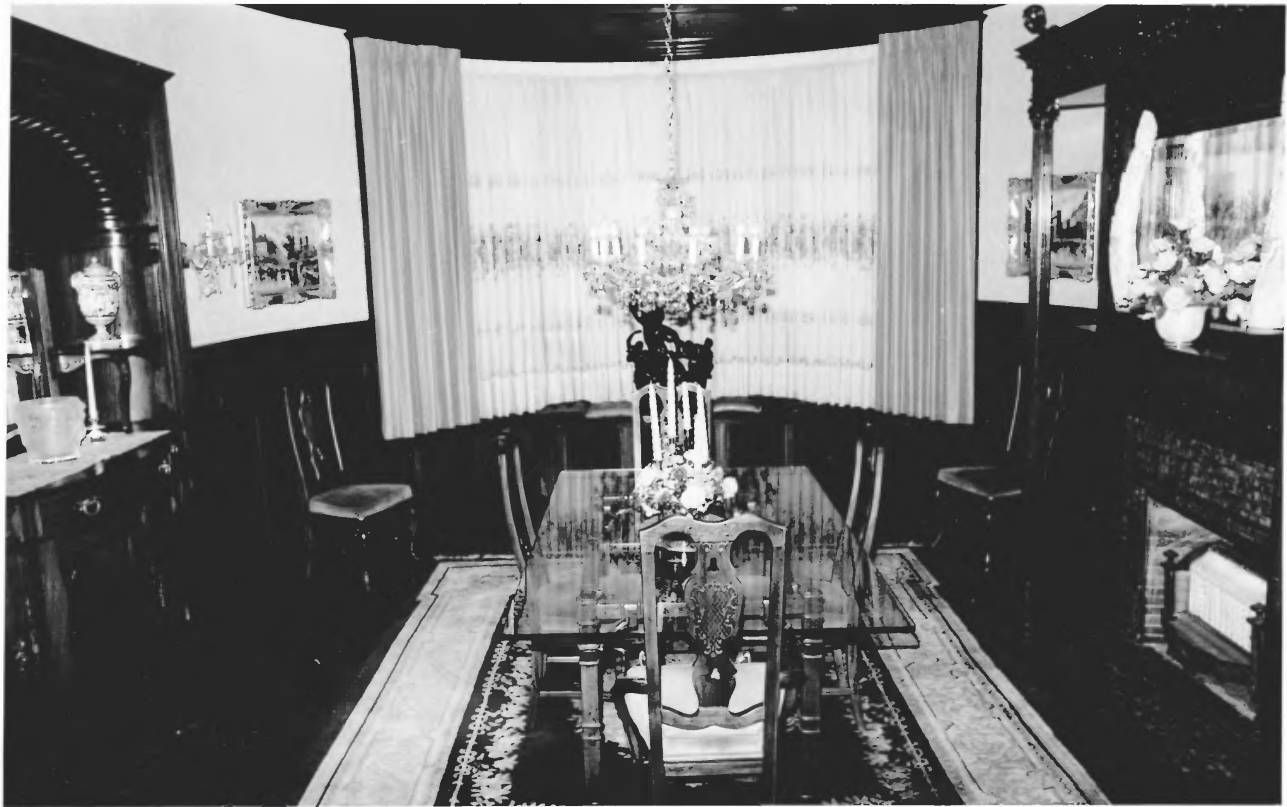
Photo 16

View of dining-room from entrance toward west bay-window, with buffet at left, mantel at right.

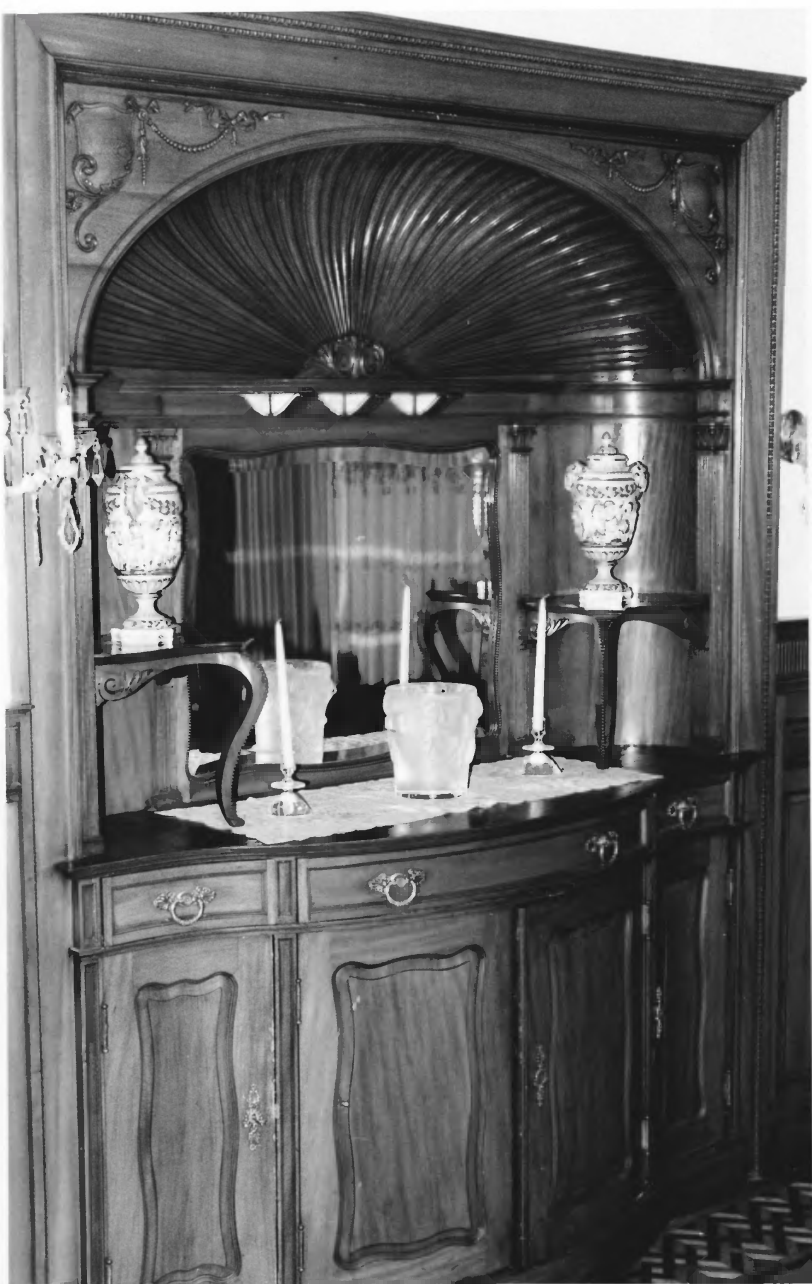
Photo 17

View, to southwest, of dining-room buffet, with a glimpse of parquet floor border at lower right.

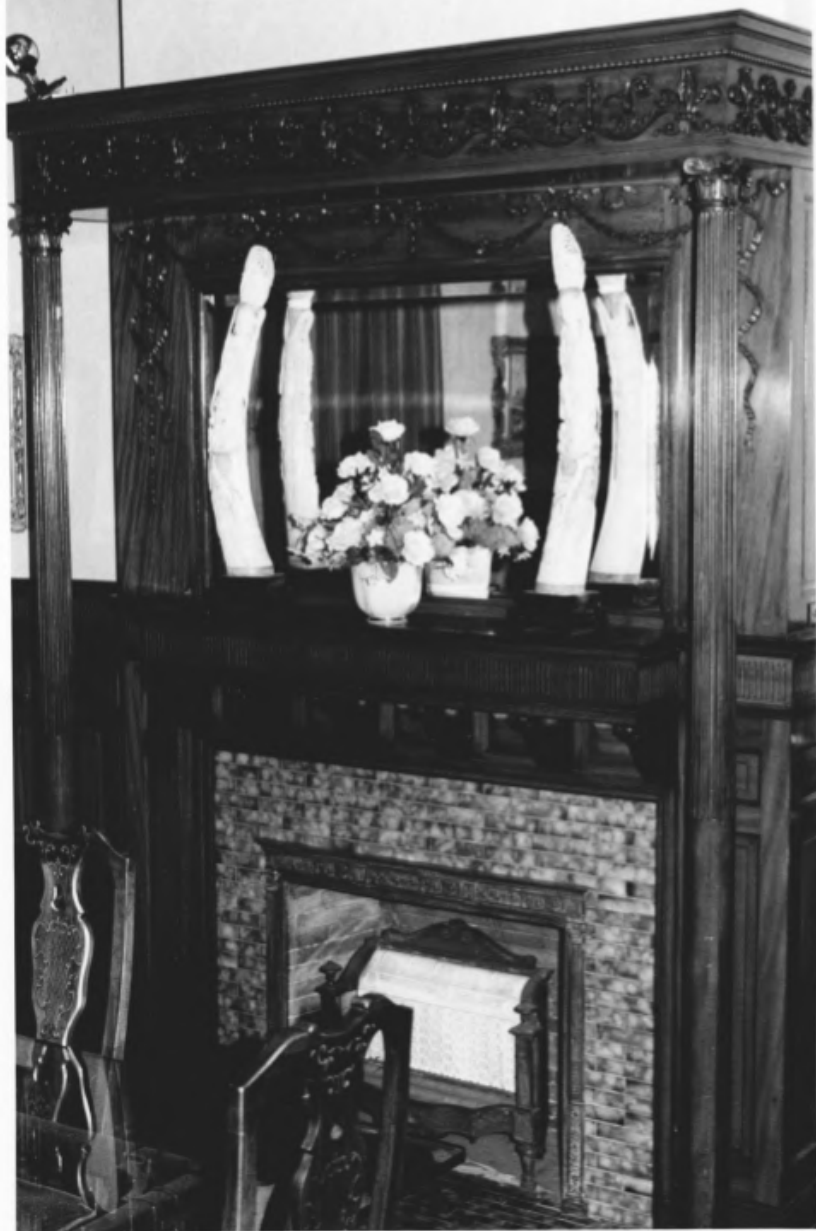
Photo 18

View, northwest, of dining-room mantel, showing continuation of wainscot frieze around mantel-shelf and detail of Neo-Classical hearth surround and grate.

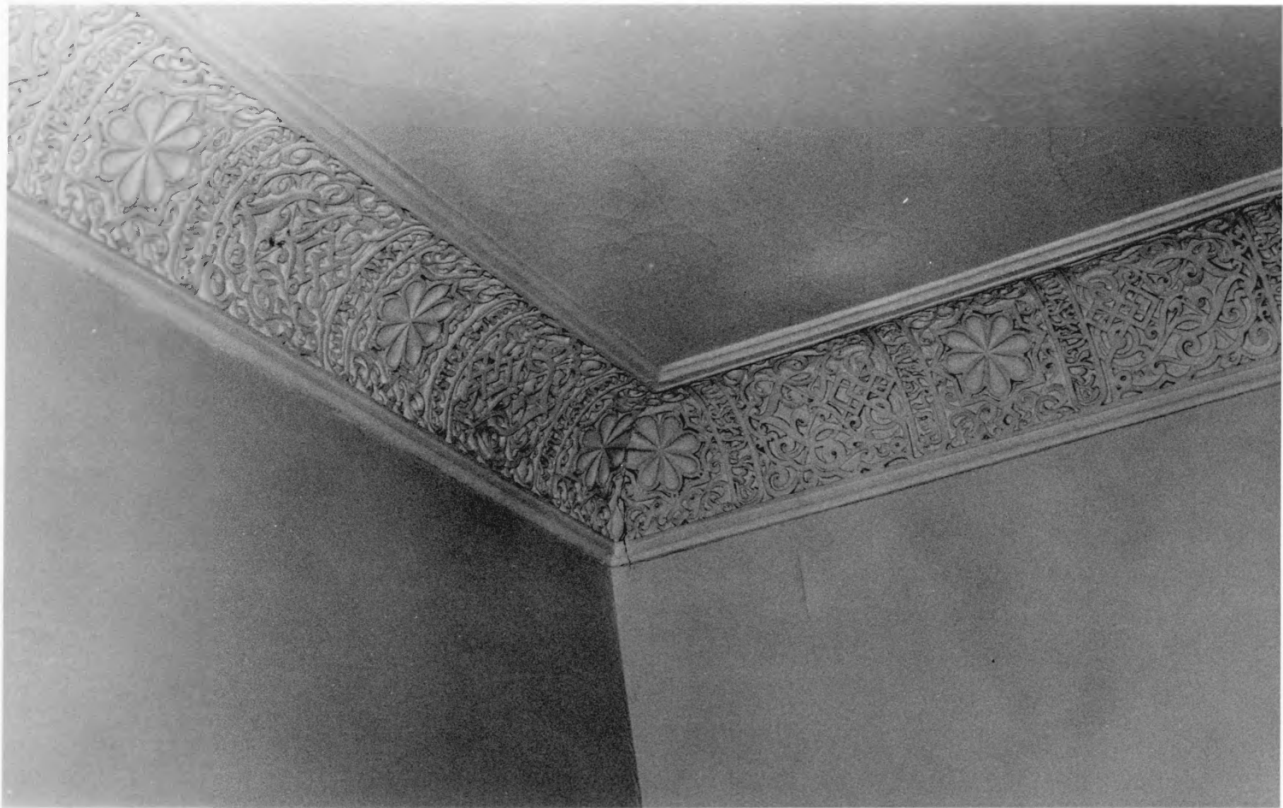
Photo 19

Detail of "Arabic" ceiling cove in smoking room off upstairs back stairhall.

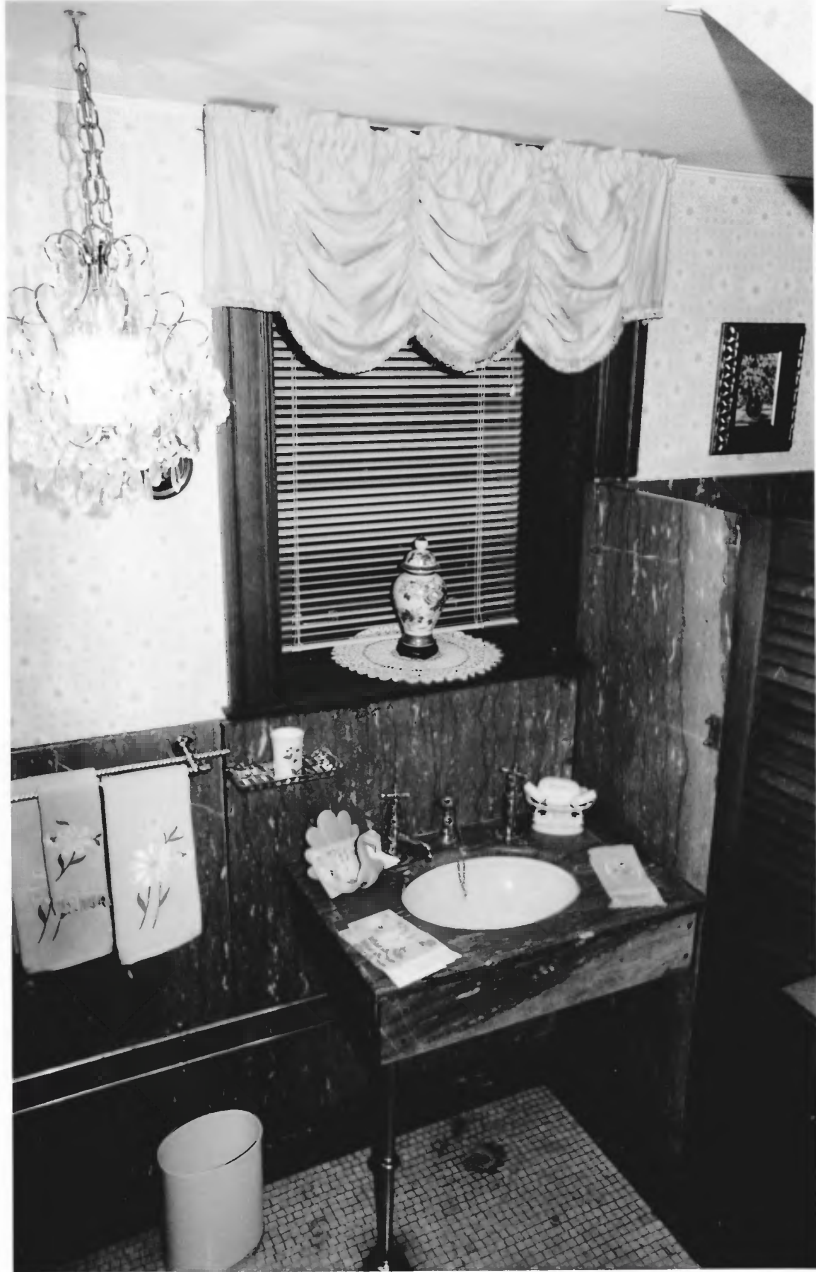
Photo 20

View of lavatory under main staircase, showing marble wainscot and basin on brass legs, mosaic-tile floor, and louvered swinging door to toilet compartment.

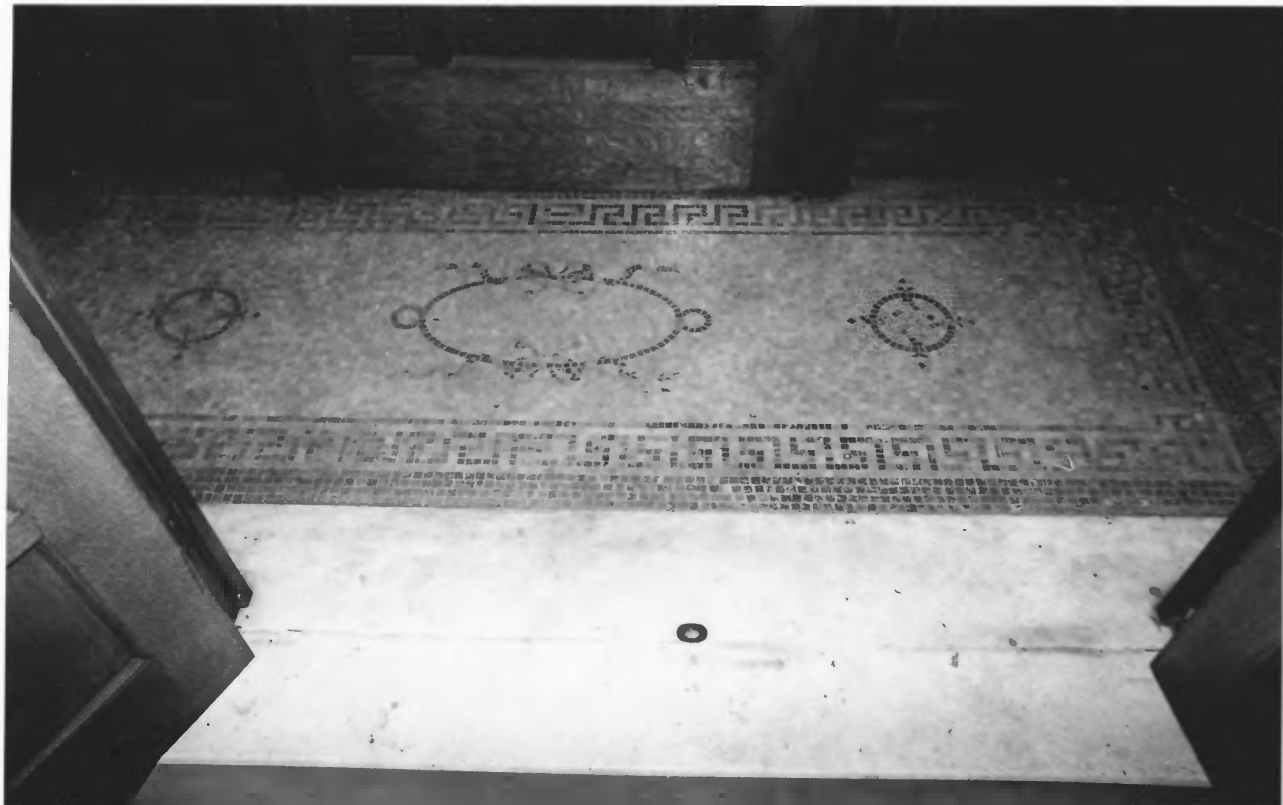
Photo 21

Detail of mosaic-tile floor in front vestibule, looking from marble thresh-hold of storm-doors toward bottom of inner front door.

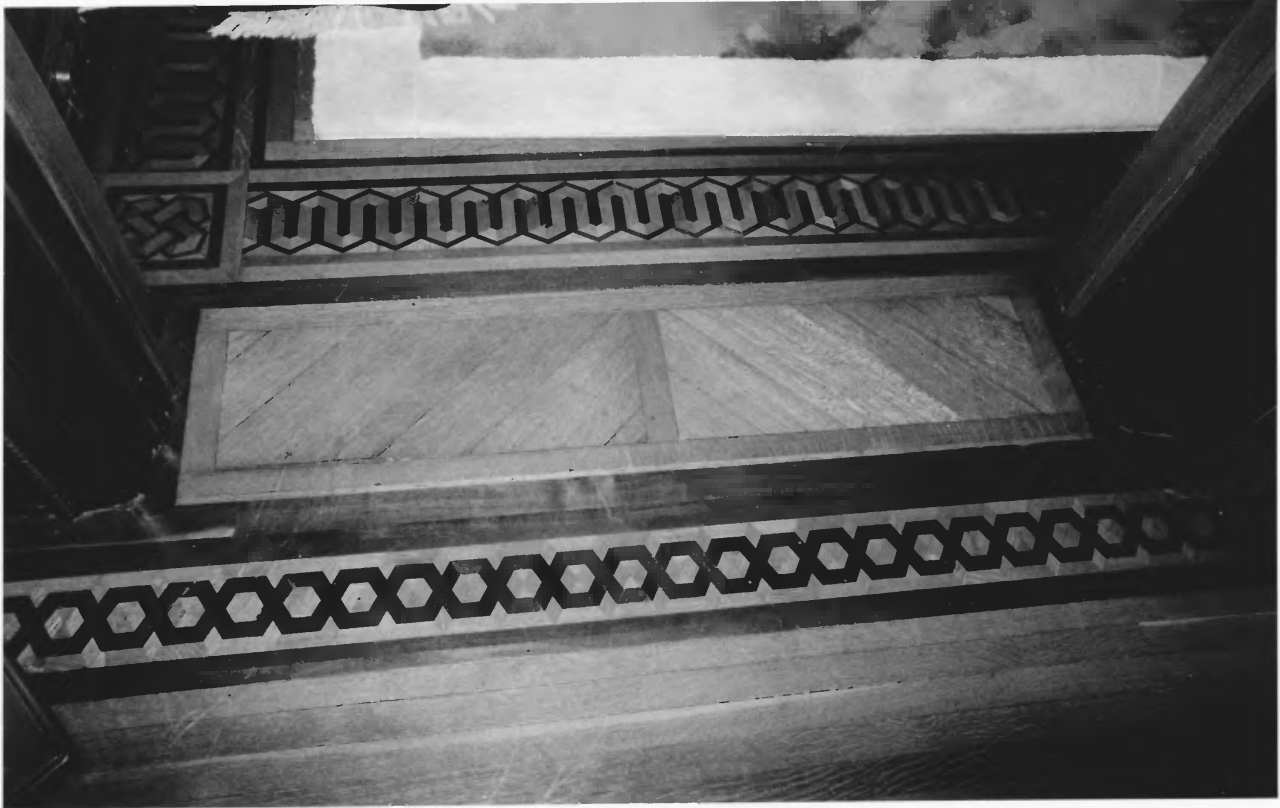
Photo 22

Detail of parquet floor borders, looking from library toward central hall.
