NATIONAL REGISTER OF HISTORIC PLACES
REGISTRATION FORM

historic name Sayre Downtown Historic District

Sayre Downtown Historic District
name of property
Beckham County, Oklahoma
county and State

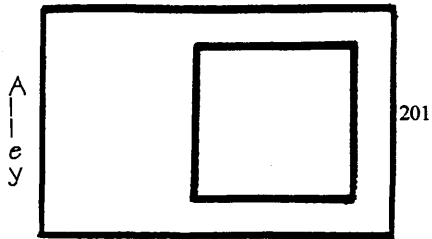
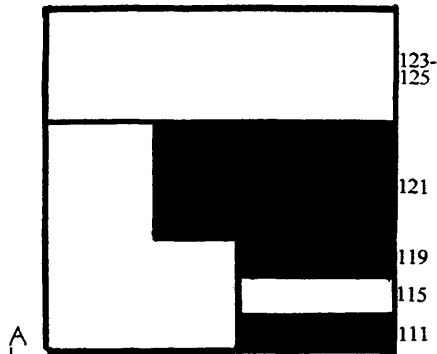
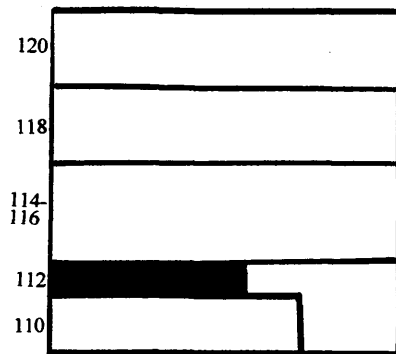
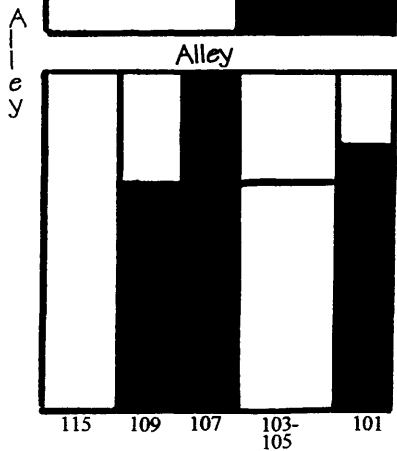
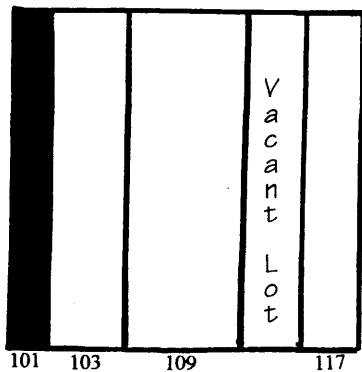
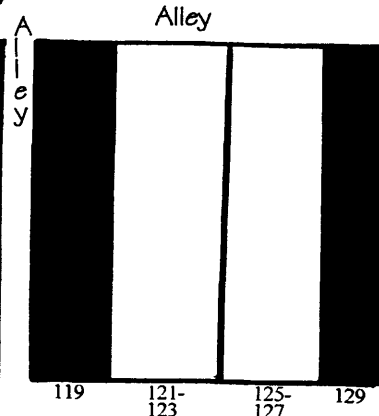
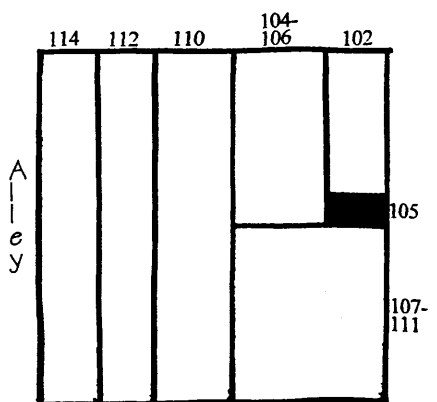
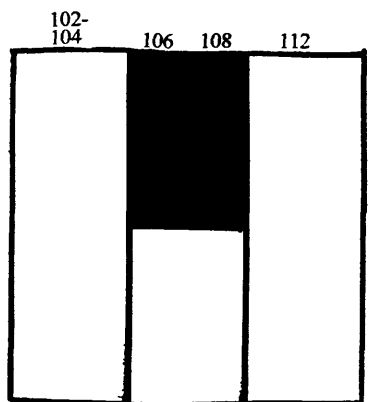
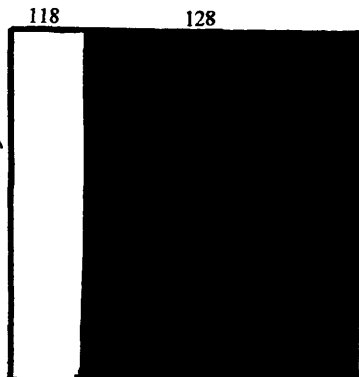
Sayre Downtown Historic District
 Sayre, Beckham County, Oklahoma

- Contributing
 - Noncontributing
