National Register of Historic Places Continuation Sheet

Property Name: Waite Grass Carpet Company

County: Winnebago

State: WI

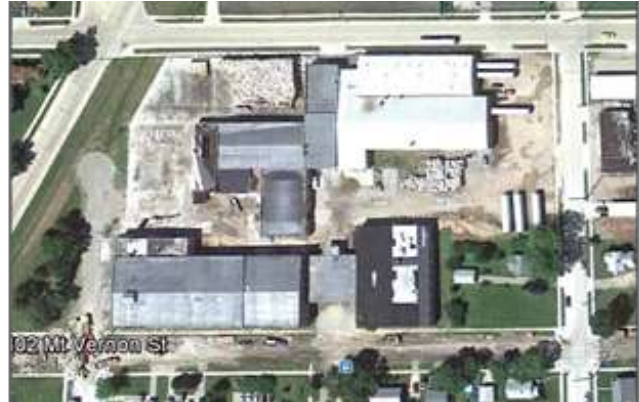
Figure 8: 2011 aerial view after demolition (2 buildings).

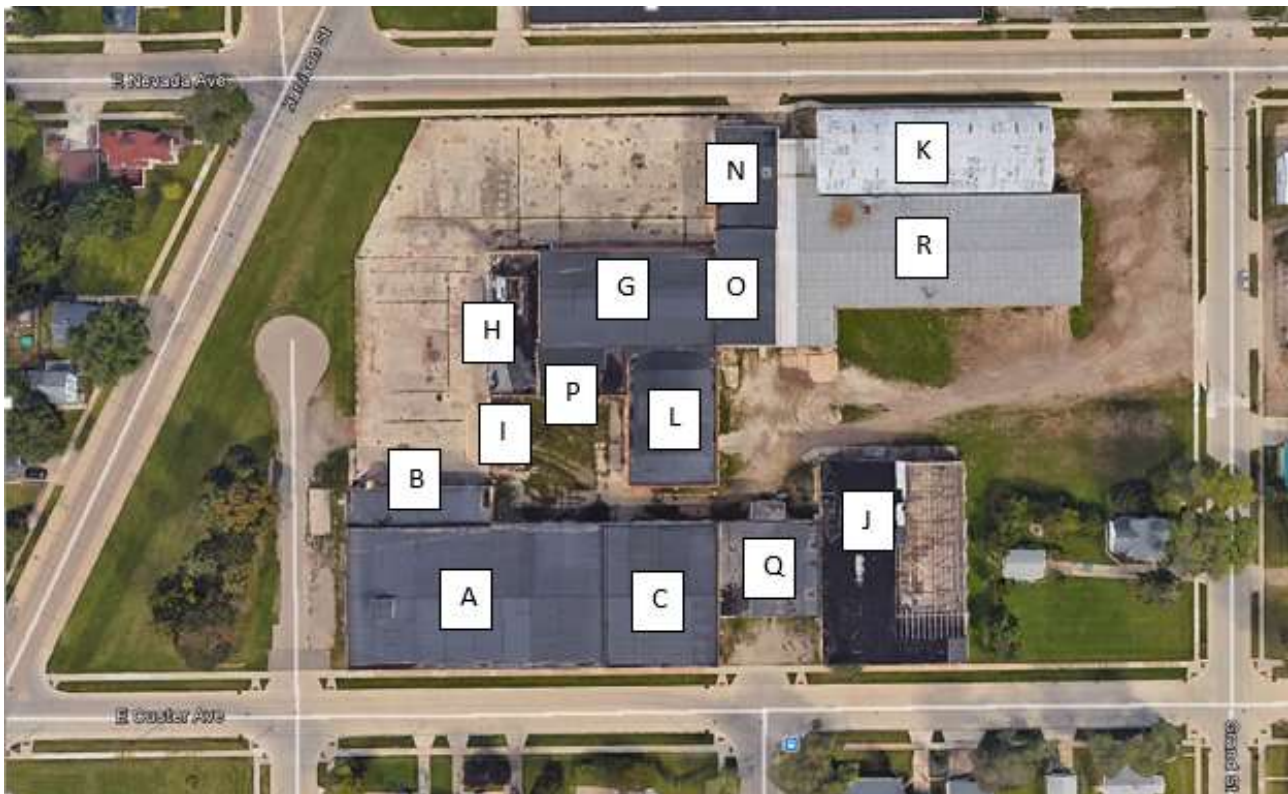
Figure 9: Aerial photo key plan. North Building (Soon to be "North Waite Plaza"), Buildings G, H, I, K, L, N, O and P. South Building (Soon to be "Waite Rug Place" Apartments), Buildings A, B, C, J and Q. Photo taken from Google Earth.

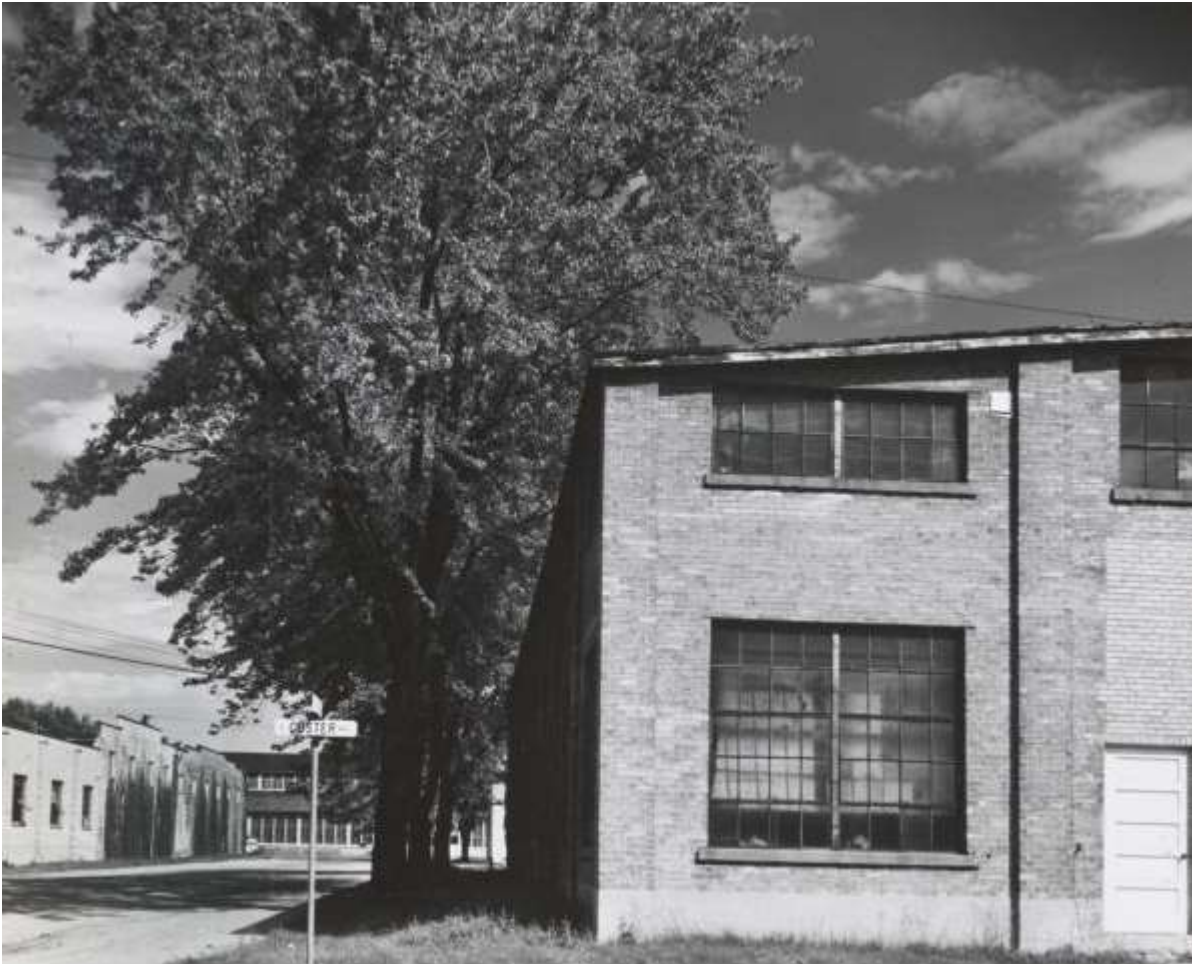
Figure 14: 1962 photograph showing the corner of Building J prior to the closing of Eastman Street. Visible at the far left are three windows of building L and the East exterior wall of Building G and E. Building E has since been demolished, and several other buildings now fill the space which was occupied by the public right-of-way. This photo places building L within the period of significance. Wisconsin Historical Society, "Oshkosh Factories" Image ID: 104499
