National Register of Historic Places
Inventory—Nomination Form

historic The Riceland Hotel

street & number Third and Main Streets

city, town Stuttgart vicinity of

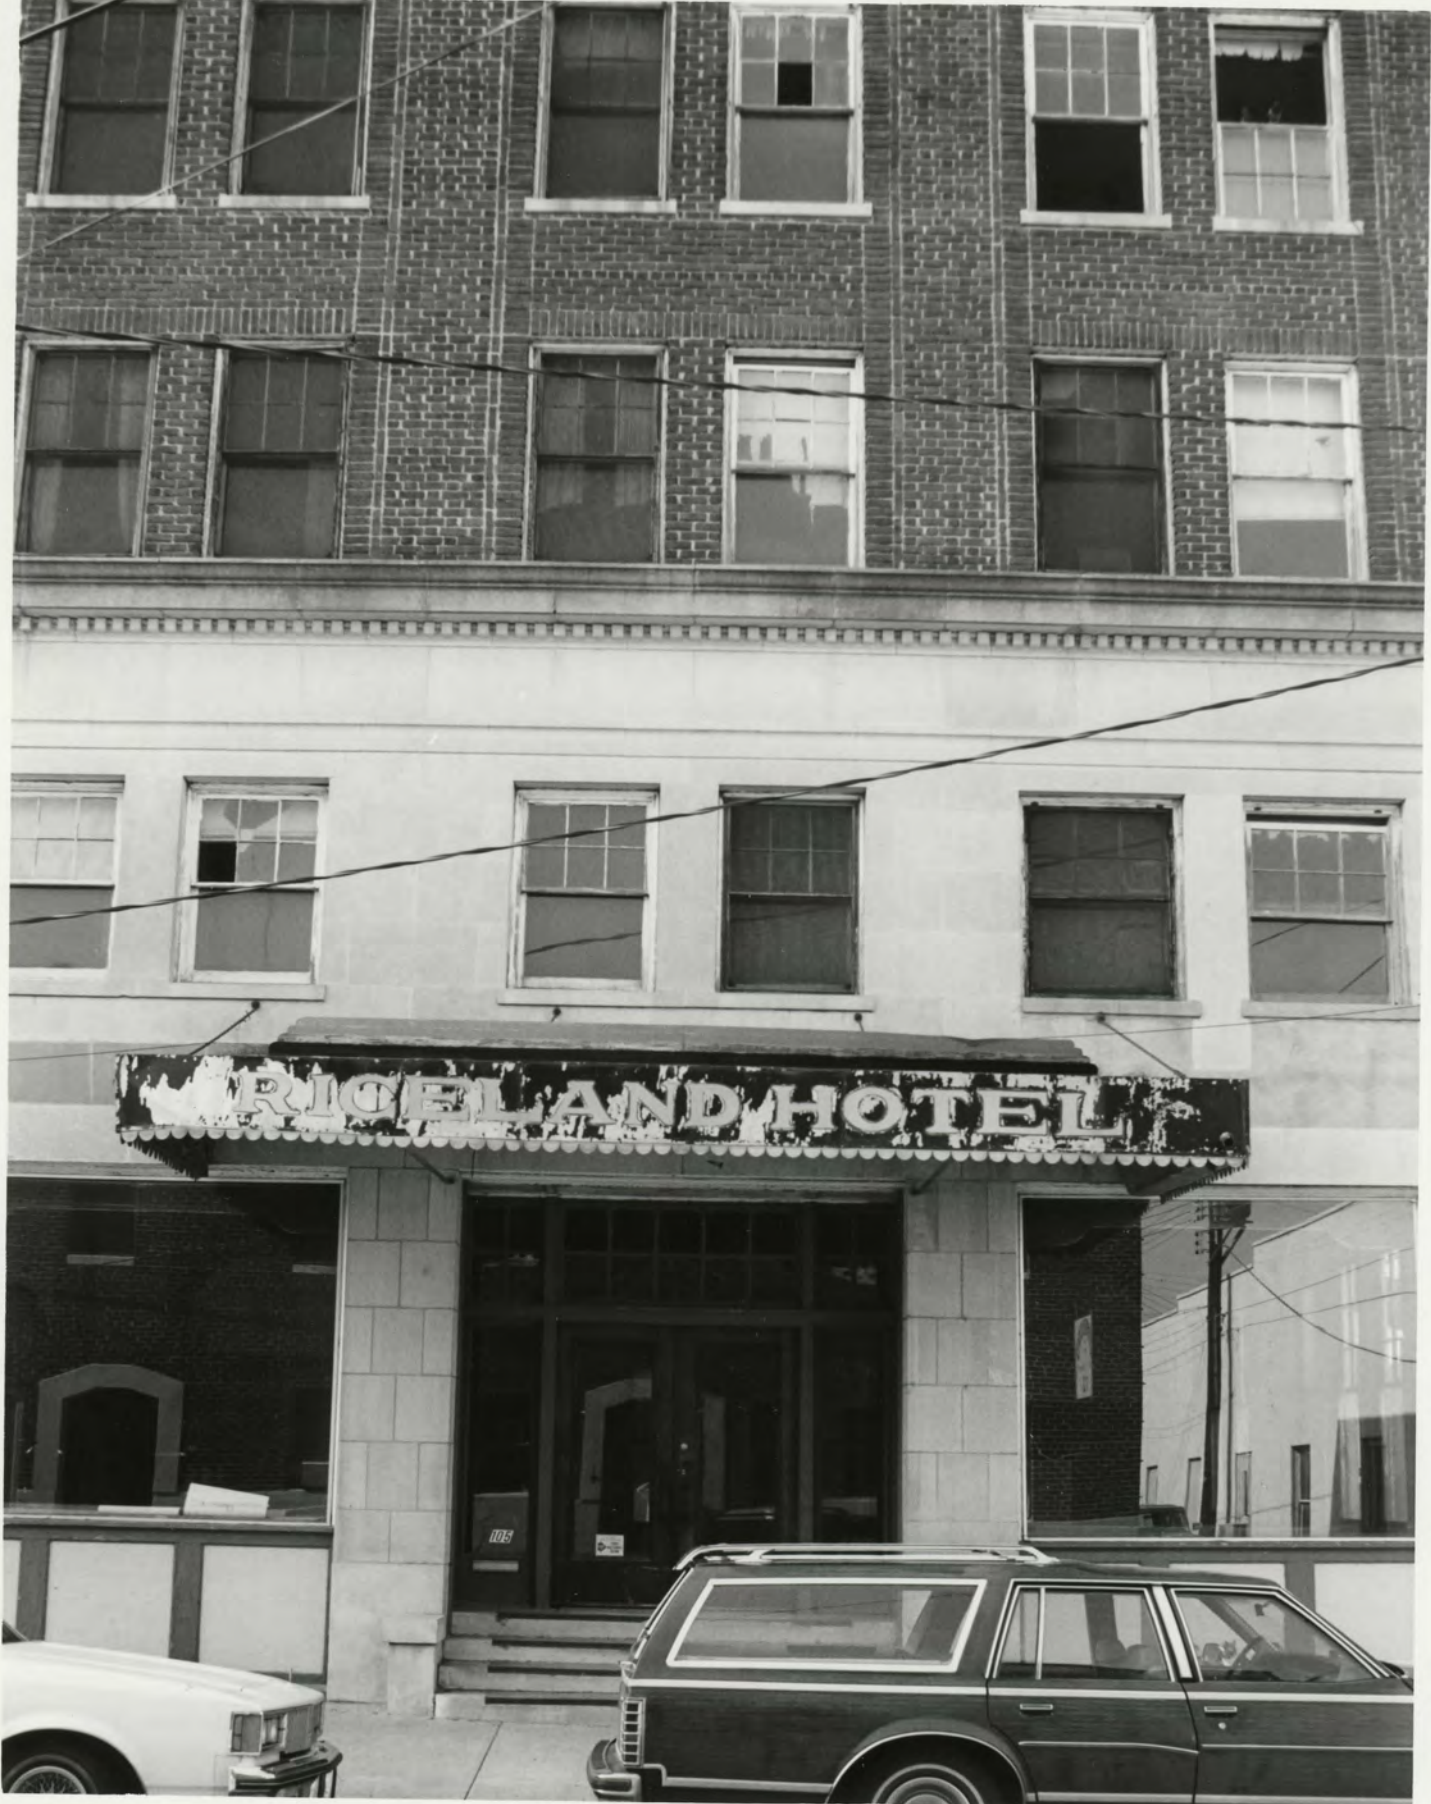
The Riceland Hotel
Stuttgart, Arkansas County
Photographed by D. Brown
September 1984
Negatives on file at AHPP
Hotel entrance - viewed from south

Many of the elements represented on the facade are continued and preserved on the north elevation, which served as the primary entrance to the Riceland Hotel. Along the lower two stories, the limestone facing is retained, capped by a limestone cornice. Shallow pilasters divide the bays. The street level windows in the four bays in the eastern end of this elevation, previously occupied by banks, have been closed with concrete blocks. The fifth bay provided a secondary entrance to the bank, with a door framed by narrow pilasters and flanked by sidelights. In 1923, a hotel and pharmacy occupied the remainder of the east elevation, which has been extensively altered. The three bays on the west end of the elevation comprised the hotel entrance. The central bay provided entry through its double doors, while the flanking bays each contained three six-over-one double-hung windows above three wooden panels. Immediately to the east of the hotel bays, a second set of double doors opened originally into the Riceland Pharmacy and, between its entrance and the bank's secondary entrance, another set of three double-hung windows over wooden panels completed the lower story of the east elevation. Originally the hotel and pharmacy entrance were sheltered by a wooden porch with paired columns on concrete piers. A wrought iron balustrade circled the roof.

Alterations to the bank and pharmacy portions of the north elevation are also extensive. The wooden porch was replaced with a metal marquee. In the three bays which contained

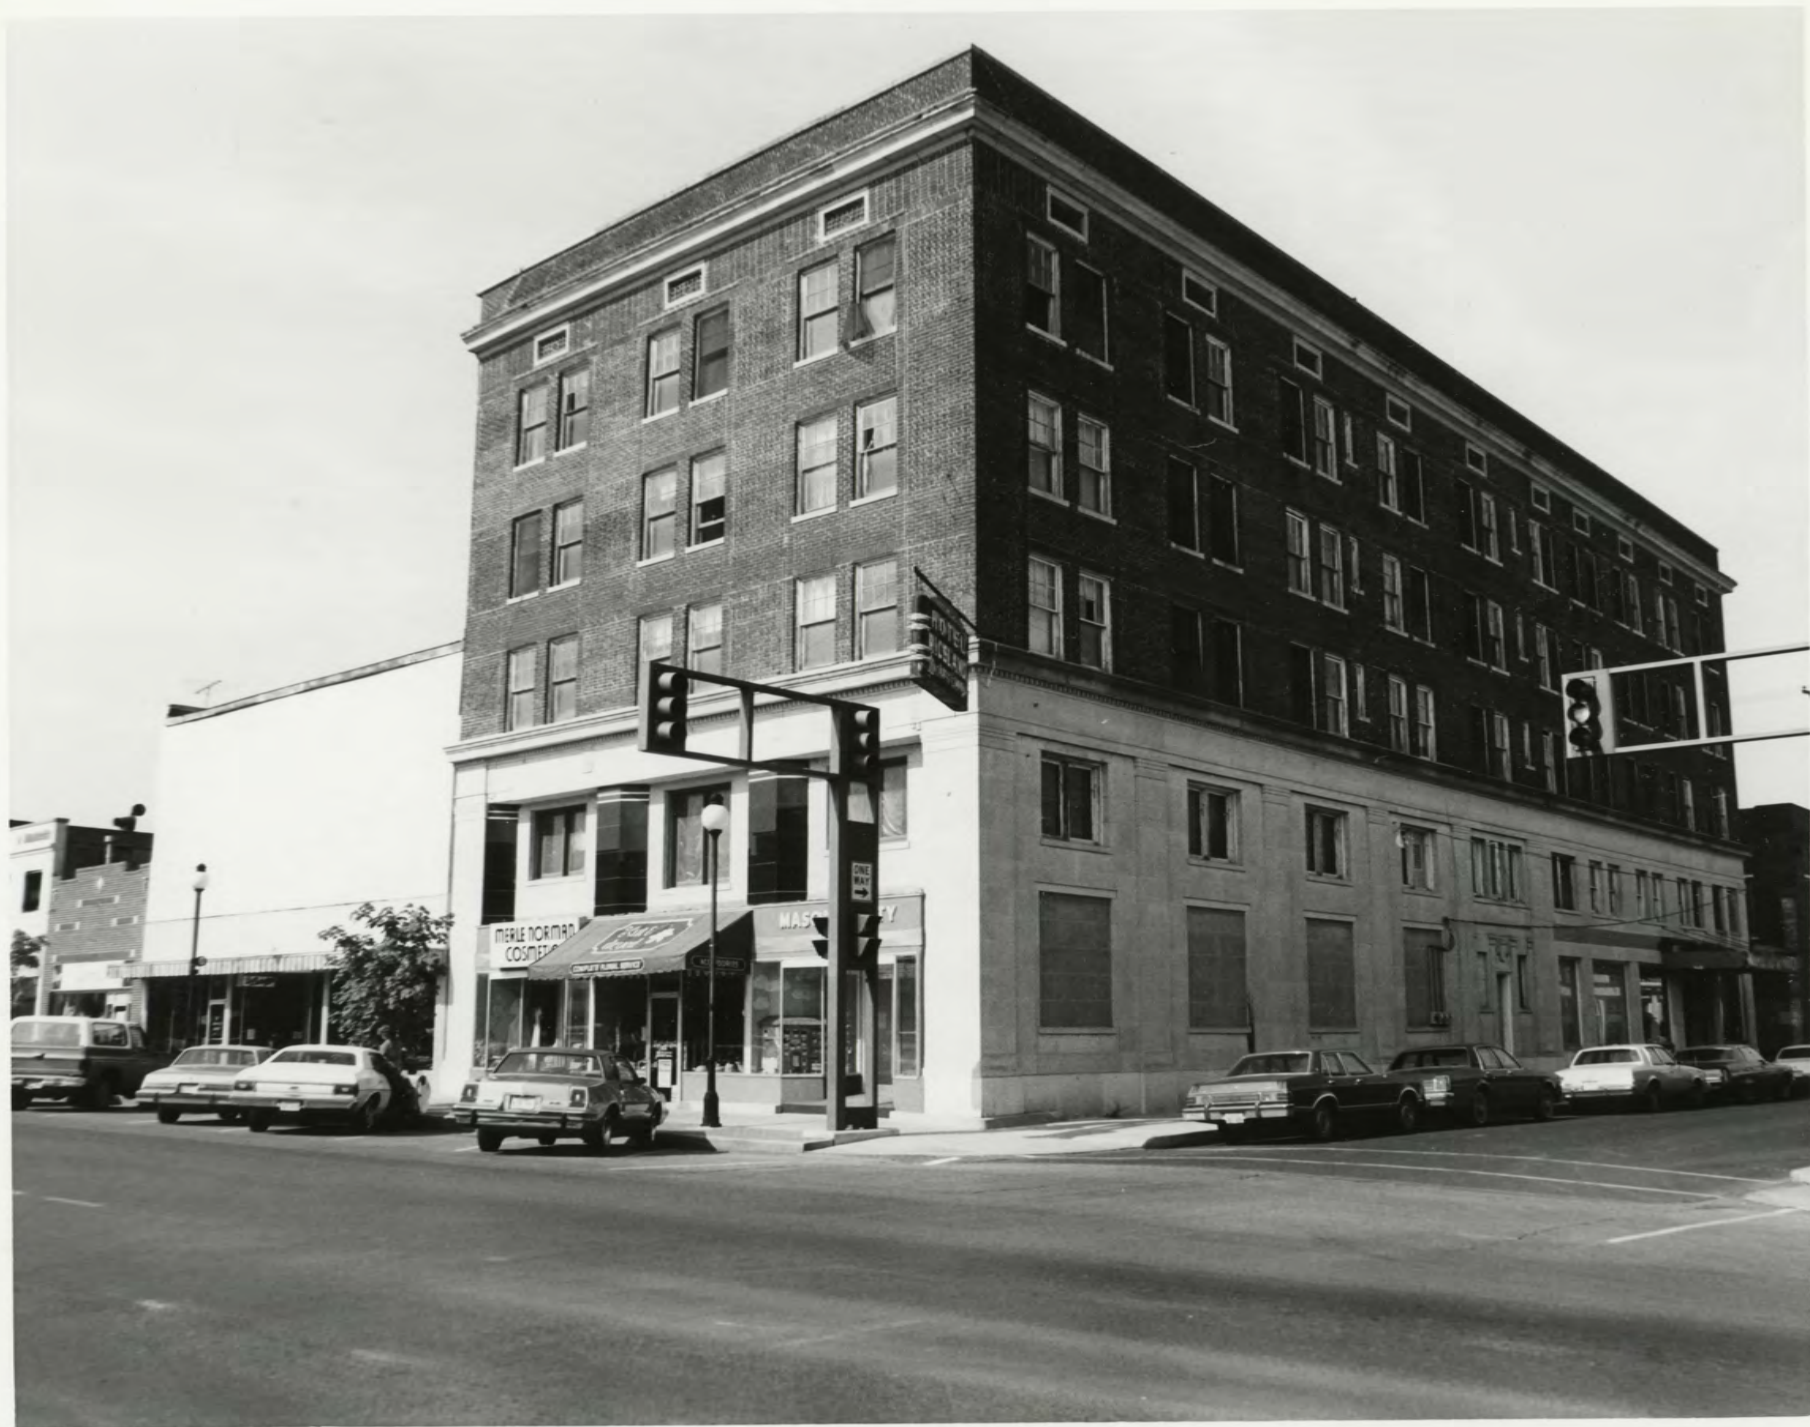
The Riceland Hotel
Stuttgart, Arkansas County
Photographed by D. Brown
September 1984
Negatives on file at AHPP
Viewed from southeast

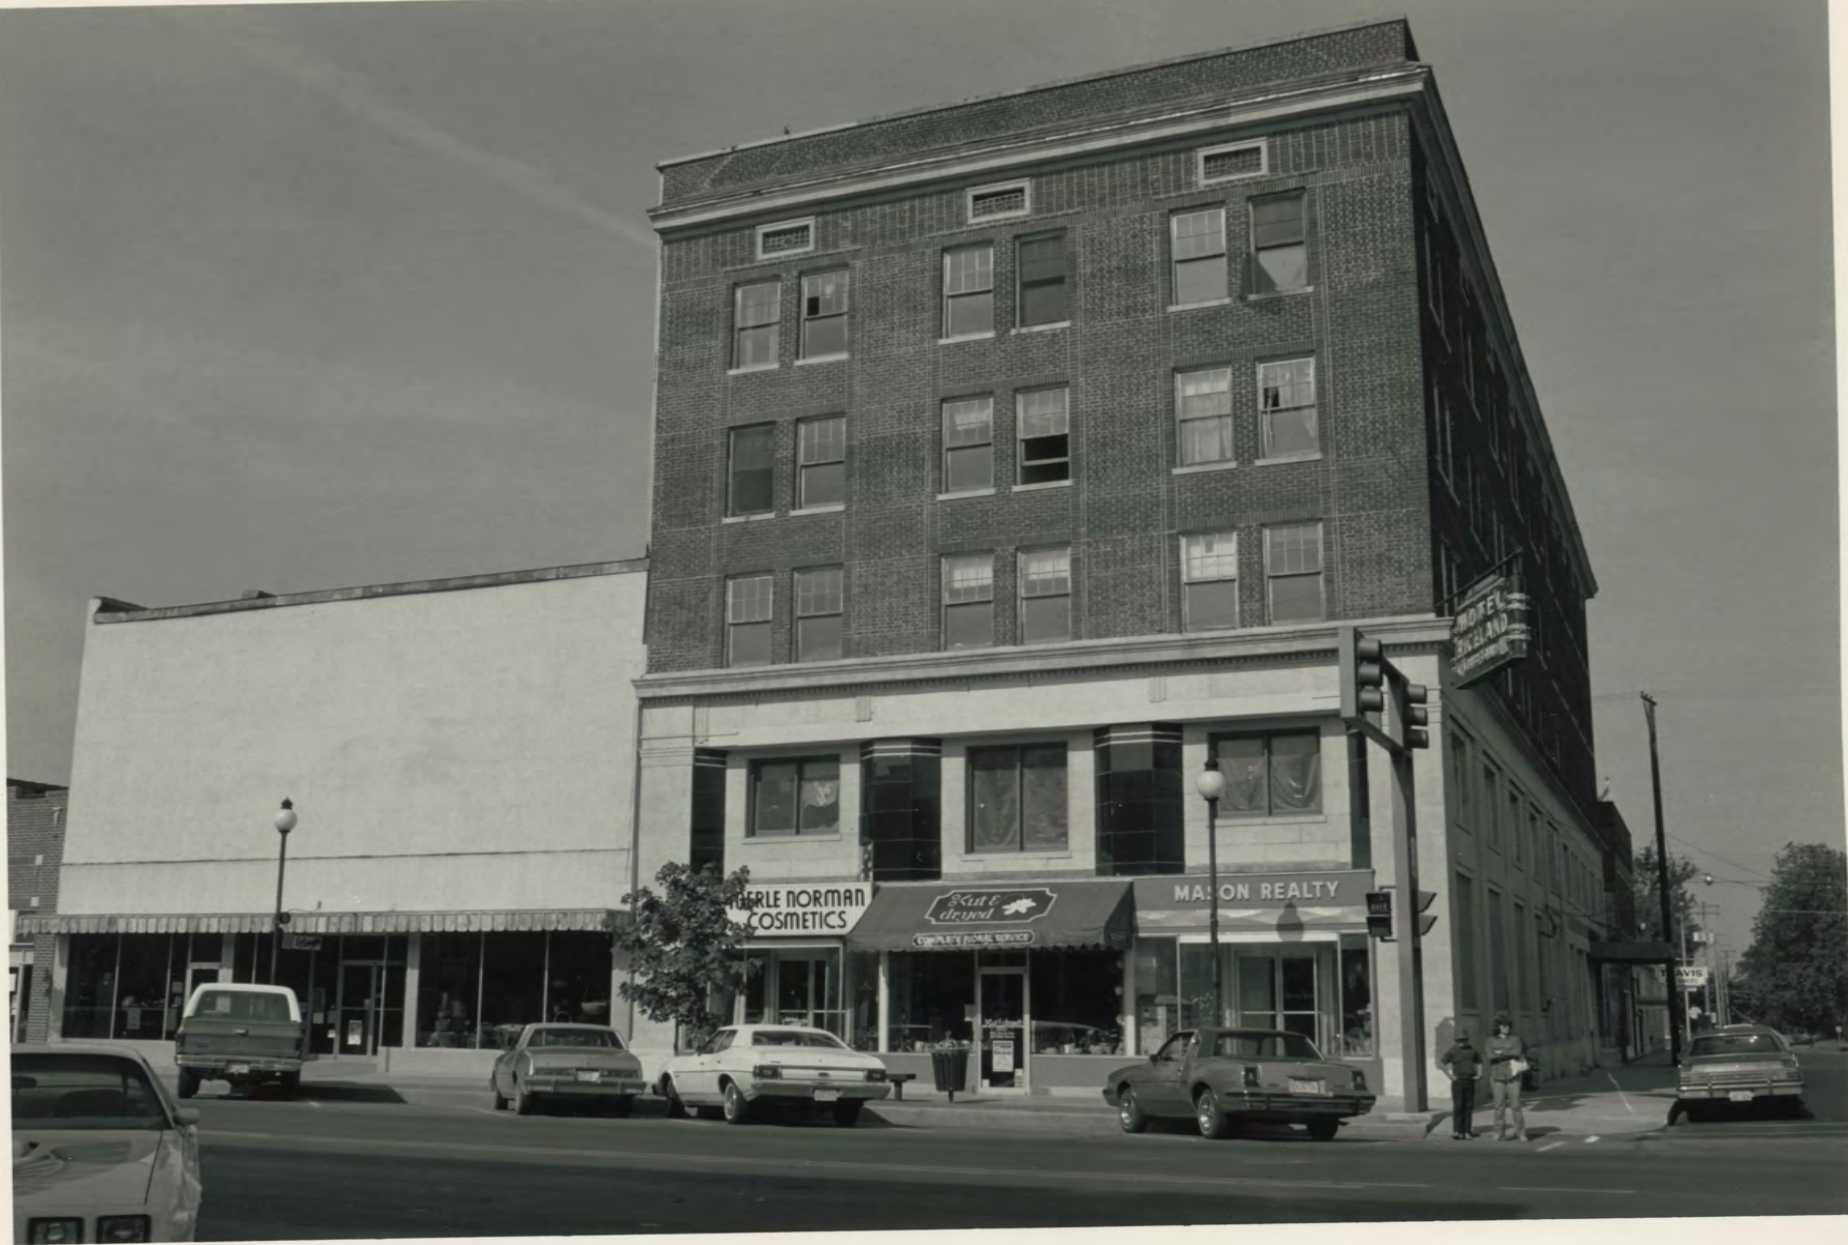
The Riceland Hotel
Stuttgart, Arkansas County
Photographed by D. Brown
September 1984
Negatives on file at AHPP
Viewed from east

Most of the neo-classic details incorporated by Mann and Stern, Architects, in their original design of the Riceland Hotel were embodied in the facade, or east elevation. On the building's opening in 1923, the lower two stories, which were faced in limestone, and capped with a denticulated limestone cornice, housed the building's owner, the Exchange Bank. The bank facade was originally divided into three bays by two story engaged columns. A double door with transom provided entry into the bank lobby, while the flanking bays contained large, double casement show windows. In the second level central bay, hopper windows were set, while smaller versions of these opened in the remaining bays. In a modern renovation, the lower floor of the facade was clad in metal and glass and the bays converted into doorways. Three commercial establishments, each with separate entries, were installed in the former bank. On the second story level, Carrera glass enclosed the columns.

The upper three levels of the facade housed the hotel. Three pairs of 6/1, double hung windows are repeated on each level. Each pair is framed by a stacked brick pattern, edged with a line of bricks set end, which continues the vertical line of the bays on the lower facade. A similar line of stacked bricks, set on end, is above each pair of windows. Centered above the three window pairs are three decorative-grill attic vents. A limestone cornice spans the facade above the vents and is surmounted by a brick parapet.

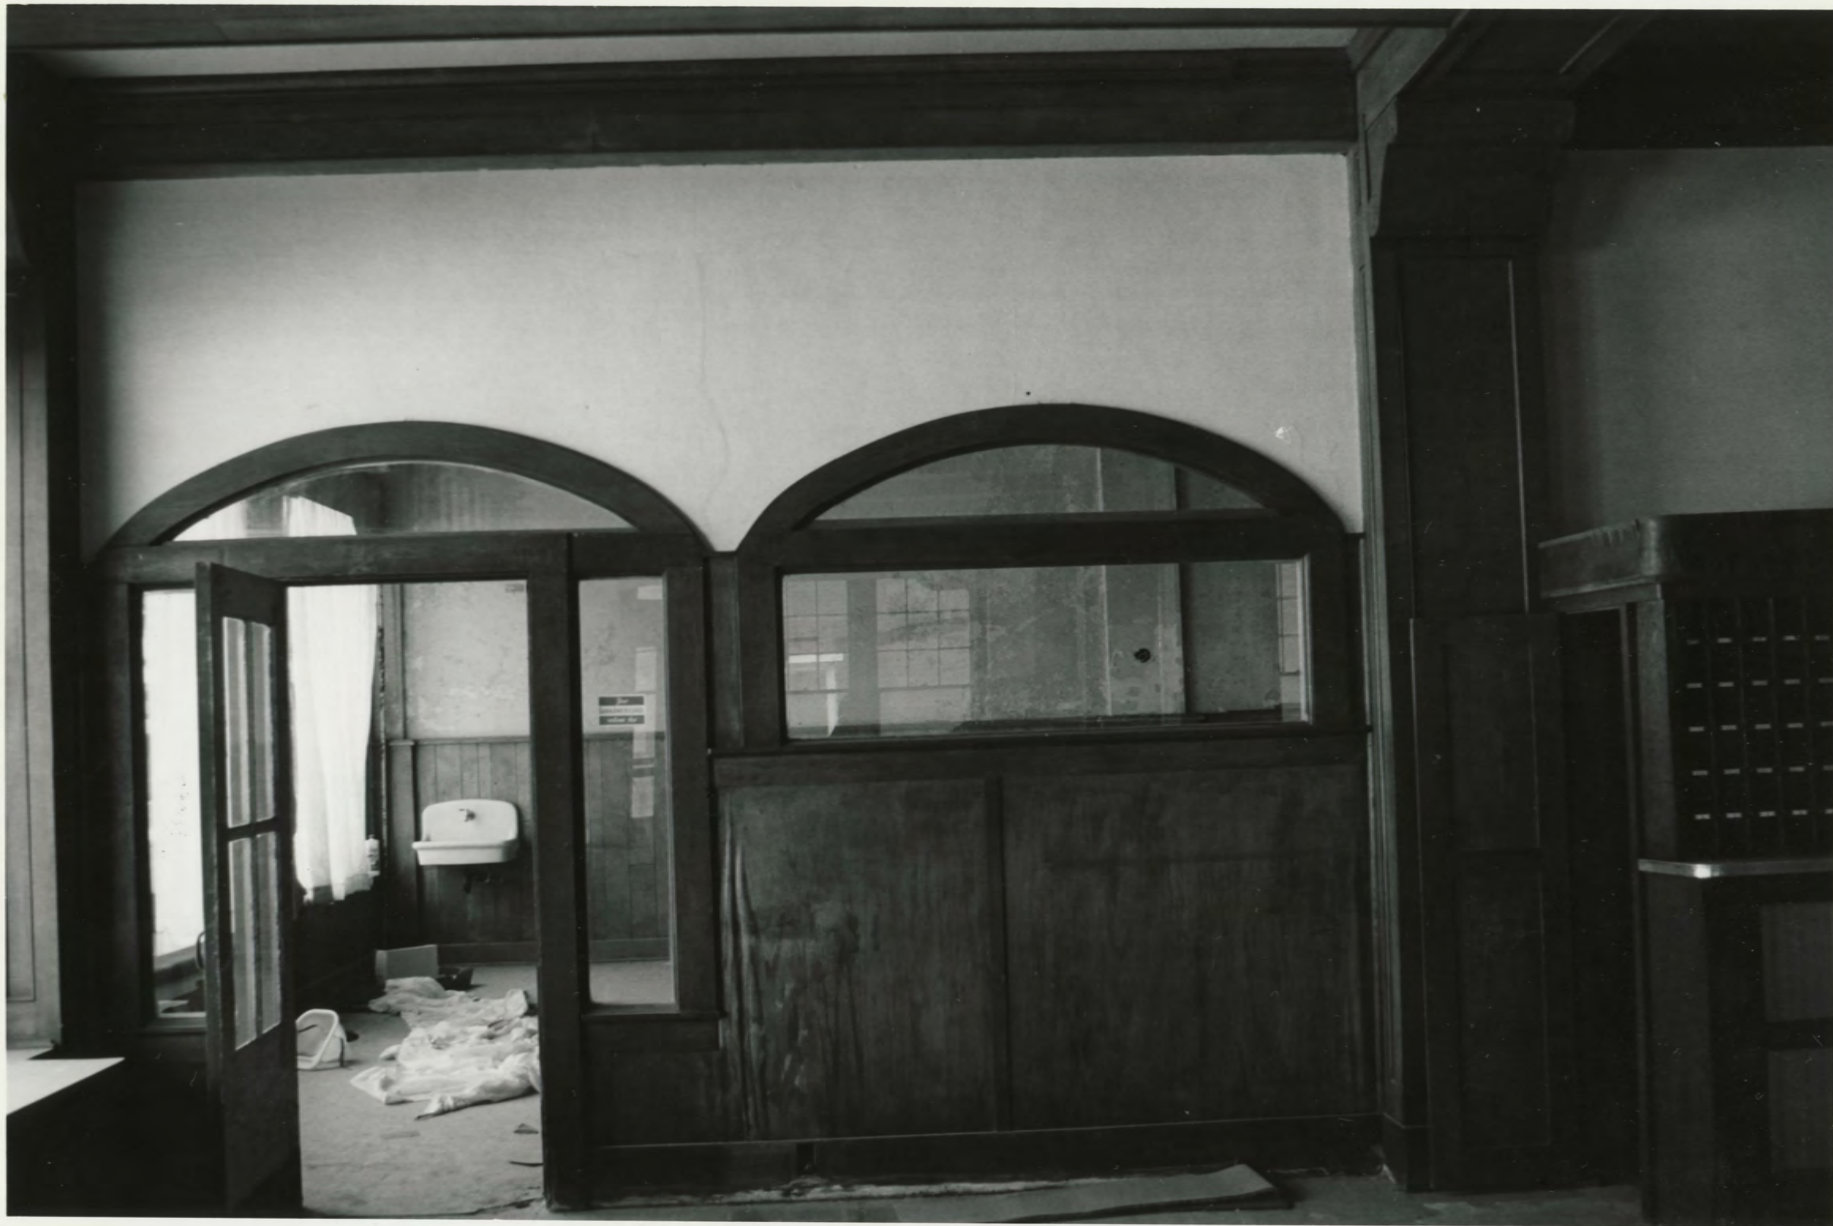
The Riceland Hotel
Stuttgart, Arkansas County
Photographed by D. Brown
September 1984
Negatives on file at AHPP
Hotel lobby

Few of the Riceland's distinctive interior features are visible or remain. The largest and most stately interior space was the bank lobby, with its square columns with composite capitals and an ornamental plaster cornice at the beams. At the rear of the bank space, a mezzanine overlooked the lobby and offered access to a director's room with a fireplace, mantle, and decorated tile. Most of these features were concealed when the building was converted to commercial spaces. The one story hotel lobby contained massive wood clad columns and beams. Now deteriorated, the dining room was decorated with columns, capitals, and coffered ceiling. The guest rooms were plainly furnished.
