Samuel Kraemer Building

76 S. Claudina St. Orange County

Anaheim, Ca. 92805

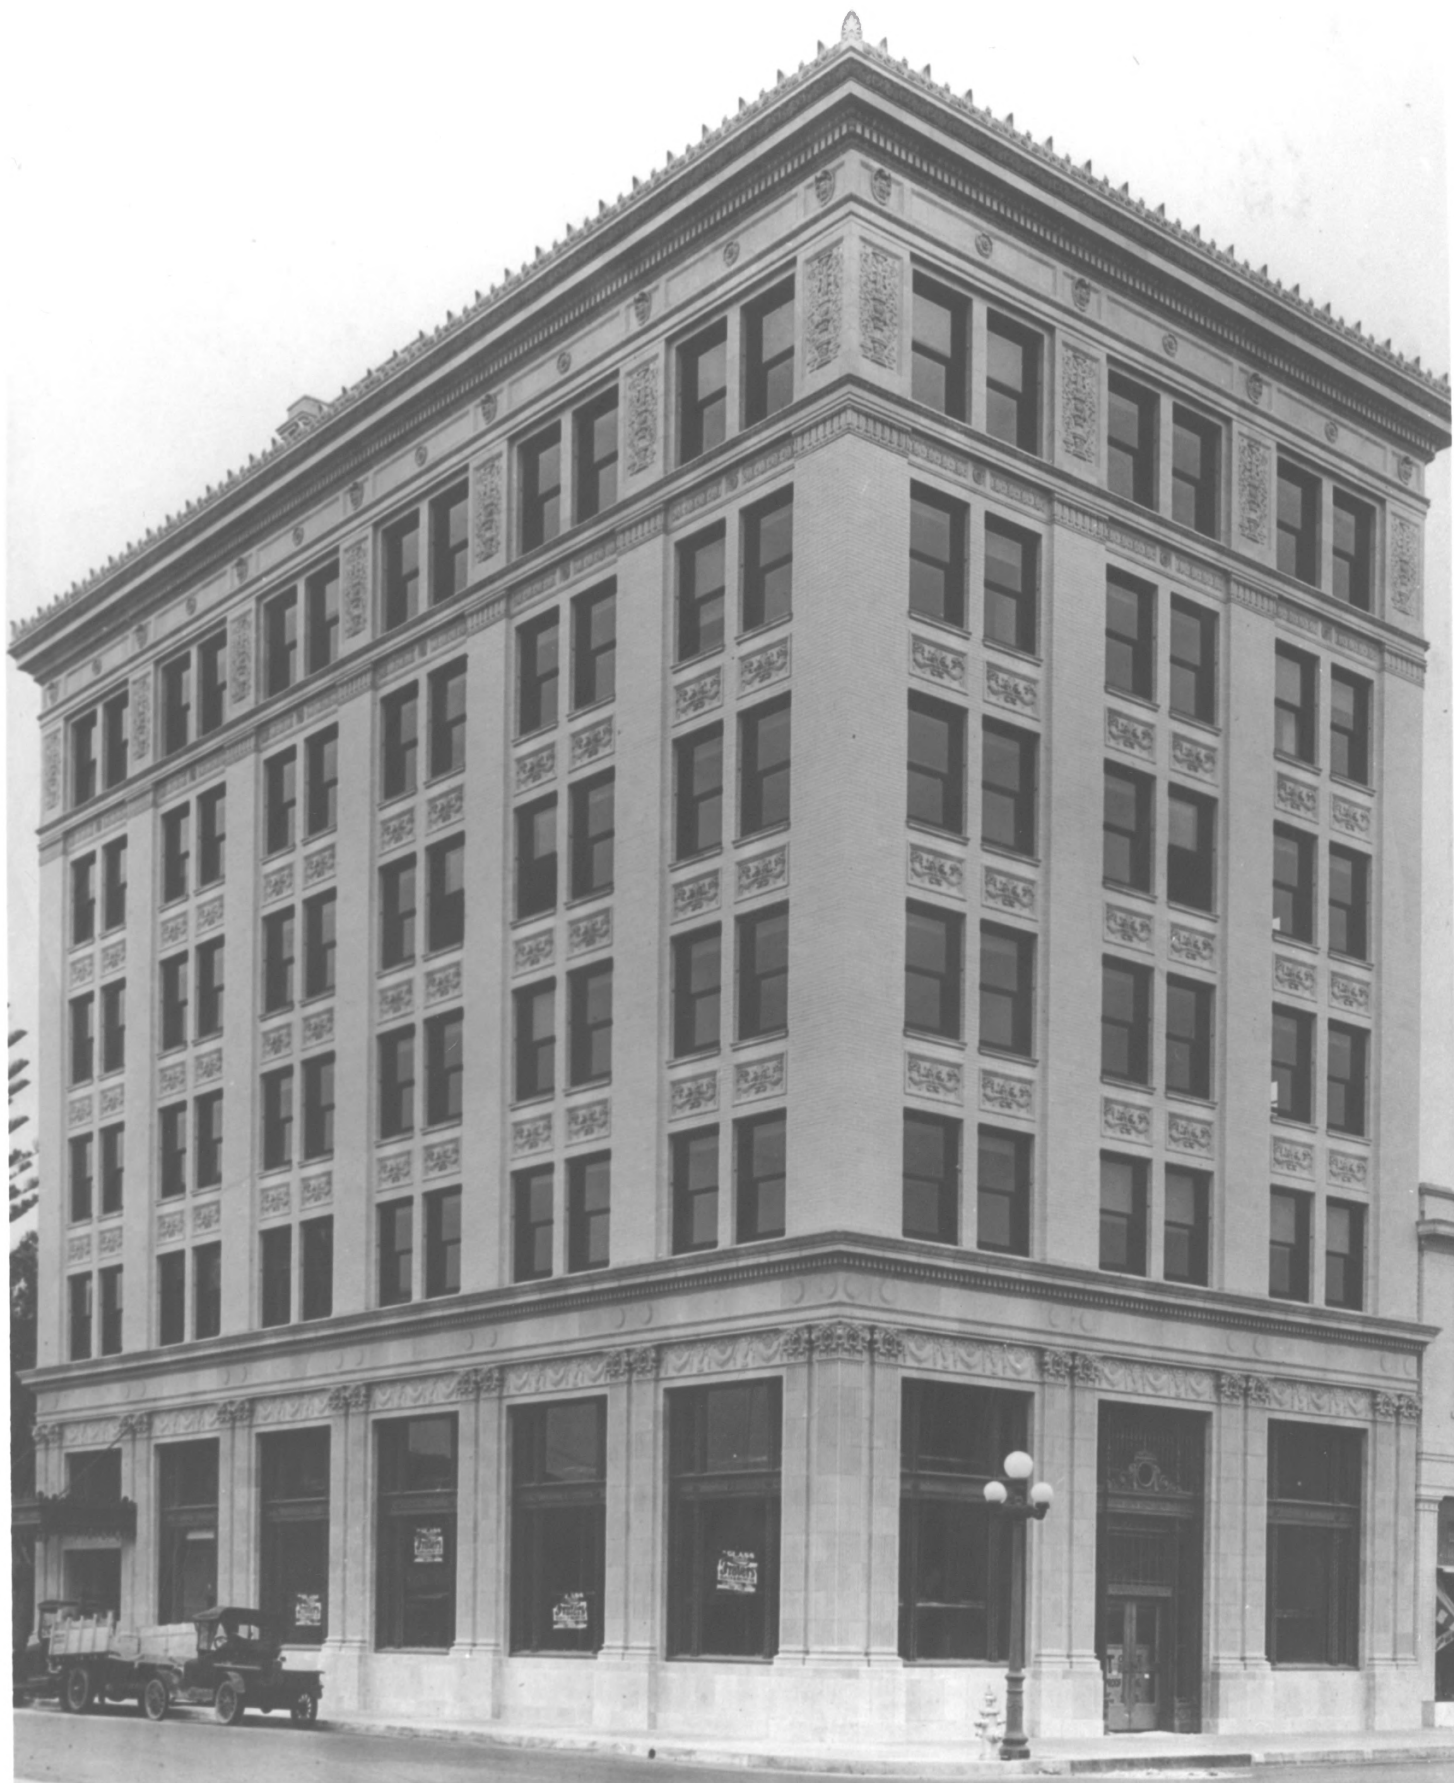
Bank building taken from across Lincoln,
looking at south and west facades. (1 of 14)

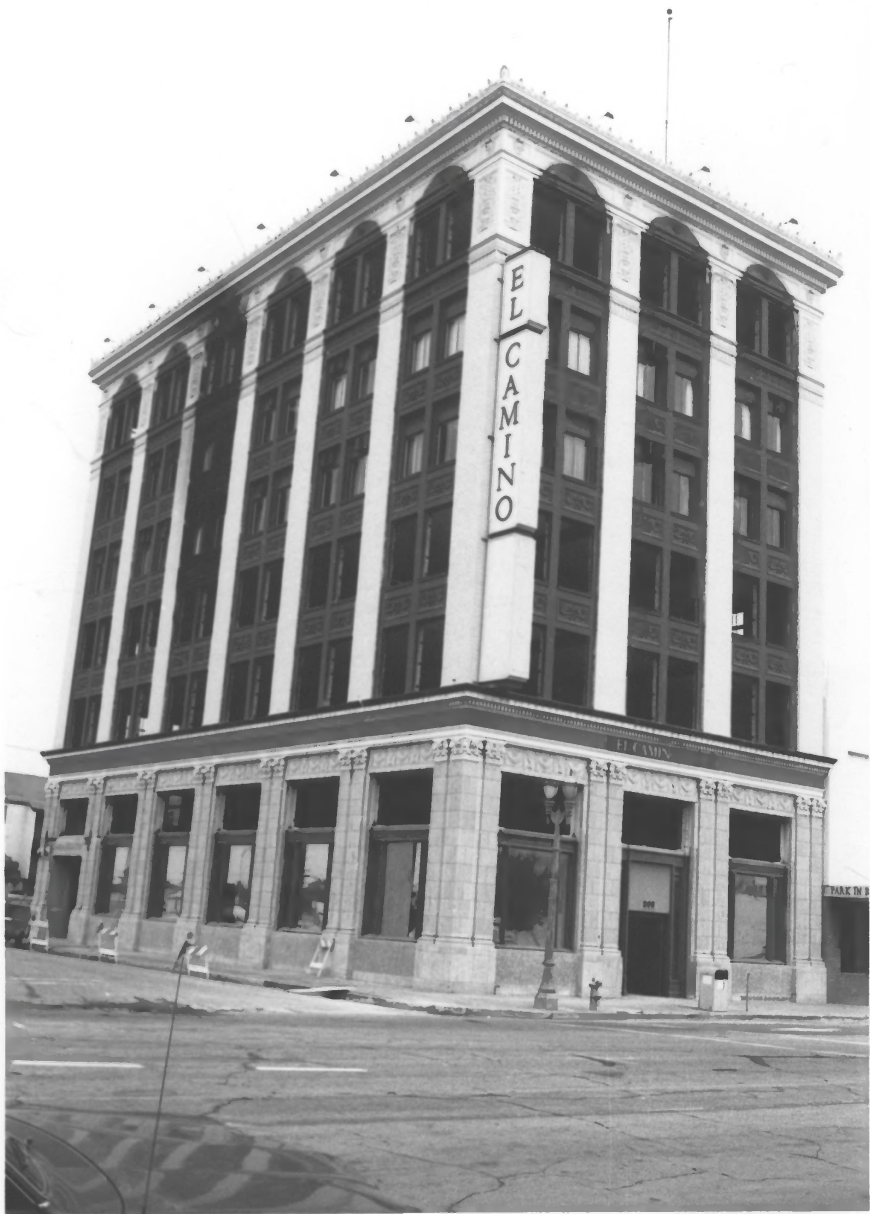
(02 of 14)

South (front) and west facades from
across the street. Taken when demolition
was completed of the altered parts. Dark
areas are where metal screen and arches
were.

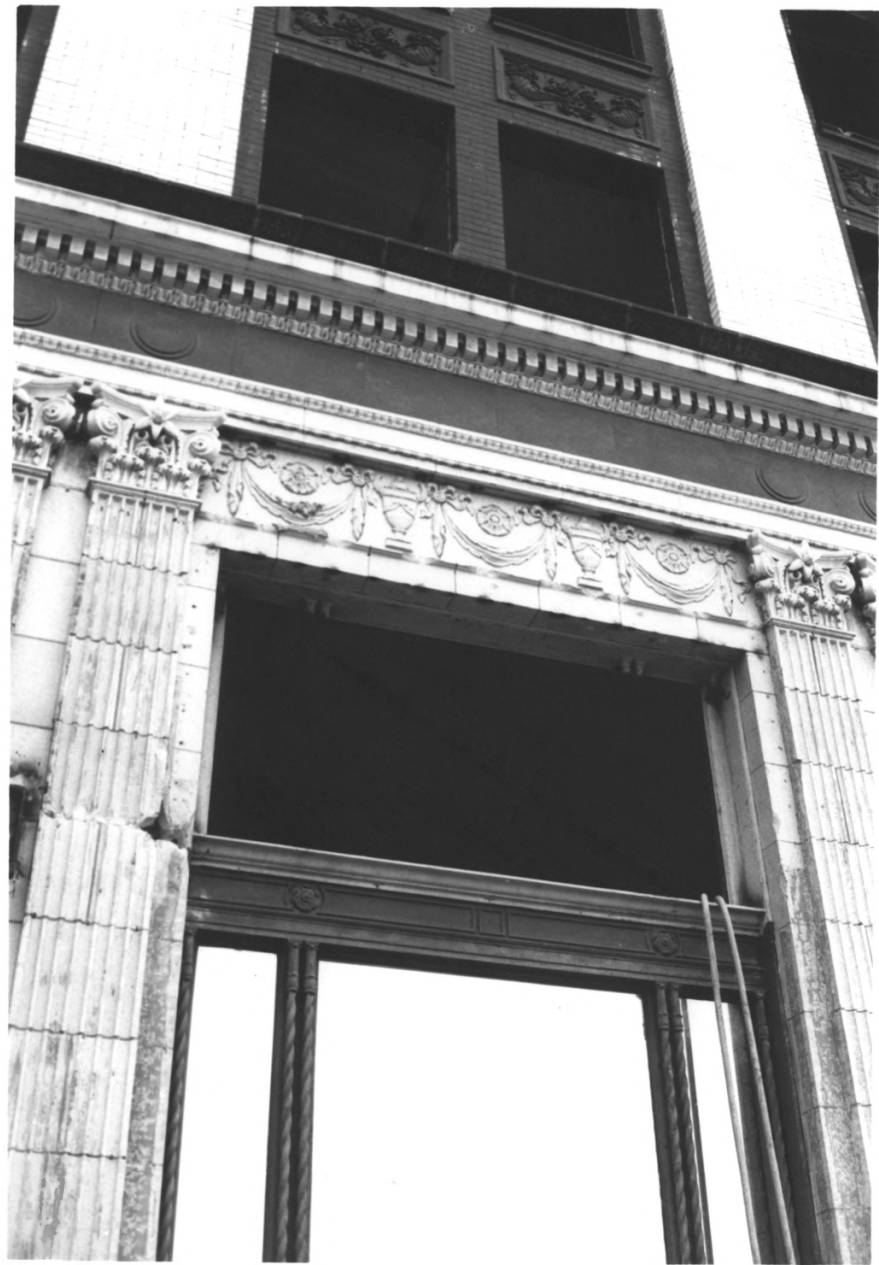
Window in west facade after demolition of altered parts, reavealing original tiles and brick. Transom window will be a wood sashed replica of the original. Lower window original. (3 of 14)

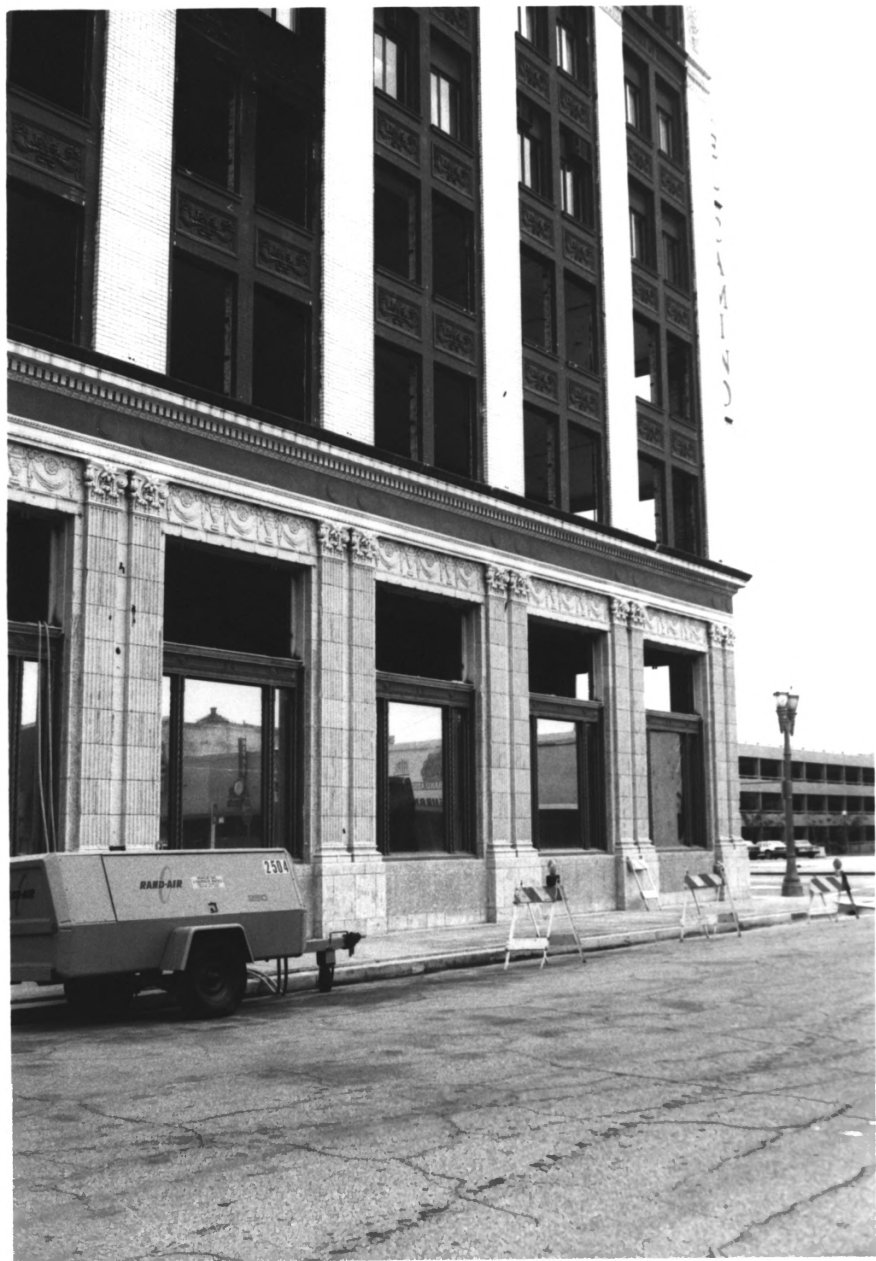
West facade after demolition of altered
parts (except for floors 4 and 5 which will
be done later). Transom windows and windows
on floors 2 through 6 will duplicate the
original wood sashes. (4 of 14)

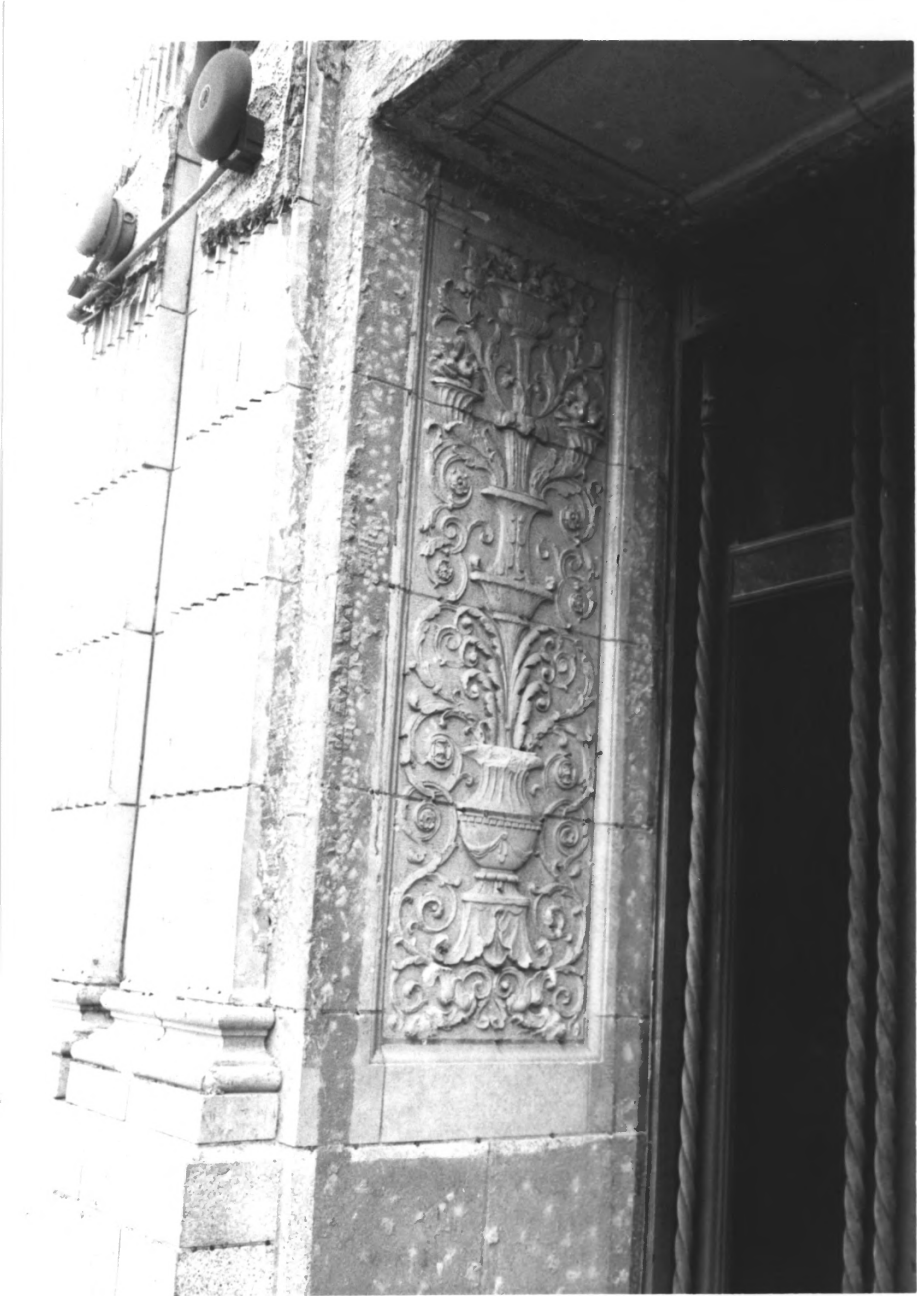
(5 of 14)

Details of panels of terra cotta tiles on
entry to rear lobby. Twisted metal columns
can be seen bordering the sidelight in the
door frame.

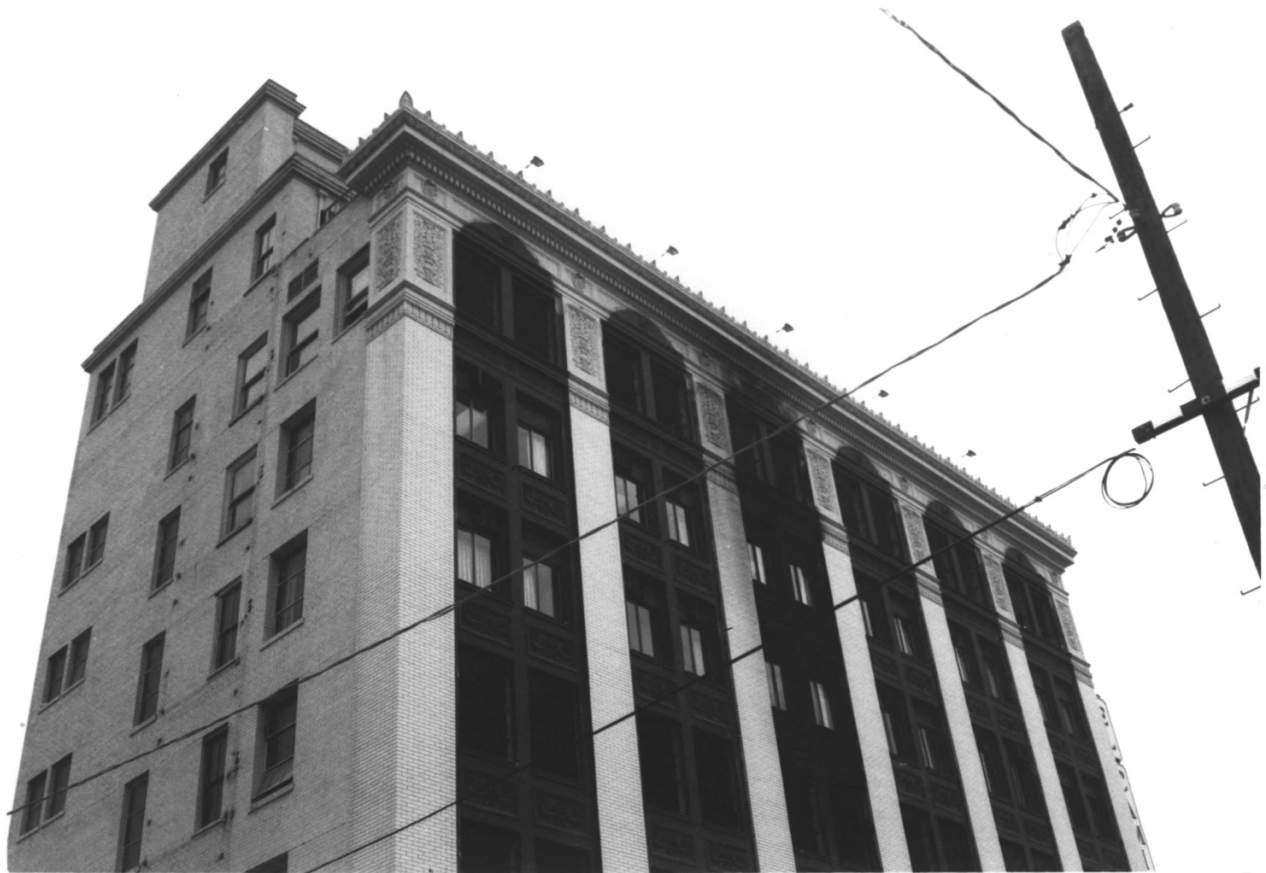
(6 of 14)

Top of building after demolition of altered
parts. Brown areas denote where the metal
arches and screens covered the building.
West facade and north side (rear).

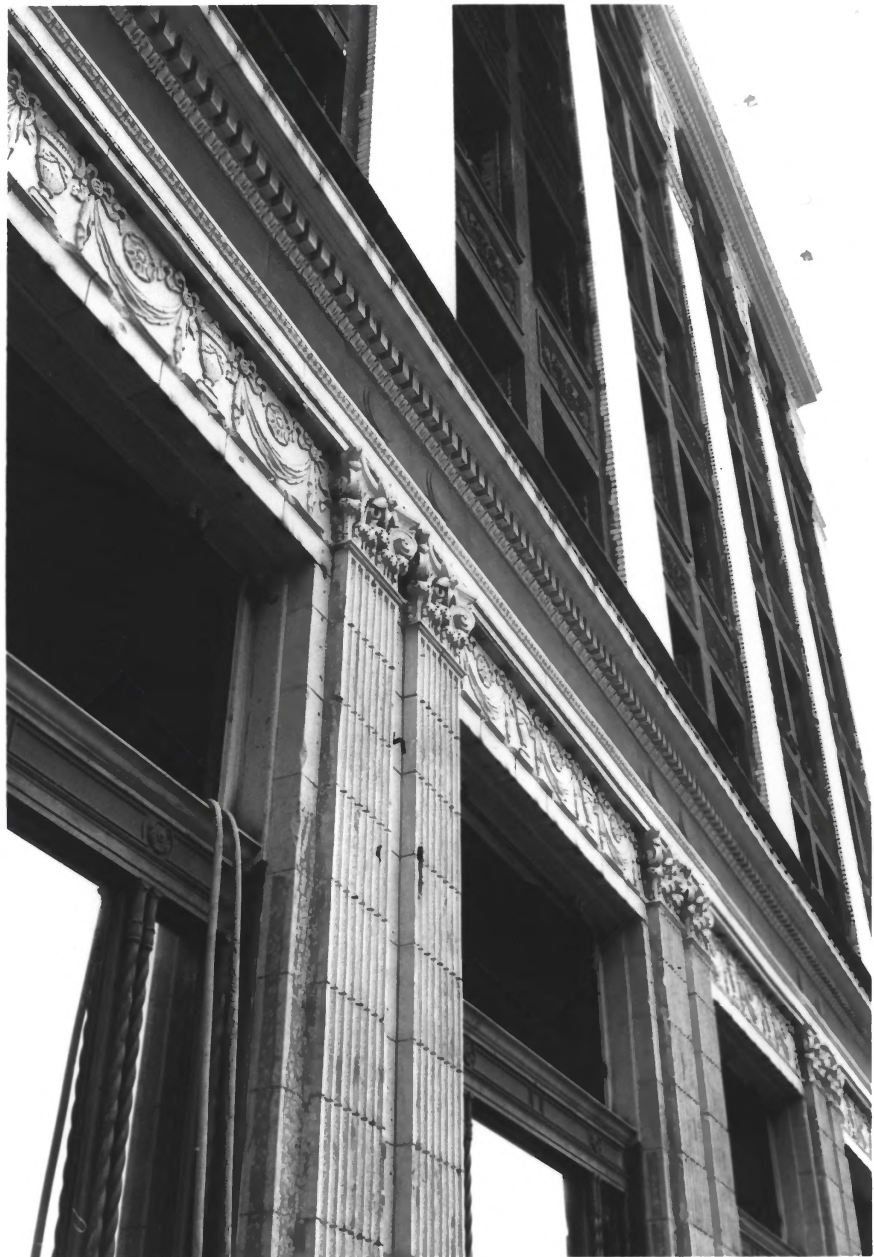
Top of windows in lower floor in the west
facade. Cornice at top of lower floor.
columns and frieze revealed when stucco
was removed. (7 of 14)

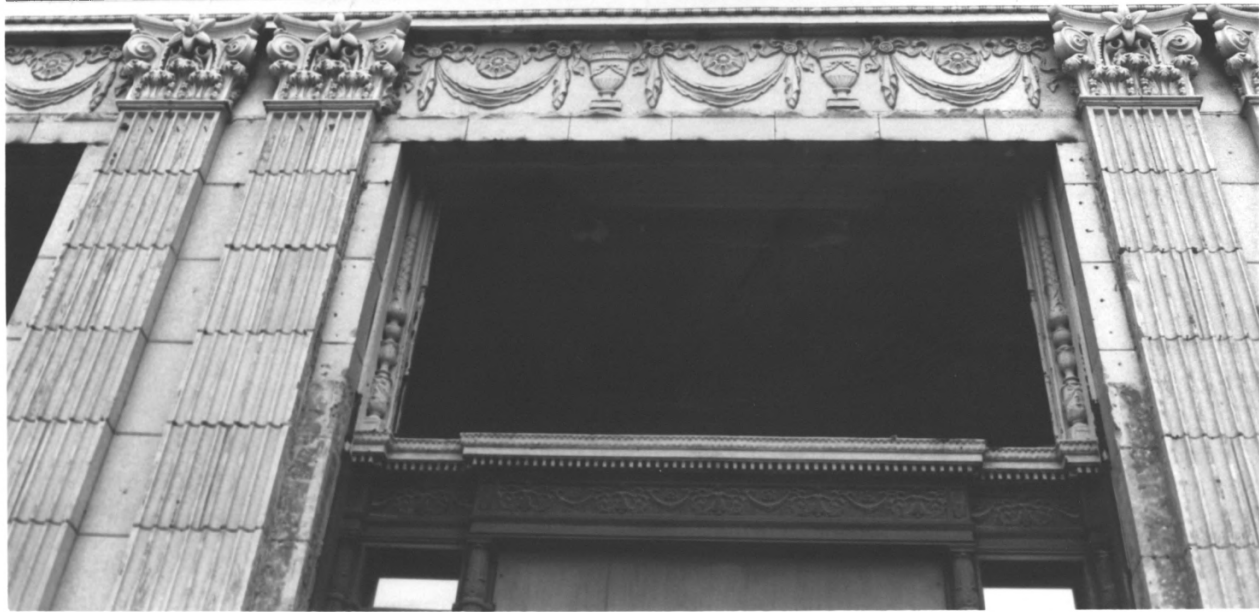
West facade facing Claudina St. Windows and cornice above lower floor. Columns and frieze were revealed when stucco was removed. Transom is ready for reinstallation of replicas of the original wood sash windows. (9 of 14)

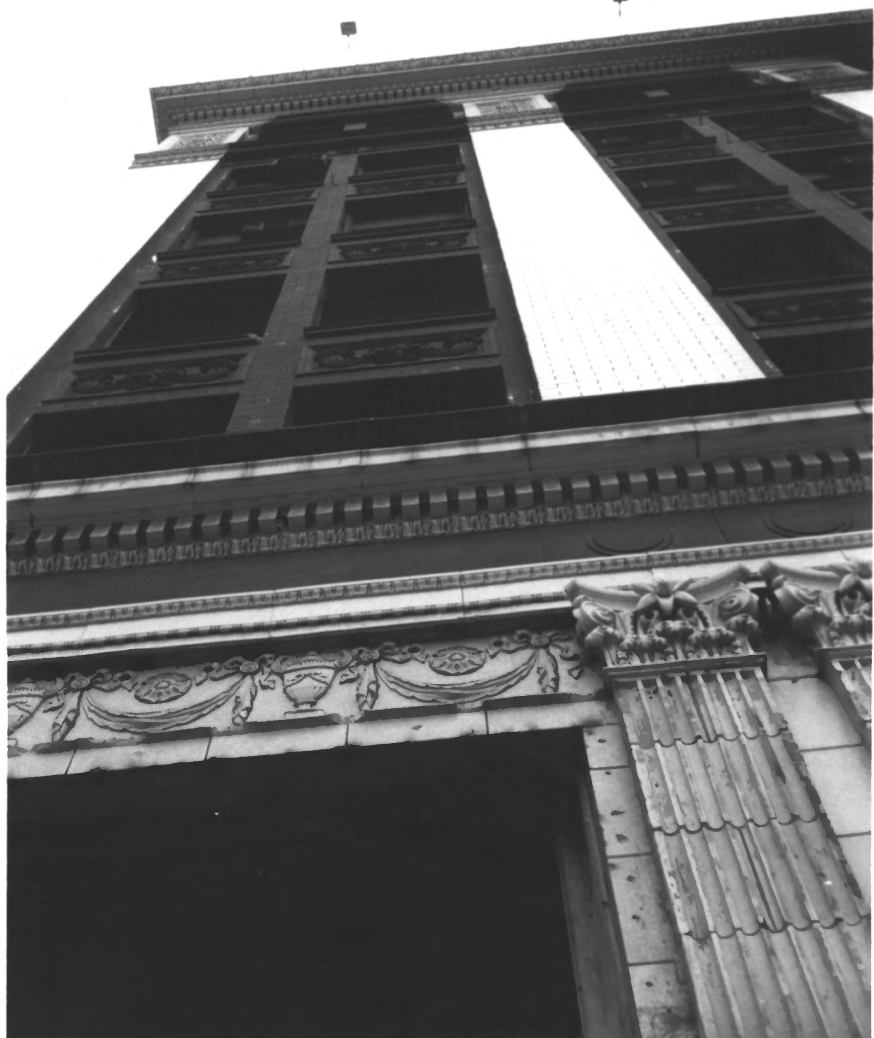
(10 of 14)

Cornice, first floor transom, and upper
floors on the west facade, looking straight
up.

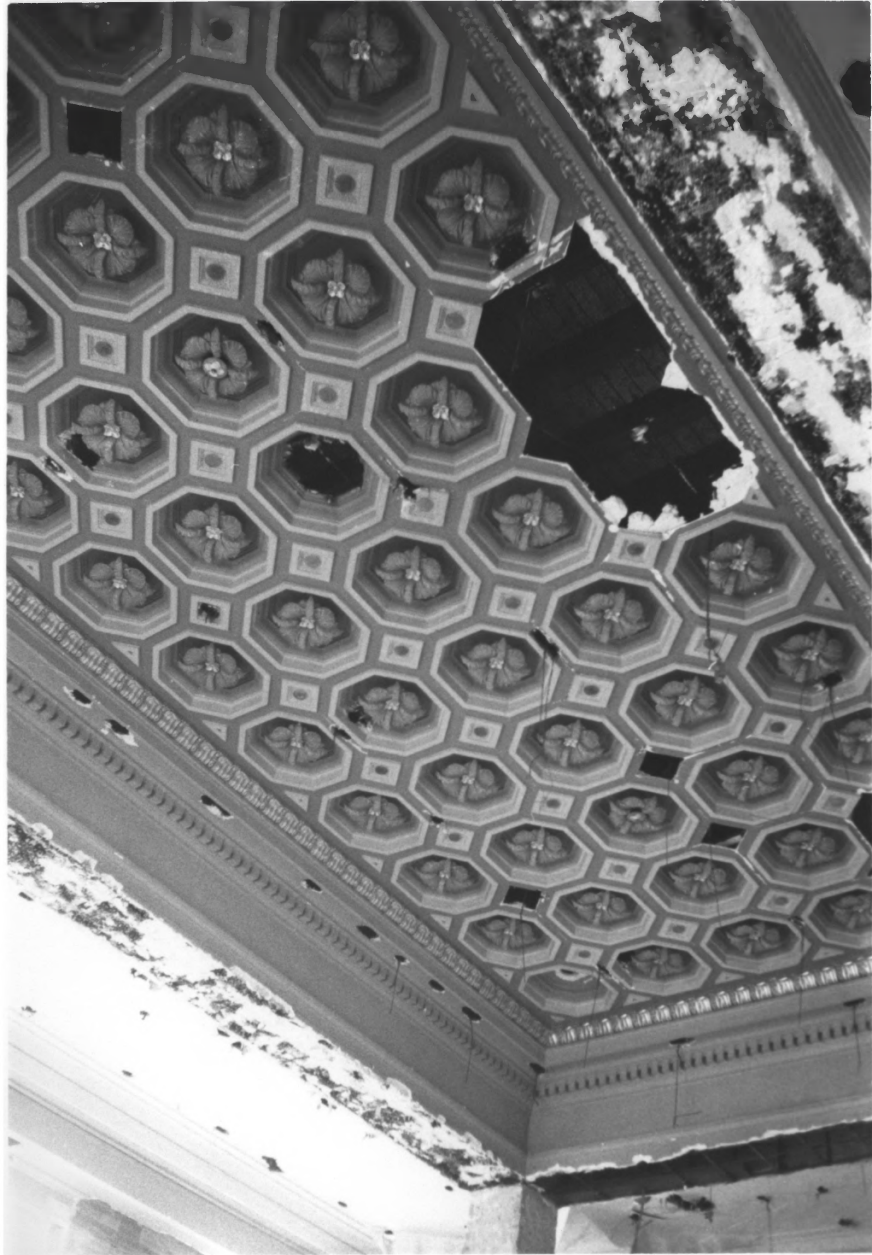
Ceiling in bank area on lower floor. It
was revealed when the acoustical ceiling
was removed. Colors are green and cream
with gold accents. (11 of 14)

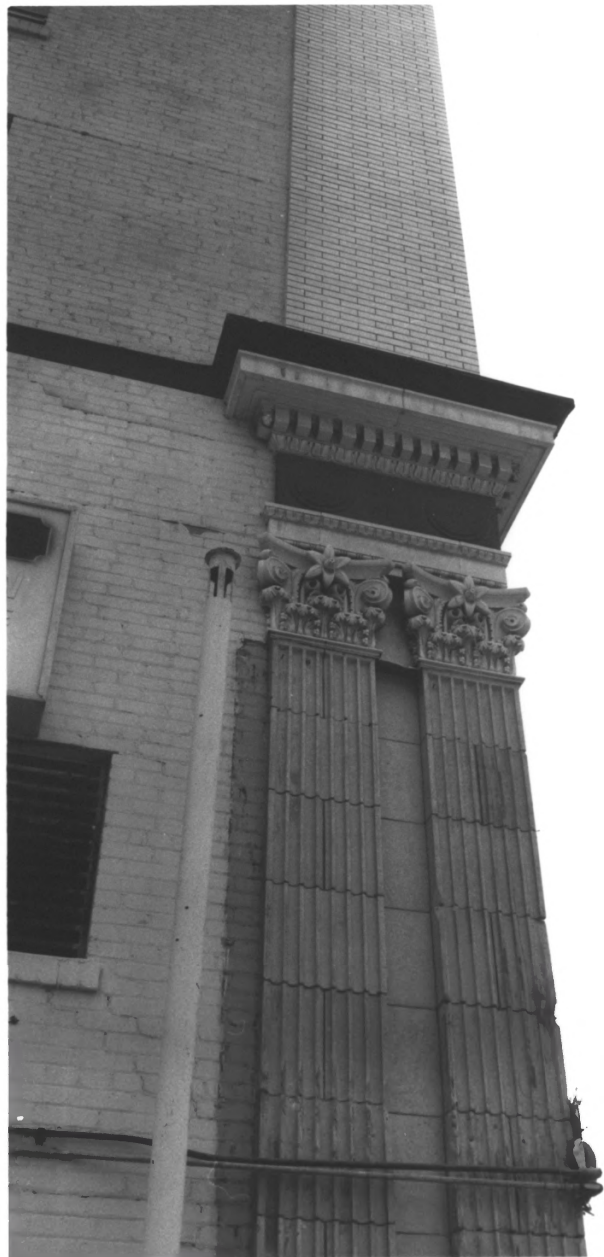
North facade facing alley. The trim from
the west and south facades is wrapped
around the end of the building. The col-
umns and capitals match those on the
front. (2 of 14)

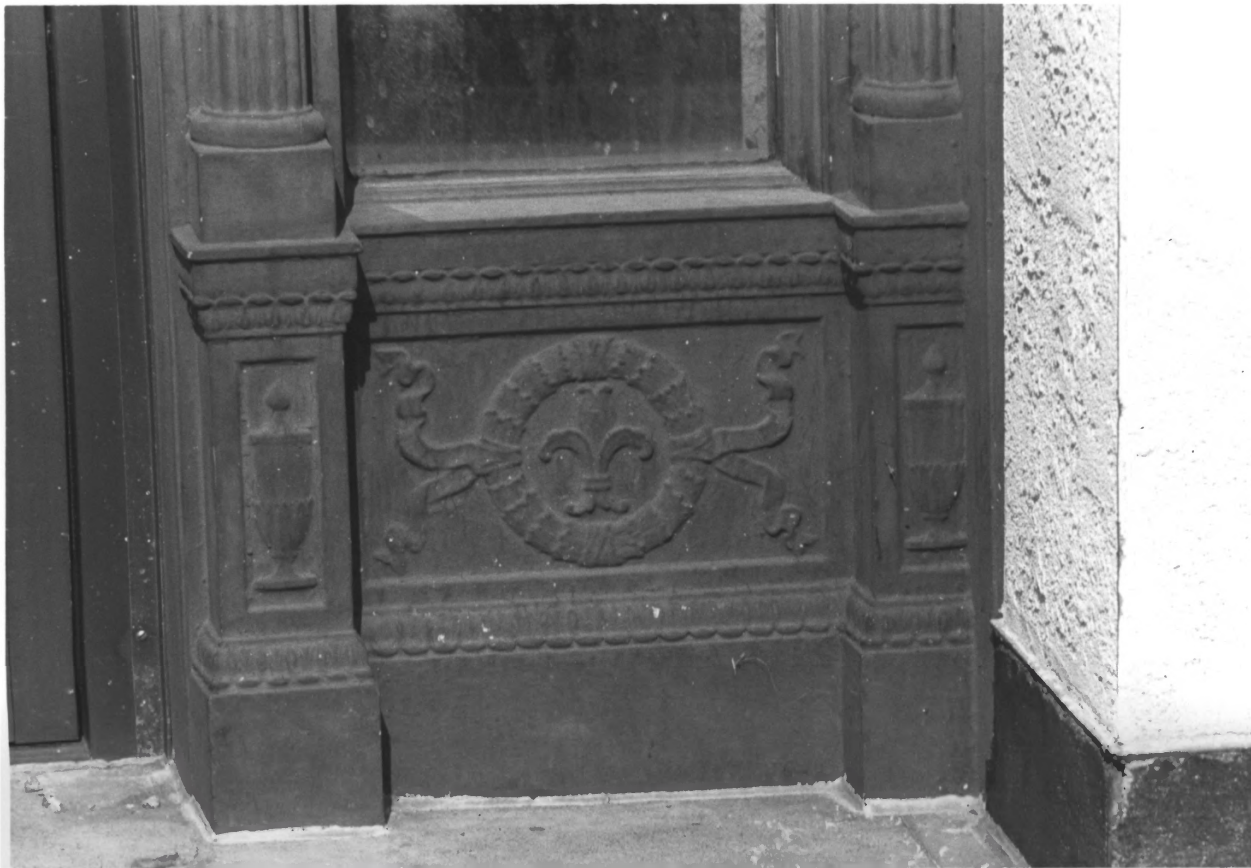
(13 of 14)

Stamped metal door and window frame in
main entrance on south facade.

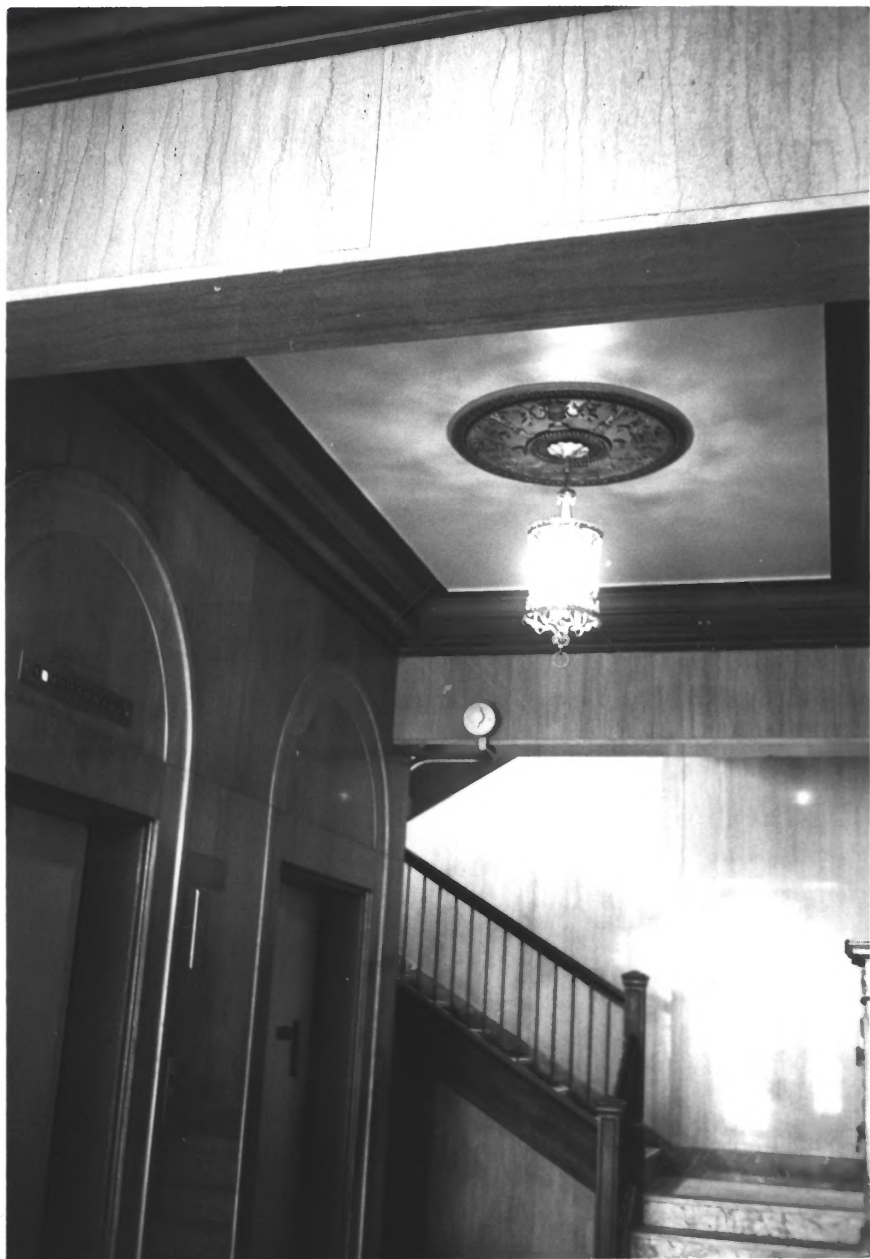
(14 of 15)

Rear lobby to upper floors. All original
except for elevator doors.
