1. Libby McNeill & Libby  
Fruit & Vegetable Cannery
2. Sacramento, California
3. Original photo date unknown (Photo of  
photo)
4. 6/5/80 (Date of photo of photo)
5. 928 Second Street  
Sacramento, California 95814
6. Aerial view facing westerly
7. Photo No. 1 of 21

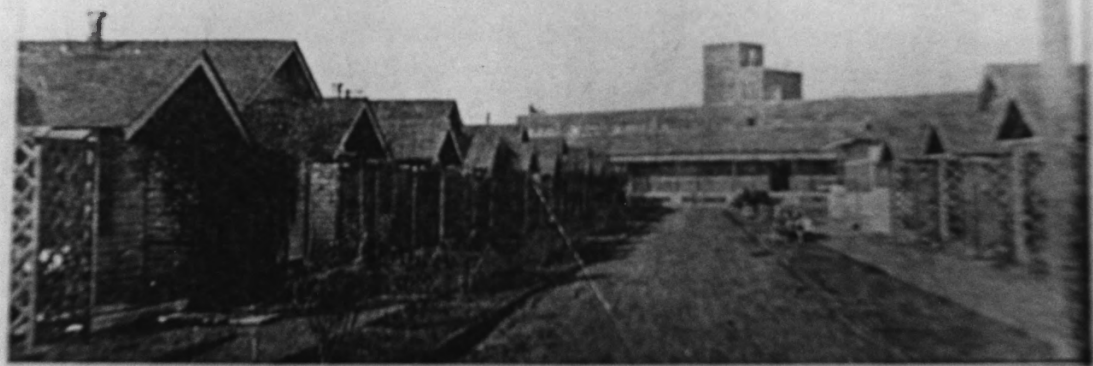
1. Libby McNeill & Libby  
Fruit & Vegetable Cannery
2. Sacramento, California
3. Original photo date unknown (Photo of  
photo)
4. 6/5/80 (Date of photo of photo)
5. 928 Second Street  
Sacramento, California 95814
6. View of worker's cottages facing  
north-easterly
7. Photo No. 3 *of 21*

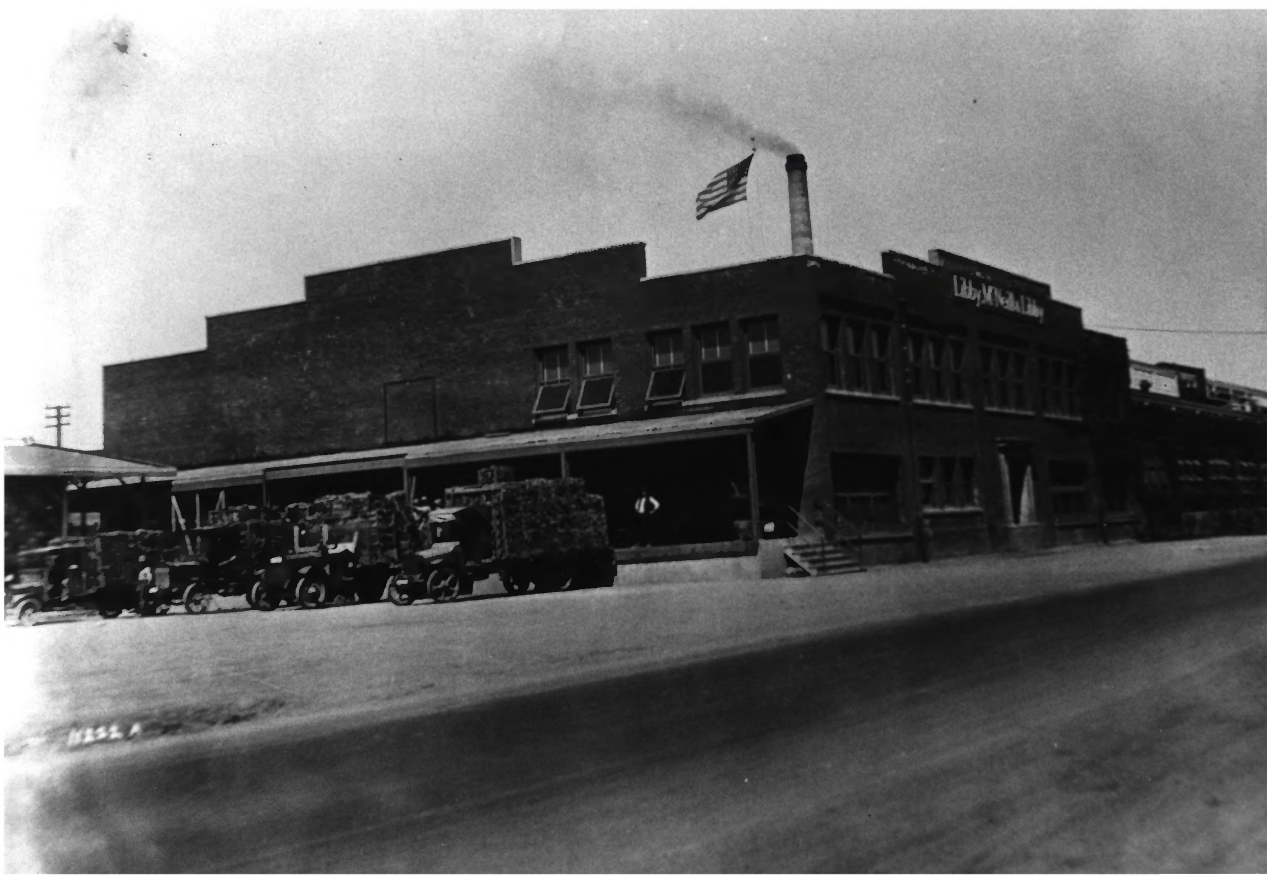
1. Libby McNeill & Libby  
Fruit & Vegetable Cannery
2. Sacramento, California
3. Original photo date unknown (Photo of  
photo)
4. 6/5/80 (Date of photo of photo)
5. 928 Second Street  
Sacramento, California 95814
6. Office and receiving dock, circa 1920,  
facing north-westerly
7. Photo No. 4 of 21

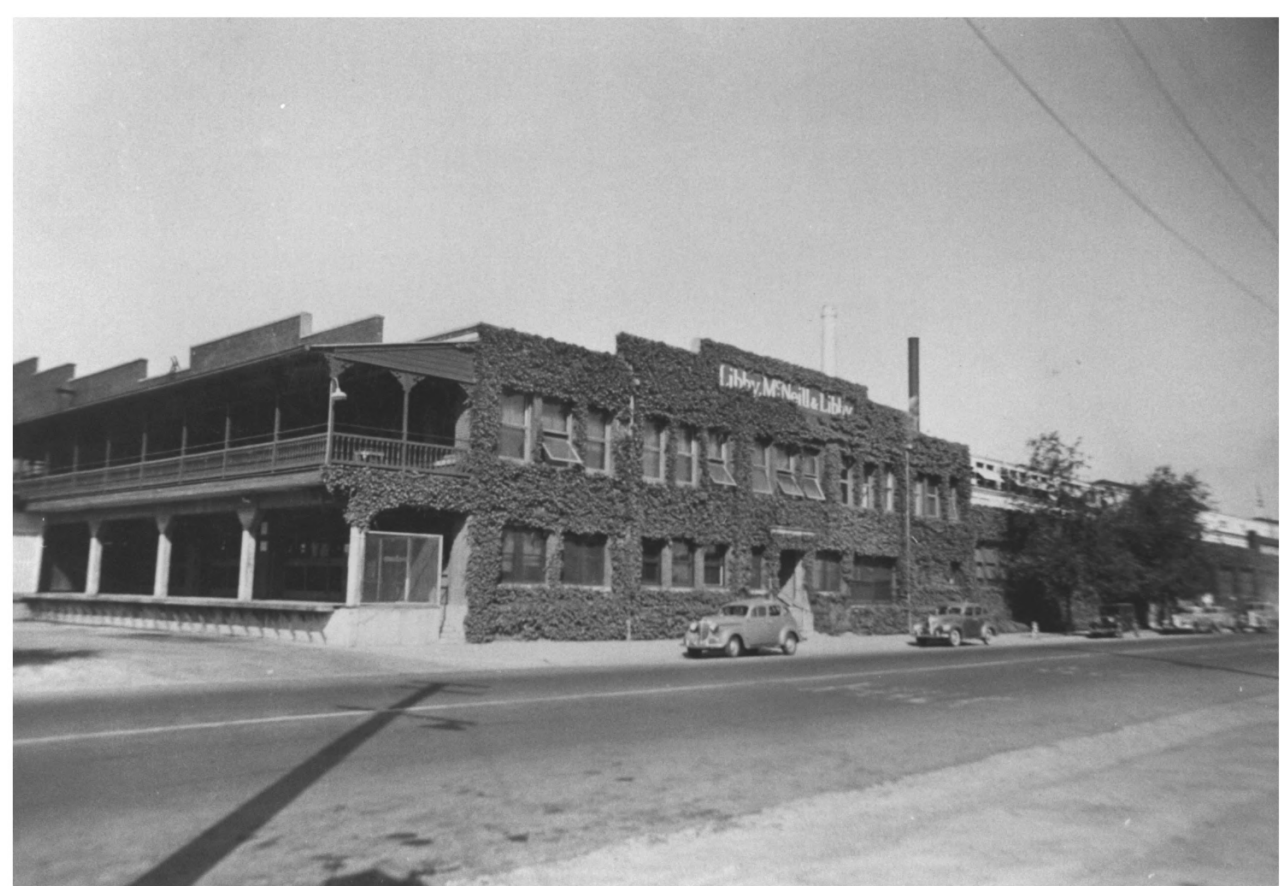
1. Libby McNeill & Libby  
Fruit & Vegetable Cannery
2. Sacramento, California
3. Original photo date unknown (Photo of  
photo)
4. 6/5/80 (Date of photo of photo)
5. 928 Second Street  
Sacramento, California 95814
6. Office and receiving dock, circa 1937,  
showing addition of balcony (galleria)  
above loading dock facing north-westerly
7. Photo No. 5 of 21

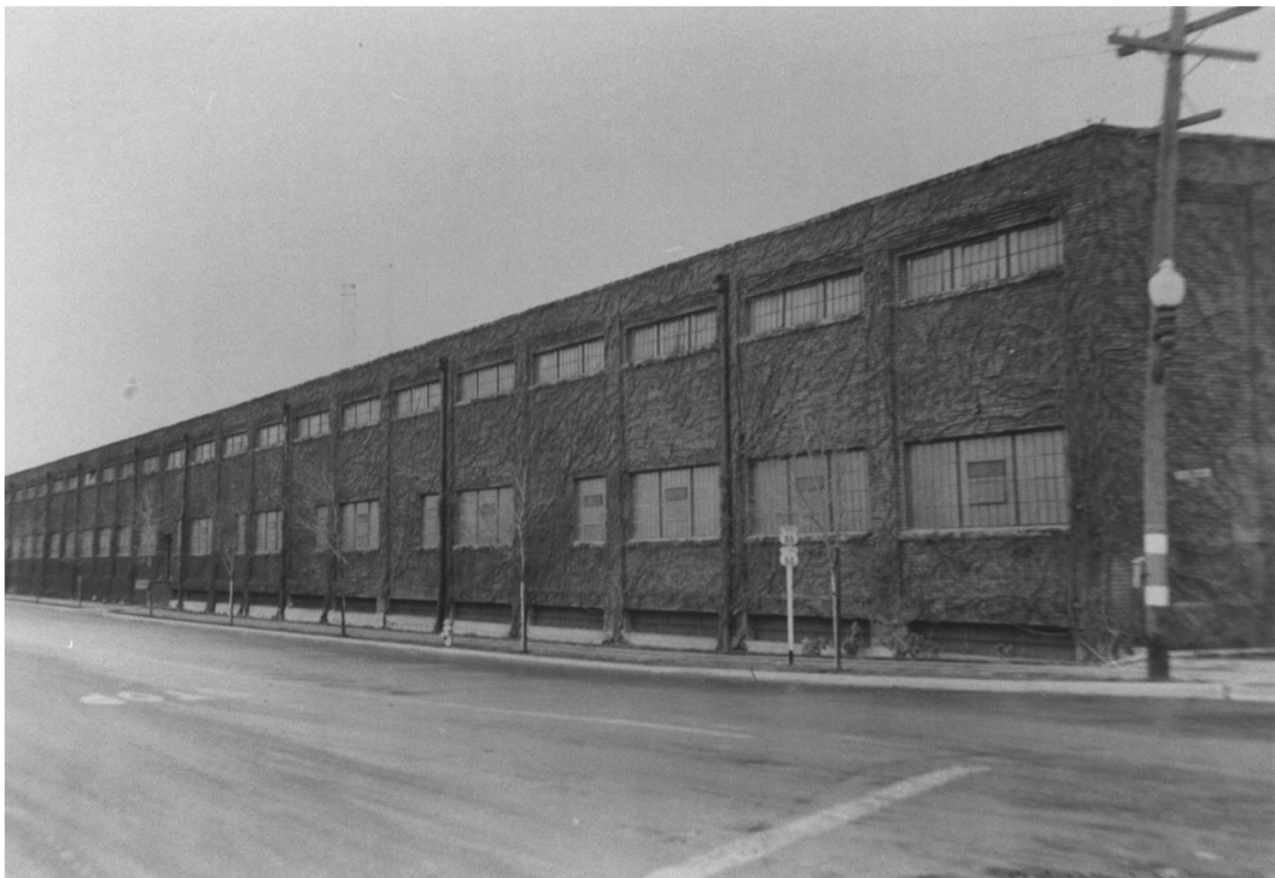
1. Libby McNeill & Libby  
Fruit & Vegetable Cannery
2. Sacramento, California
3. Original photo date unknown (Photo of  
photo)
4. 6/5/80 (Date of photo of photo)
5. 928 Second Street  
Sacramento, California 95814
6. Warehouse Complex adjoining main cannery  
building and office, Stockton Blvd. front-  
age, circa 1937, facing south.
7. Photo No. 6 of 21

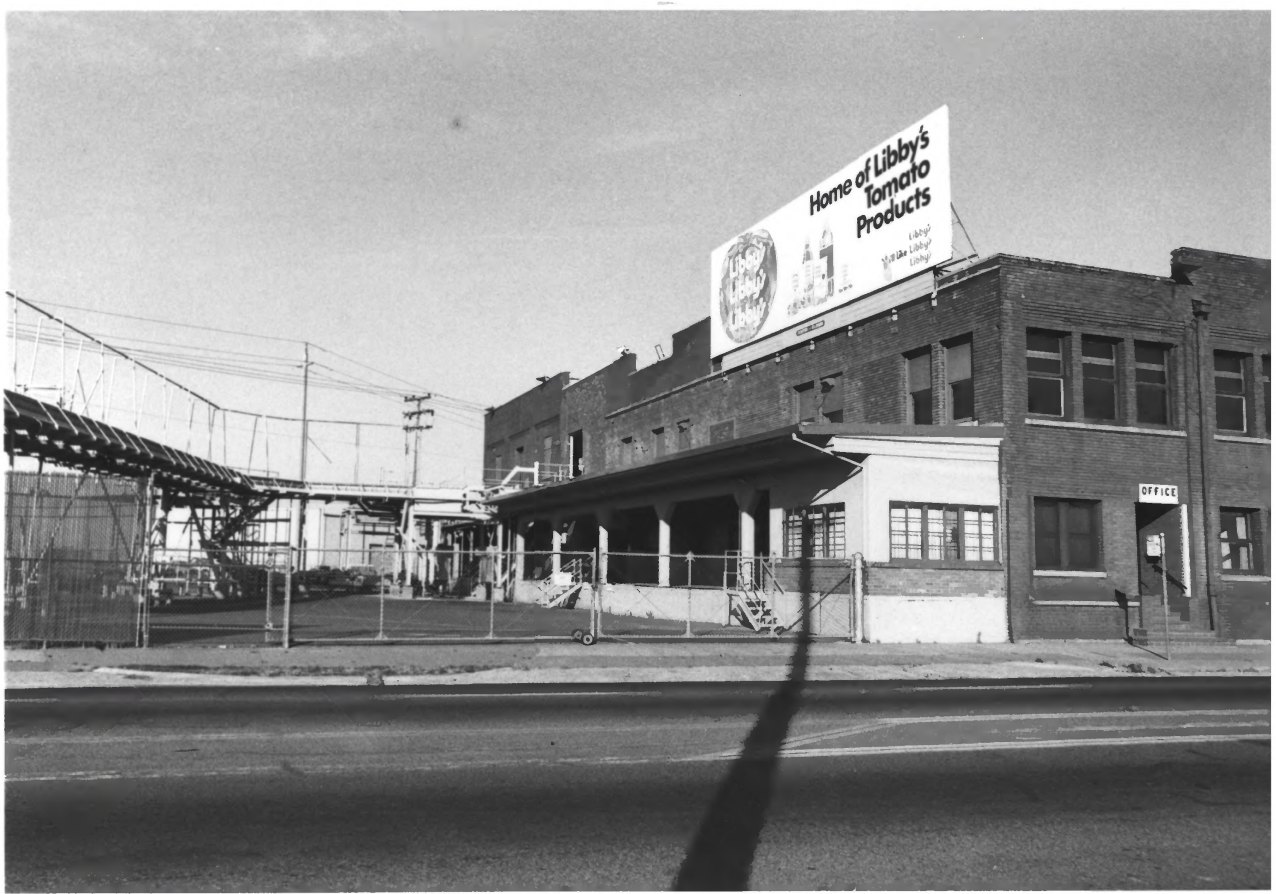
1. Libby McNeill & Libby  
Fruit & Vegetable Cannery
2. Sacramento, California
3. Edwin S. Astone
4. 6/5/80
5. 928 Second Street  
Sacramento, California 95814
6. South end of main building showing receiving dock, galleria removed and addition of small office on receiving dock, facing westerly
7. Photo No. 7 of 21

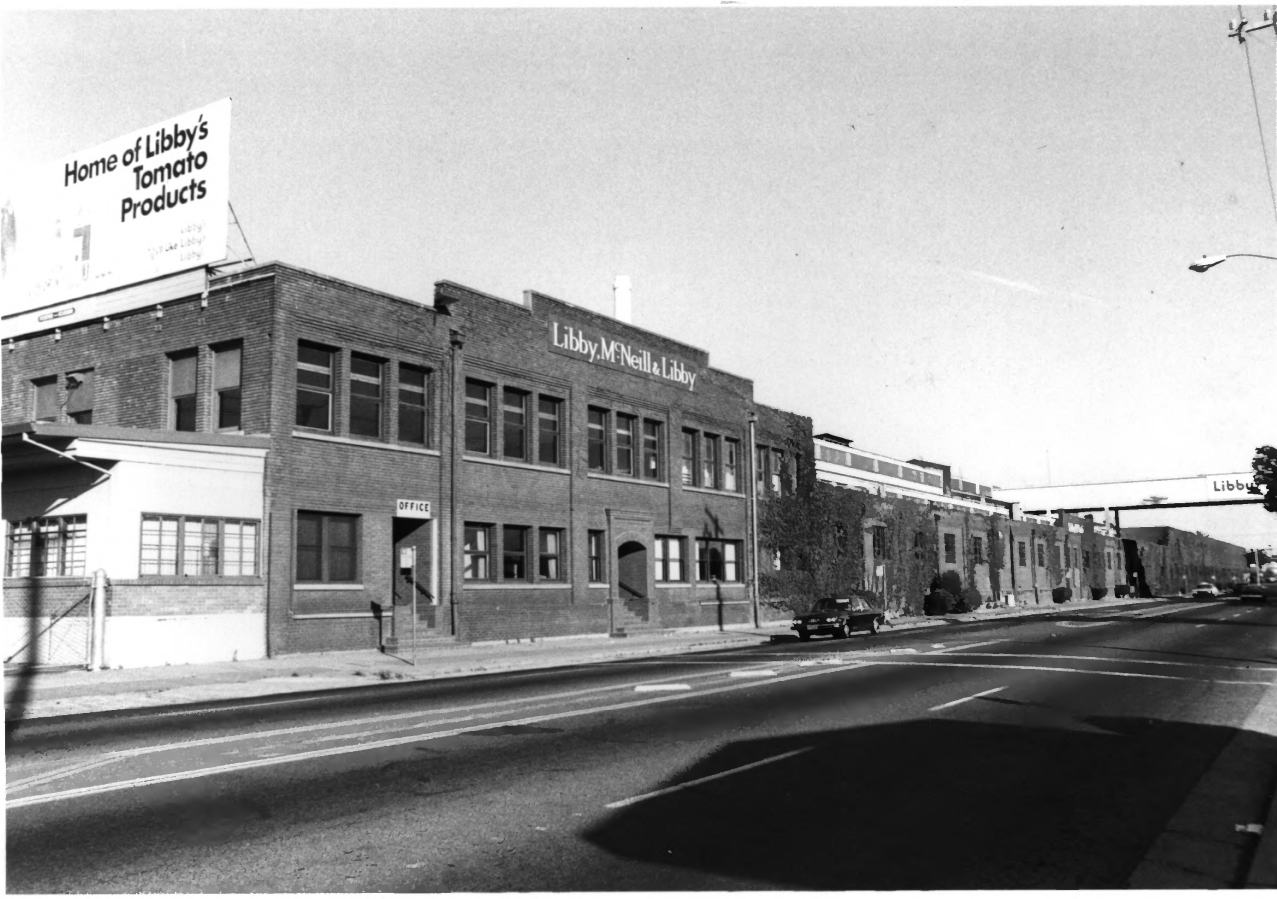
1. Libby McNeill & Libby  
Fruit & Vegetable Cannery
2. Sacramento, California
3. Edwin S. Astone
4. 6/5/80
5. 928 Second Street  
Sacramento, California 95814
6. Office and main cannery, along Stockton,  
showing elevated can conveyor feeding the  
main cannery processing area from can  
storage buildings, circa 1950's, facing  
north-westerly
7. Photo No. 8 of 21

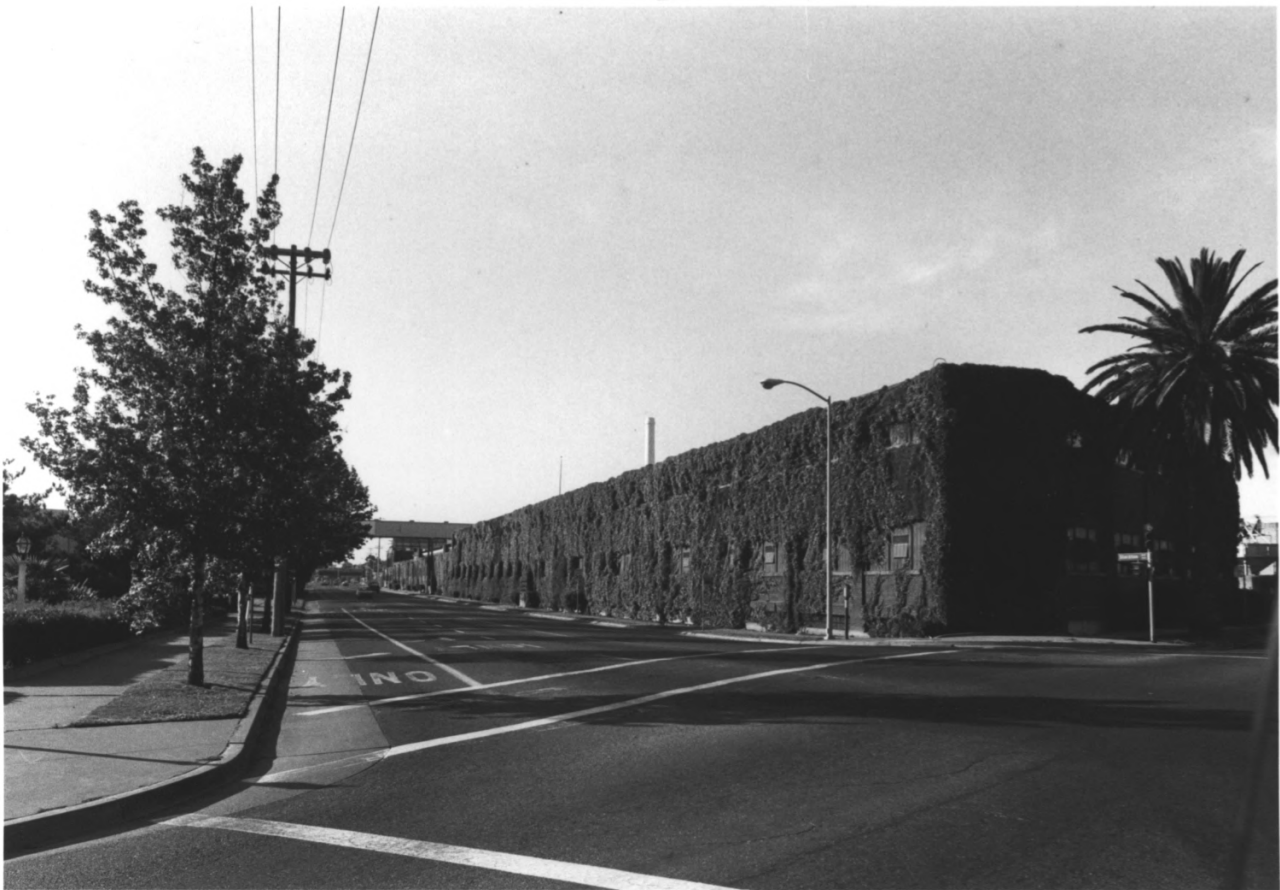
1. Libby McNeill & Libby  
Fruit & Vegetable Cannery
2. Sacramento, California
3. Edwin S. Astone
4. 6/5/80
5. 928 Second Street  
Sacramento, California 95814
6. General view of cannery complex showing  
ivy covered warehouse at the corner of  
Stockton and Alhambra Blvds., facing  
south
7. Photo No. 9 of 21

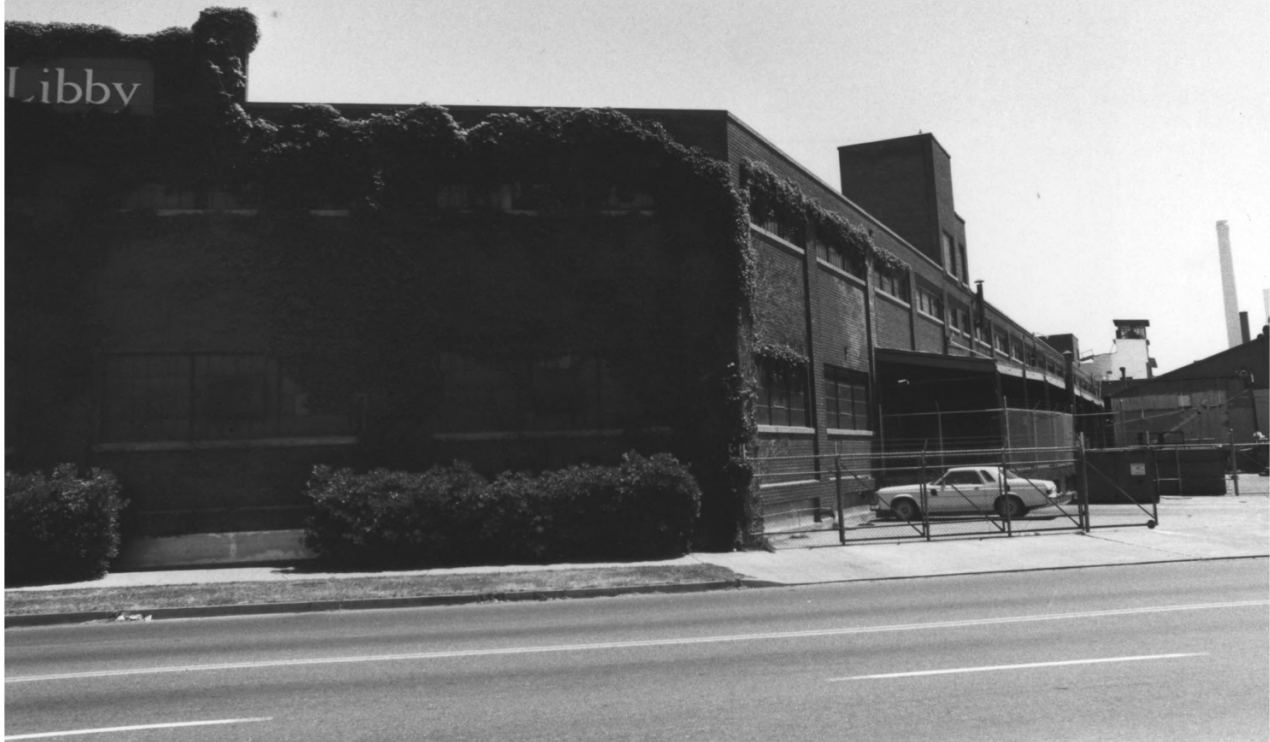
1. Libby McNeill & Libby  
Fruit & Vegetable Cannery
2. Sacramento, California
3. Edwin S. Astone
4. 6/5/80
5. 928 Second Street  
Sacramento, California 95814
6. Warehouse No. 8 (most northerly of the  
cannery complex) showing Alhambra Blvd.  
frontage and a portion of the receiving  
and service yard, facing south-easterly
7. Photo No. 10 of 21

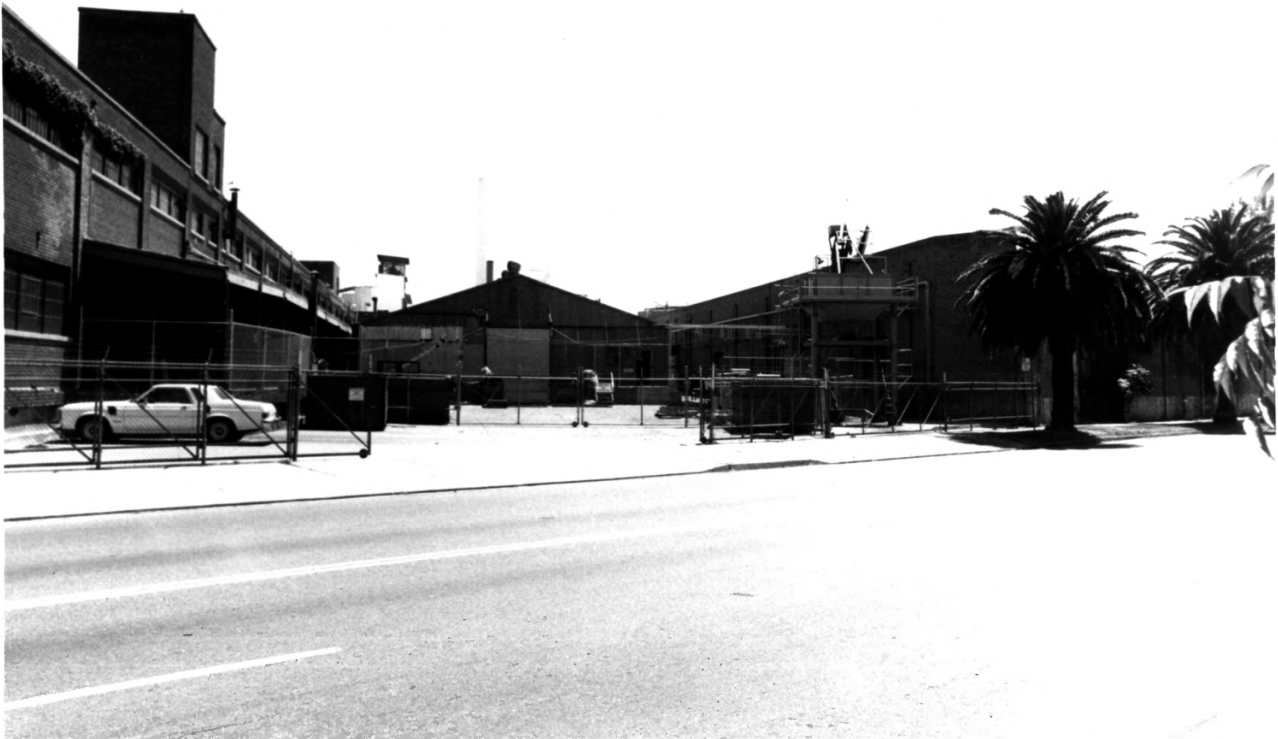
1. Libby McNeill & Libby  
Fruit & Vegetable Cannery
2. Sacramento, California
3. Edwin S. Astone
4. 6/5/80
5. 928 Second Street  
Sacramento, California 95814
6. Receiving and service yard off of  
Alhambra Blvd. in between old warehouse  
complex (Buildings No. 7 & 8) and ware-  
house building No. 37. Also shows  
original concrete smoke stack, facing  
south-easterly
7. Photo No. 11 *of 21*

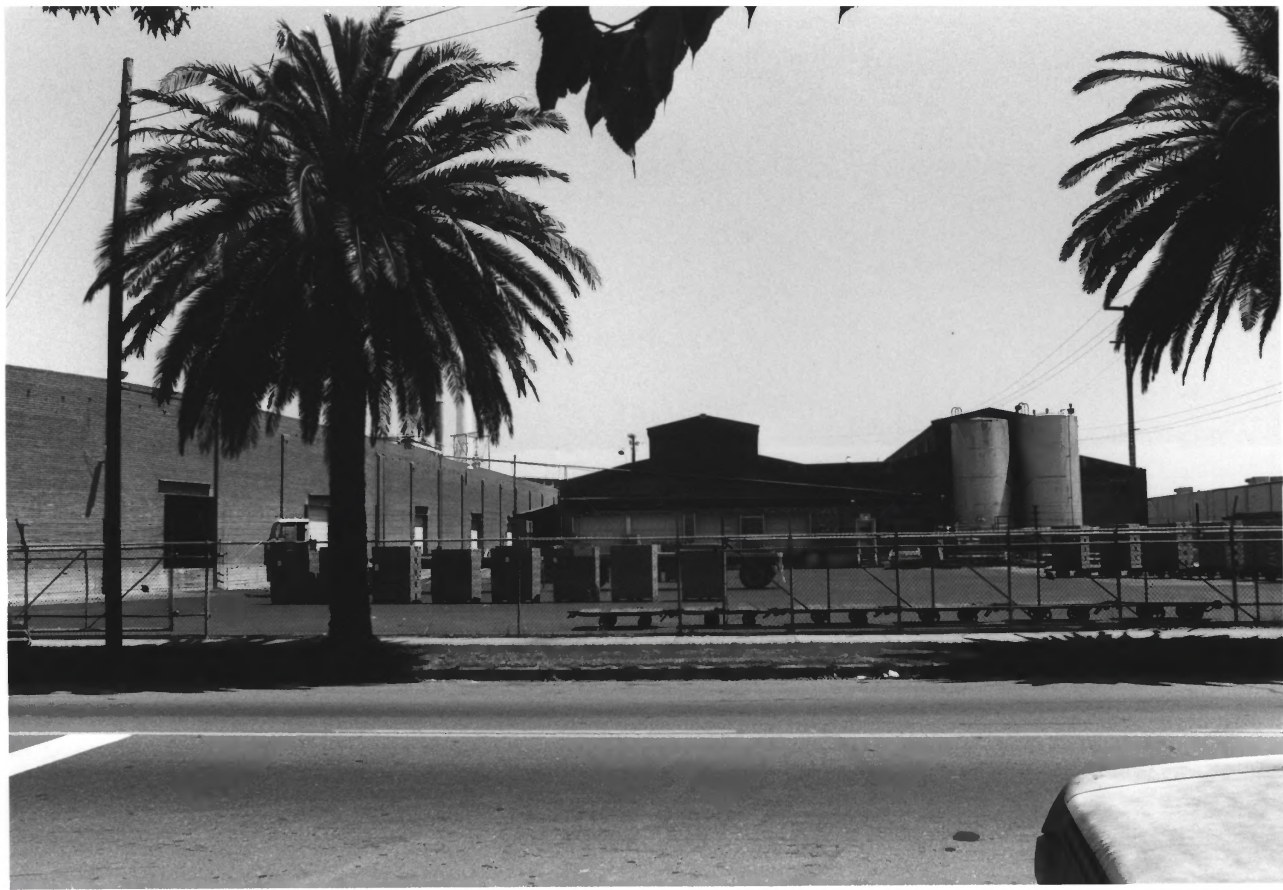
1. Libby McNeill & Libby  
Fruit & Vegetable Cannery
2. Sacramento, California
3. Edwin S. Astone
4. 6/5/80
5. 928 Second Street  
Sacramento, California 95814
6. Shipping yard along Alhambra Blvd. and  
railroad spur line on right. Warehouse  
No. 37 is on left (curved configuration  
followed rail spur line) and the old can  
factory is in the rear center, facing  
easterly
7. Photo No. 12 of 21

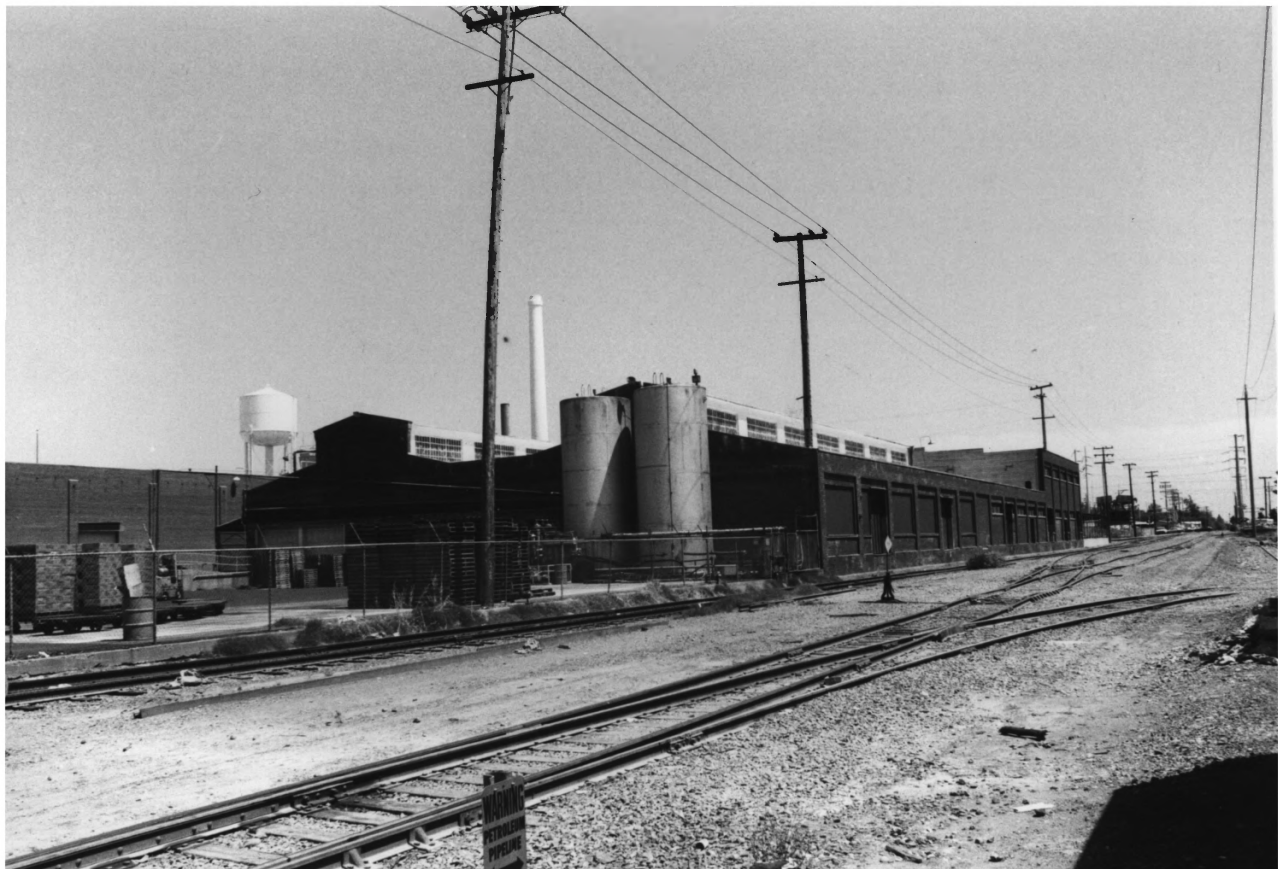
1. Libby McNeill & Libby  
Fruit & Vegetable Cannery
2. Sacramento, California
3. Edwin S. Astone
4. 6/5/80
5. 928 Second Street  
Sacramento, California 95814
6. Old can factory and warehouse along  
railroad frontage, warehouse No. 37  
on the left, facing easterly
7. Photo No. 13 *of 21*

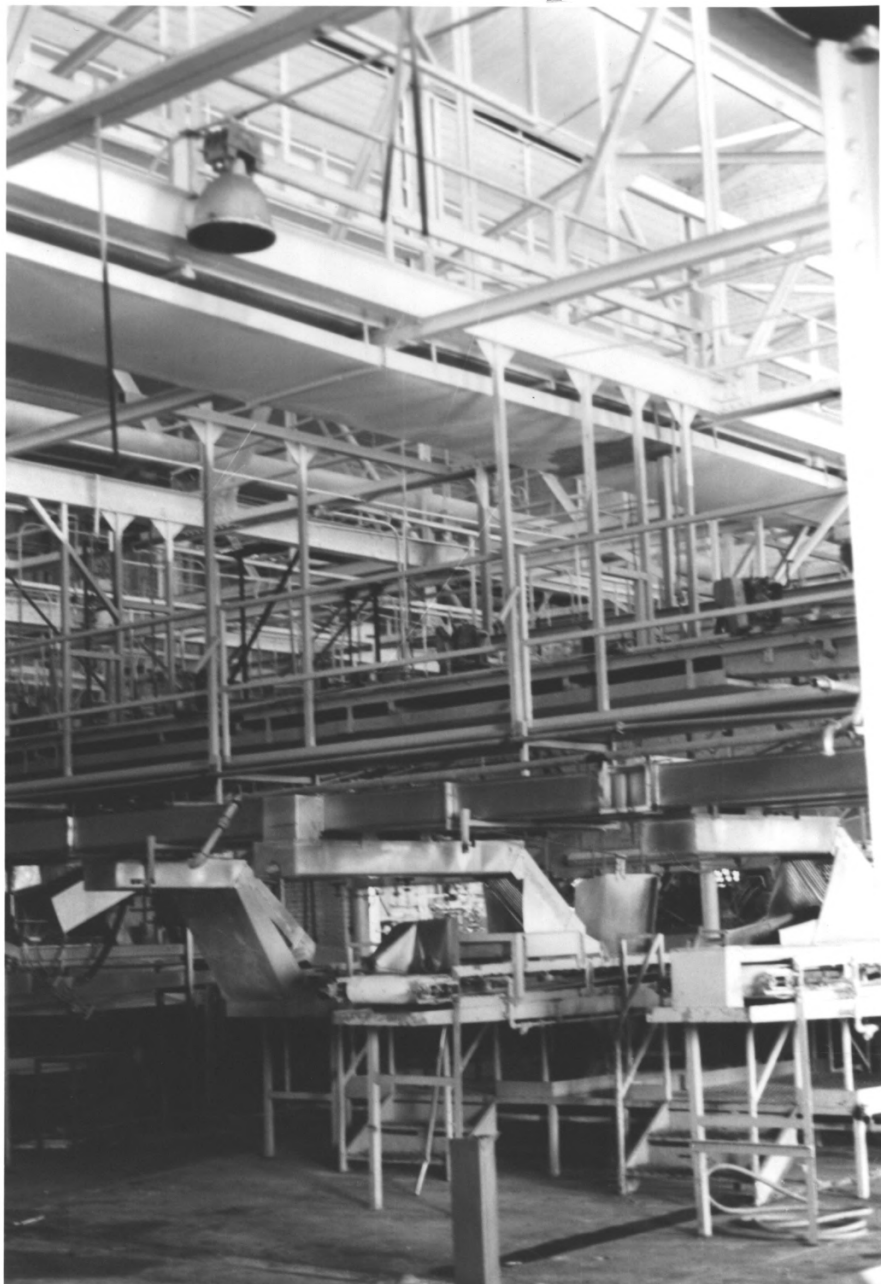
1. Libby McNeill & Libby Fruit & Vegetable Cannery
2. Sacramento, California
3. Brian Halloway
4. March, 1980
5. 711 J Street, Sacramento, California
6. Overview of interior from the plant main building. Photo direction is northwesterly and up.
7. Photo No. 14. of 21

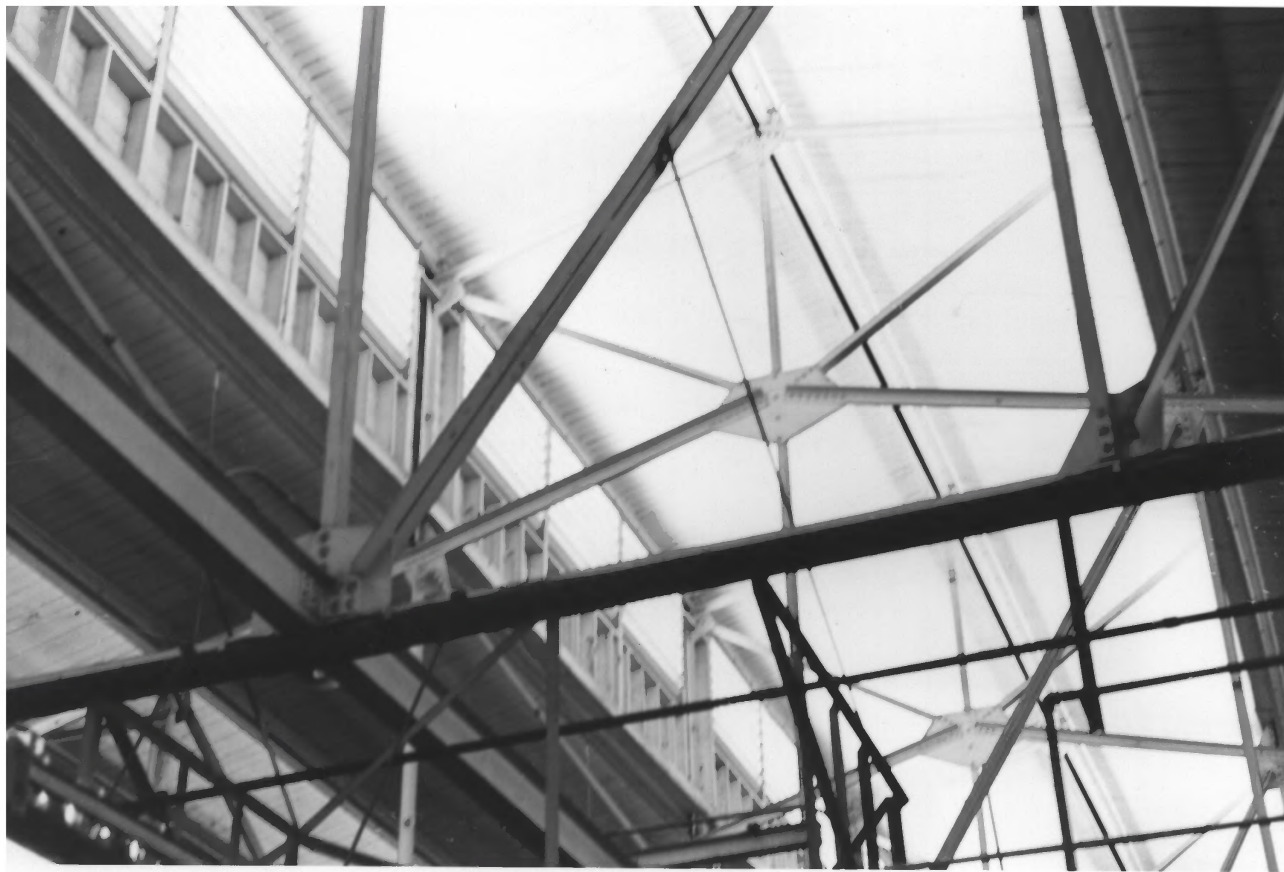
1. Libby McNeill & Libby Fruit & Vegetable Cannery
2. Sacramento, California
3. Brian Halloway
4. March, 1980
5. 711 J Street, Sacramento, California
6. Detail view of steel truss roof over raised frame sidelight of main building. Photo direction is up.
7. Photo No. 15. of 21

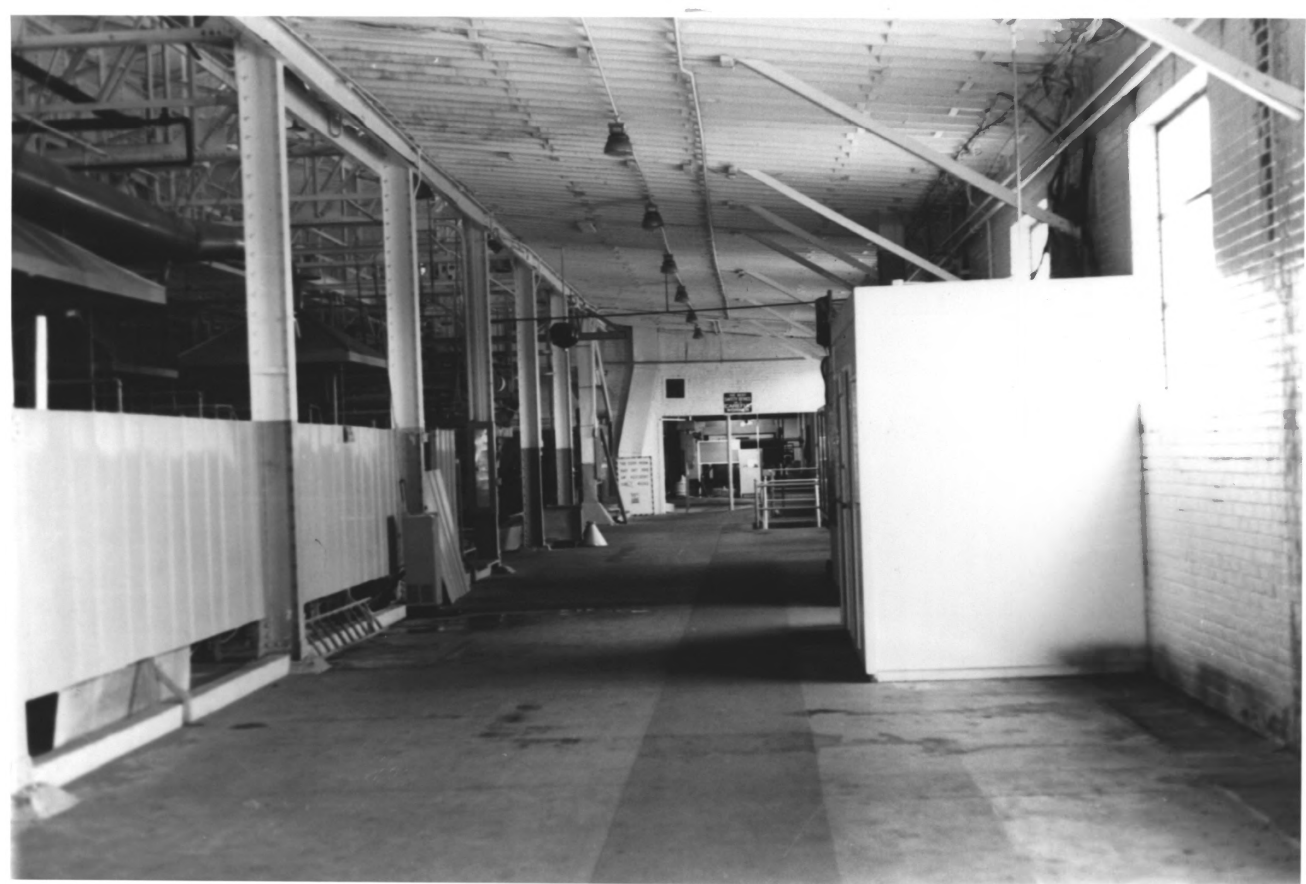
1. Libby McNeill & Libby Fruit & Vegetable Cannery
2. Sacramento, California
3. Brian Halloway
4. March, 1980
5. 711 J Street, Sacramento, California
6. General view of side area of main building showing steel post and beam support system and wood frame roof system. Photo direction is north.
7. Photo No. 16. of 21

1. Libby McNeill & Libby Fruit & Vegetable Cannery
2. Sacramento, California
3. Brian Halloway
4. March, 1980
5. 711 J Street, Sacramento, California
6. General overview of main floor looking in a south westerly direction across the main floor into the side area shown in Photo No. 16.
7. Photo No. 19. of 21

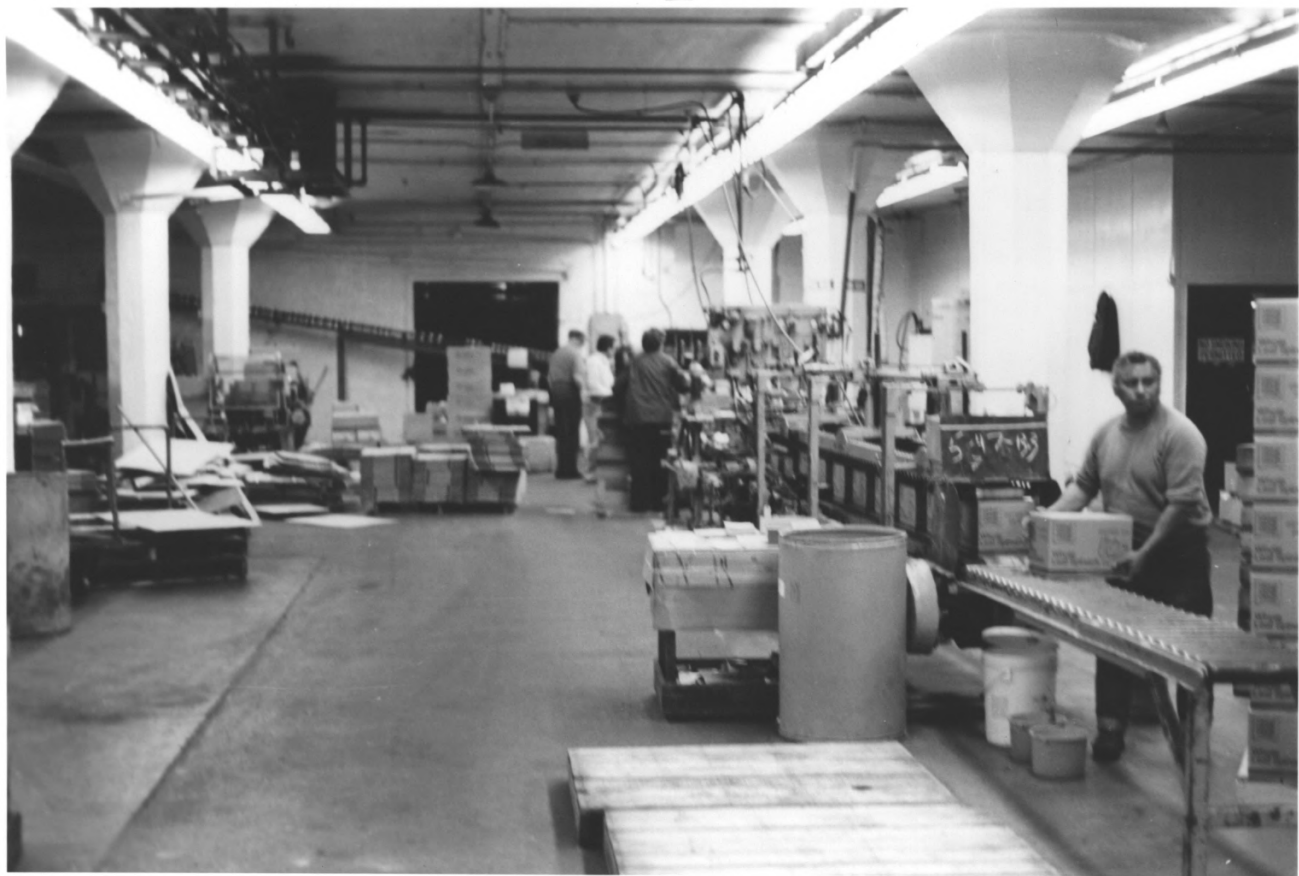
1. Libby McNeill & Libby Fruit & Vegetable Cannery
2. Sacramento, California
3. Brian Halloway
4. March, 1980
5. 711 J Street, Sacramento, California
6. General overview of a typical warehouse construction showing mushroom headed reinforced column and beam system. Photo view is south.
7. Photo No. 17. of 21

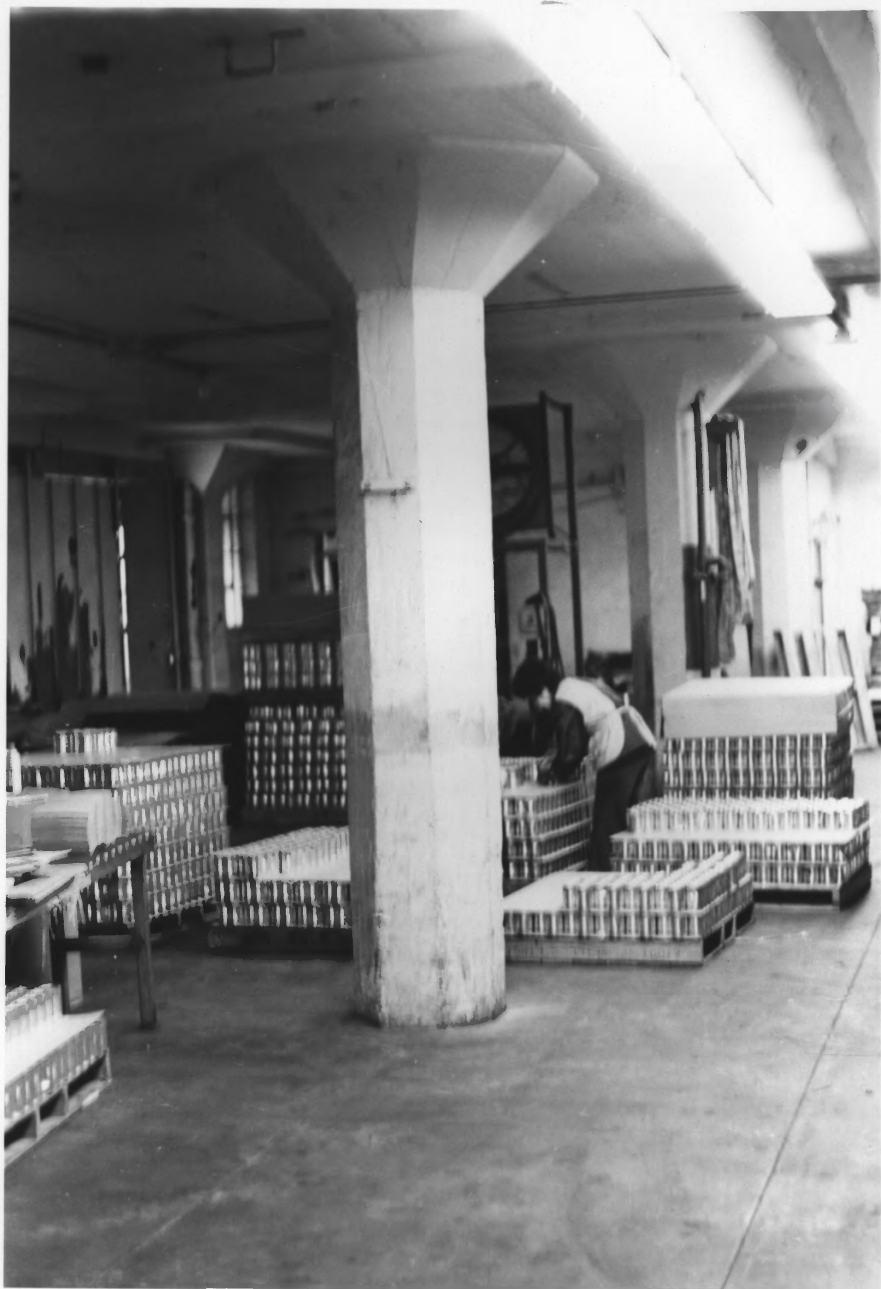
1. Libby McNeill & Libby Fruit & Vegetable Cannery
2. Sacramento, California
3. Brian Halloway
4. March, 1980
5. 711 J Street, Sacramento, California
6. Detail view of mushroom headed reinforced columns. View is southeasterly.
7. Photo No. 18. of 21

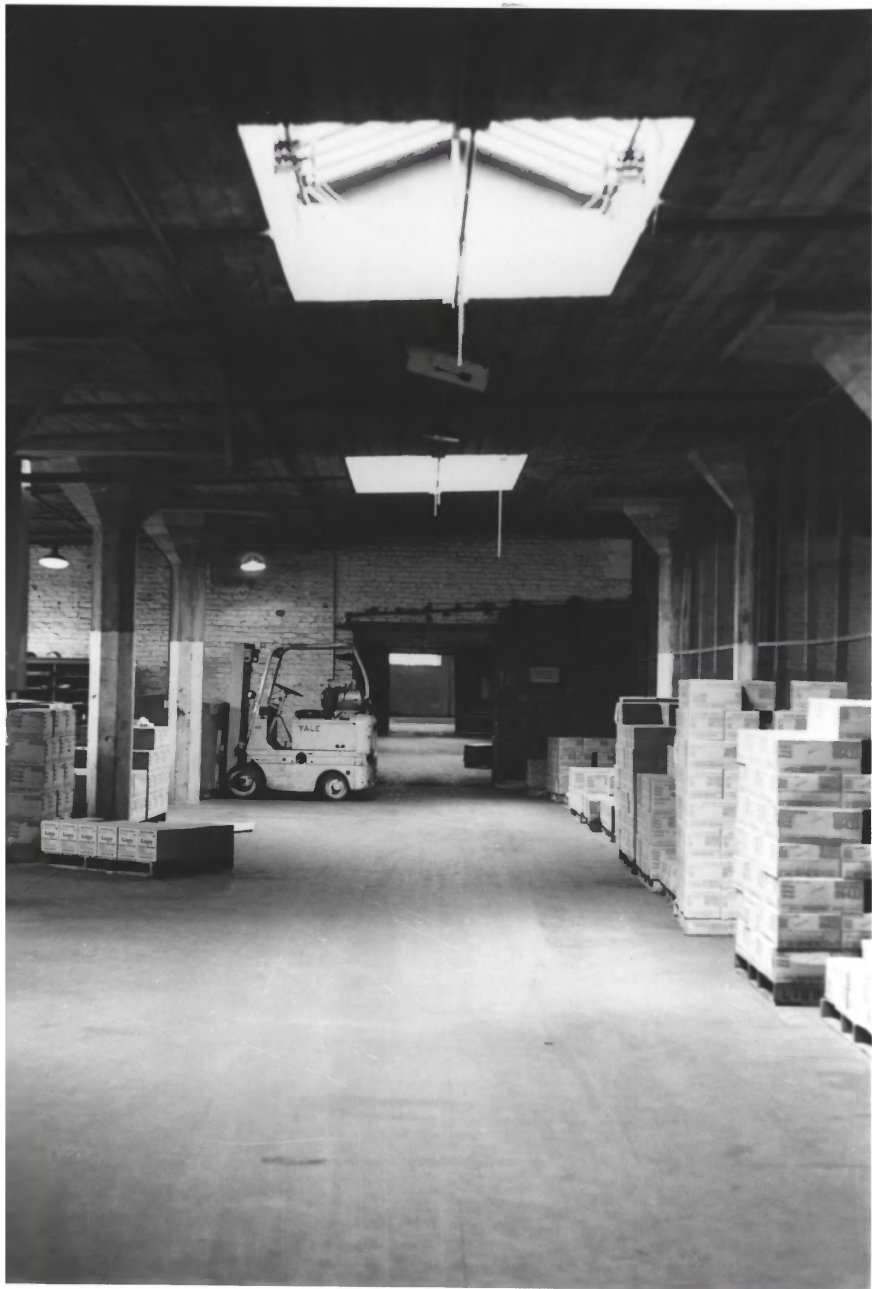
1. Libby McNeill & Libby Fruit & Vegetable Cannery
2. Sacramento, California
3. Brian Halloway
4. March, 1980
5. 711 J Street, Sacramento, California
6. General view of second floor of warehouse showing basic reinforced columns and frame with brick walls including sky light. Photo direction is south.
7. Photo No. 20. of 21

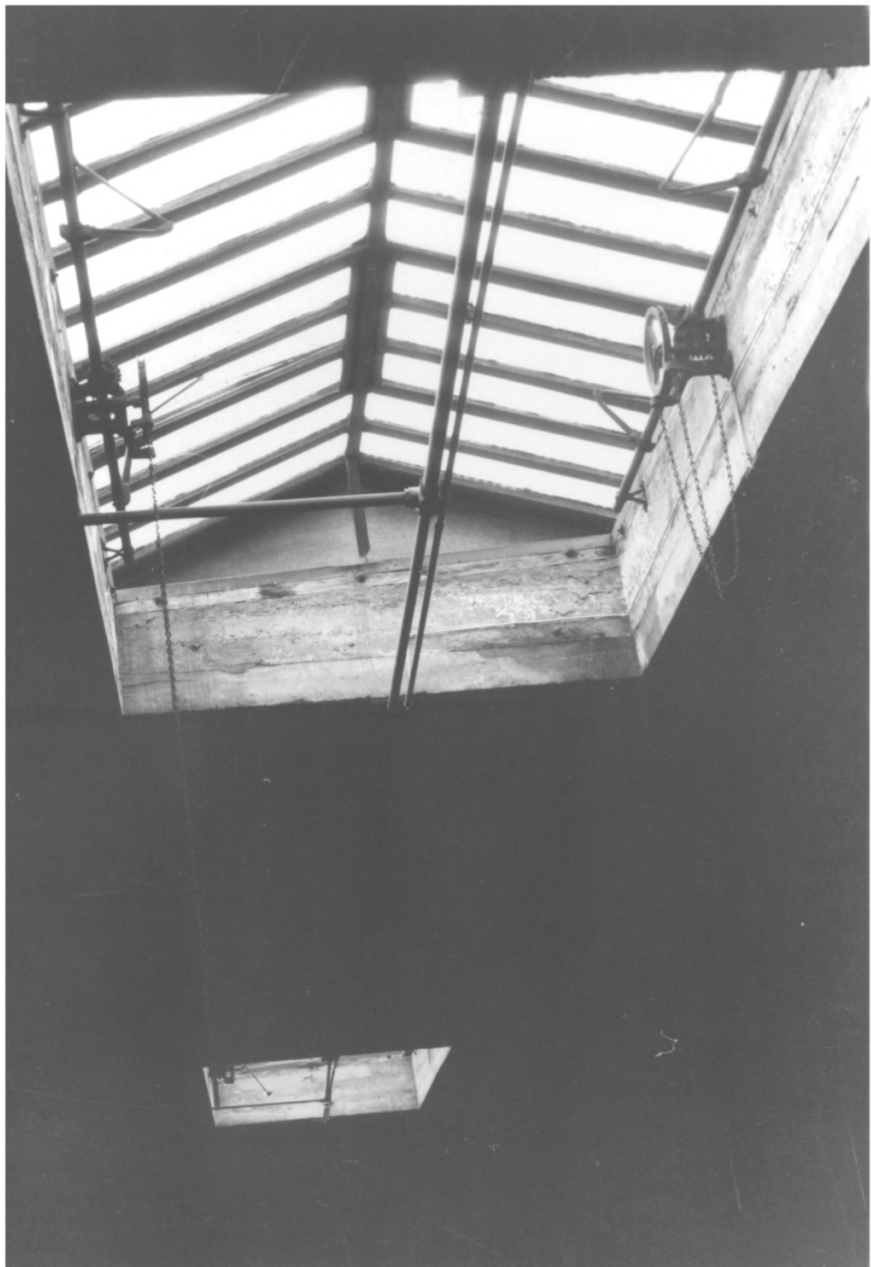
1. Libby McNeill & Libby Fruit & Vegetable Cannery
2. Sacramento, California
3. Brian Halloway
4. March, 1980
5. 711 J Street, Sacramento, California
6. Detail view of sky light, typical throughout upper floor of warehouse. Photo direction is up.
7. Photo No. 21. of 21
