**National Register of Historic Places
Continuation Sheet**

Bagsby Guard Station
Property Name

BAGBY GUARD STATION (1913)
(The common style, above, is preferred for listing)
Estacada vicinity, Mt. Hood National Forest
Clackamas County, Oregon

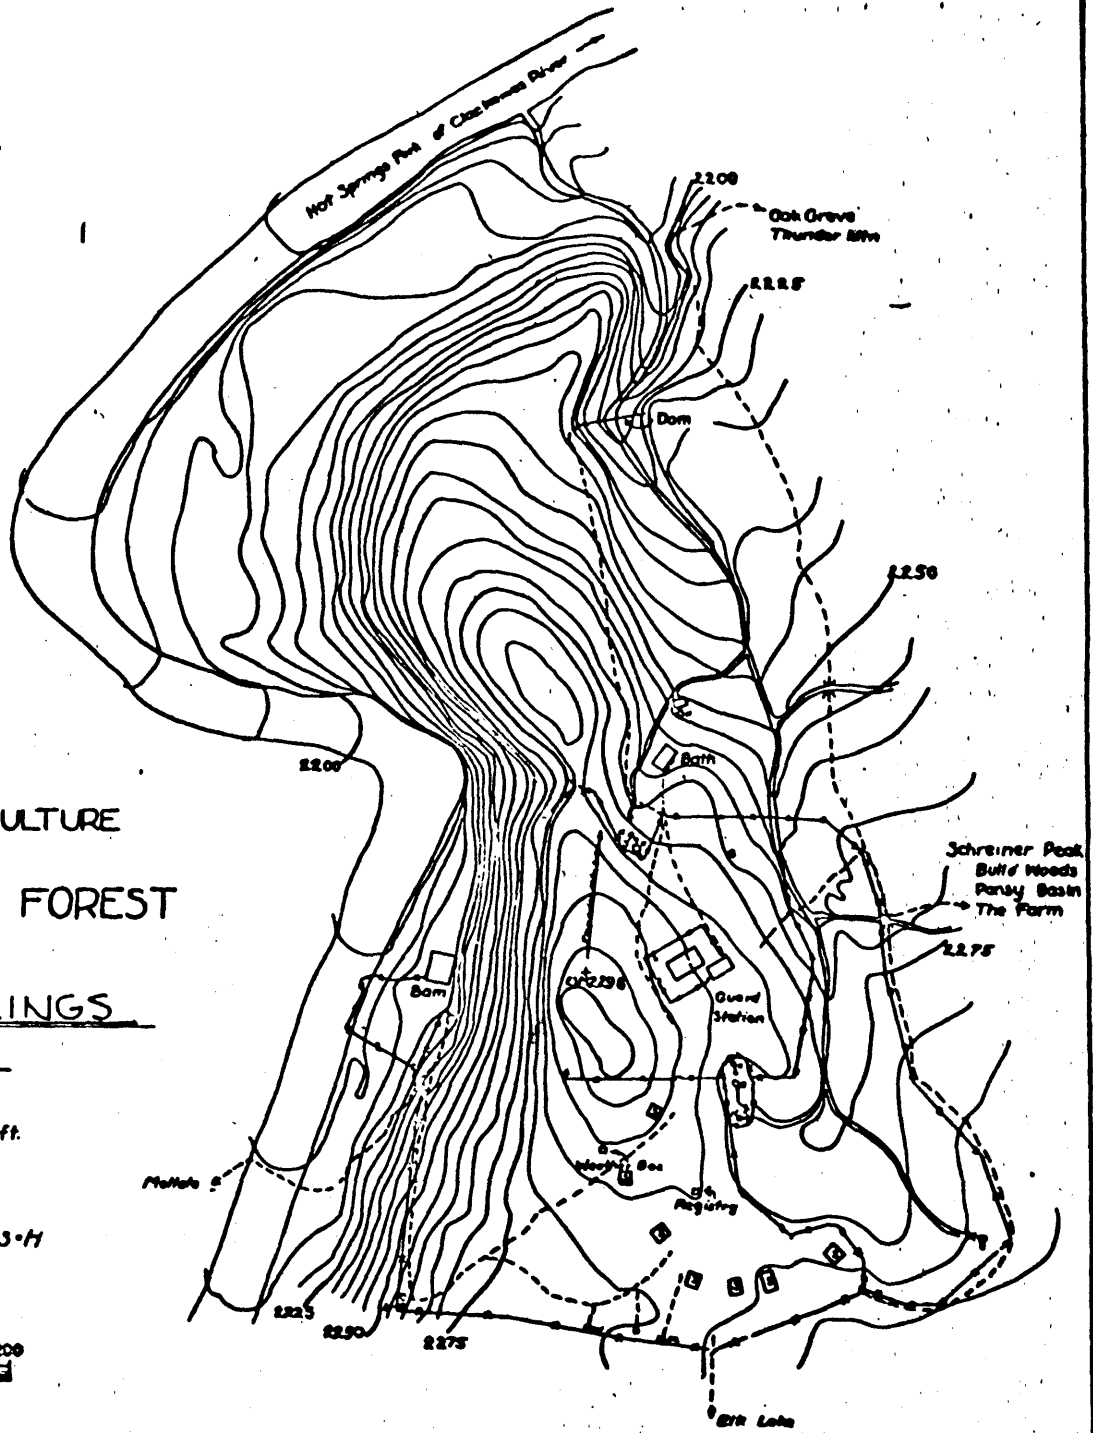
SITE PLAN
 U.S. DEPARTMENT OF AGRICULTURE
 FOREST SERVICE
 MOUNT HOOD NATIONAL FOREST
 Sec. 27 T7S R5E WM
BAGBY HOT SPRINGS
CAMPGROUND

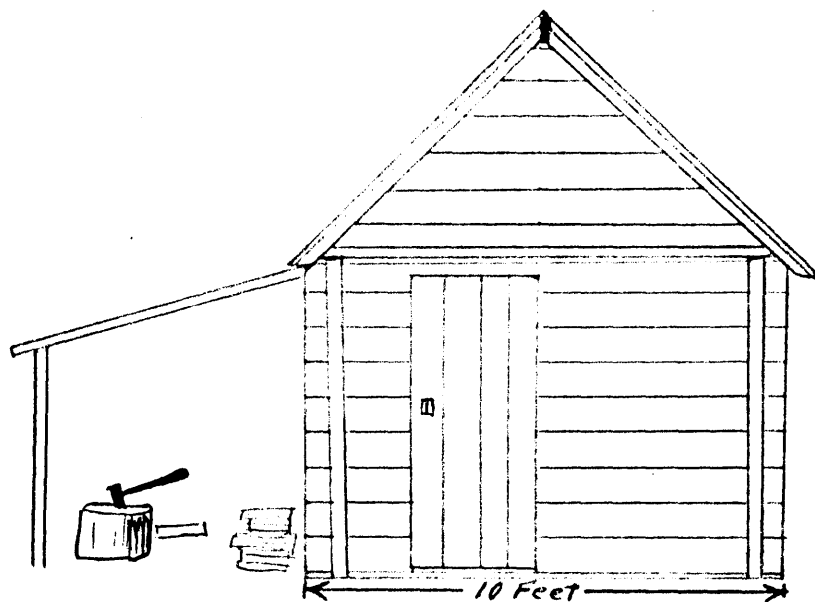
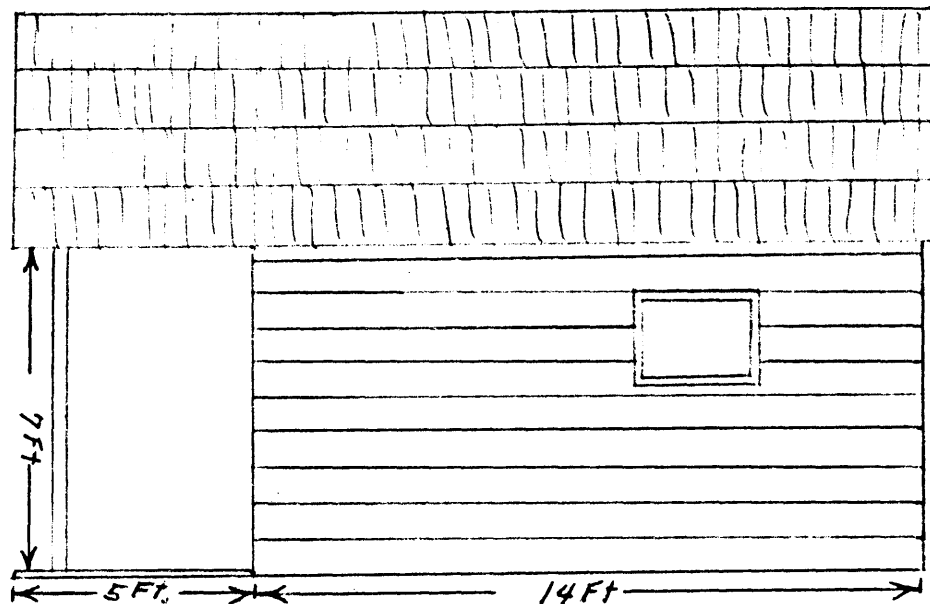
Bagsby R. S. Storehouse.

Front Elevation

S. Side Elevation.

The back porch of the cabin leads to the front porch of the storage shed. The dimensions of the shed are fourteen feet by ten feet. The front porch extends five feet from the main volume. The wood framed shed is a simple rectangular structure with a steeply pitched gabled roof which, like the cabin roof, extends out over a porch supported by peeled log posts. The interior is a single open space. The studs, sills, floor boards, and rafters are split cedar boards. The purlins and porch posts are peeled logs. The building is roofed with cedar shakes and sided with cedar clapboards. Each clapboard spans only the distance between two studs, about thirty four inches. The visual effect of this is to divide up each wall into several vertically oriented segments. The shed's foundation configuration is similar to the cabin's; there are two sills set on piers and field stone footings.

The interior of the shed is open, and the structure exposed. The original wood floor has been covered over with plywood. When the shed was first built, a simple single-sash four-light casement window was situated on the south elevation. Currently, this whole elevation is covered with clapboards. Originally the shed had a lean-to open addition on the north elevation. This was used to store fire wood (photo file, Bagby Historic Files, and Bagsby R.S. Storehouse plans, Bagby Historic Files). One early photograph shows this addition. A lean-to on the back elevation was built by 1916. Neither of these lean-to additions is extant.

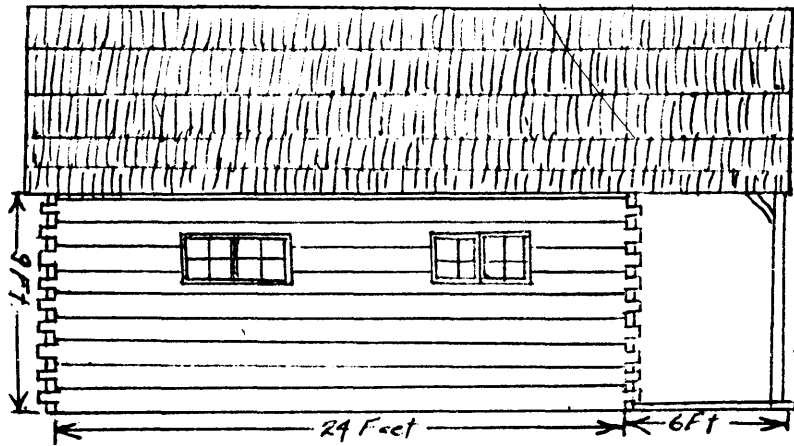
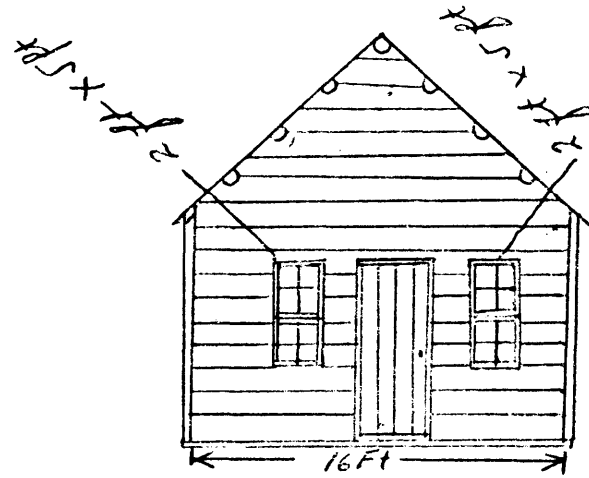
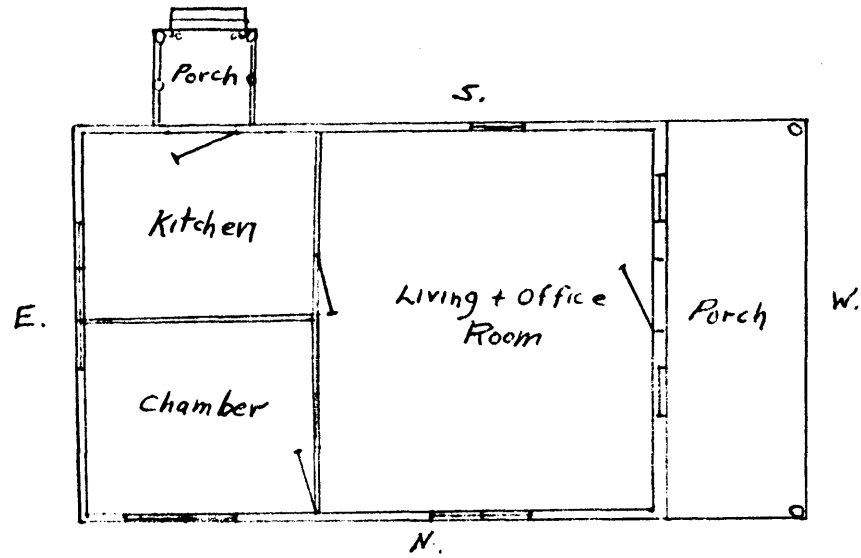
Bagsby Ranger Station Cabin.

Side Elevation.

Front Elevation.

Floor Plan.

→ scale ←
 $\frac{1}{8}$ in. = 1 ft
 Constructed of
 Split Logs.

Alterations to the interior include the removal of the original interior walls that divided the back portion of the cabin into a "kitchen" and "chamber" according to the original plans labeled "Bagsby Ranger Station Cabin" found in Mount Hood National Forest Service historic Bagby files. The date of this alteration is unknown. Originally the stove was closer to the front of the cabin in the northwest corner. Photographs from 1949 and later show that the stove had been moved to the far southeast corner. The removal of the interior walls may coincide with the change of location of the stove (photo file, Bagby Historic Files, Mt. Hood National Forest).
