BENJAMIN SHOTWELL HOUSE # 1/13  
Edison Twp., Middlesex Co., N.J.  
Photo 1986, by Arthur Brecknell  
(negatives in photographer's file)

26 Runyon's Lane

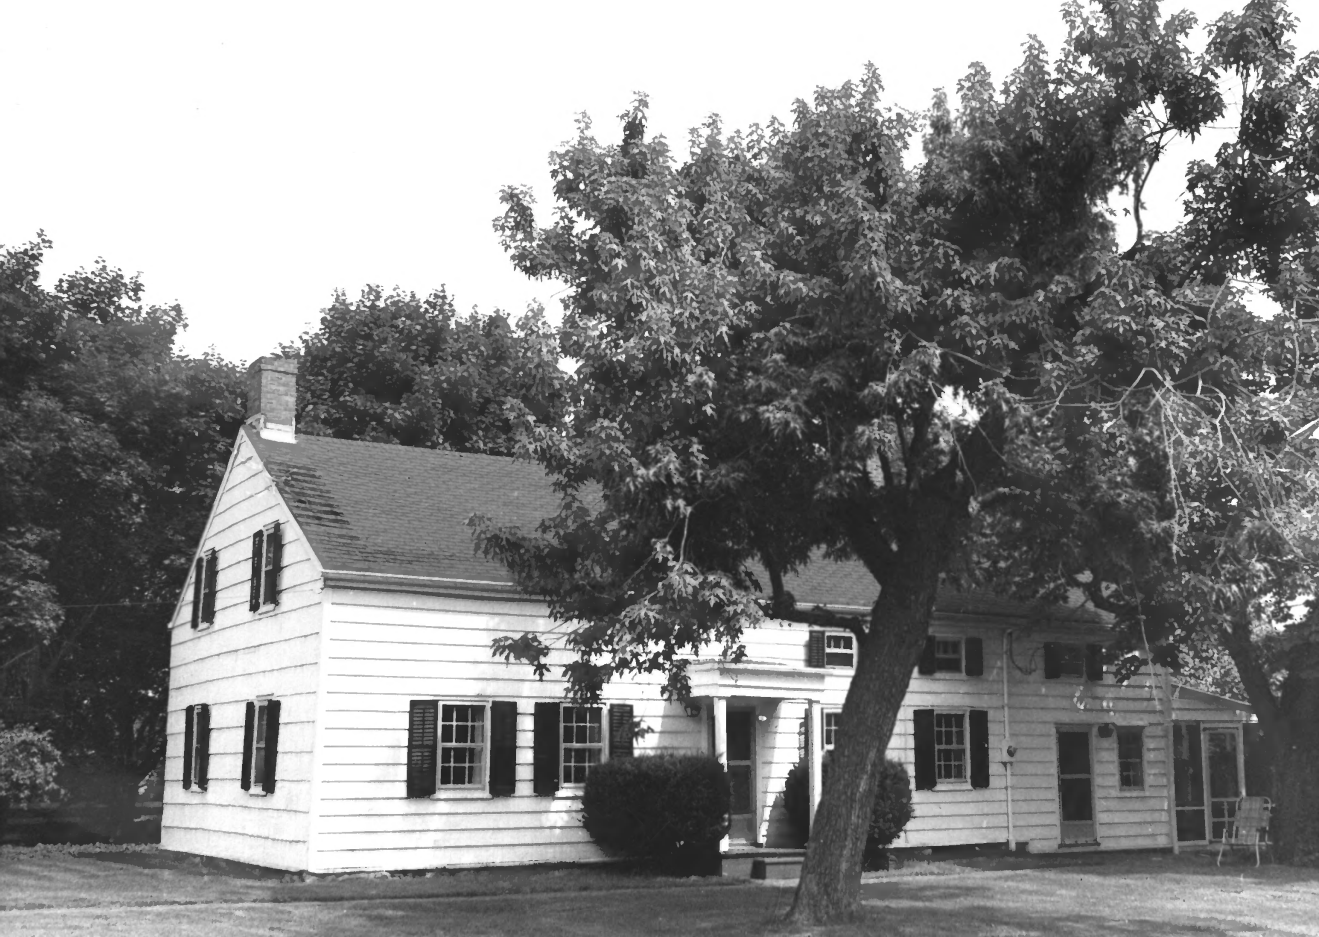
Facing northeasterly, front facade  
of house.

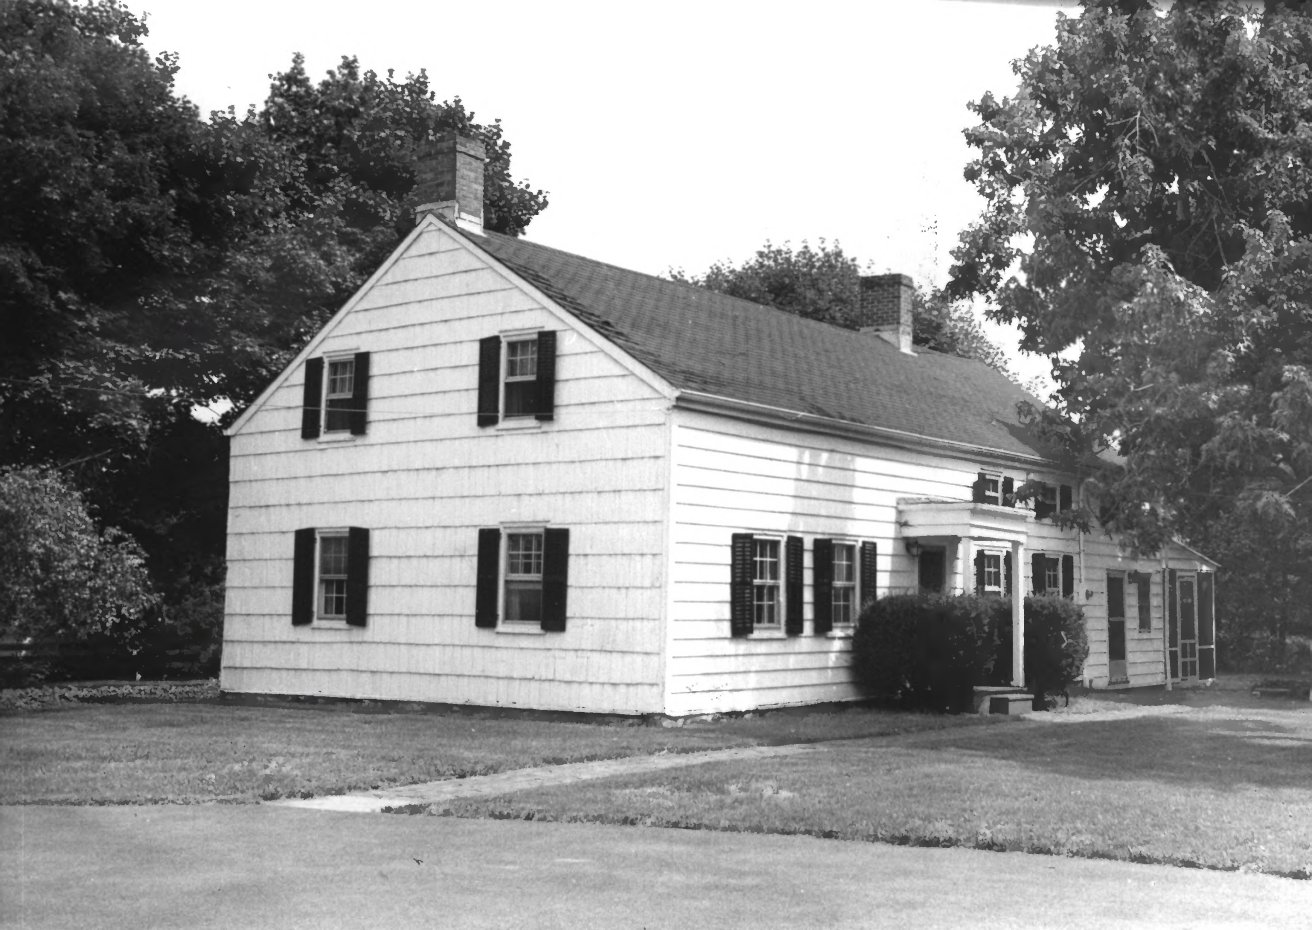
BENJAMIN SHOTWELL HOUSE # 2/13  
Edison Twp., Middlesex Co., N.J.  
Photo 1986 by Arthur Brecknell  
(negatives in photographer's file)

Facing easterly, close-up of  
shingled west gable and front  
facade of house

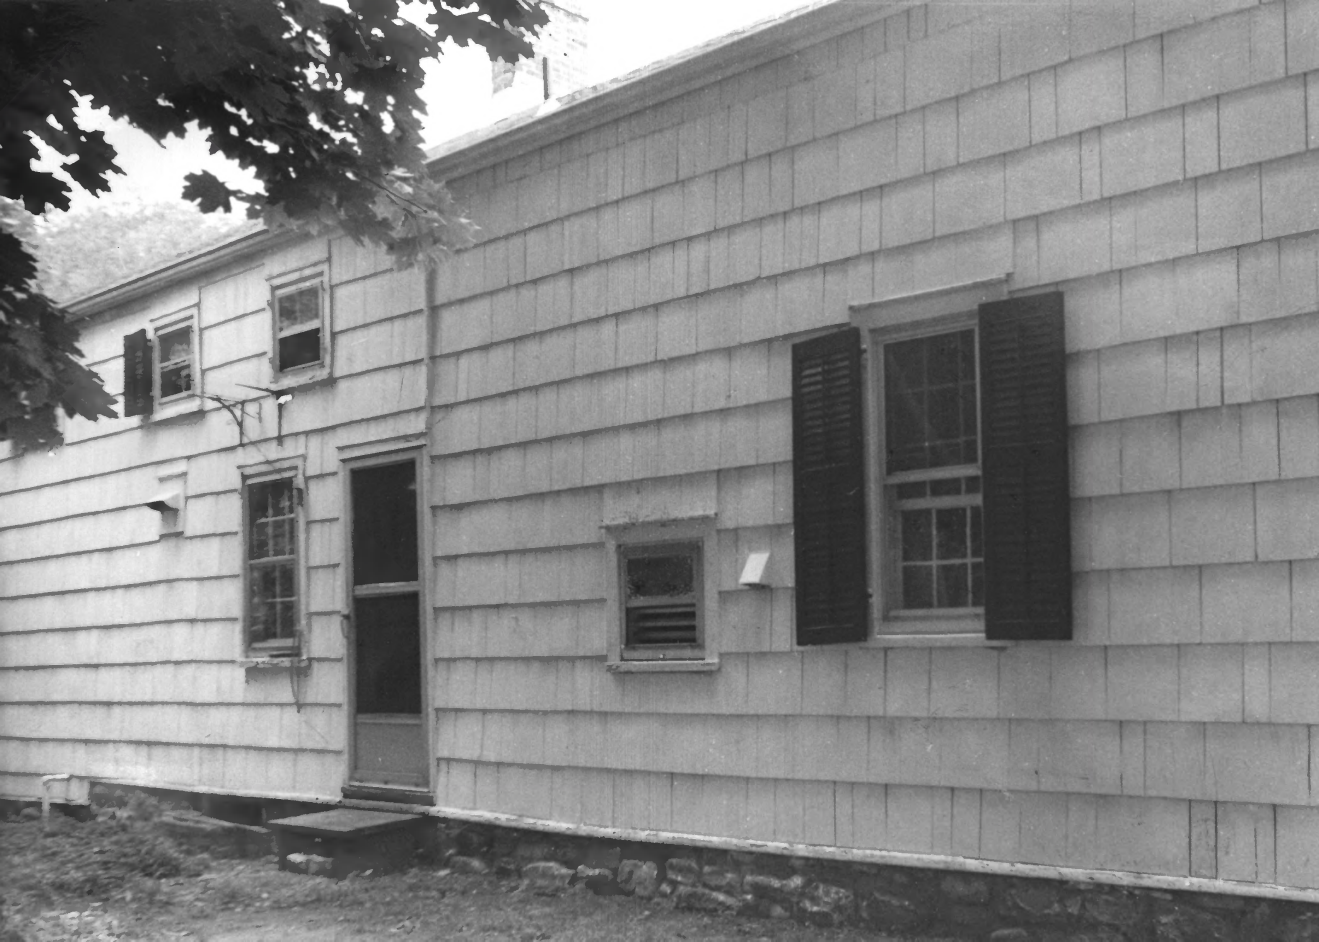
BENJAMIN SHOTWELL HOUSE # 3 / 13  
Edison Twp., Middlesex Co., N.J.  
Photo 1986, by Arthur Brecknell  
(negatives in photographer's file)

Facing southerly, view of rear  
wall of house, showing 1840s  
section (left) attached to house,  
low stone rubble foundation, and  
water table

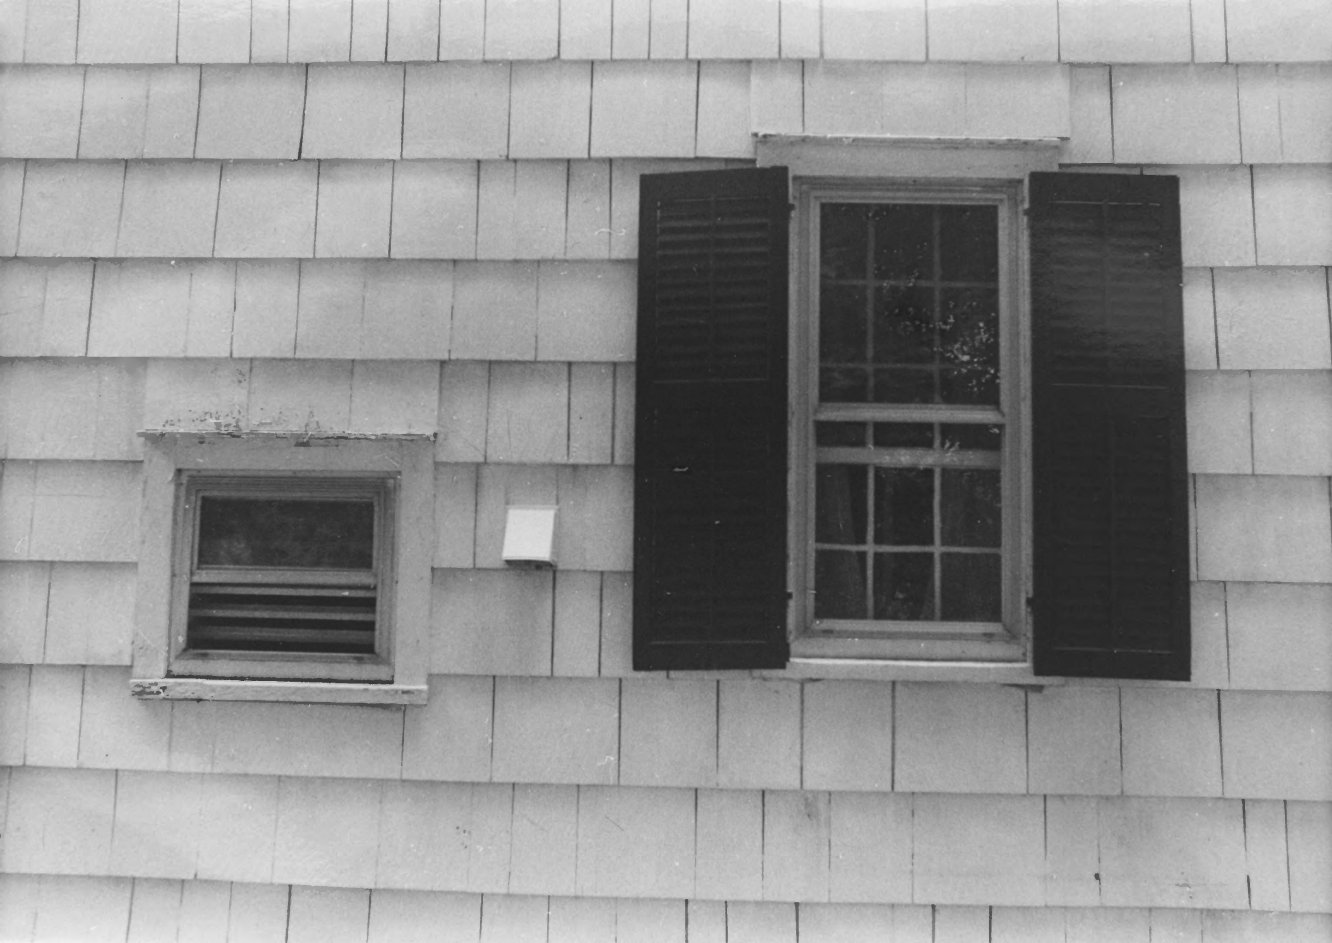
BENJAMIN SHOTWELL HOUSE... # 4/13  
Edison Twp., Middlesex Co., N.J.

Facing south, close-up of wall of  
original house, showing small  
grilled window to lower level  
milk room and 9/6 sash in rear  
room

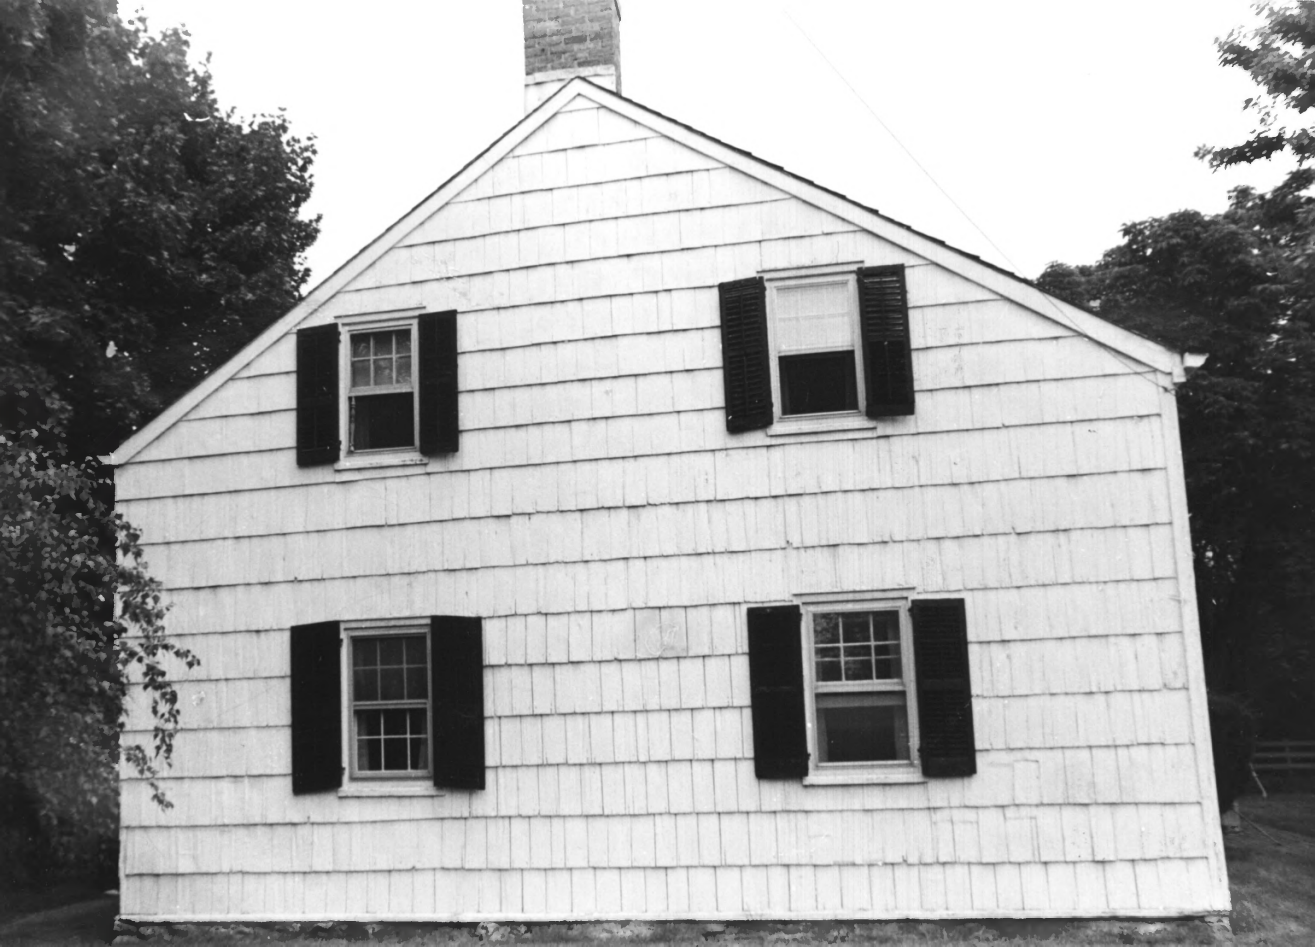
BENJAMIN SHOTWELL HOUSE # 5/13

Facing east, close-up of west  
gable wall showing surviving old  
shingles and low foundation

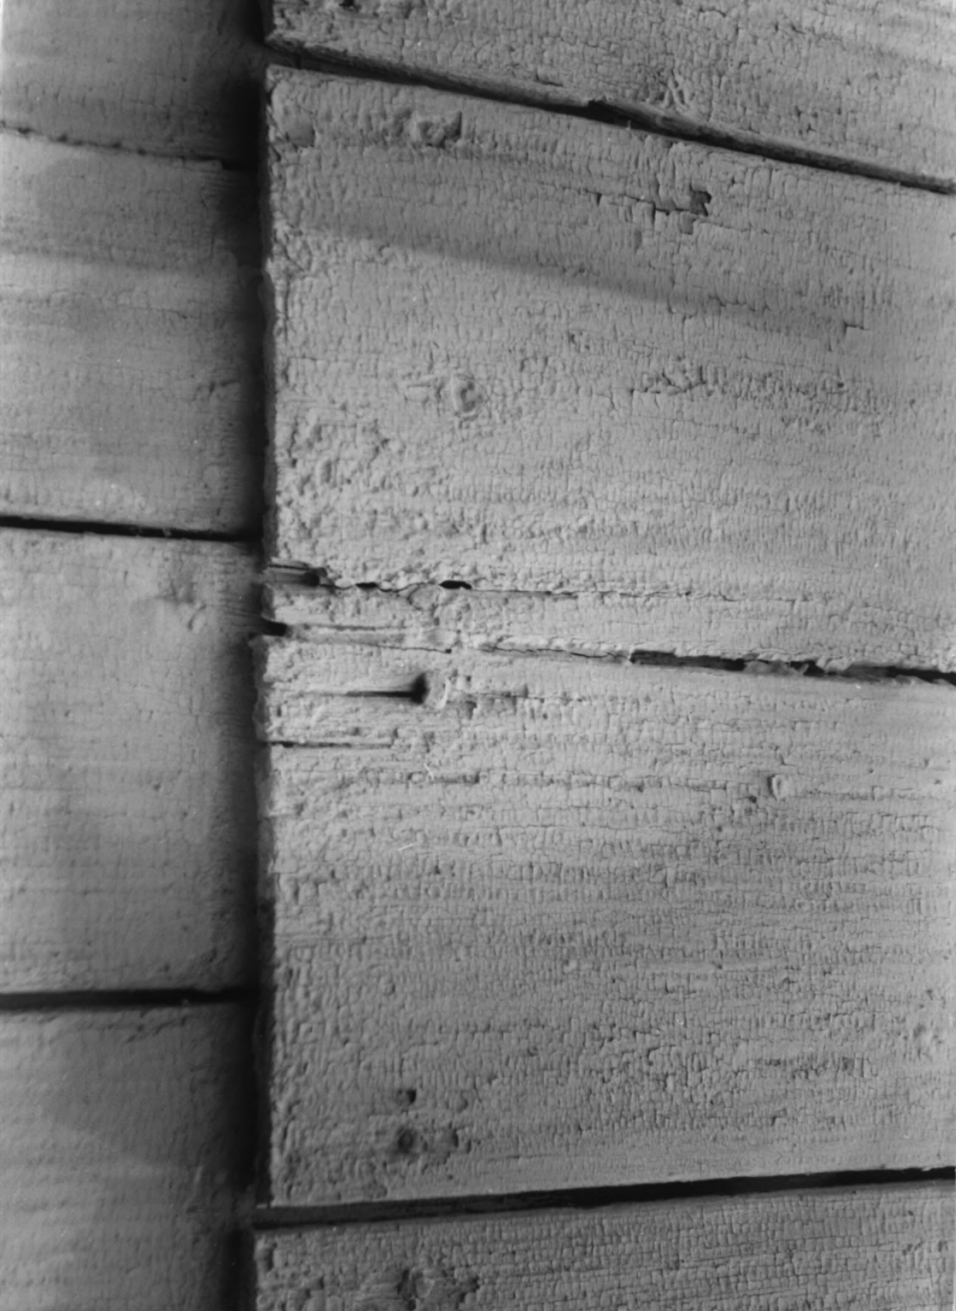
BENJAMIN SHOTWELL HOUSE # 6/13  
Edison Twp., Middlesex Co., N.J.  
Photo 1986, by Arthur Brecknell  
(negatives in photographer's file)

Close-up detail of course of  
shingled west gable wall, showing  
size and age of shingles

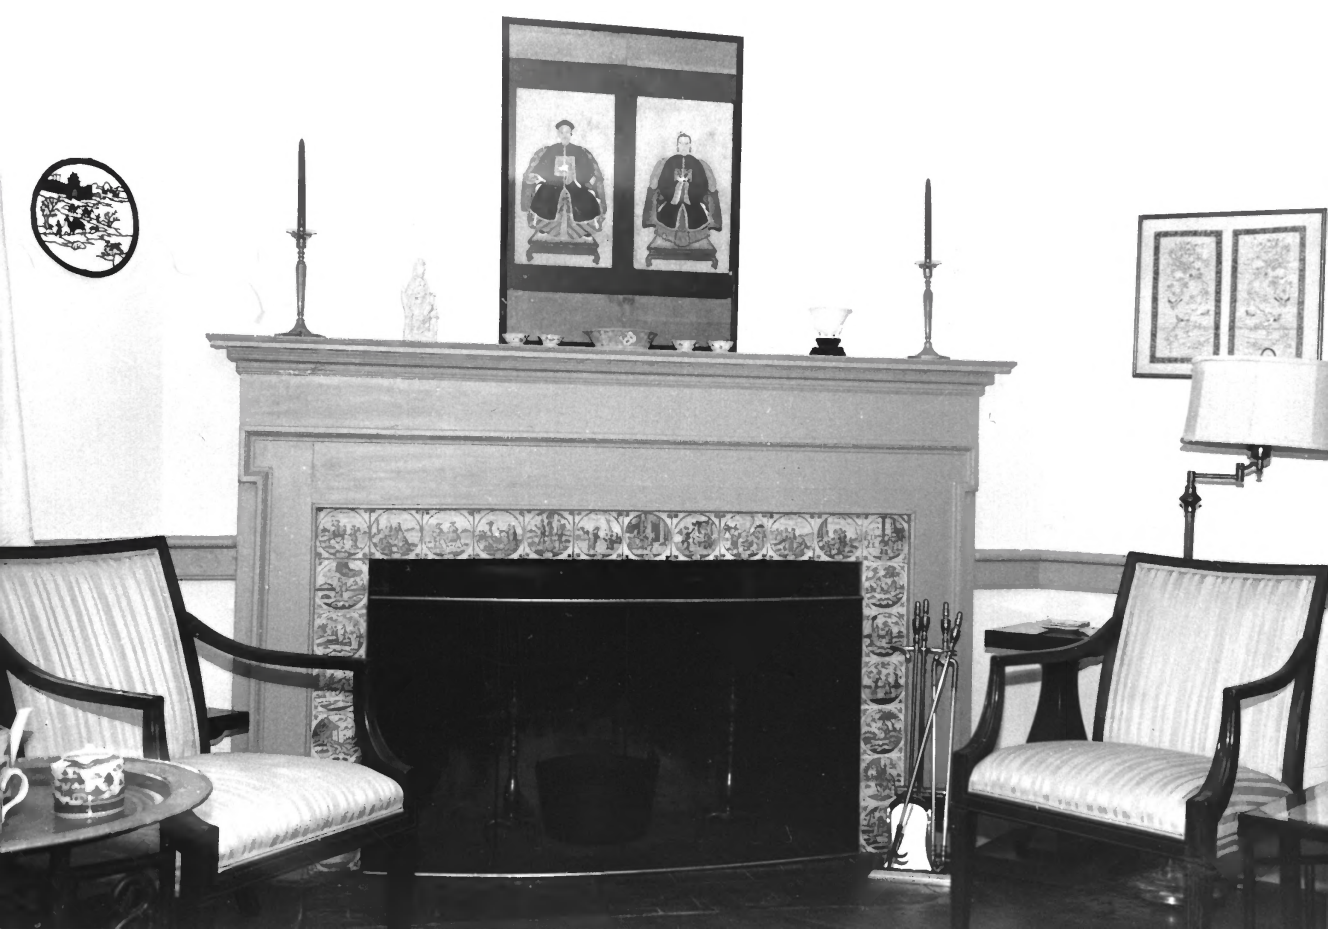
BENJAMIN SHOTWELL HOUSE # 7/13  
Edison Twp., Middlesex Co., N.J.  
Photo 1986, by Arthur Brecknell  
(negatives in photographer's file)

Facing northwesterly, corner fire-  
place in original dwelling room  
(southwest room)

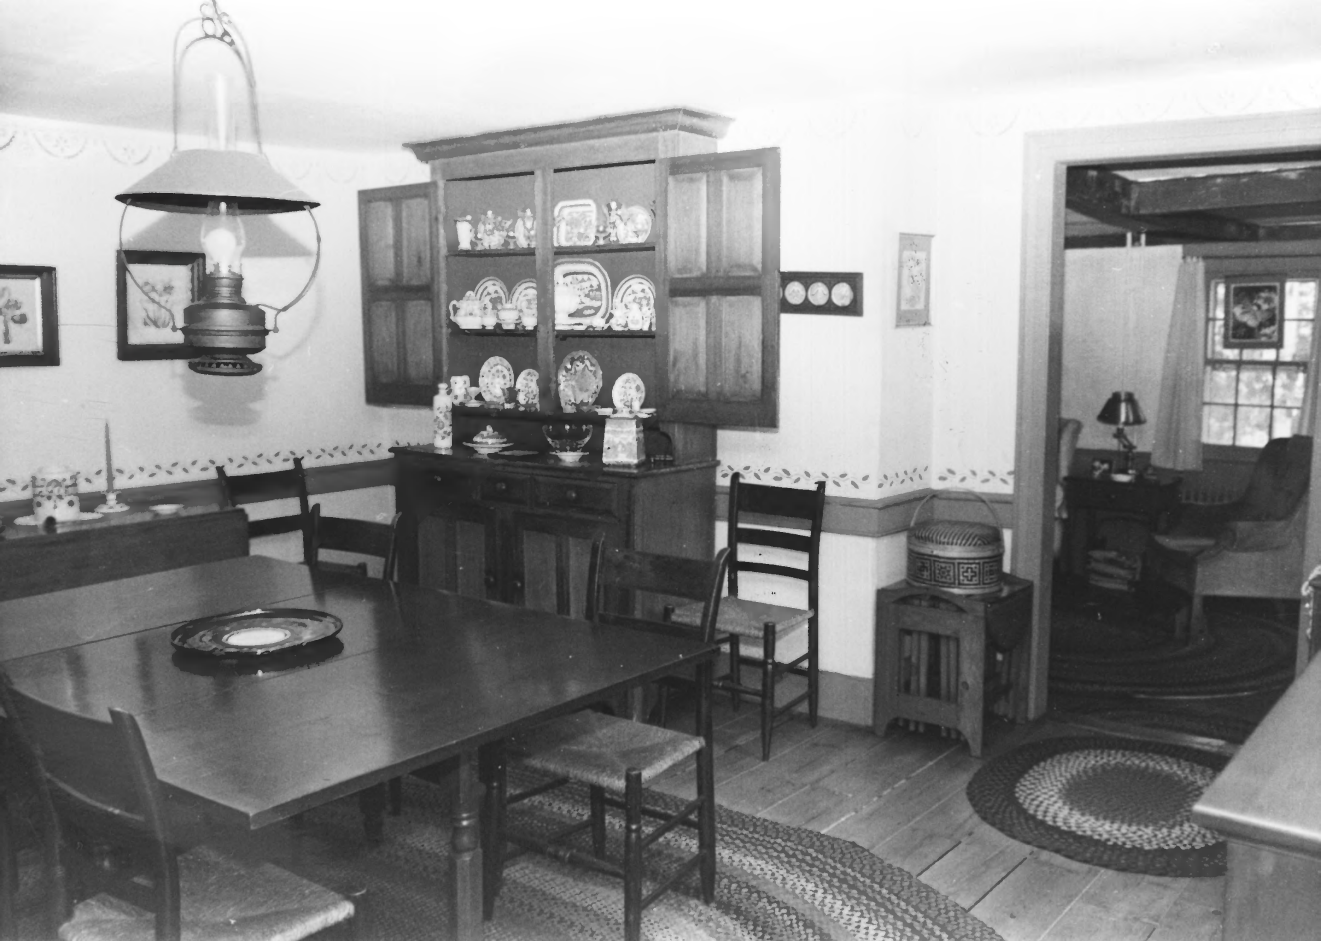
BENJAMIN SHOTWELL HOUSE # 8/13  
Edison Twp., Middlesex Co., N.J.  
Photo 1986, by Arthur Brecknell  
(negatives in photographer's file)

Facing easterly, looking across  
front room of 1840s addition to  
den created out of original kitchen  
leanto. (Fireplace opening  
has been closed.)

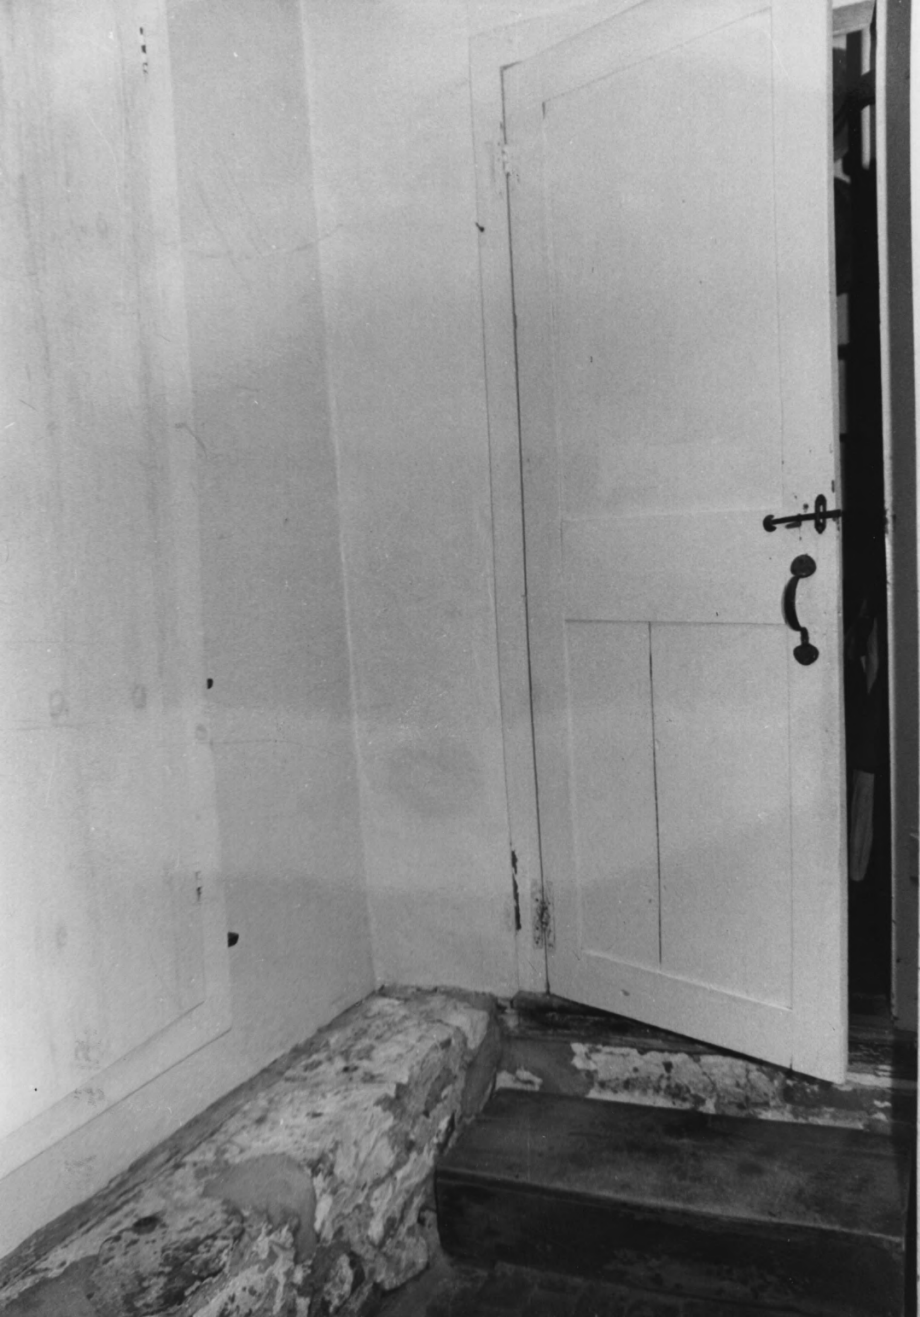
BENJAMIN SHOTWELL HOUSE # 9/13  
Edison Twp., Middlesex Co., N.J.  
Photo 1986, by Arthur Brecknell  
(negatives in photographer's file)

Facing south, corner of sunken  
milk room, showing stone walls,  
step down, and rear face of pan-  
eled door

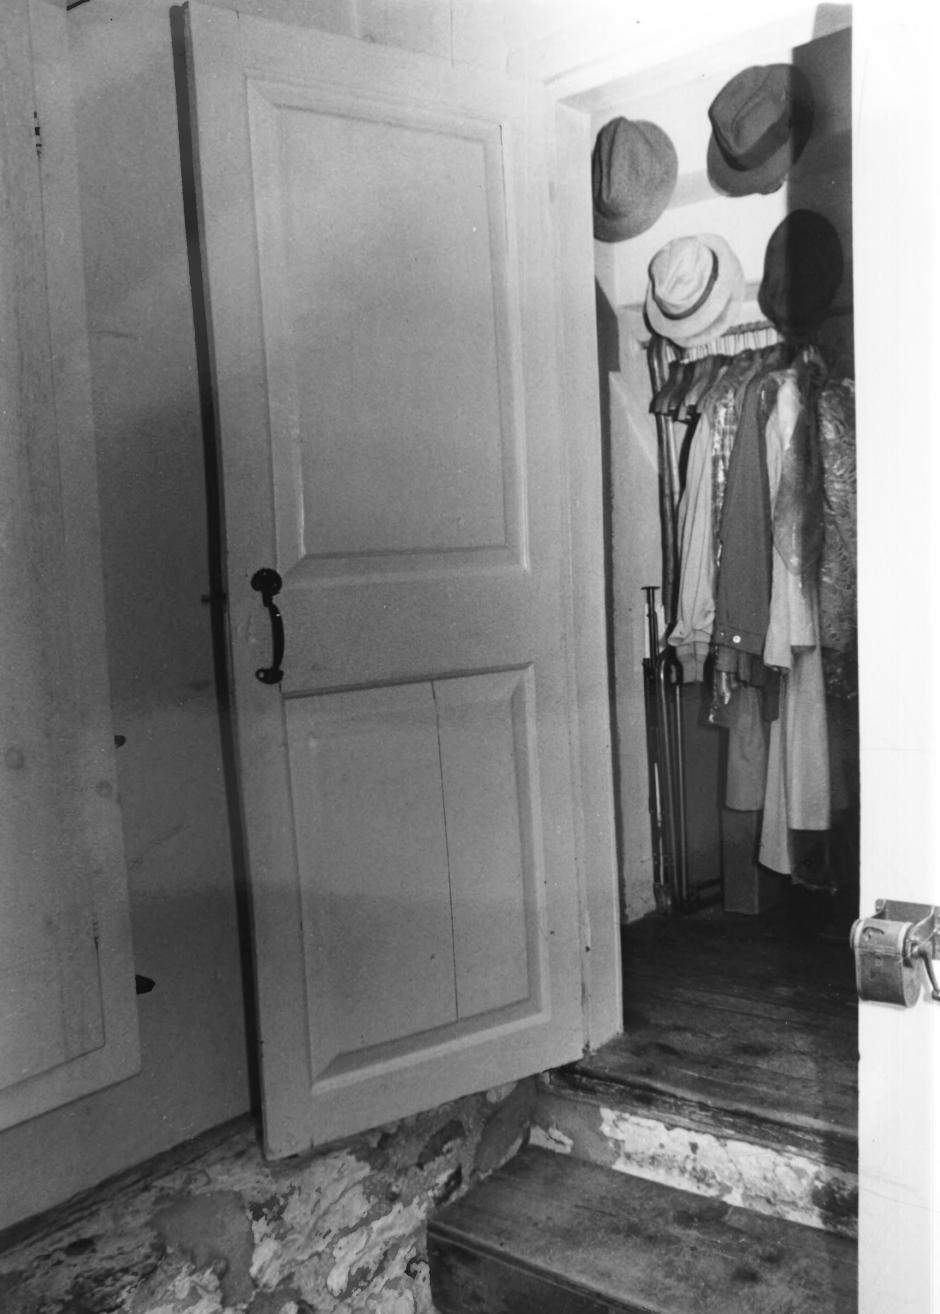
BENJAMIN SHOTWELL HOUSE # 10/13  
Edison Twp., Middlesex Co., N.J.  
Photo 1986, by Arthur Brecknell  
(negatives in photographer's file)

Facing south, another view of  
corner of sunken milk room,  
showing paneled face of door  
leading to under-stairs area

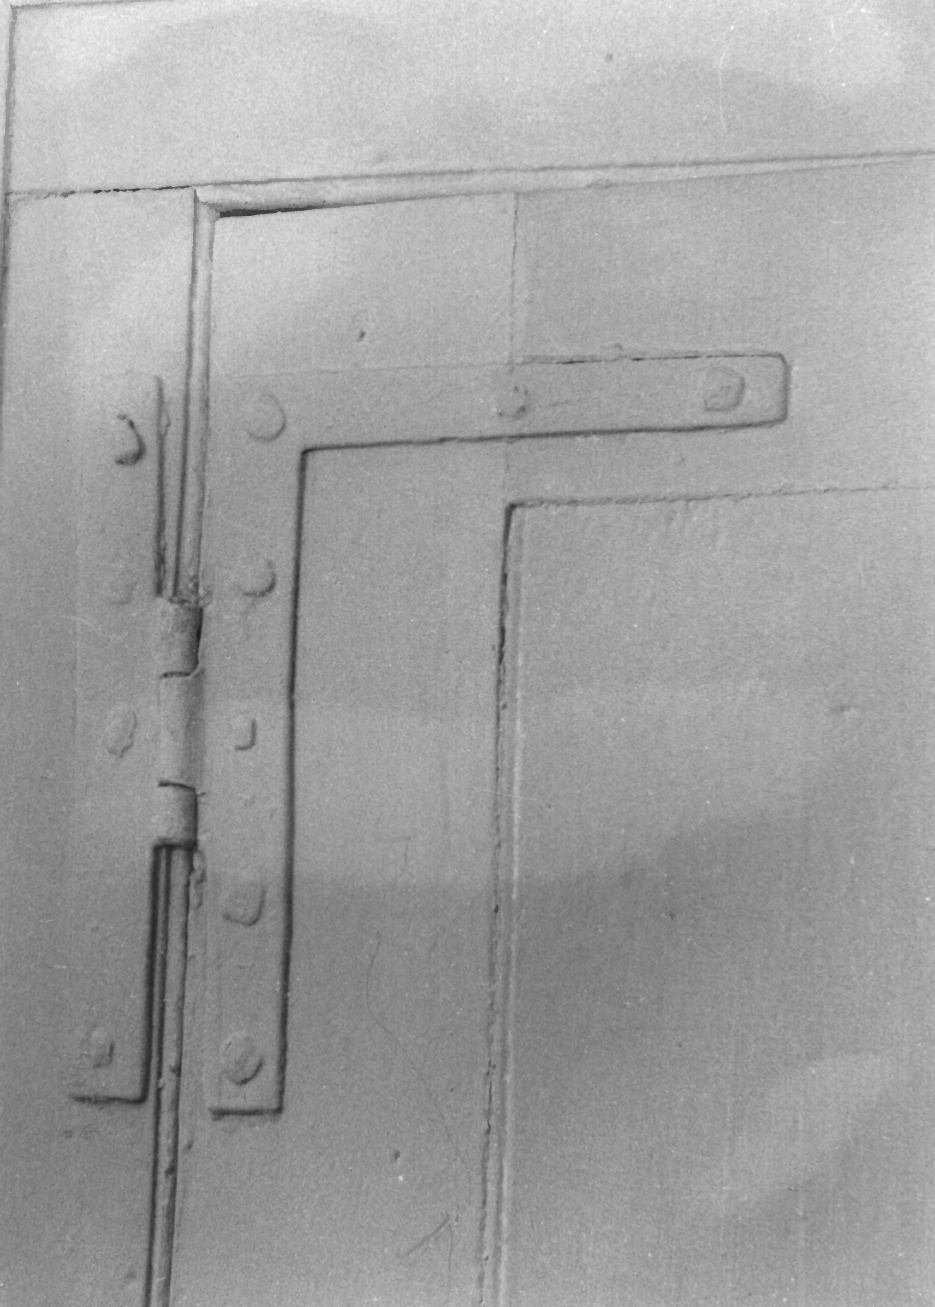
BENJAMIN SHOTWELL HOUSE # 11/13

Detail: H-L hinge on rear flush  
face of paneled door between  
front and rear rooms of original  
house

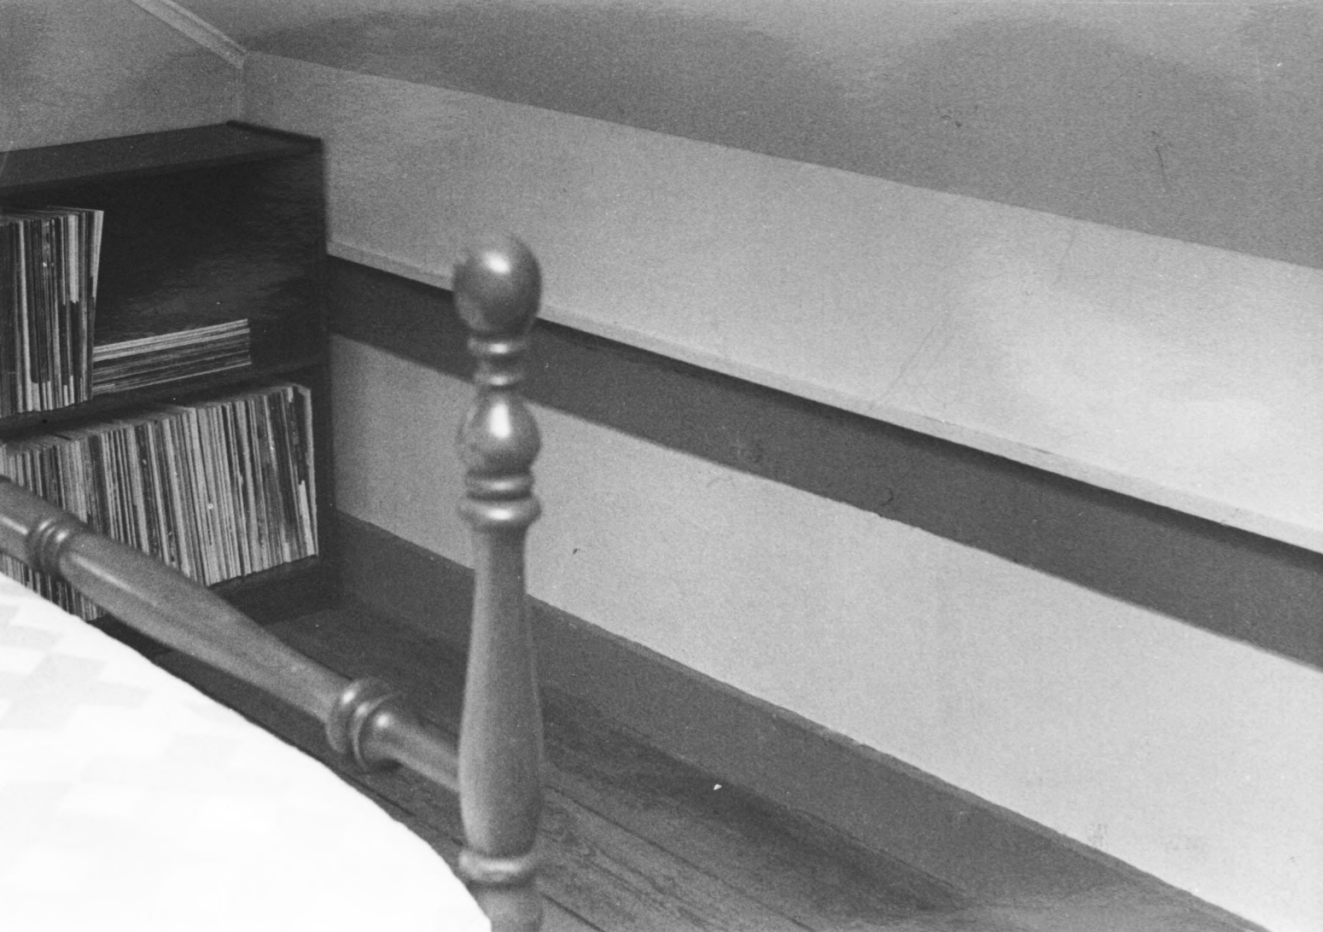
BENJAMIN SHOTWELL HOUSE # 12/13

Facing northwesterly, rear garret room, showing original half-height of wall and how it was raised in 1840s.

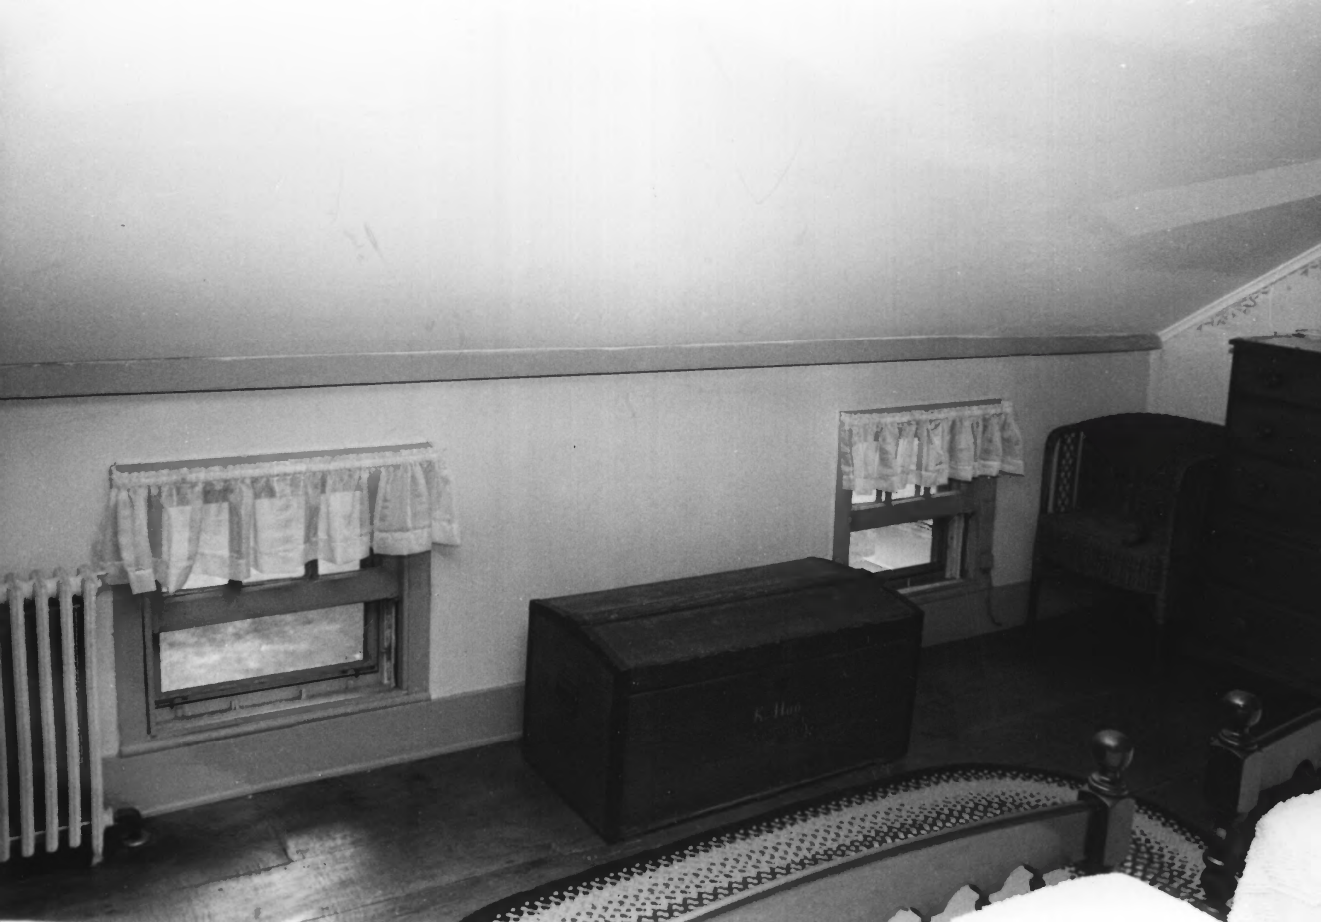
BENJAMIN SHOTWELL HOUSE # 13 of 13  
Edison Twp., Middlesex Co., N.J.  
Photo 1986, by Arthur Brecknell  
(negatives in photographer's file)

Facing southerly, front garret  
room of 1840s addition, reached  
by a step down from original  
section
