National Register of Historic Places Registration Form

historic name Supply Laundry Building

street & number 1265 Republican Street

city or town Seattle

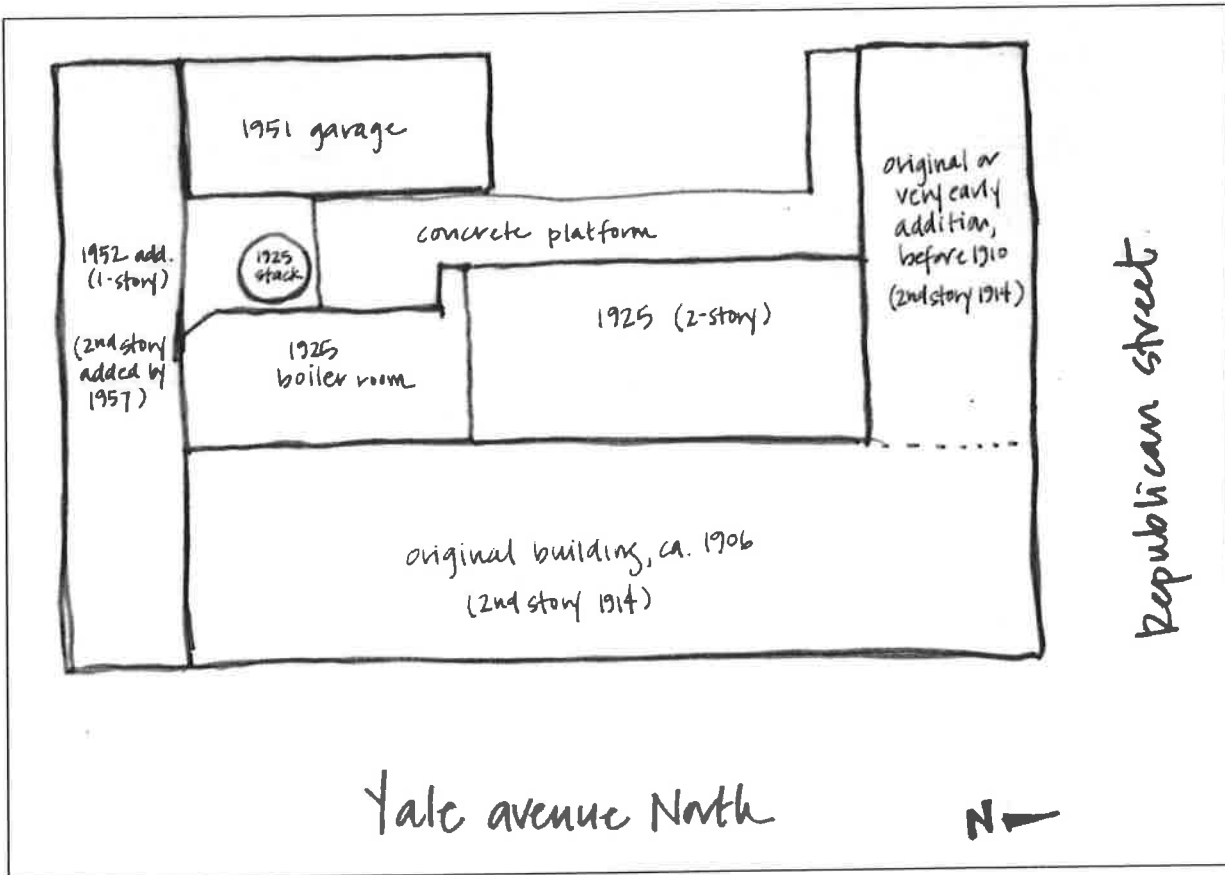
A sketch of the Supply/New Richmond Laundry Building footprint, indicating when different portions of the building were constructed. (BOLA Architecture + Planning, 2005)

The initial building permit records are unclear, but construction of the earliest existing portion of the Supply Laundry Company building appears to have been completed by June 1906. The brick masonry structure was originally one story in height, with the east façade extending 160' along Yale Avenue North (then known as Howard Avenue). It appears that the western portion of the narrow "L" extending along Republican Street was built very shortly after, giving the resulting building a narrow, L-shaped footprint. The northern leg of the "L" was 34' wide, the southern leg was 41'. A second story was permitted in 1914, and appears to have been built to match the dimensions of the existing one-story footprint. In 1925, another addition was constructed on the alley (west) side of the building, incorporating a boiler room, a new two-story section, and the stack. All three of those earliest building campaigns employed bearing brick masonry construction, and are described in this report as "original."

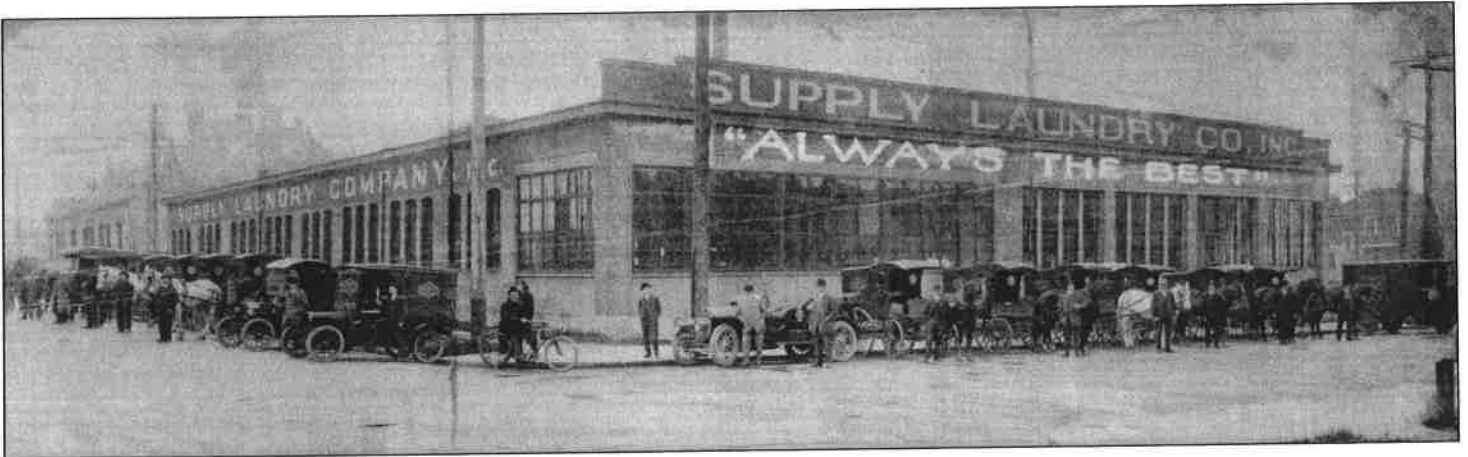
Looking southwest at the north and east facades of the Supply Laundry Building, ca. 1912. This view shows the earliest construction, before a second story addition. (Courtesy Tomlinson Linen Service)

Two photos show the Supply Laundry as it appeared ca. 1912 and ca. 1921 (see historic photos starting on page 23). The original first floor north facade was composed with a single large window opening at the eastern half. When the second floor was added, the new design provided for evenly spaced second floor windows and a subdivision of the large first-floor window, in what appears to be an attempt to rationalize its fenestration pattern. A plaster band ran along the window headers on the north facade and the northernmost bay on the east facade. This band and everything below it was painted white, in stark contrast to the original unpainted or darker color of the brick masonry.

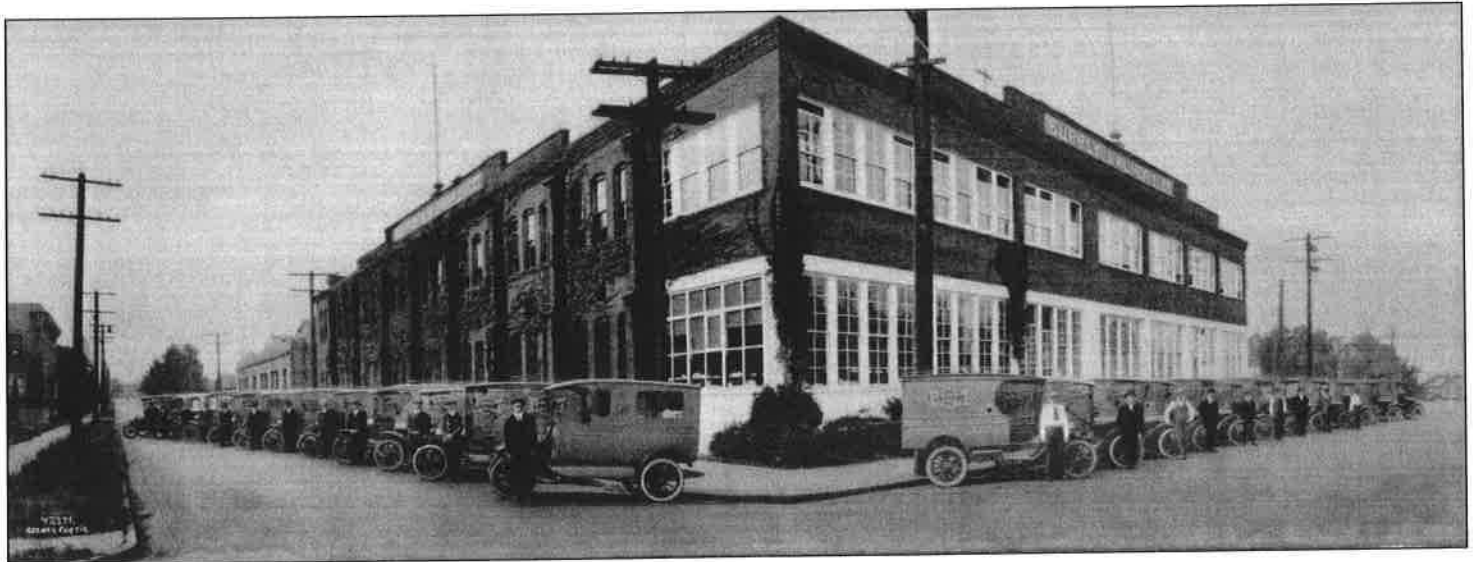
A composite view by photographer Asahel Curtis, showing the north and east facades of the Supply Laundry Building, ca. 1921. This view shows the building after a second story addition. (Courtesy Tomlinson Linen Service)

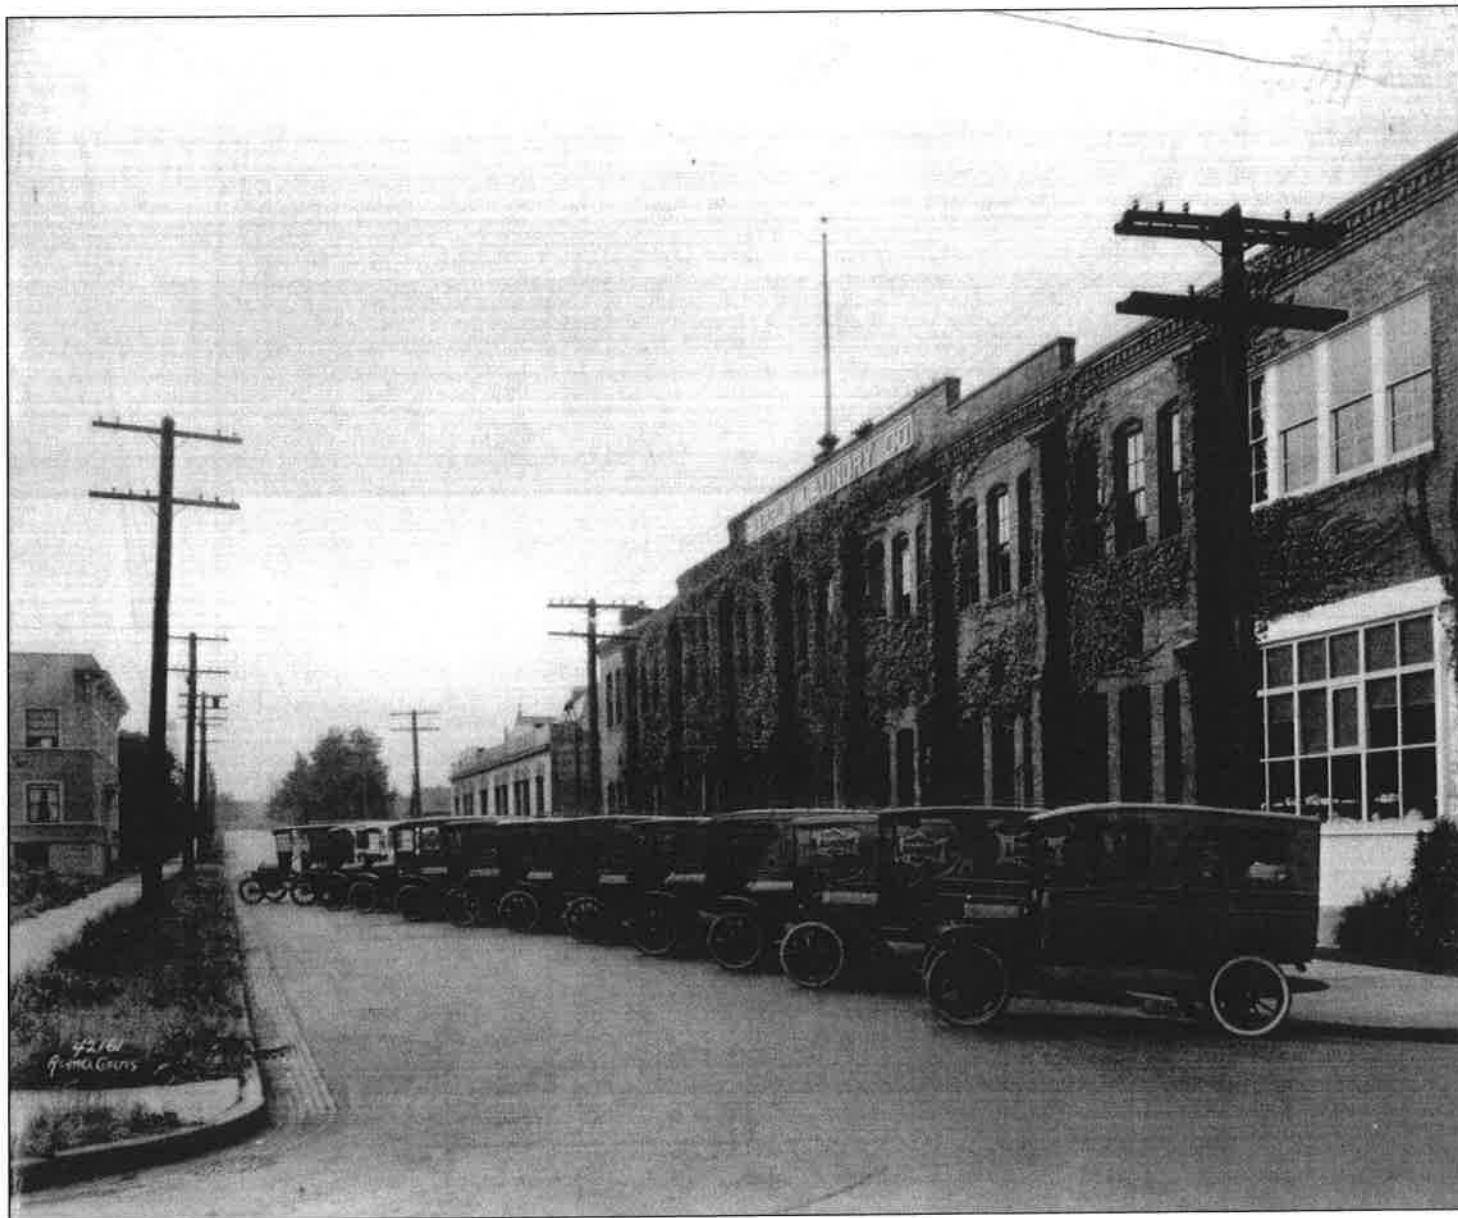
One of the photos used to form the composite view by Asahel Curtis, ca. 1921. This view is looking southwest along Yale Avenue North (formerly Howard Avenue North), showing the east facade of the building. (Courtesy Tomlinson Linen Service)

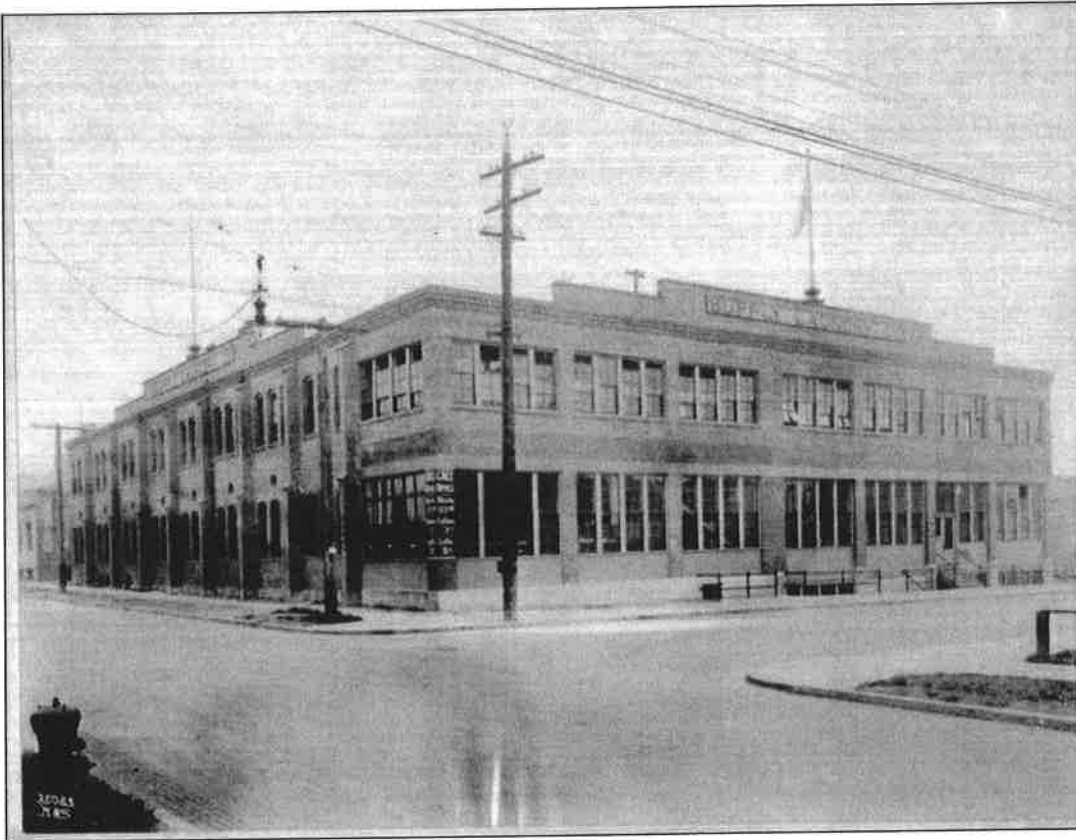
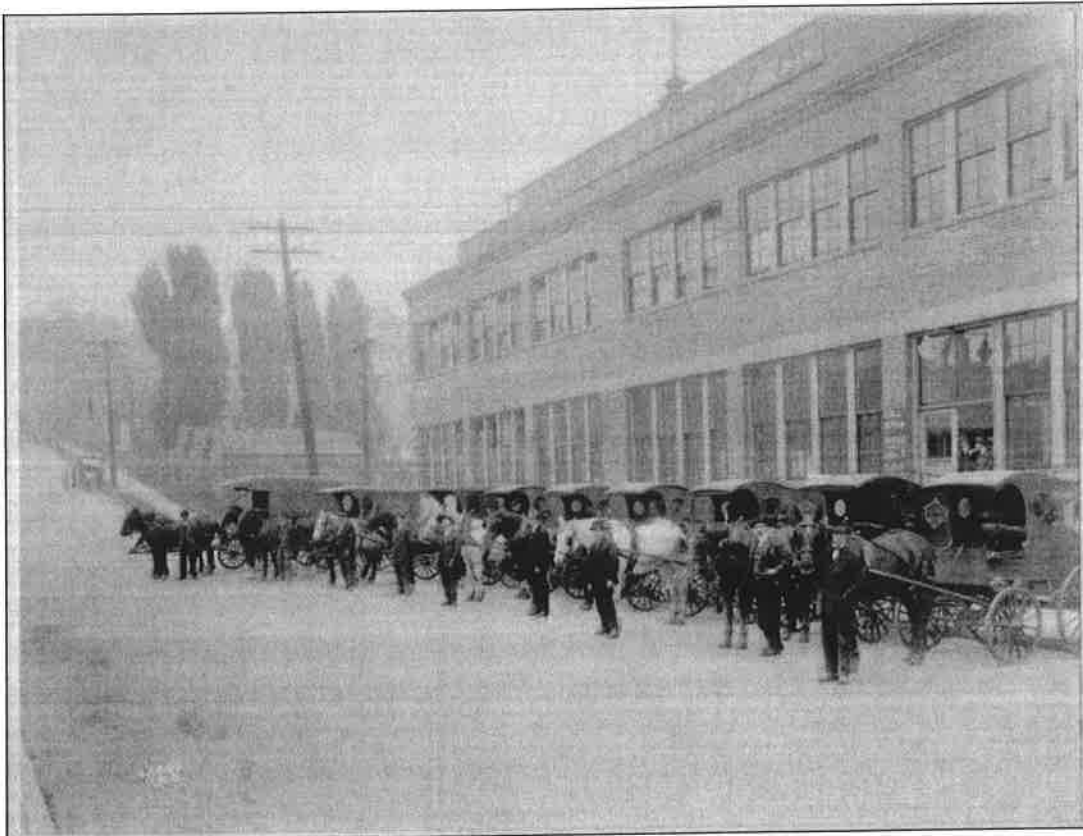
Two views of the Supply Laundry Building in 1917.

Left: Looking southwest at the north and east facades. (Museum of History & Industry [MOHAI], image no. 2010.52.2)

Below left: Looking southeast along Republican Street, showing the north facade and the company's fleet of delivery wagons with their male drivers. (MOHAI, image no. 2010.52.24)

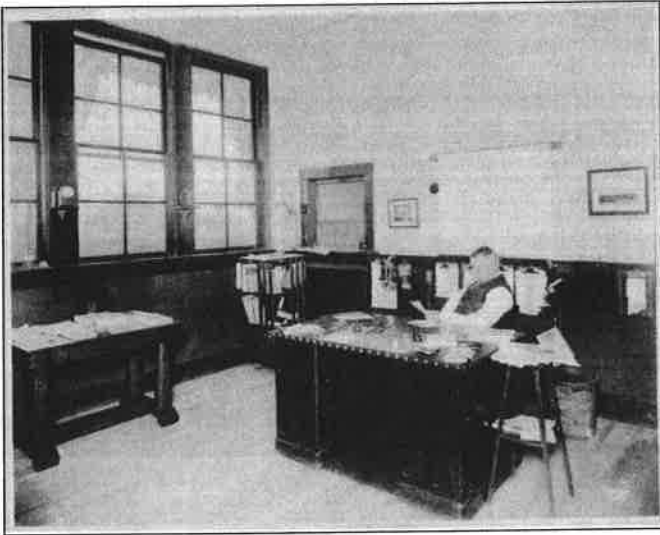
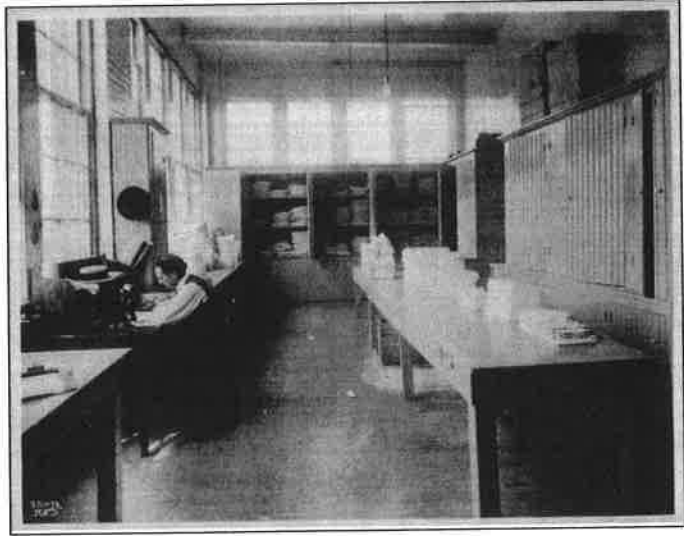
Interior views of the Supply Laundry Building ca. 1915, clockwise from top left.

Man seated at desk (MOHAI, image no. 2010.52.20); man working at table (MOHAI, image no. 2010.52.22); man operating machinery (MOHAI, image no. 2010.52.6); women pressing and folding laundry (MOHAI, image no. 2010.52.4).

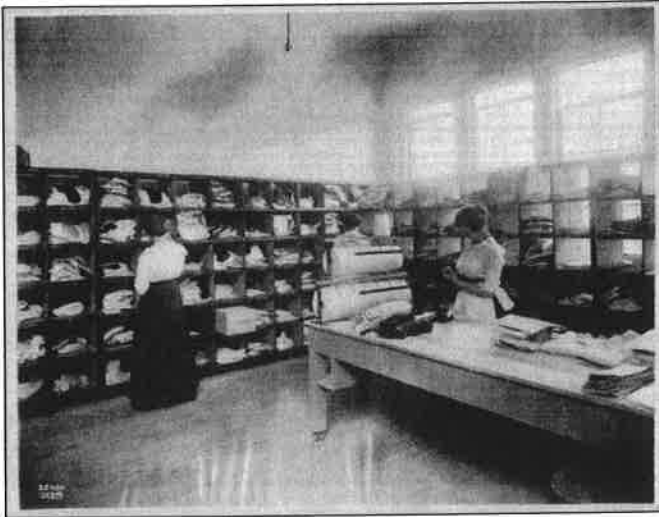
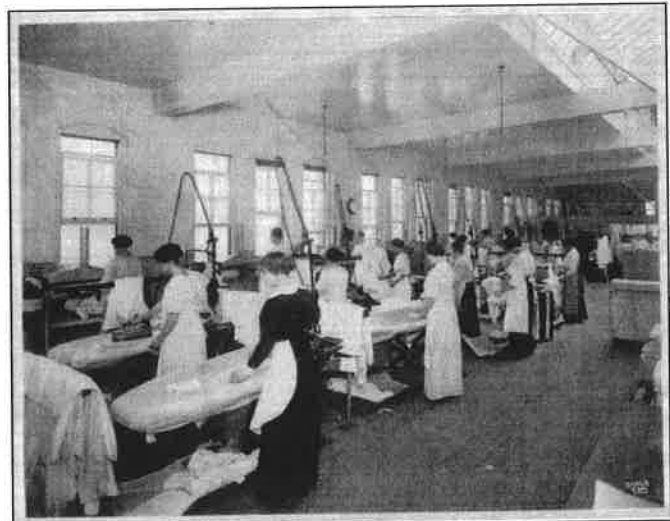
Interior views of the Supply Laundry Building ca. 1915, clockwise from top left.

Women sorting clothes (MOHAI, image no. 2010.52.17); women sorting laundry (MOHAI, image no. 2010.52.8); women pressing clothes (MOHAI, image no. 2010.52.12); women at sewing machines (MOHAI, image no. 2010.52.11).

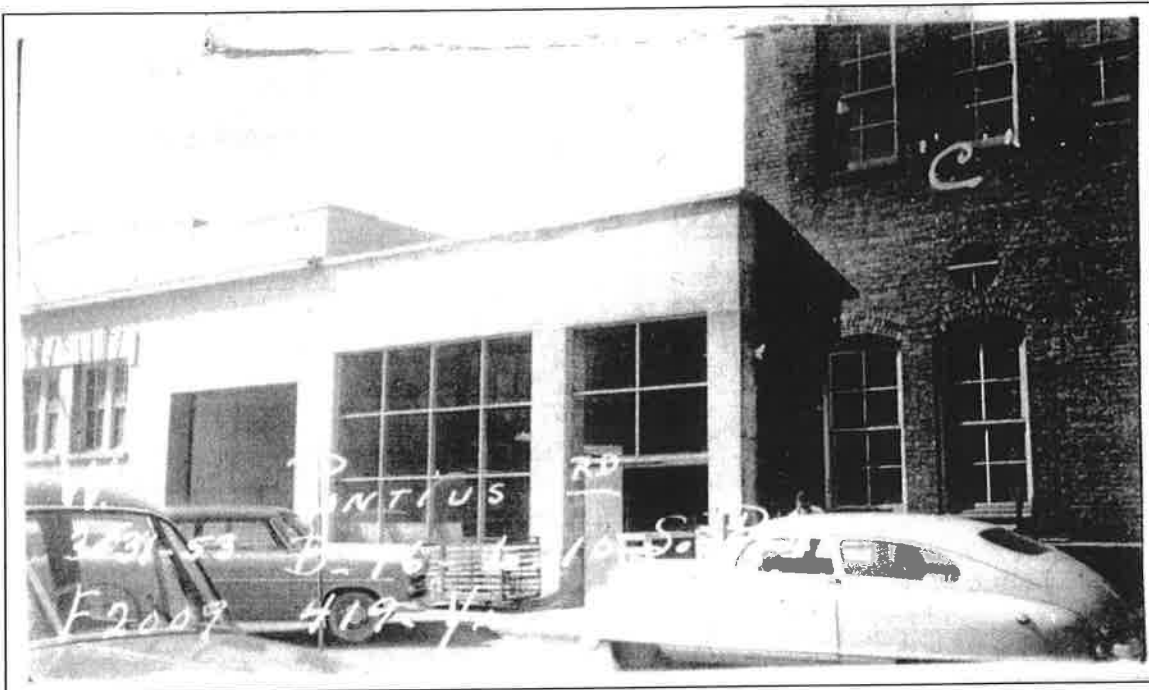
A 1953 property tax record photo of a one-story addition at the south end of the original building. This view is looking southwest and shows a portion of the original east facade (red brick) and the addition (concrete masonry unit). (Puget Sound Regional Archives)

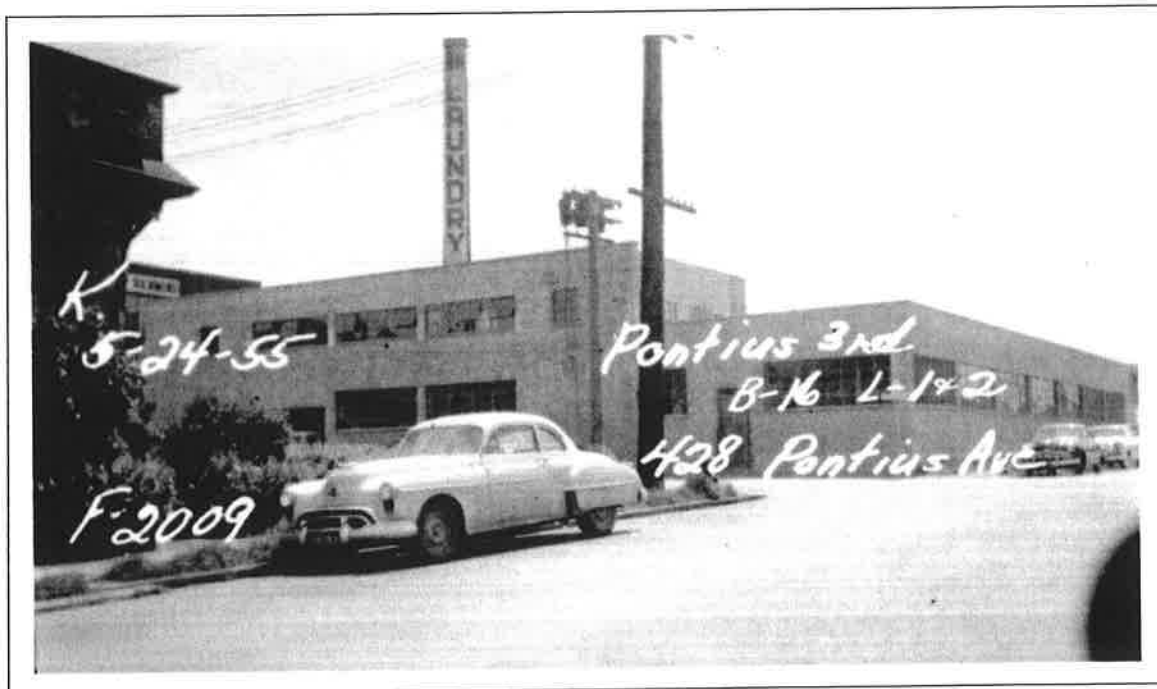
View looking southeast from Pontius Avenue North (a block west of the subject building). The laundry's chimney stack is visible behind the building in the foreground. (Puget Sound Regional Archives)

A 125'-tall, radial brick exhaust chimney, approximately 11' in diameter, was built in 1925. It rises next to the southwest corner of the building, where the boiler room once was located. A concrete loading platform was also provided along the alley side of the building, where there were three iron doors that accessed the fuel bin.

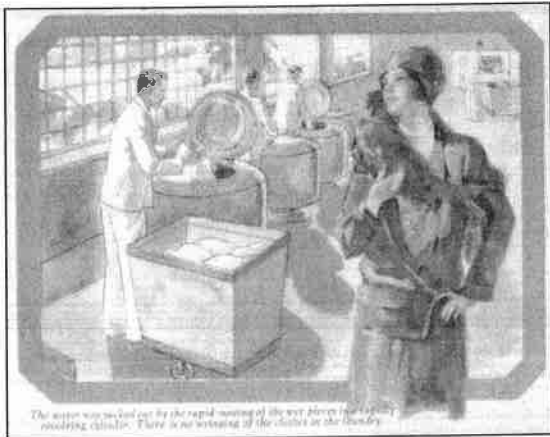
The water was washed out by the rapid rotating of the wet fibers in the rapidly revolving cylinder. There is no wringing of the clothes in the laundry.

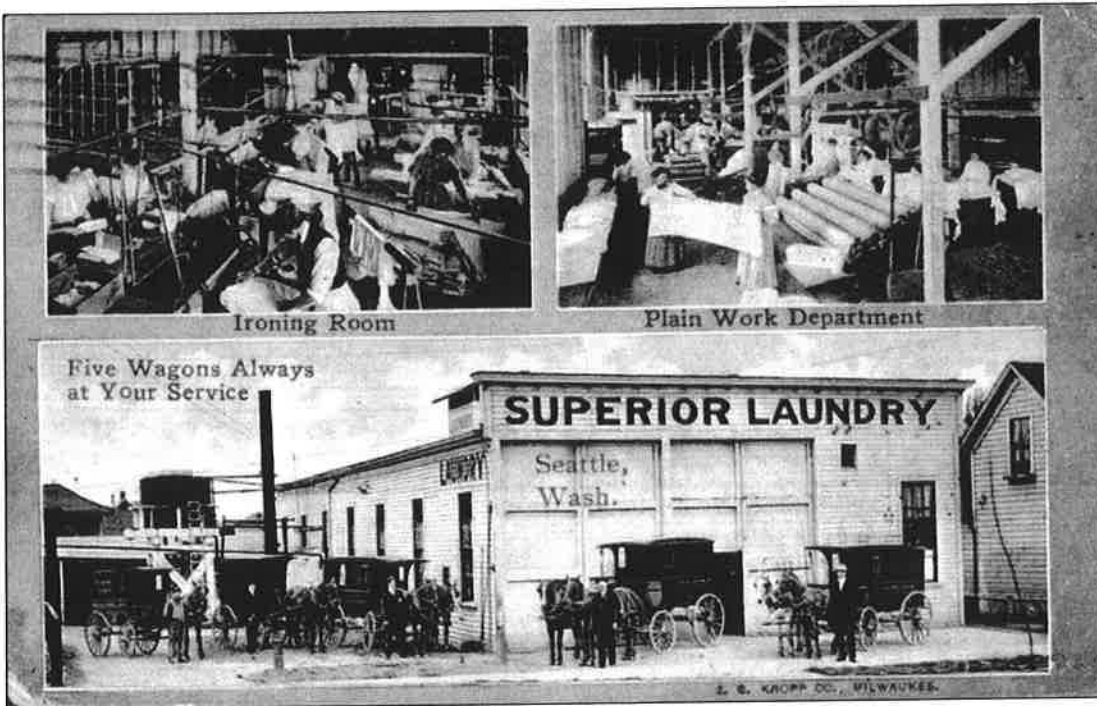
Postcard of exterior and interior views of Superior Laundry in Seattle, ca. 1910. (UW Libraries Special Collections, SEA1788)

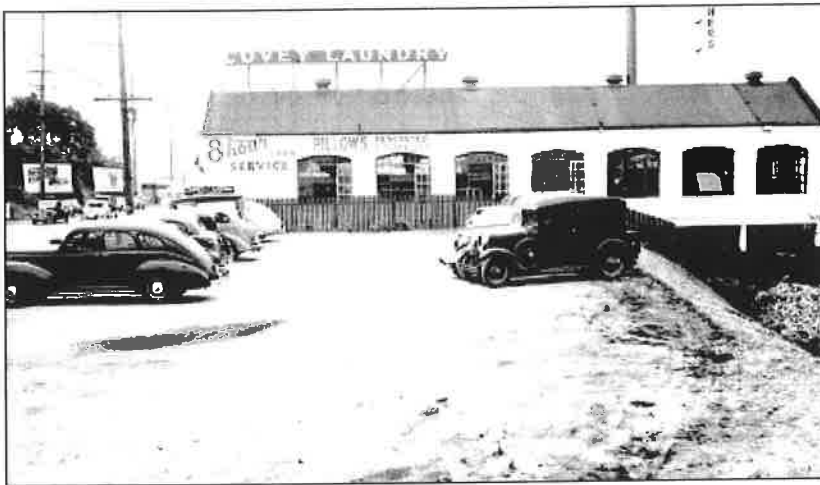
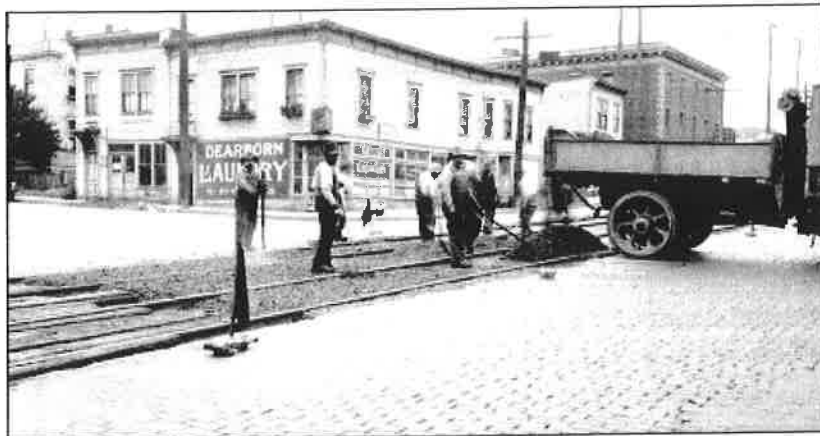
Three other Seattle laundry buildings shown in photos from Seattle Municipal Archives:
Top left: Covey Laundry, Eastlake Avenue East and Shelby Street, 1941 (item no. 39961)
Left: Dearborn Laundry, 7th Avenue South and Dearborn Street, 1927 (item no. 38261)
Above: Paris Laundry after a 1915 landslide, 10th Avenue and Main Street (item no. 882).
