CRATER LAKE

PNRO  
INVENTORY

1. SITE I.D. NO		5. ORIGINAL USE		7. CLASSIFICATION			9. RATING	
2. NAME(S) OF STRUCTURE		Comfort Station					10. DATE	
COMFORT STATION #72		6. PRESENT USE					1930	
3. SITE ADDRESS (STREET & NO)		Transformer Station--PPL Vault #6		8. UTM ZONE EASTING NORTHING			11. REGION	
Rim Village Crater Lake National Park							10	
4. CITY/VICINITY		COUNTY		SCALE		QUAD NAME		
Crater Lake National Park, Klamath, Oregon				1:24 1:62.5				
12. OWNER/ADMIN ADDRESS		STATE		OTHER				
U.S. Department of Interior, National Park Service, Seattle, Washington

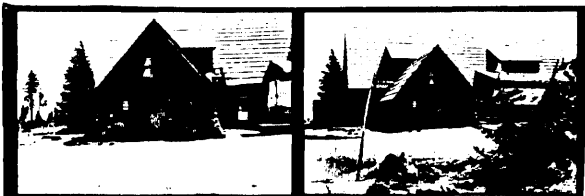
A rustic style stone and wood 1-1/2 story structure designed by the Landscape Division of the National Park Service. Rectangular in plan, measuring 18' x 26'-4", it was probably erected to serve the concessionaire's cafeteria and is located just south of it. It has a steep gable shake roof on 1 x random width board sheeting on 2 x 6 rafters which were originally exposed but have now been enclosed. Purlins are large square-section timbers extended beyond walls and are trimmed with a 2 x 8 fascia; the bottom purlins were 12 x 12; the one on the east elevation has been replaced with a combination of 1-by and 2-by built-up wood. First floor walls are massive stone masonry, battered at the corners. Gable ends have board and batten siding with decorative angled cuts at the bottom edge. East and west elevations had two ribbons of five square four-light windows each; the center of the east elevation has an original paneled door, and the center of the west elevation had a six-light window now boarded up. The north and south elevations each had a centralized door flanked on either side by three multi-light square windows; doors have been altered. Gable ends each had a pair of six-light casements; only one original casement on the south end remains. All windows have been removed and openings filled with concrete block and boards. Original plan had a women's bathroom on the north end and a men's bathroom on the south, with storage and a small transformer in an east-west hallway running between the two. The Pacific Power and Light Company has since installed transformers in this building to serve the cafeteria, the cold water cabins, and the four plexes operated by the concessionaire.

14. CONDITION	<input type="checkbox"/> EXCELLENT	<input type="checkbox"/> GOOD	<input checked="" type="checkbox"/> FAIR	<input type="checkbox"/> DETERIORATED	<input type="checkbox"/> RUINS	15. DANGER OF DEMOLITION? (SPECIFY THREAT)	<input type="checkbox"/> YES	<input type="checkbox"/> NO	<input checked="" type="checkbox"/> UNKNOWN
---------------	------------------------------------	-------------------------------	--	---------------------------------------	--------------------------------	--	------------------------------	-----------------------------	---
