National Register of Historic Places Registration Form

Historic name Fix Farmstead

Name of related Multiple Property Listing Historic Agriculture-Related Resources of Kansas

State Kansas Code KS County Wabaunsee Code 197 Zip code 66401

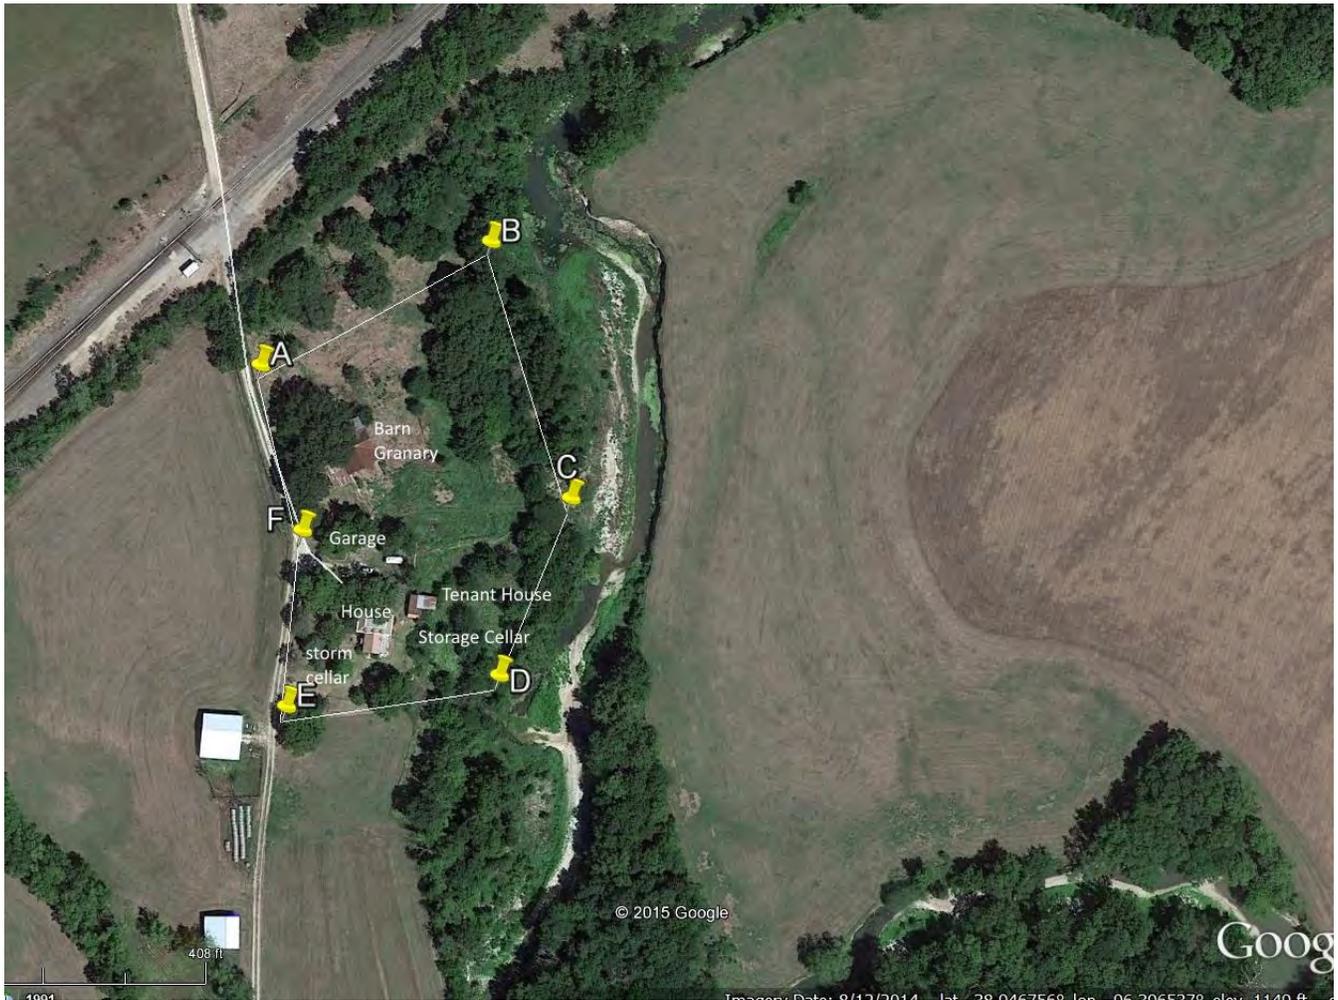
Figure1: Site Plan, Google Earth imagery, 2014

The Fix House is the southernmost structure with the tenant house to the northeast and a storage cellar excavated into the stream terrace south of the tenant house. Southwest of the Fix House, there is a concrete storm cellar. The garage is directly north of the house. Further to the north, the bank barn also was constructed in the terrace. A large granary was added to the west (uphill) side of the barn forming an ell. There is a roughly semicircular driveway from the lane that provides access to the house, tenant house, and garage, and then circles past the barn- granary to the lane.

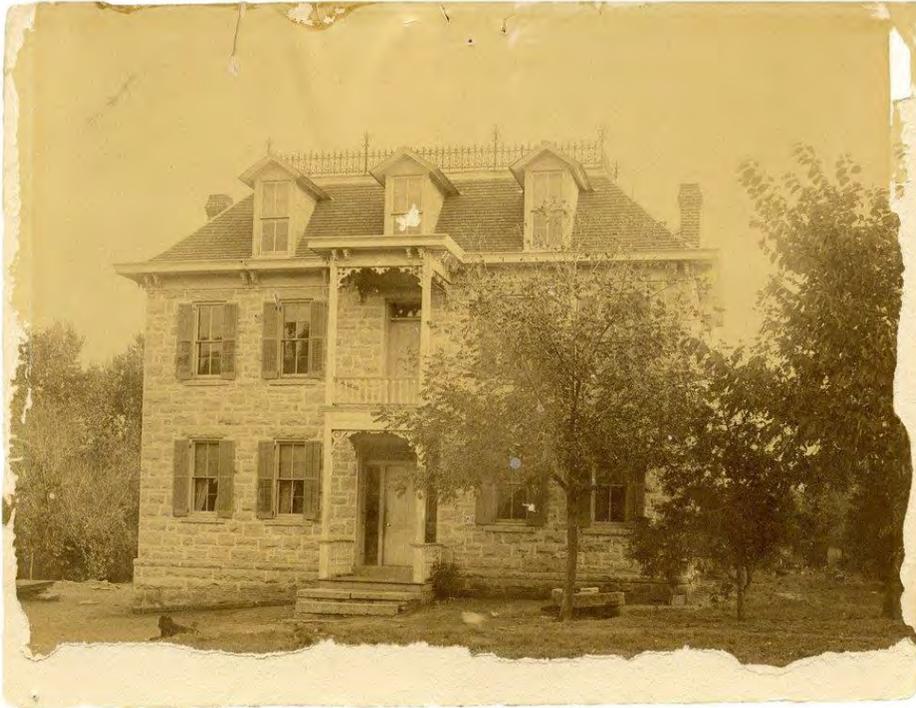
Figure 5. Historic image of Fix House, c. 1901, Kansas Memory, KSHS

There have been some minor alterations and some features have been removed since the historic photographs were taken. Stone slabs forming entrance steps have been removed. Louvered wooden shutters beside the window have been removed. Brick interior end chimneys with ornamental corbelled tops to the east and west have been removed. The iron cresting which ornamented the central flat roof has been removed. In the southwest corner of the Italianate block, a first floor door opening has been filled with stone. In the west façade, one of the two first floor windows has been covered by a large concrete block chimney (constructed c. 1955). On the west side of the south façade of the rear block, a masonry opening which may have been a rear entrance has been partially filled with stone and a replacement 2/2 window. The wooden lintel above this opening also appears to have been

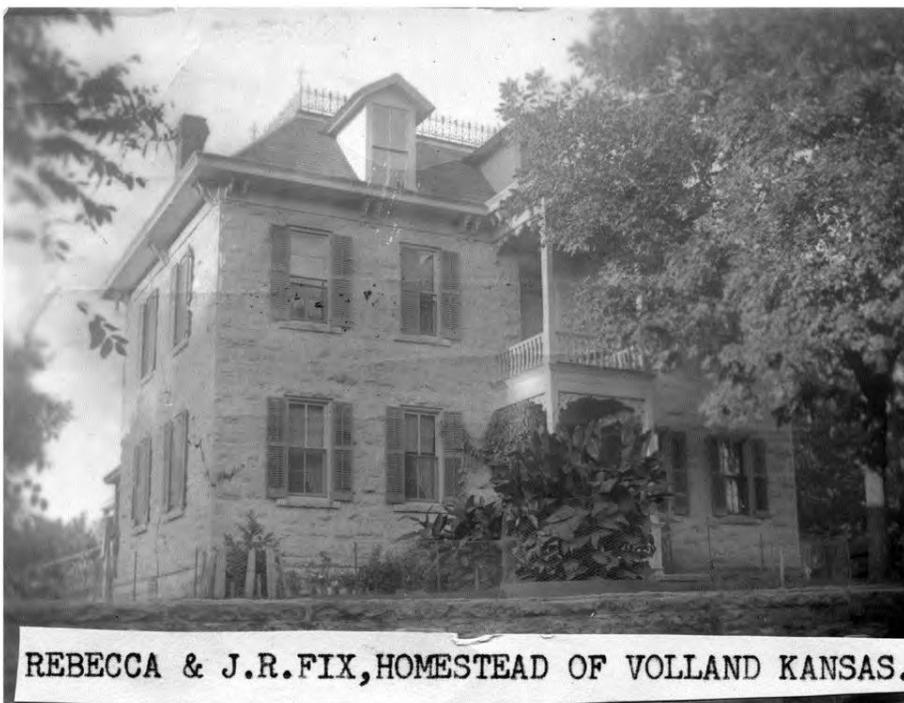
Figure 6. Historic image of Fix House, c. 1901, Kansas Memory, KSHS

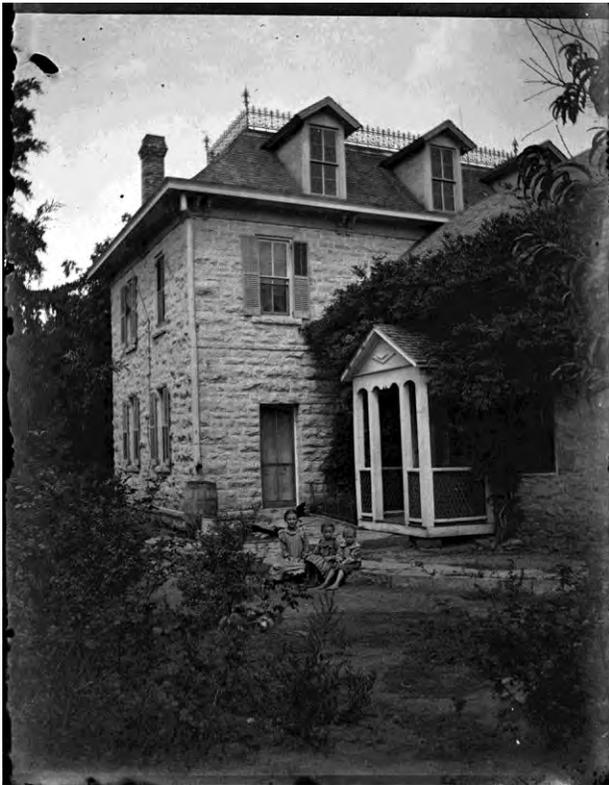
Figure 7. Historic image, Fix House, c. 1901, Greg Hoots, Wabaunsee County Museum
