HISTORIC RESOURCES INVENTORY
BUILDING AND STRUCTURES
 HIST-6 NEW 5/77.

1. BUILDING NAME (Common) <i>(Historic)</i> Duffy House Whitman House	
2. TOWN/CITY West Hartford	VILLAGE
3. STREET AND NUMBER (and/or location) 208 North Main Street approx. .7 acres Vol. 551, p. 202.	
4. OWNER(S) Gregory and Norine Burns <input type="checkbox"/> Public <input checked="" type="checkbox"/> Private	
5. USE (Present) <i>(Historic)</i> residence farmhouse	
6. ACCESSIBILITY TO PUBLIC: <input checked="" type="checkbox"/> Yes <input type="checkbox"/> No	EXTERIOR VISIBLE FROM PUBLIC ROAD <input type="checkbox"/> Yes <input checked="" type="checkbox"/> No
IF YES, EXPLAIN

7. STYLE OF BUILDING Colonial		DATE OF CONSTRUCTION c.1764 and 1807
8. MATERIAL(S) (Indicate use or location when appropriate)		
<input checked="" type="checkbox"/> Clapboard	<input type="checkbox"/> Asbestos Siding	<input type="checkbox"/> Brick <input type="checkbox"/> Other (Specify) _____
<input type="checkbox"/> Wood Shingle	<input type="checkbox"/> Asphalt Siding	<input type="checkbox"/> Fieldstone
<input type="checkbox"/> Board & Batten	<input type="checkbox"/> Stucco	<input type="checkbox"/> Cobblestone
<input type="checkbox"/

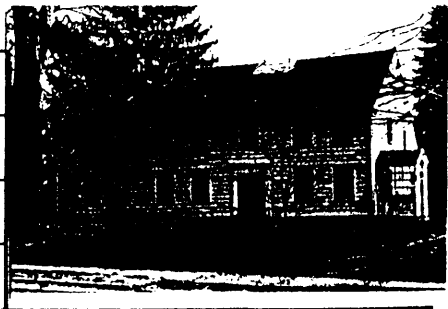
PHOTO

One of the few remaining 18th century houses in West Hartford, this building was originally a 5 bay saltbox, increased to 9 bays with two chimneys circa 1813. The front door is framed by carved and fluted pilasters, with 8-petaled rosettes under scroll capitals; round headed panels form the bases. A photograph of the capitals is shown in Kelly, Early Domestic Architecture of Connecticut.

VIEW northwest NEGATIVE ON FILE CHC II-13,14,15

Exterior condition is good: chimney rebuilt and exterior painted. Interior includes finely detailed raised-panel walls and wainscoting. Said to be built on site of 17th-century Cornelius Merry house.
