Moody (Malcolm A.) House
300 W. 13th St.
The Dalles, Wasco Co, Oregon
1 of 10 - North (front) eleva-
tion from W. 13th St.

Moody (Malcolm A.) House

300 W. 13th St.

The Dalles, Wasco Co., Oregon

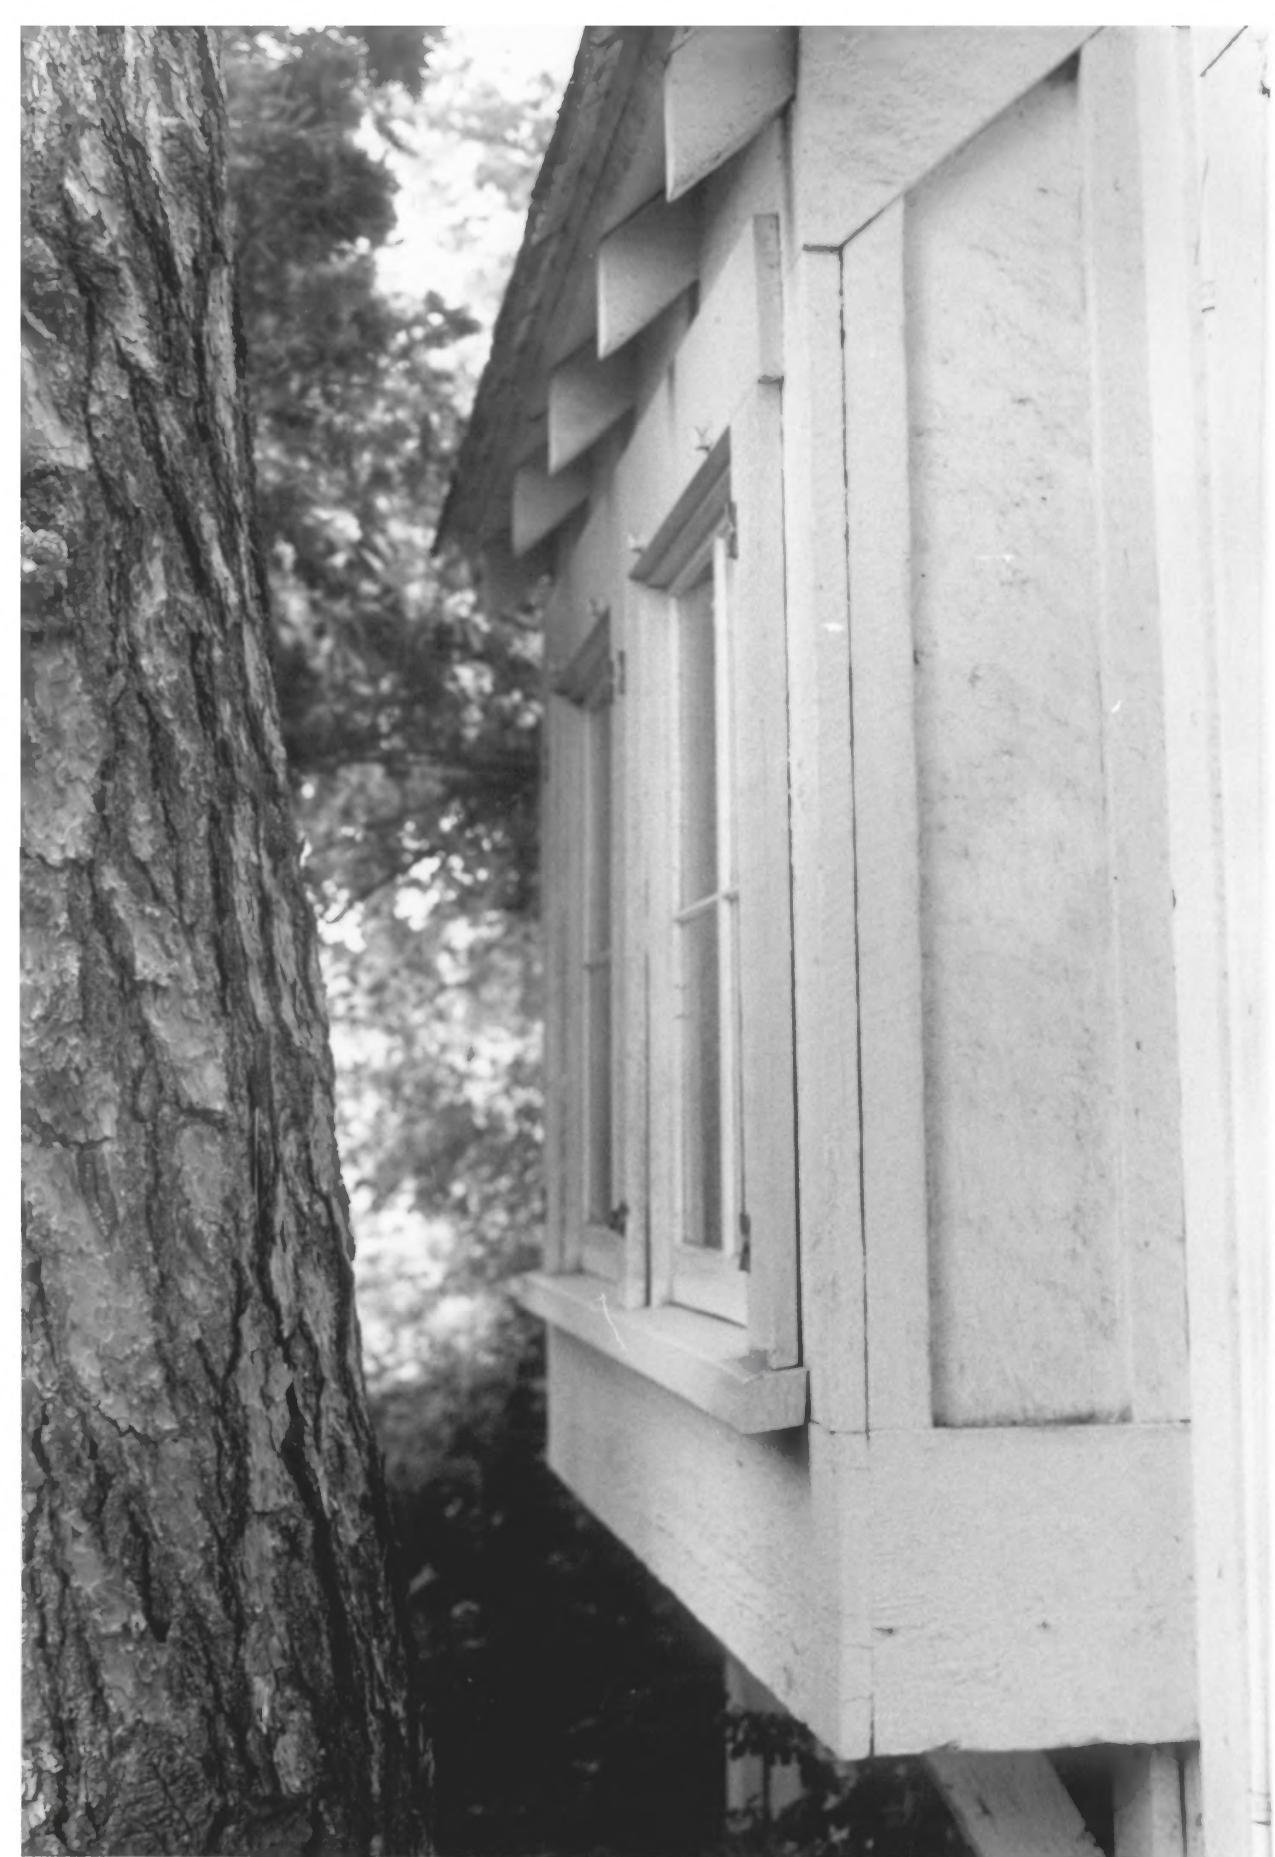
Windows on front of house

2 of 10 - Detail of window bay
north elevation, probably

added in 1900-1915.

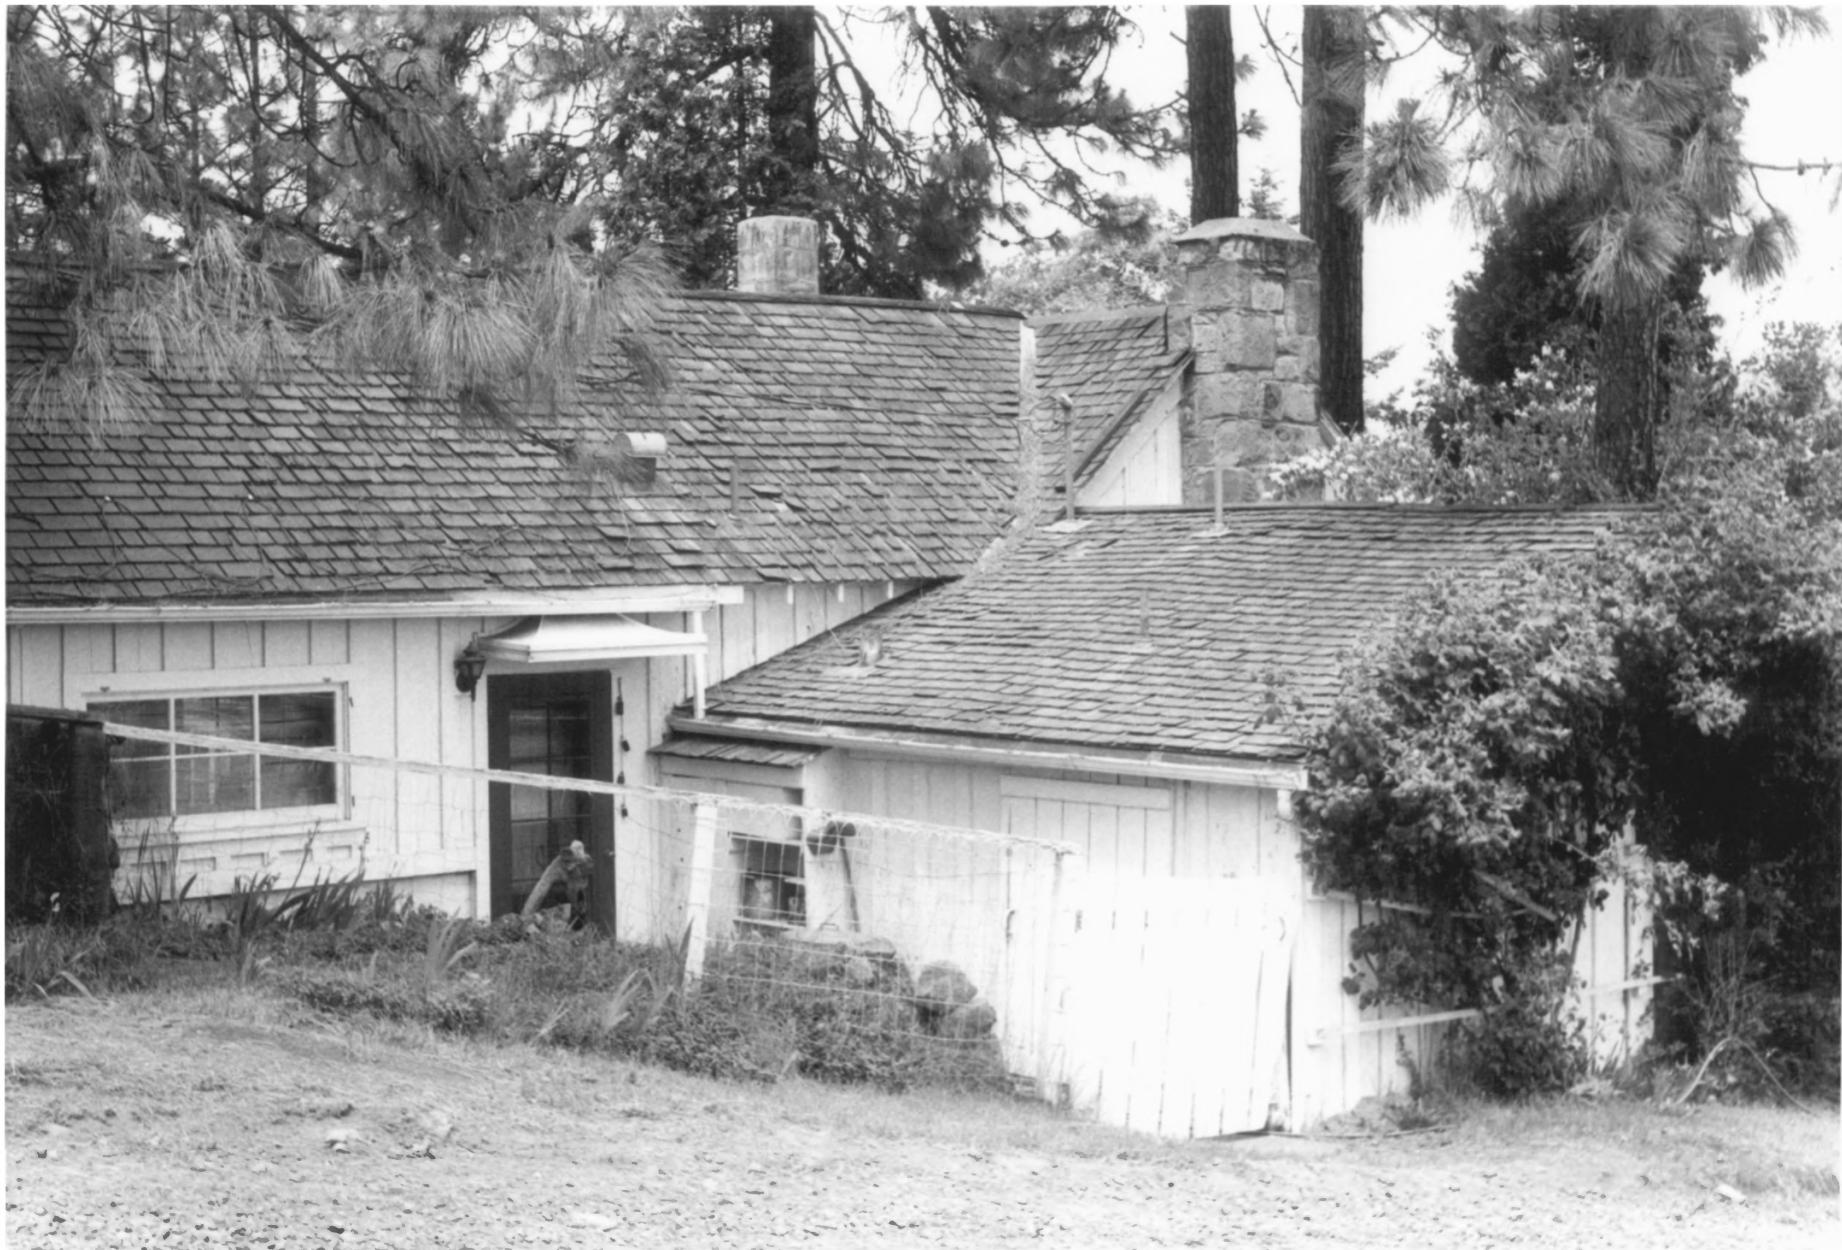
Moody (Malcolm A.) House
300 W. 13th St.
The Dalles, Wasco Co, Oregon
3 of 10 - East (side) eleva-
tion, showing stone chimney
added c. 1900, and east bath-
room wing added 1915. South
wing incorporating original
kitchen area was extended to
present configuration in 1950.

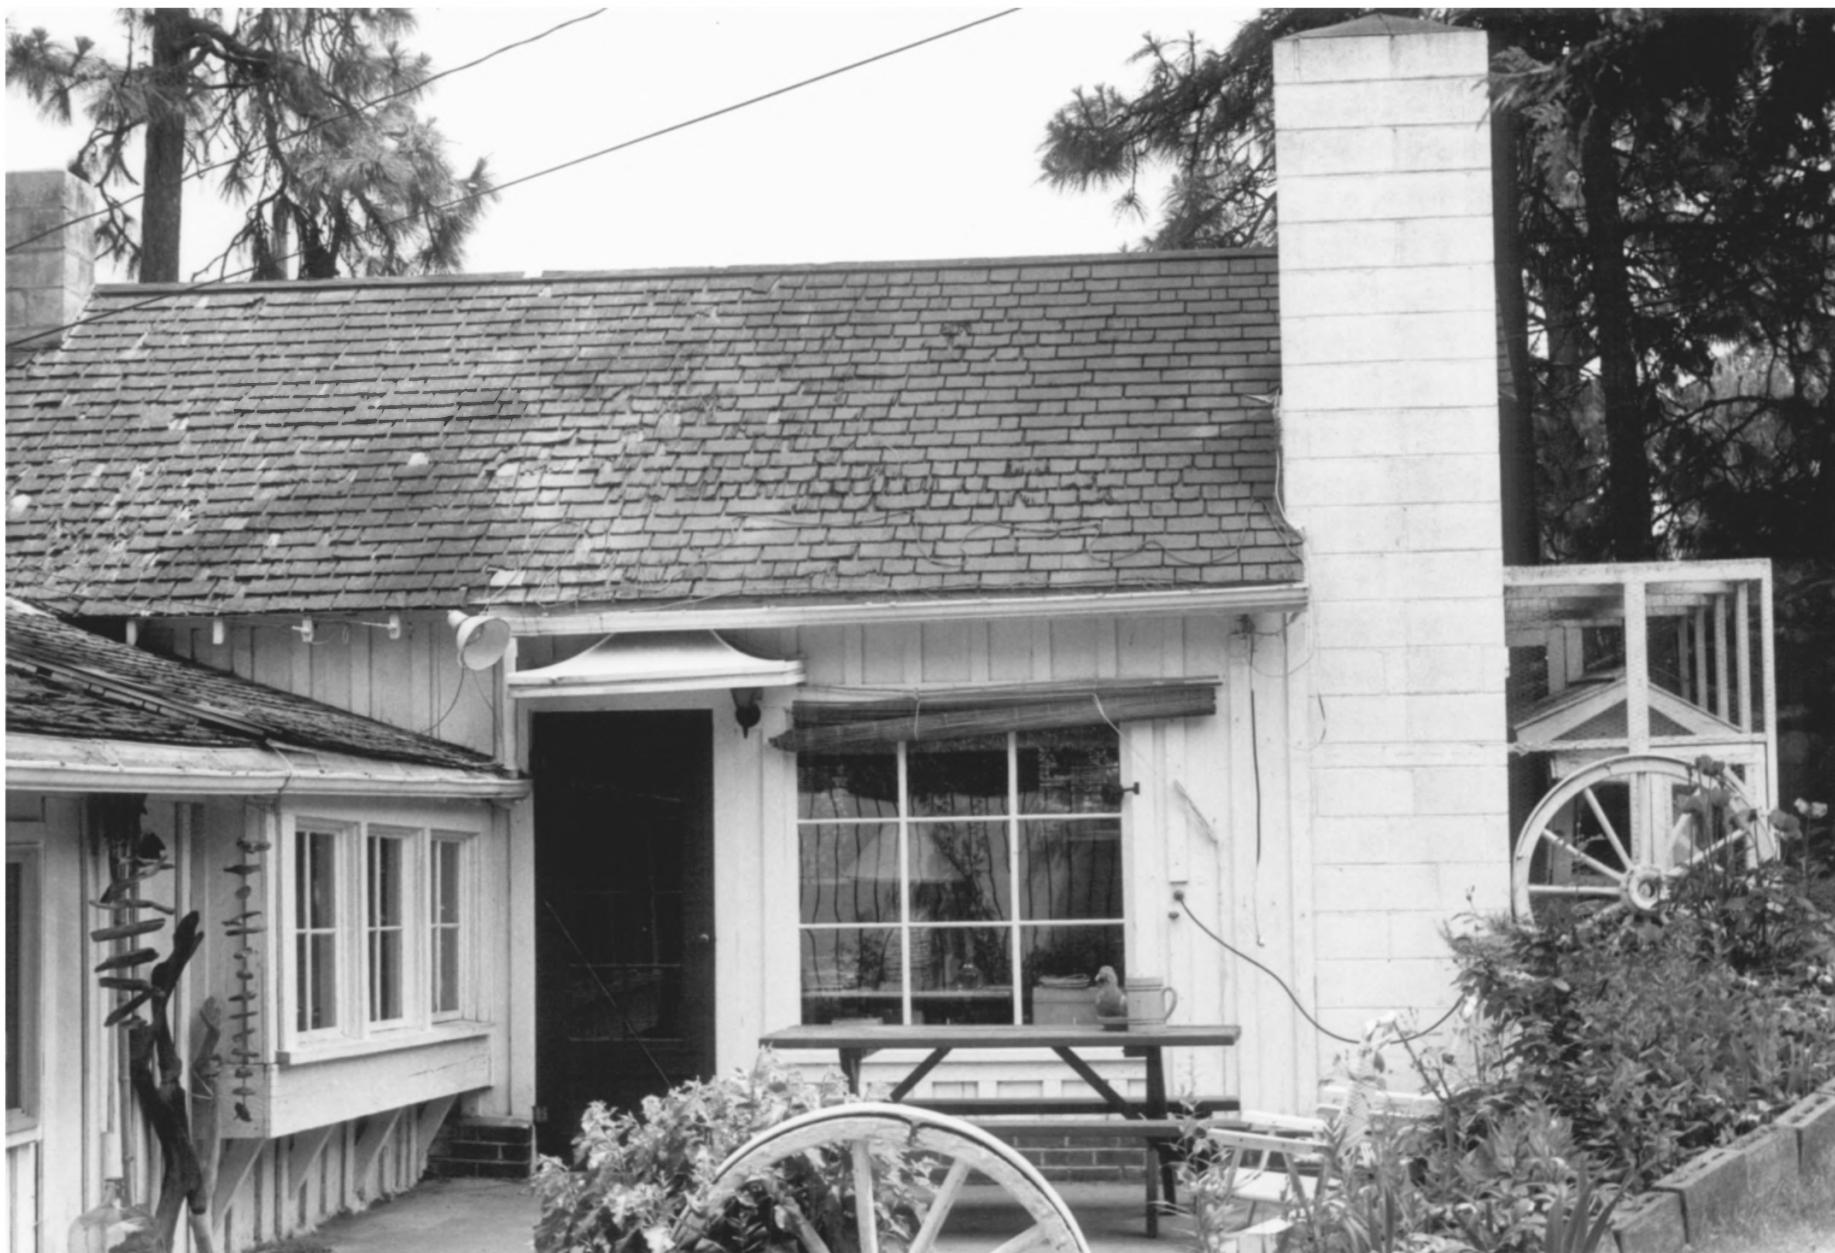
Moody (Malcolm A.) House
300 W. 13th St.
The Dalles, Wasco Co, Oregon
4 of 10 - West elevation of
1950 kitchen extension.

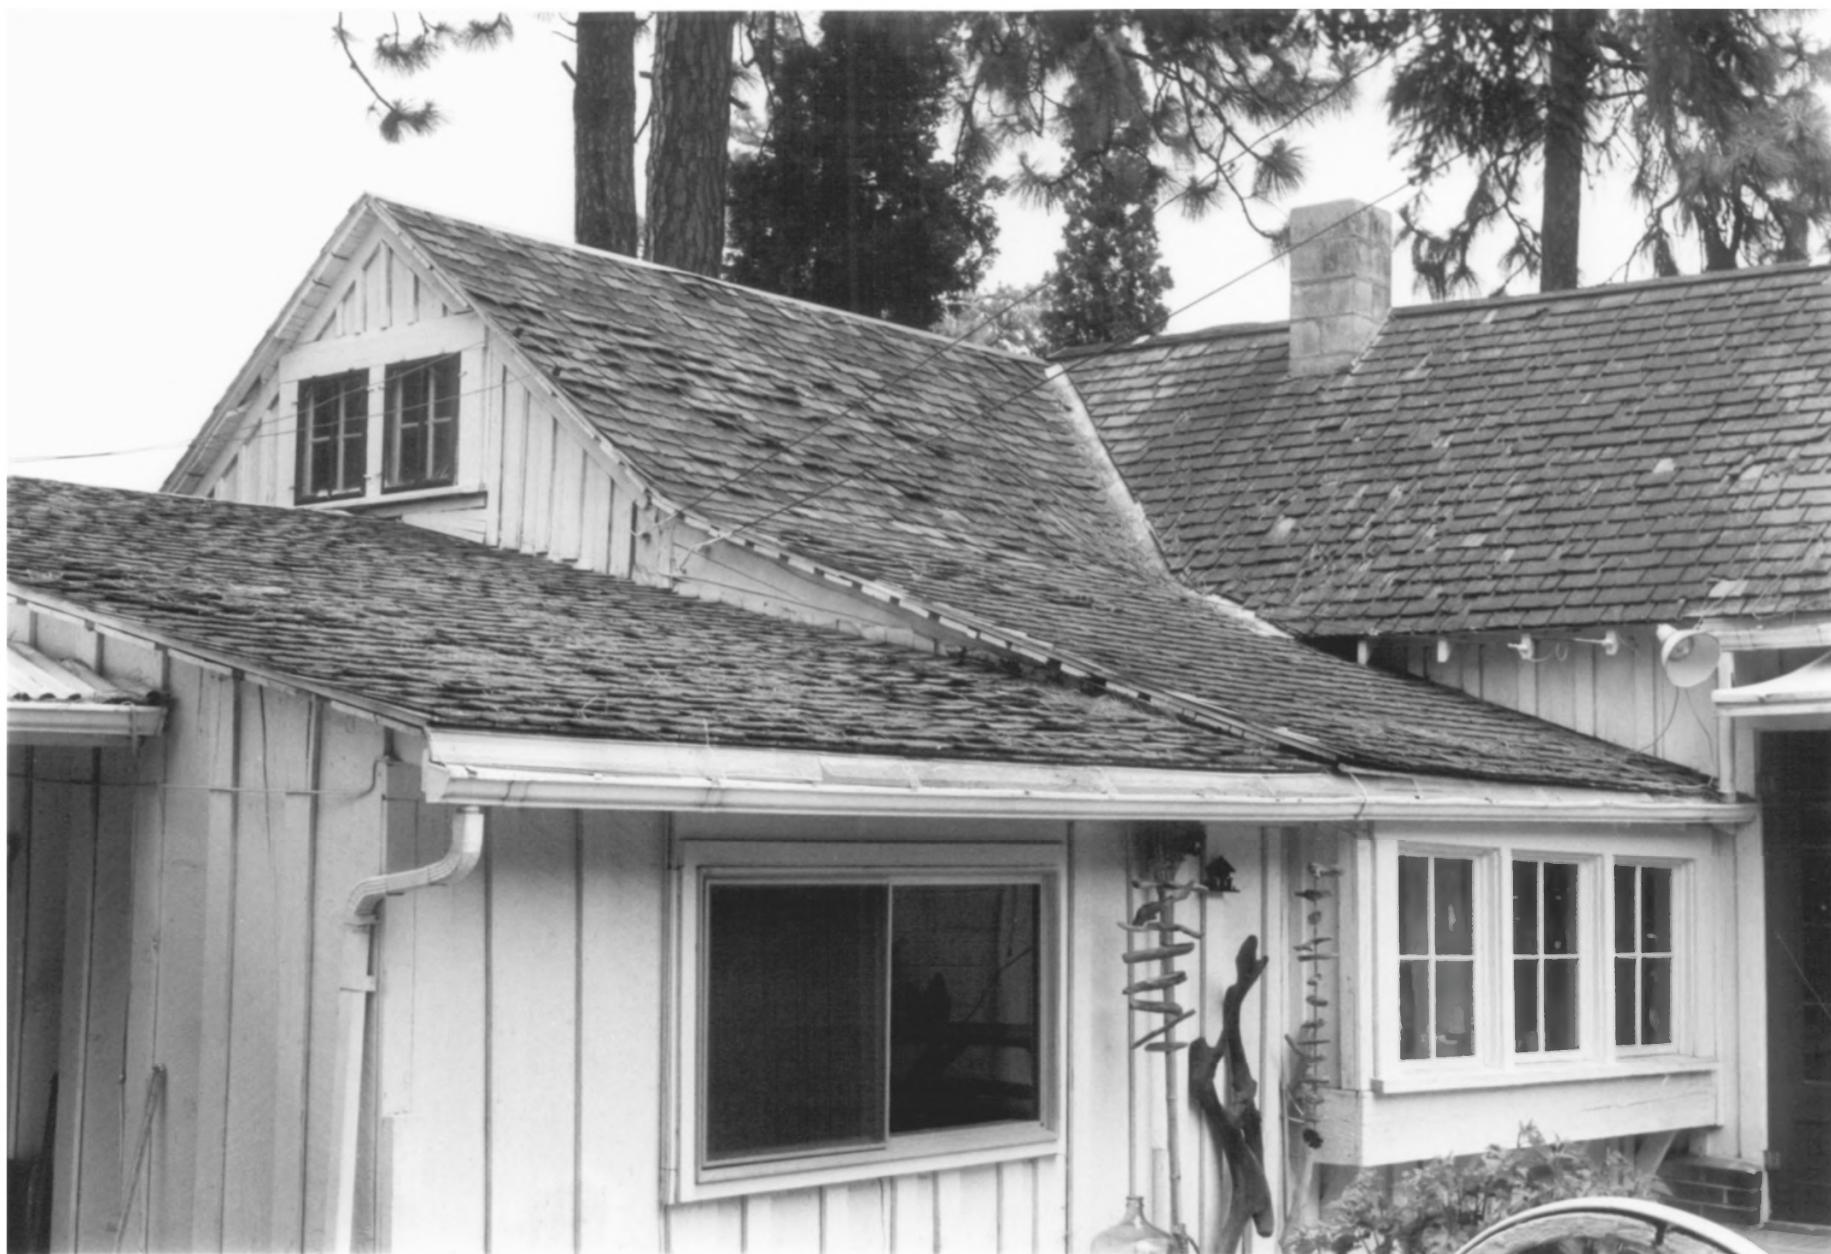
Moody (Malcolm A.) House
300 W. 13th St.
The Dalles, Wasco Co, Oregon
5 of 10 - West and south elevations, showing gable-roofed main block and shed-roofed rear portion of original house. Bay window probably was added 1900-1915. Extension on west is bedroom added 1933.

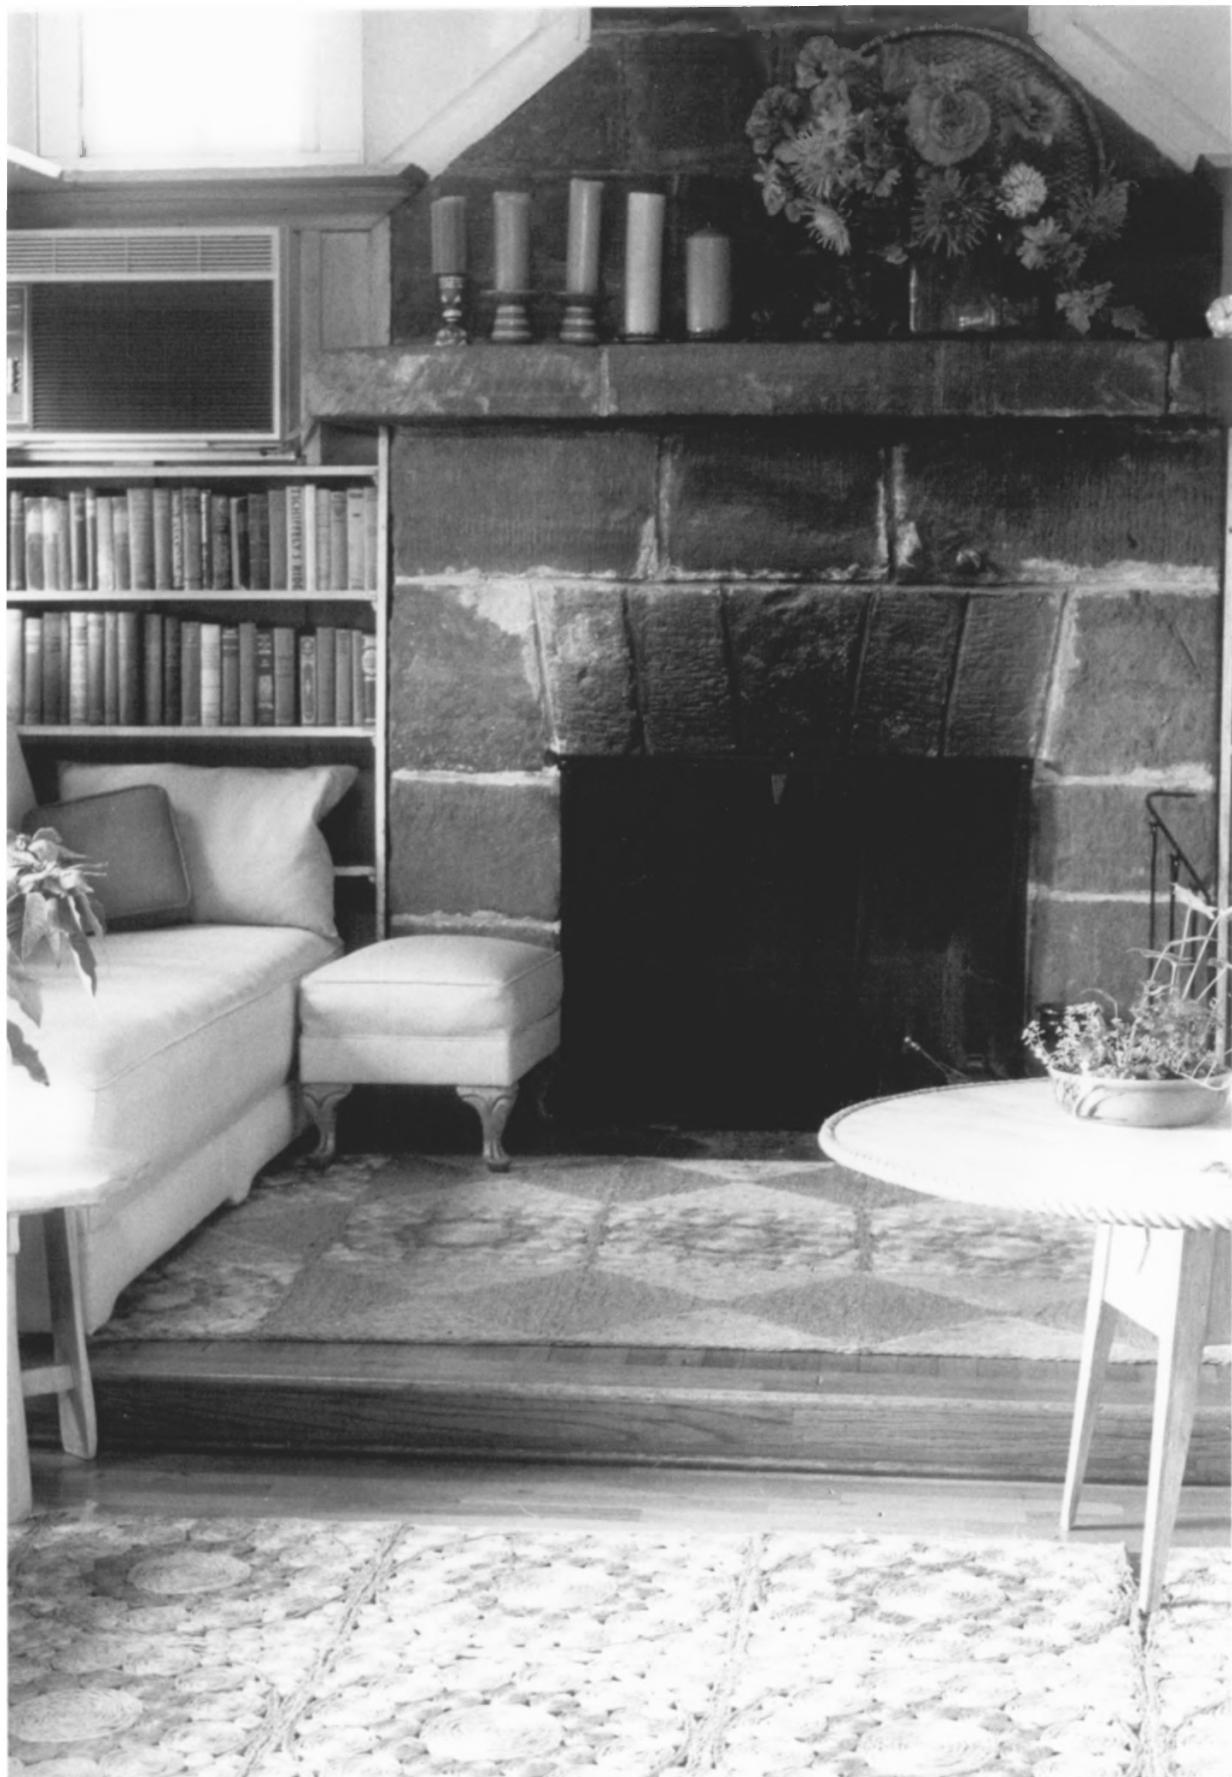
Showing different level
from east end of living room
to west of living room and
bedroom.

7 of 10 - Stone chimney piece,
east end of parlor, original

main block of house, added by
Malcolm Moody c. 1900.

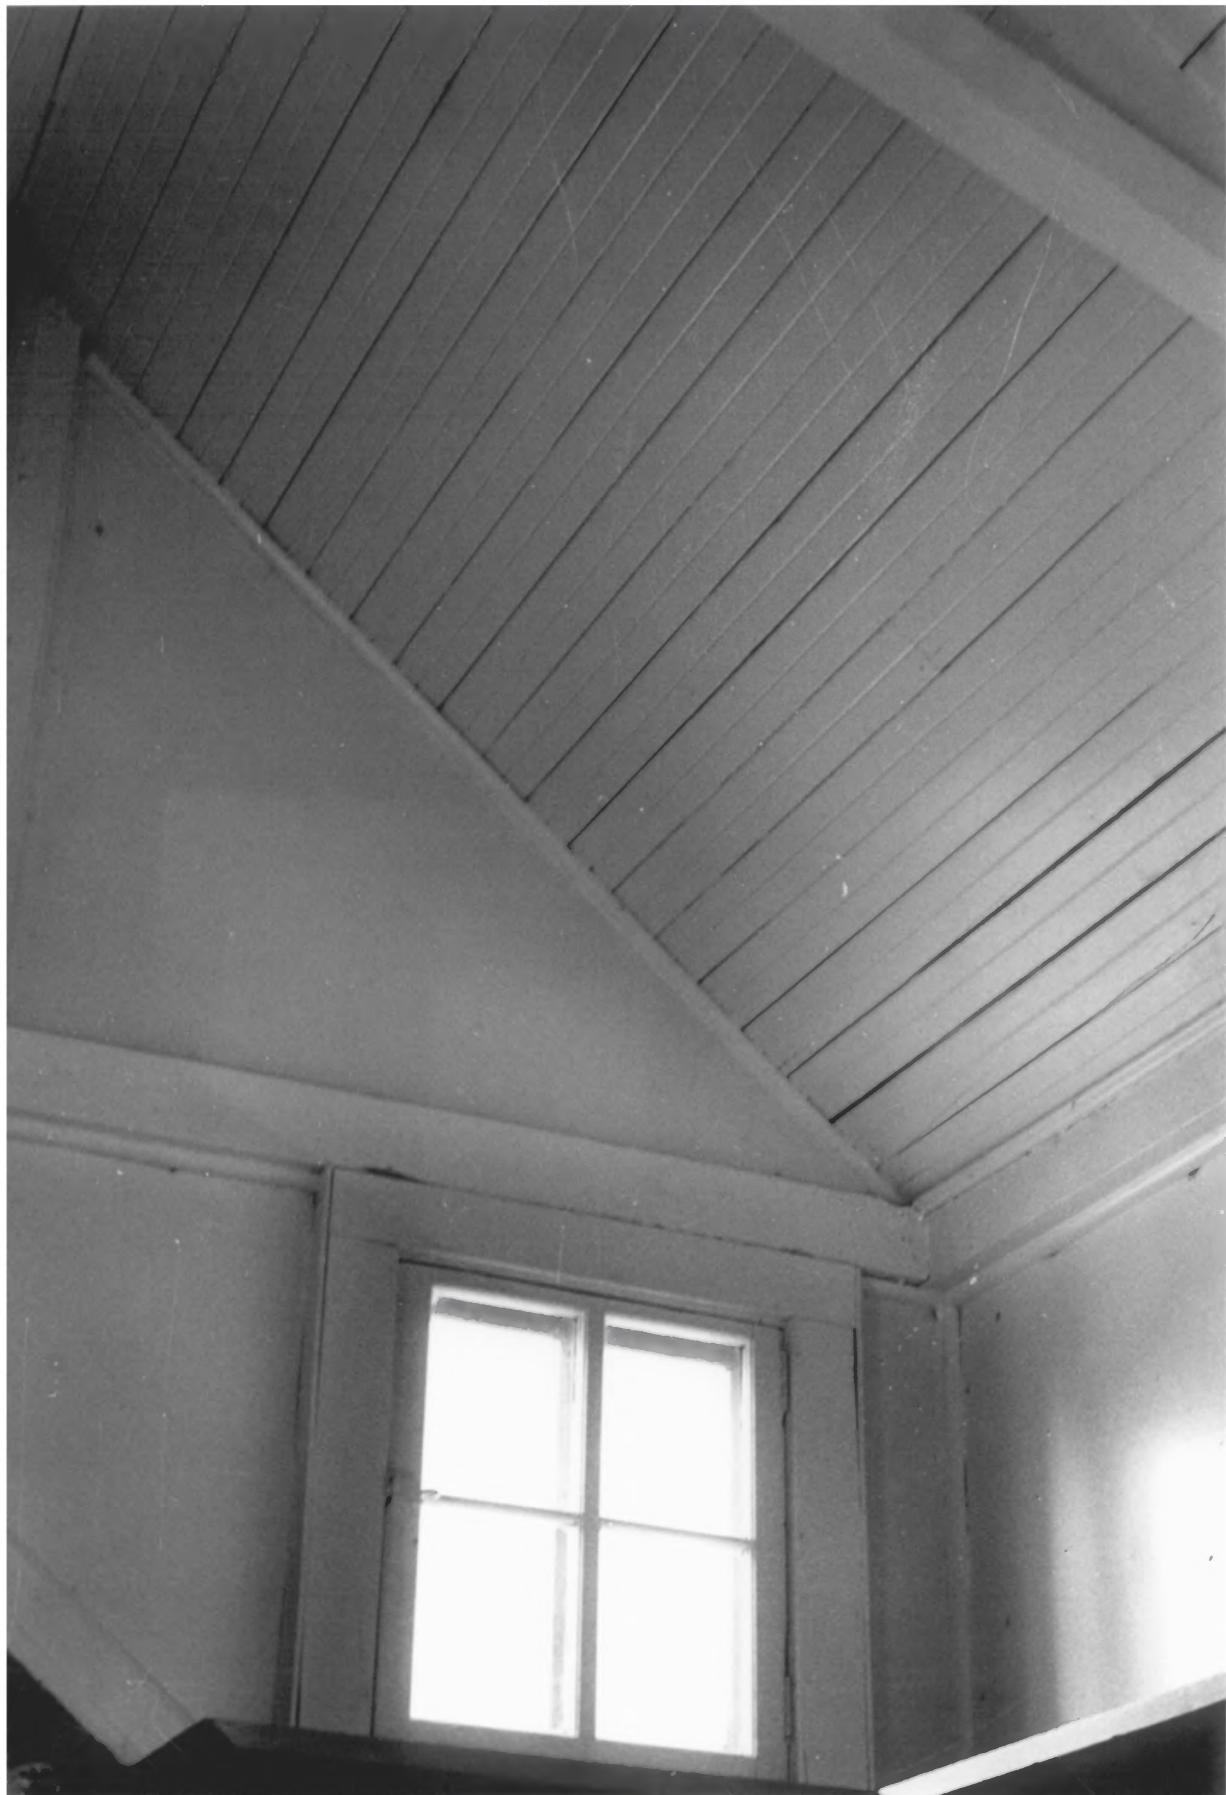
Window at east end of
living room.

OCT 10 1980
8 of 10 - Detail view of
tongue and groove ceiling

cover and window in east end
wall of main block.

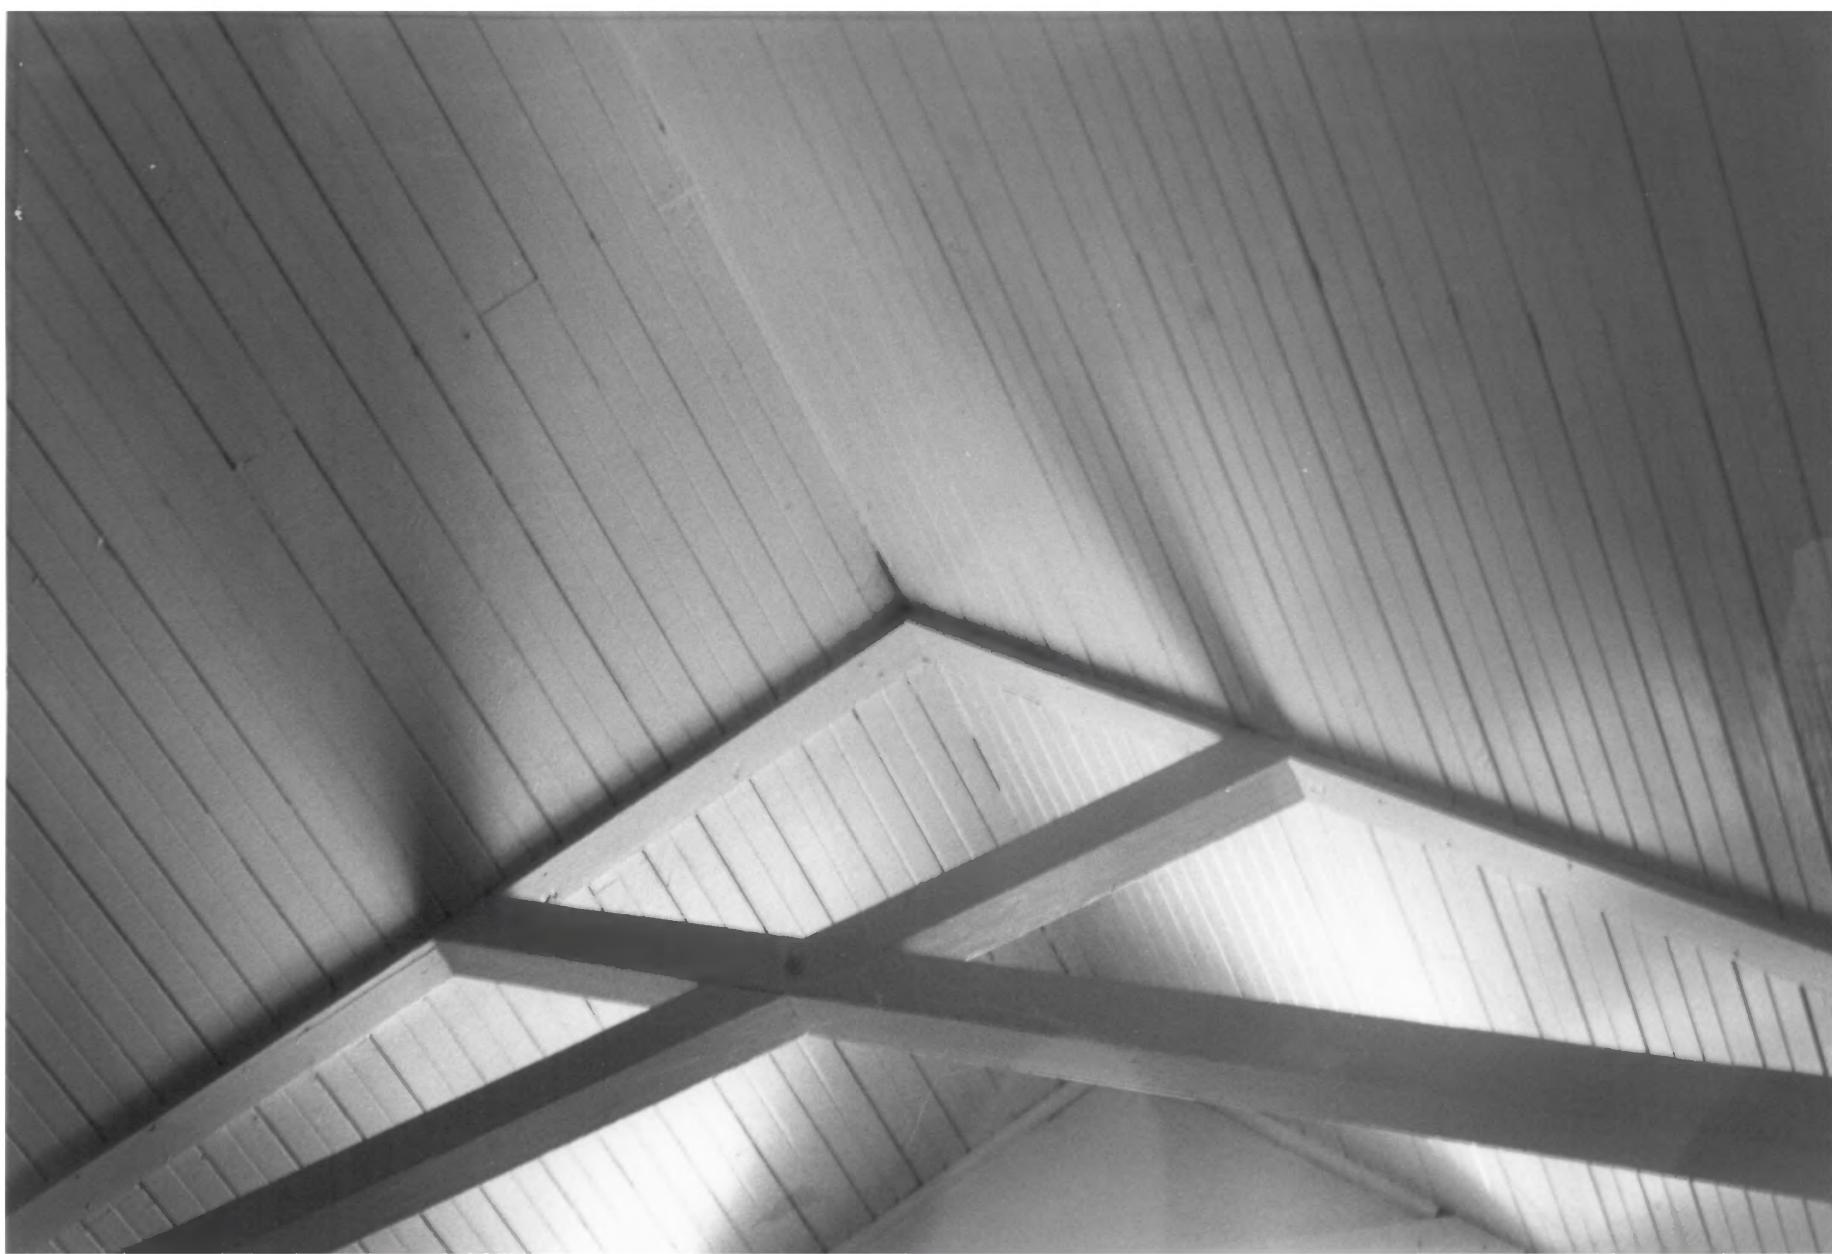
Details of ceiling of living room (part of original house)

Moody (Malcolm A.) House
300 W. 13th St.
The Dalles, Wasco Co., Oregon
9 of 10 - Detail view of one
of the set of scissors
trusses in original main
block of house AUG 13 1980

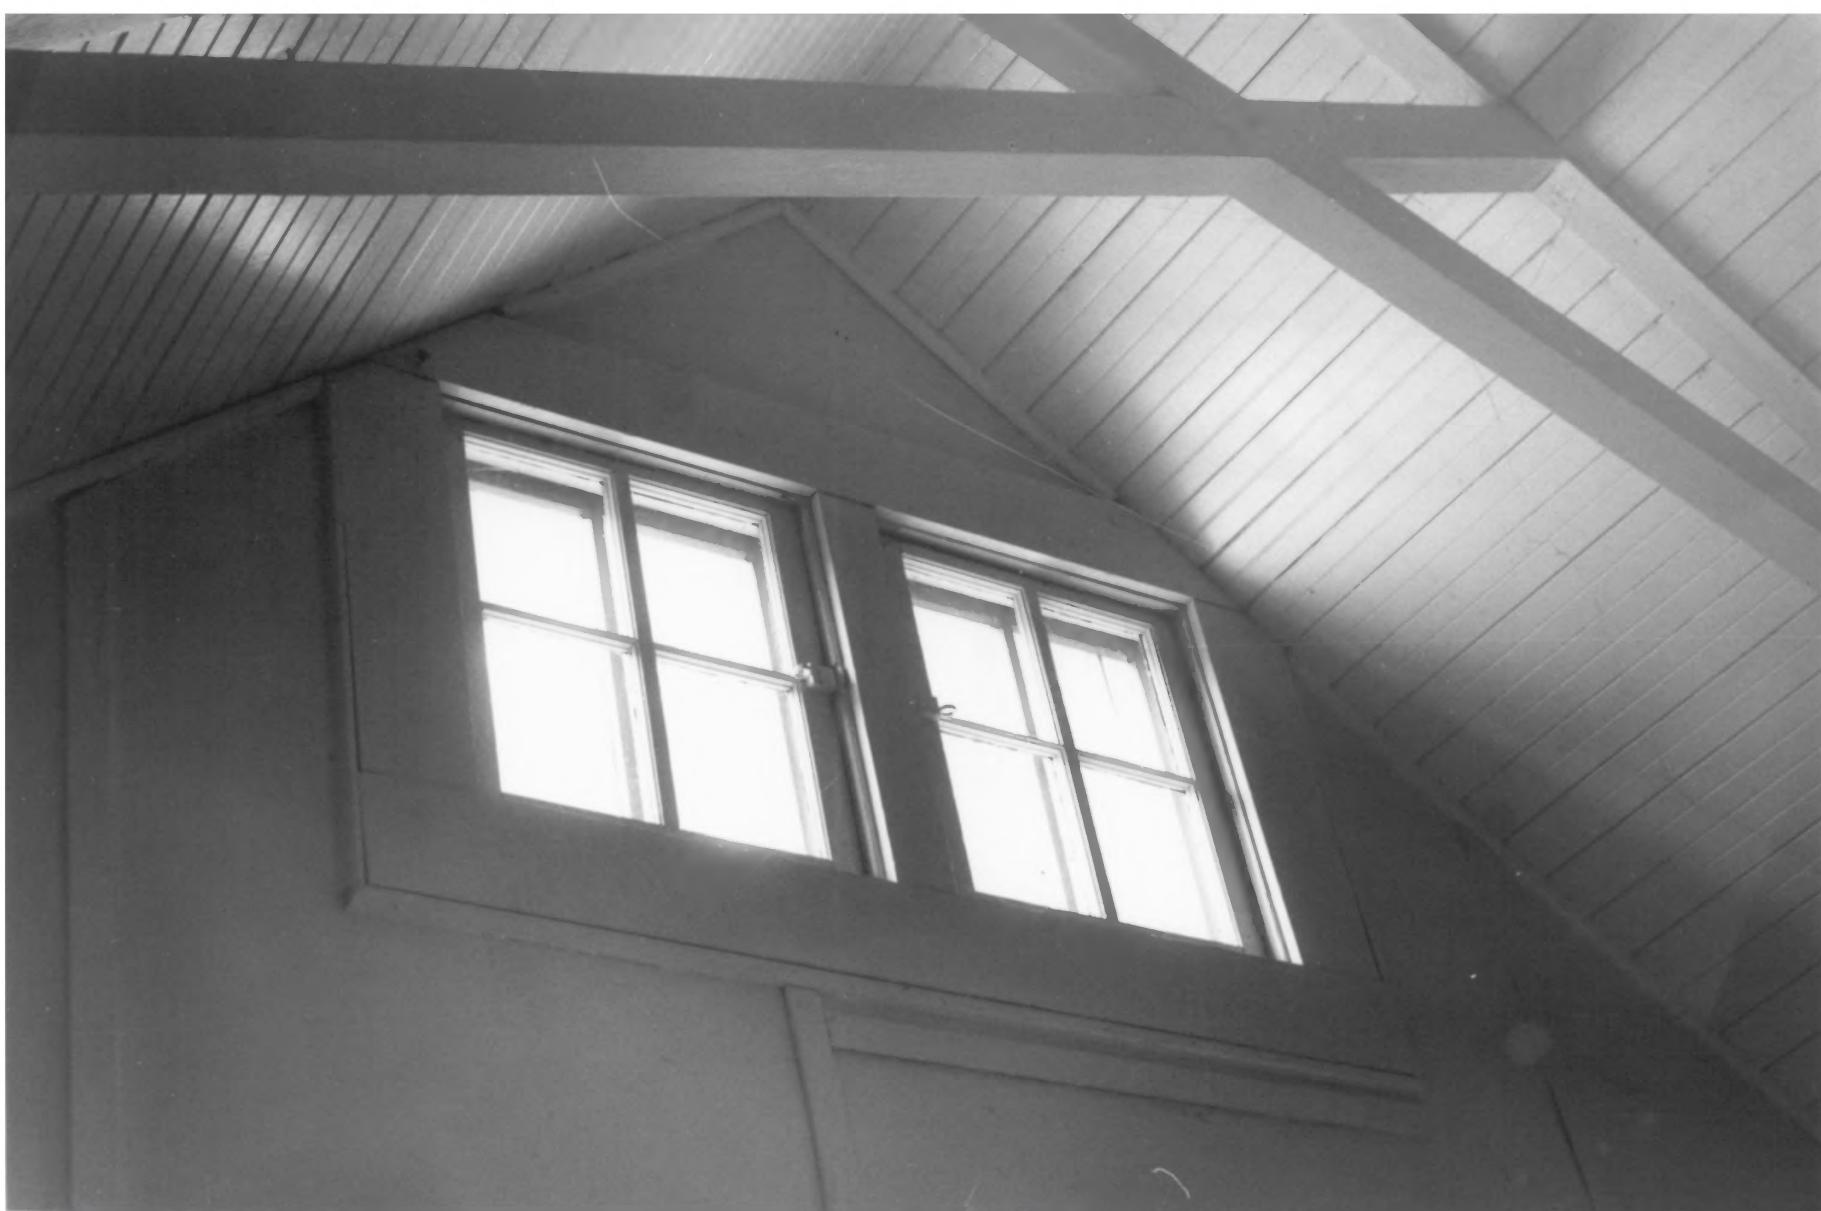
Windows in west end of living room

— 10 of 10 - Detail view of
— windows in the west end wall
of main block.
