NATIONAL REGISTER OF HISTORIC PLACES
REGISTRATION FORM

Historic Name: East Markham Street Historic District

Street & Number: 301-303, 305-307, 313, & 323 East Markham Street

City/Town: Little Rock

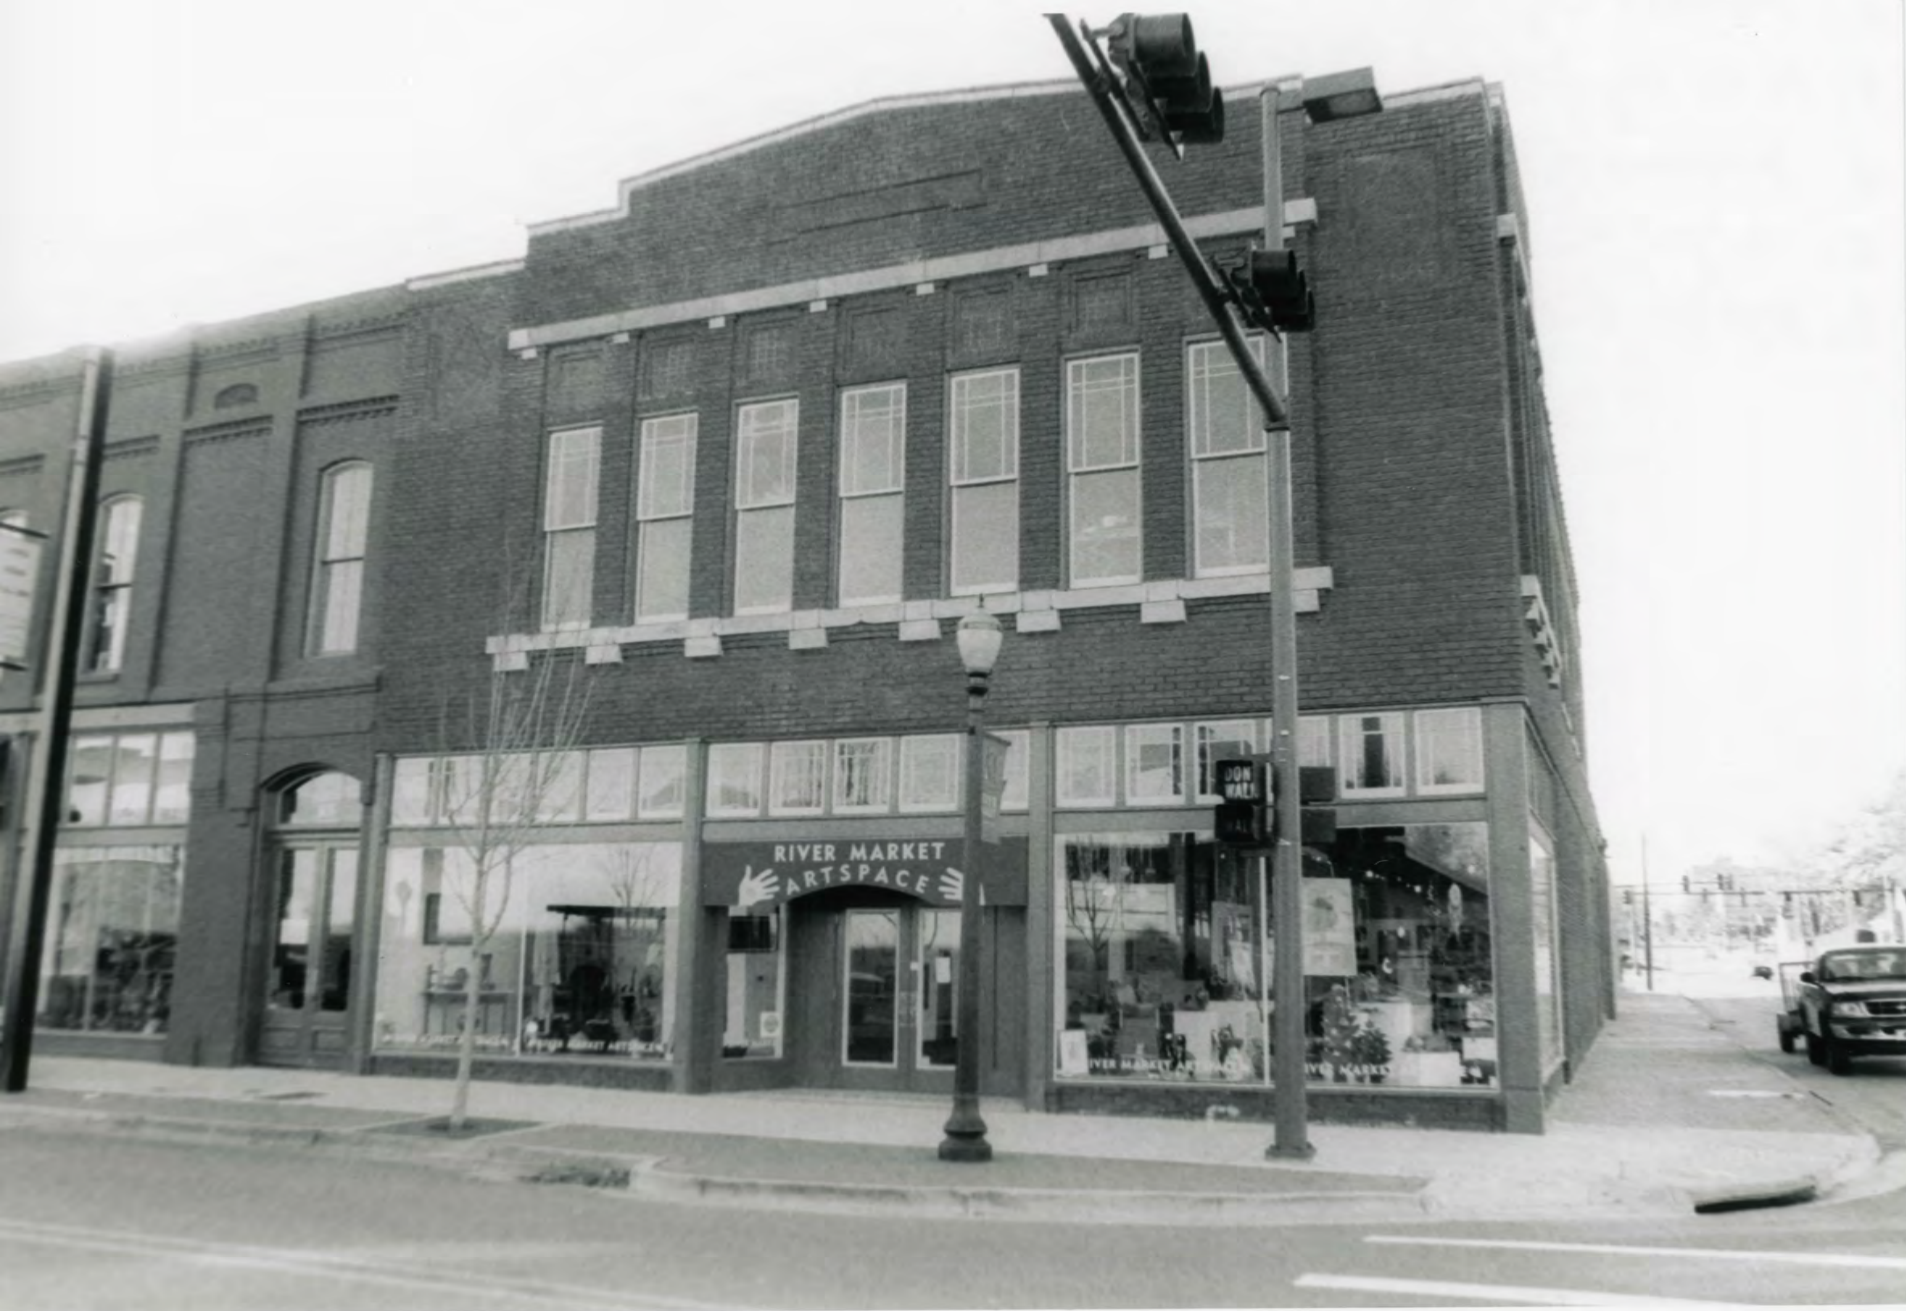
1. East Markham Street Historic District
2. Pulaski Co. AR
3. Photo By Sandra Taylor Smith
4. December, 1998
5. negative on file AHPP
6. 301-303 E. Markham; view from north

The front facade (north) is symmetrically arranged. At first floor level, large glass storefront windows flank recessed double entry doors. Each panel of the storefront windows is composed of two pieces of plate glass, subdivided by a thin copper mullion. The remainder of the frame is wood. A pair of wooden, single-light doors is situated in the recessed entry between two brick columns. Small plate glass windows angle out on the sidewalls of the recess.

A band of wood sash transoms above the entry and storefront windows spans the width of the front (north) of this building. Each transom features the same decorative Craftsman pattern of wood mullions. Several of these transoms are operable, hinged at the bottom and opening inward, with restraining chains still in place.

Seven double-hung one-over-one sash windows are symmetrically located on the second story of the front of 301-303 East Markham. The upper sash of the windows features the same Craftsman mullion pattern as seen on the first floor transoms.

A recessed brick panel is located above each of the second story windows. Above and below the window assembly are horizontal bands of limestone with evenly spaced ornamental blocks. A brick parapet with concrete banding steps up and rises to a shallow point in the center.

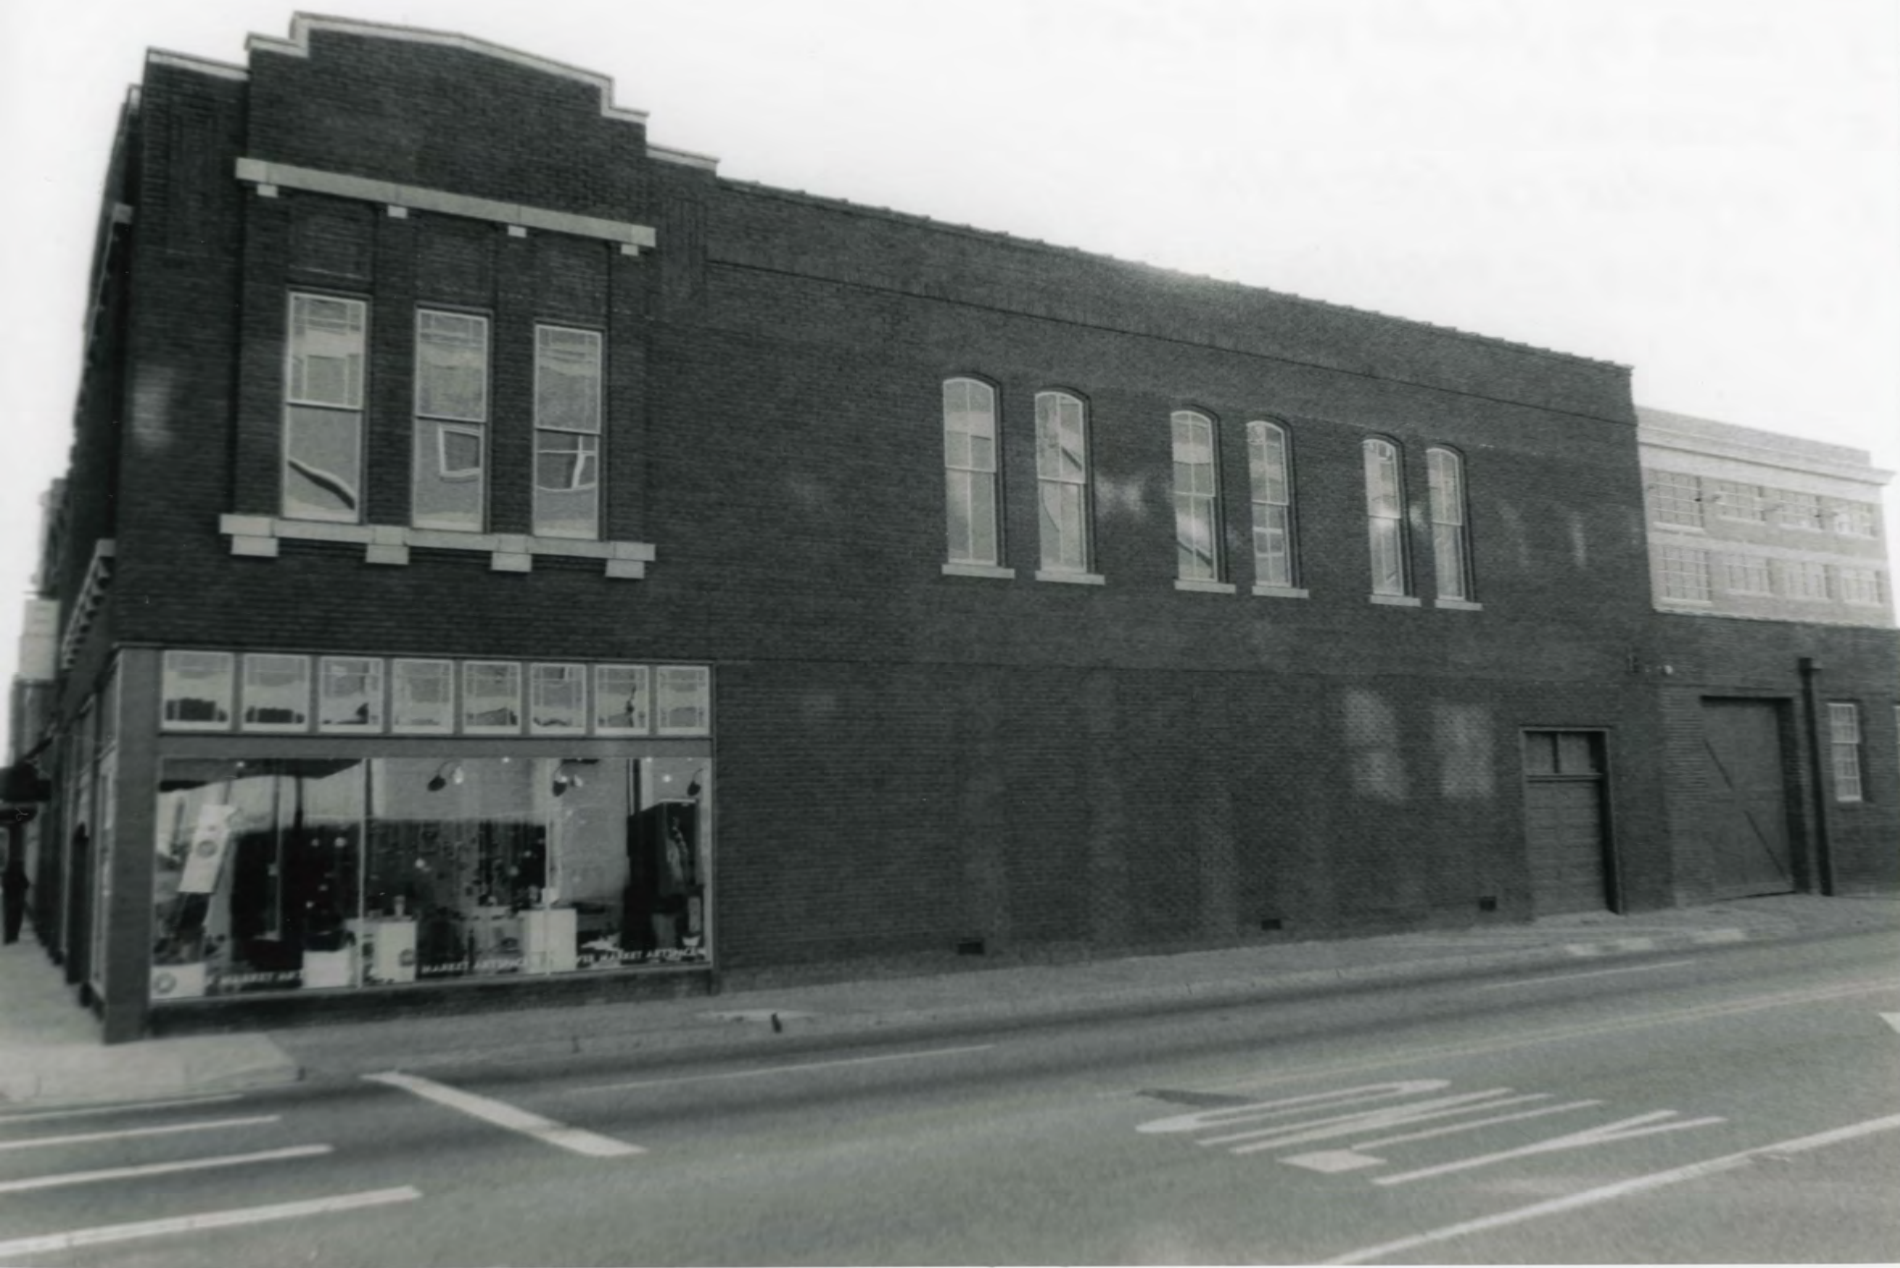
1. EAST MARKHAM STREET Historic District
2. Pulaski Cty. AR
3. Photo By Sandra Taylor Smith
4. December, 1998
5. negative on file AHPP
6. 301-303 E. MARKHAM; view from the west

The west side of the 301-303 East Markham Street building can be divided into three distinct sections. At the north end there is a first floor storefront window with transoms as seen on the front (north). A set of three double-hung windows like those on the front are located on the second story above the first floor window. The details are the same as on the front, including the pointed parapet at the top of the building. The next segment of the west wall features three sets of paired double-hung windows. These windows have arched tops and two-over-two sashes. According to the 1916 Thompson drawings, these windows were in the original building, but in a different location.

Further south on the west wall, a pair of six-panel doors features a four-light transom over each door. The remainder of the south end of the west wall of the building is denoted by a horizontal brick soldier

course at the roofline, clay tile coping and a brick header course just above the sidewalk. The third section of the west side of 301-303 East Markham is a one-story addition which was built of similar brick and joint detail as used in the 1916 reconstruction. Five eight-over-twelve light double-hung windows and a pair of wooden doors are located on the west wall of the addition. The rear (south) of the building contains a sliding door flanked by double-hung eight-over-twelve light windows.

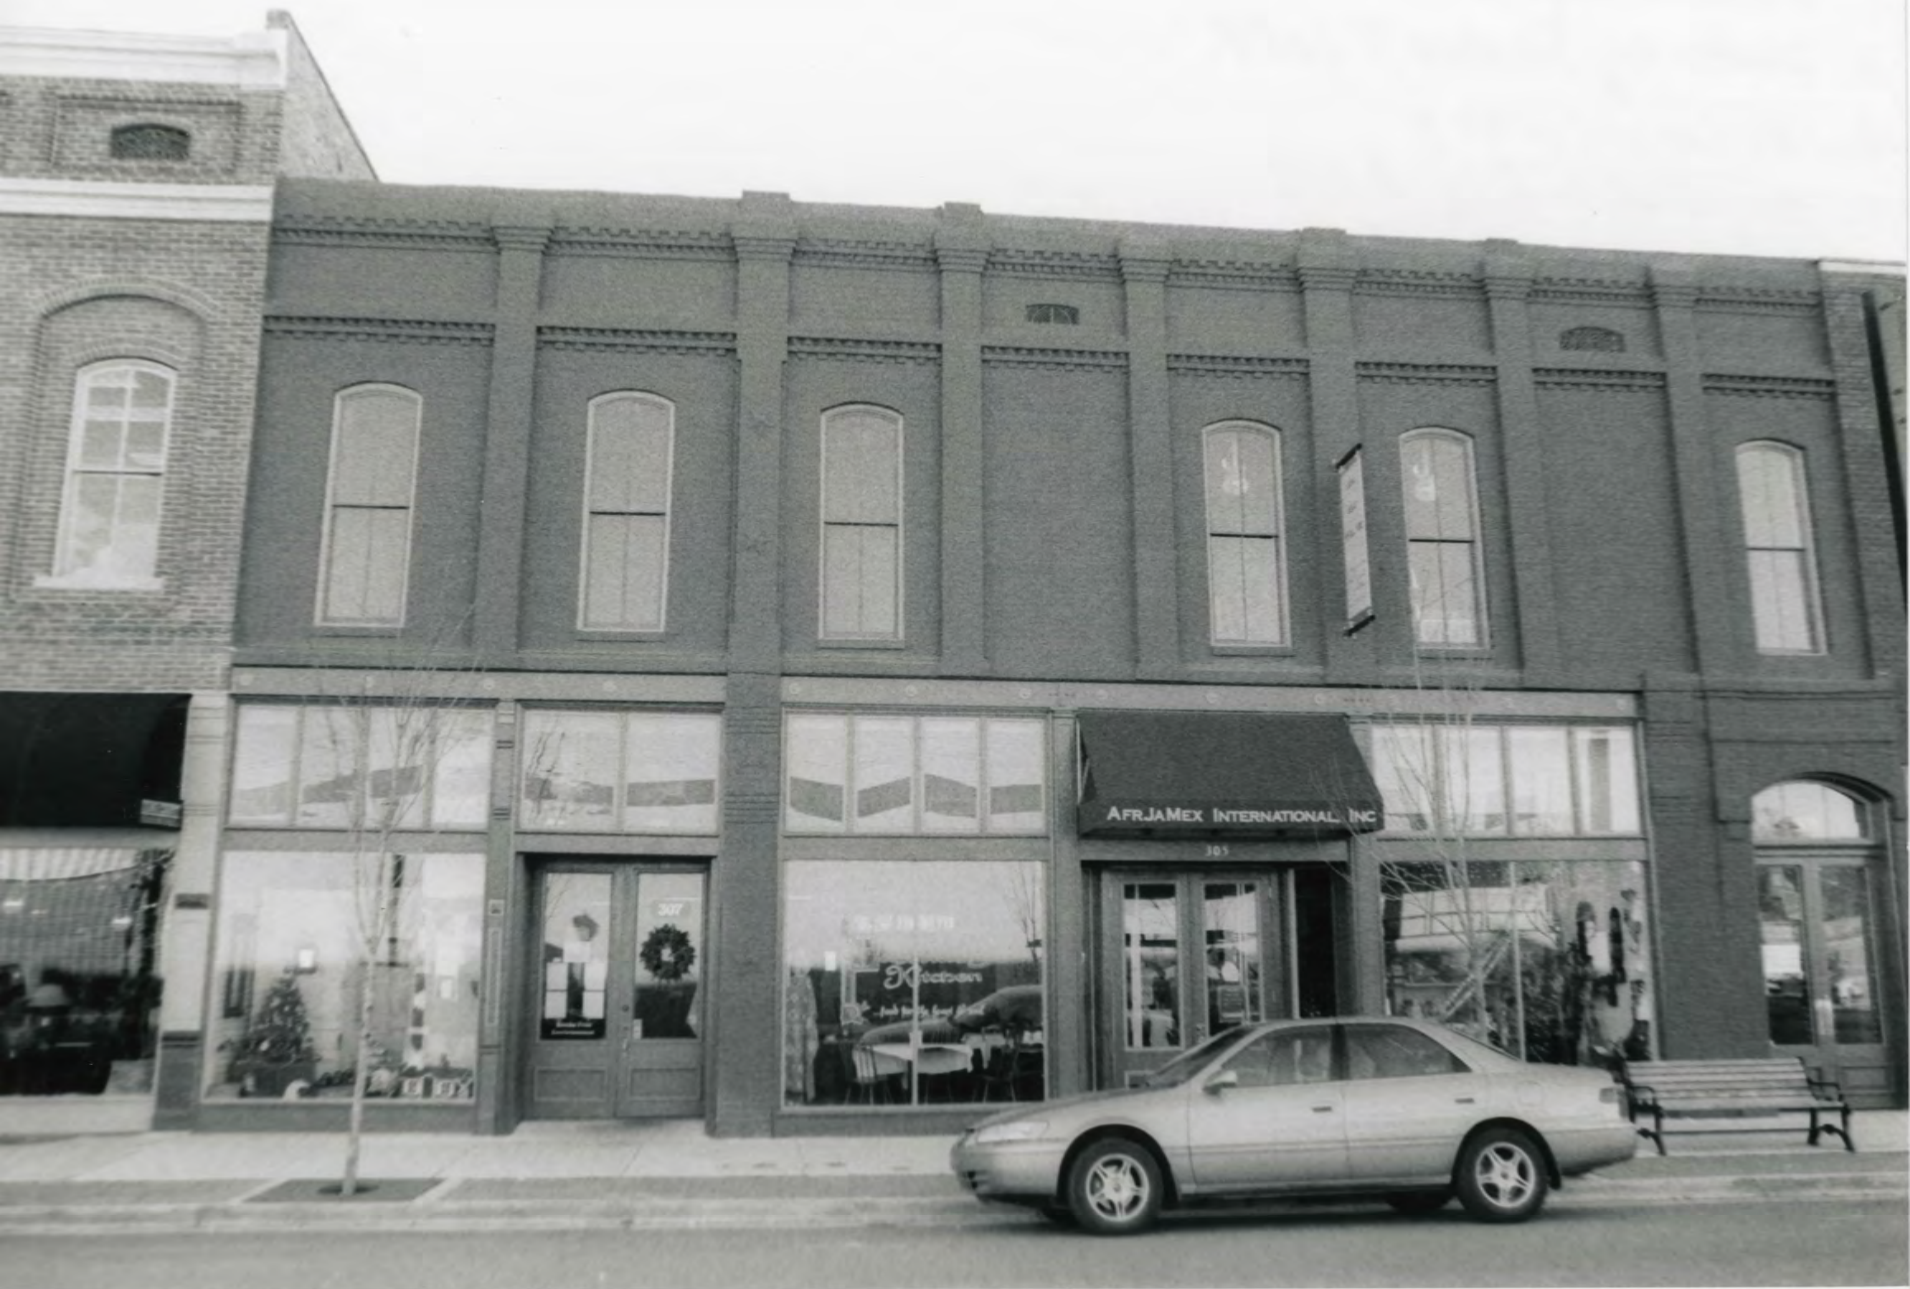
1. EAST Markham Street Historic District
2. Polaski Cty. AR
3. Photo by Sandra T. Smith
4. December, 1998
5. negative on file AHPP
6. 305-307 E. Markham; view from north

The first floor of the front (north) is divided into six bays, separated by either cast iron columns or brick pilasters. One entry is located in the first bay on the west and features a pair of wood doors with glass lights and a round-arched transom. A similar pair of wood doors with glass lights is located in the second bay from the east. The original plate glass window arrangement in the remaining bays features transoms with wood sashes. Four cast-iron pilasters separate these windows. An iron beam runs across the top of the cast-iron columns and features thirteen, evenly spaced rosettes.

The second story of the front of the building is divided into eight bays defined by shallow brick pilasters defining recessed brick panels. The tops of the brick pilasters are corbelled. Six of the eight panels contain double-hung two-over-two light windows. Over the second floor windows is a double band of brick dentils, above which are eight horizontal brick panels. Two of these small panels contain decorative cast iron vents. Another double band of brick dentils is located above these brick panels.

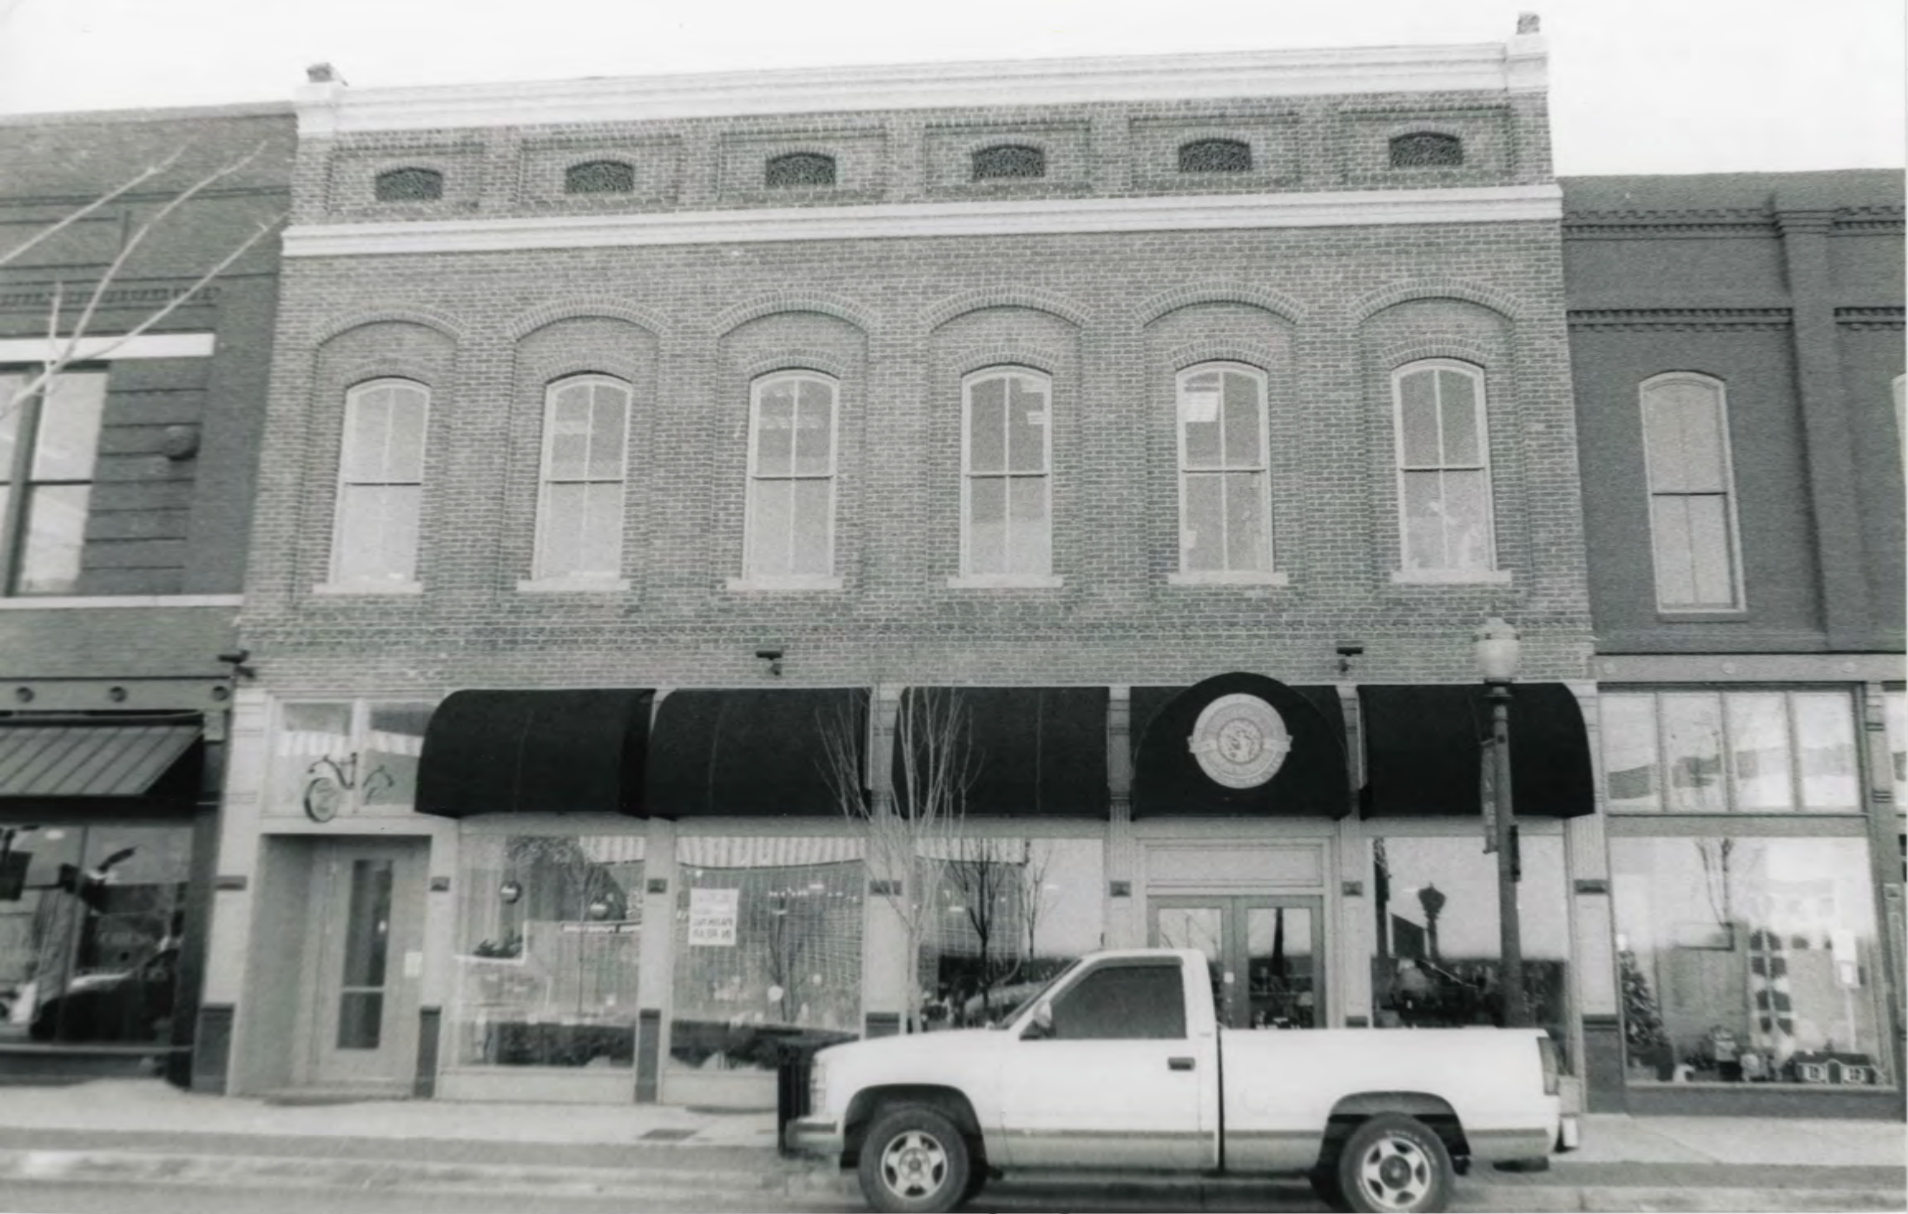
1. EAST MARKHAM Street Historic District
2. Pulaski Cty. AR
3. Photo By Sandra Taylor Smith
4. December, 1998
5. negative on file AHPP
6. 313 E. Markham; view from north

The first floor of the two-story brick building at 313 East Markham is divided into six bays. Narrow cast-iron pilasters separate the bays and slightly wider cast-iron pilasters cover the brick outer corners of the building. The entry is located in the second bay from the west and contains a pair of wood doors with glass lights and is topped by a single horizontal wood-framed glass transom. A transom tops each bay and features a single vertical wood mullion in the center.

Six bays, corresponding to the first floor bays delineate the second story. These bays are round arched at the tops and feature a recessed brick wall containing a double-hung, two-over two light sash window with arched tops and limestone lintels in each bay. A narrow projecting brick band with dentiling spans the width of the building between the first and second story. A double band of limestone runs across the building above the window bays. Above this band are six small horizontal recessed panels containing decorative iron vents. A limestone cornice denotes the top of the flat-roof building.

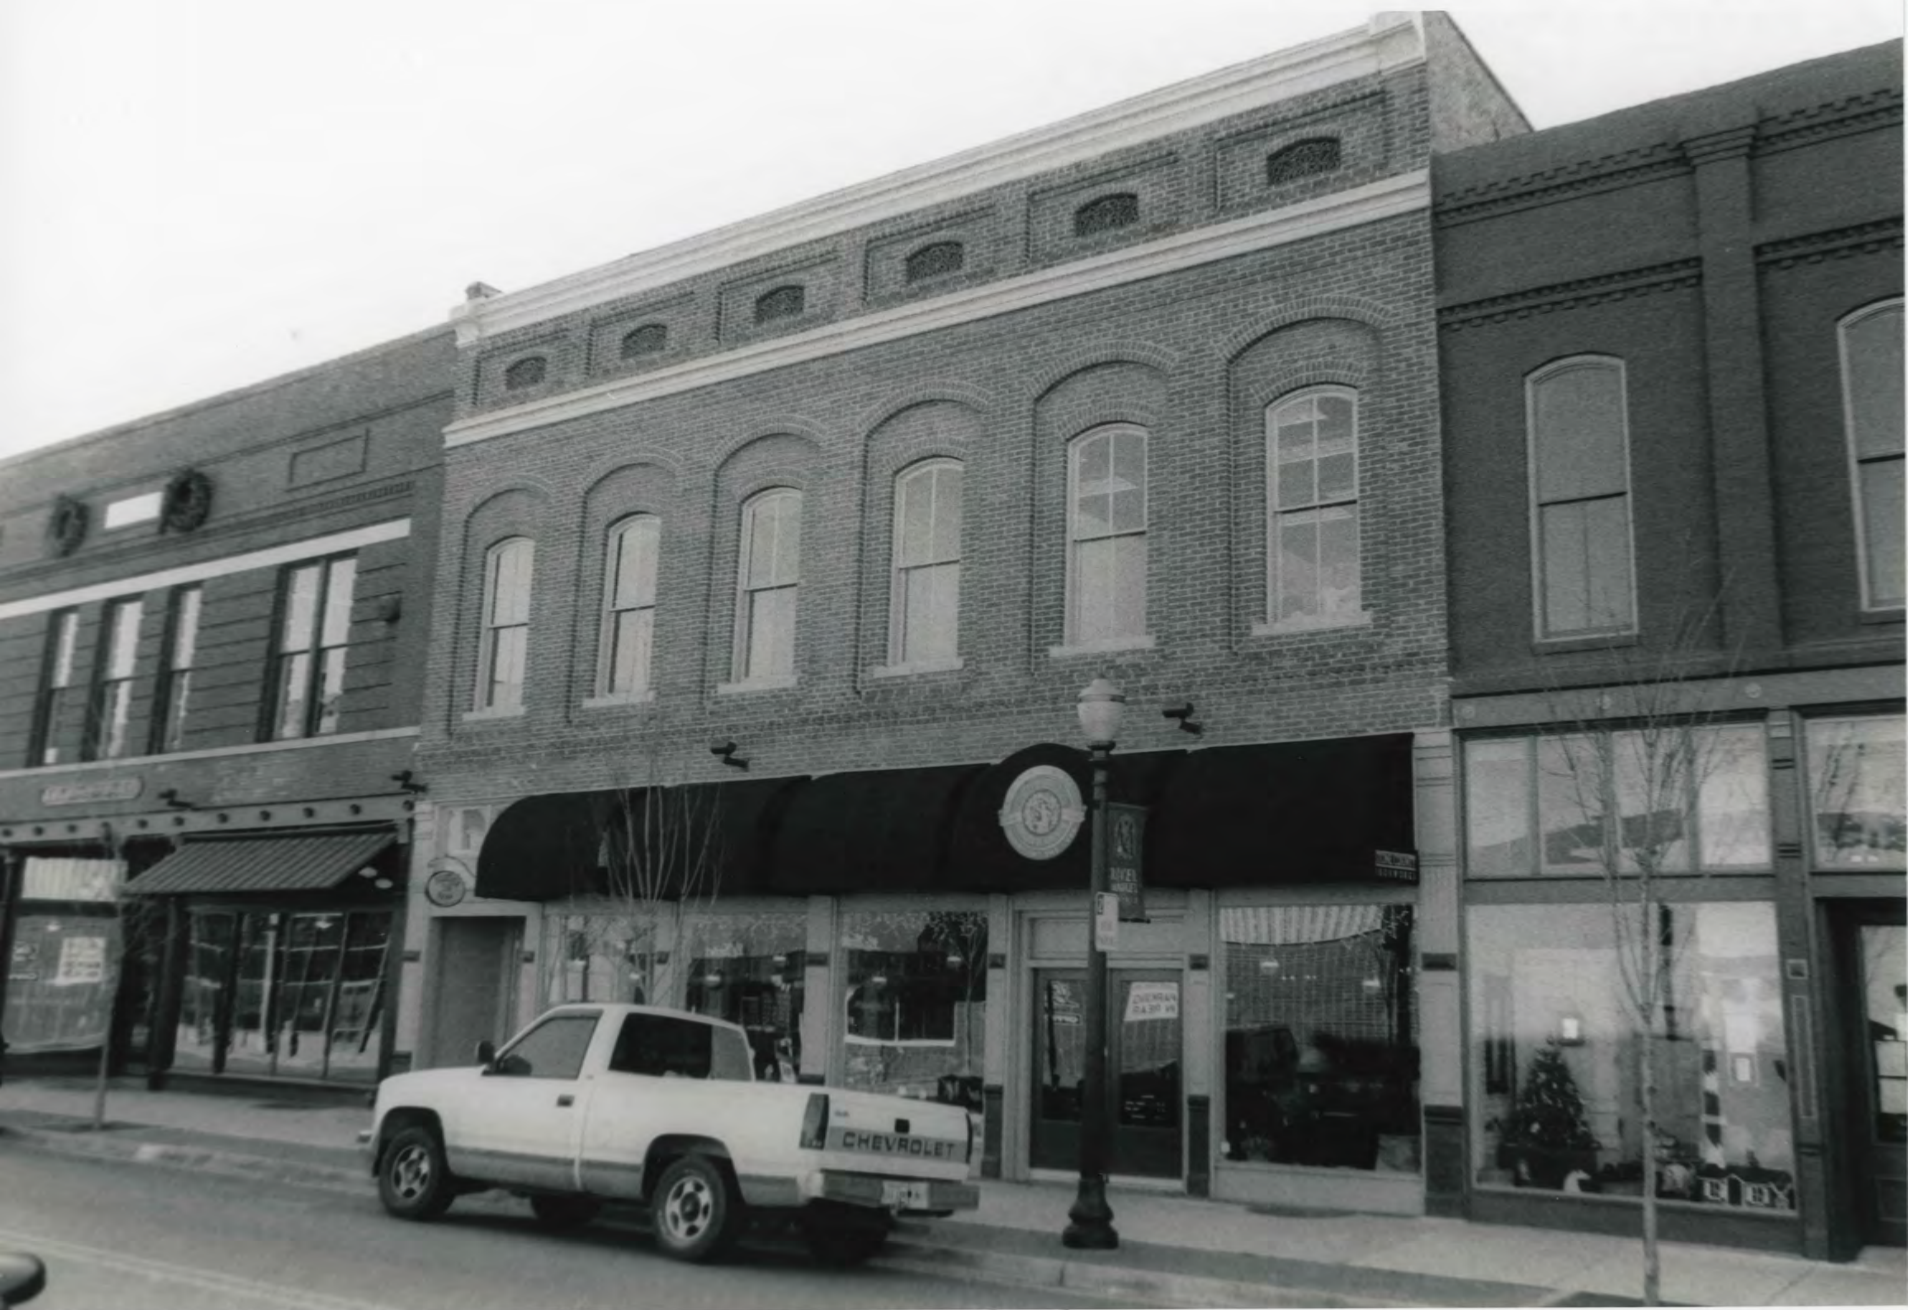
1. EAST Markham Street Historic District
2. Pulaski Cty. AR
3. photo By Sandra Taylor Smith
4. December, 1998
5. negative on FILE AHPP
6. 313 E. Markham; view from north

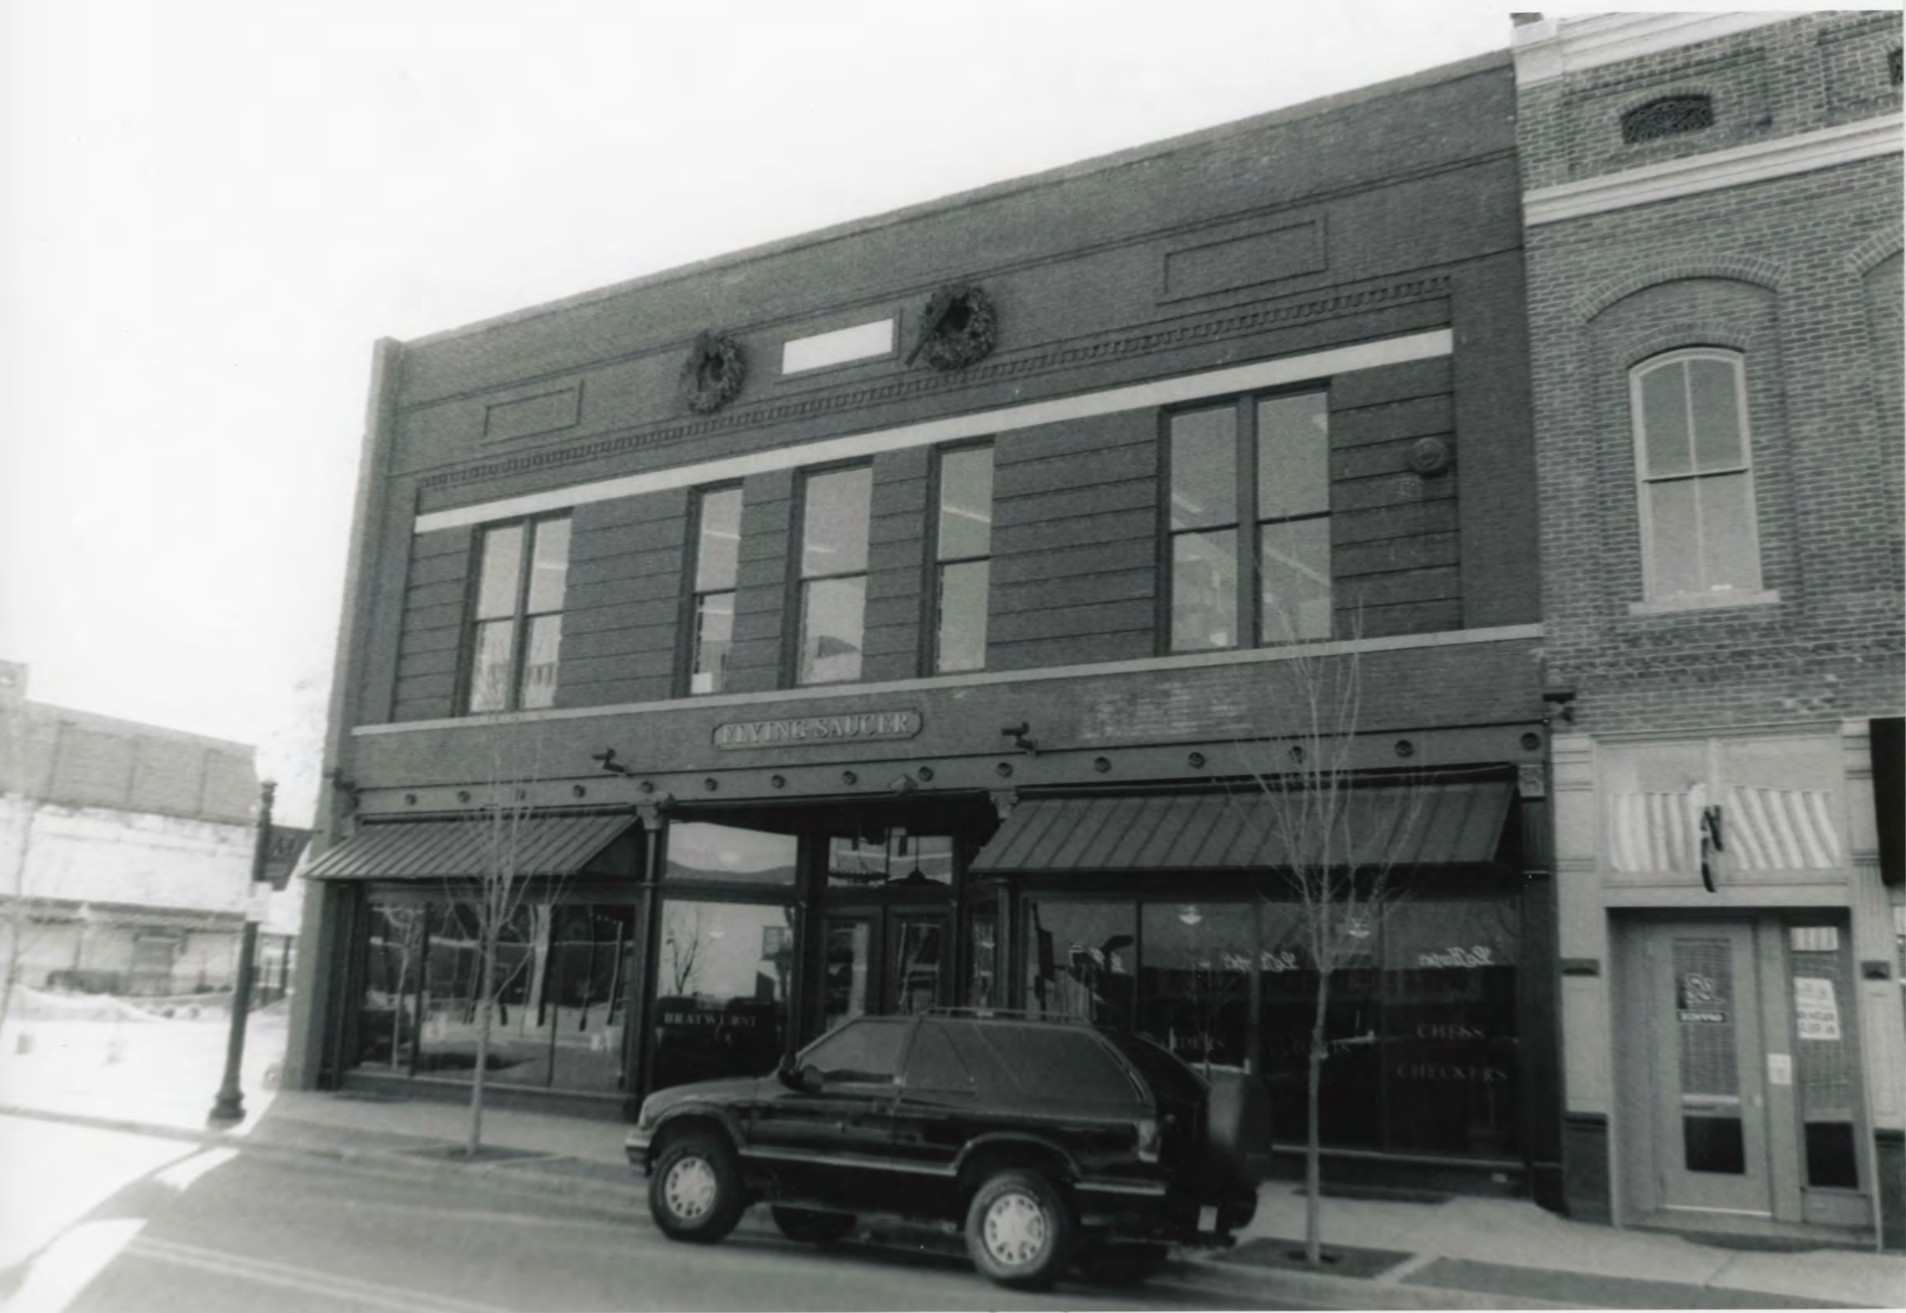
1. EAST MARKHAM STREET Historic District
2. Palaski Ch. AR
3. photo By Sandra Taylor Smith
4. December, 1998
5. negative on file AHDP
6. ROSENBAUM Bldg. - 323 E. Markham; view from north

The building at 323 East Markham was constructed c. 1880 and was remodeled for the C.E. Rosenbaum Machinery Co. in 1905. Architect Charles L. Thompson designed the 1905 remodeling of the building and original drawings show that the date originally planned to go on the front of the building was 1904. The building features a centered recessed entry with double wood doors with glass lights. Angled to each side of the doors are plate glass windows. Decorative cast-iron columns are located on the corners of the entry bay and on the outer corners of the building. An iron beam runs across the windows above first floor transoms.

Three evenly spaced double-hung one-over-one windows on the second story are centered above the first floor entry bay. This group of windows is flanked by pairs of similar double-hung windows, which are centered over the two first floor plate glass windows. The second story windows are set into a panel denoted by horizontal bands of brick which is underlined by a narrow limestone band.

A narrow row of brick dentils tops the second story window panel. Three brick-banded horizontal nameplates are located above the band of dentils. The center plate reads "C.E. Rosenbaum 1905" and is flanked by decorative round brick-banded vents. A brick band spans the width of the building at the cornice line. The brick parapet on the building features limestone coping.

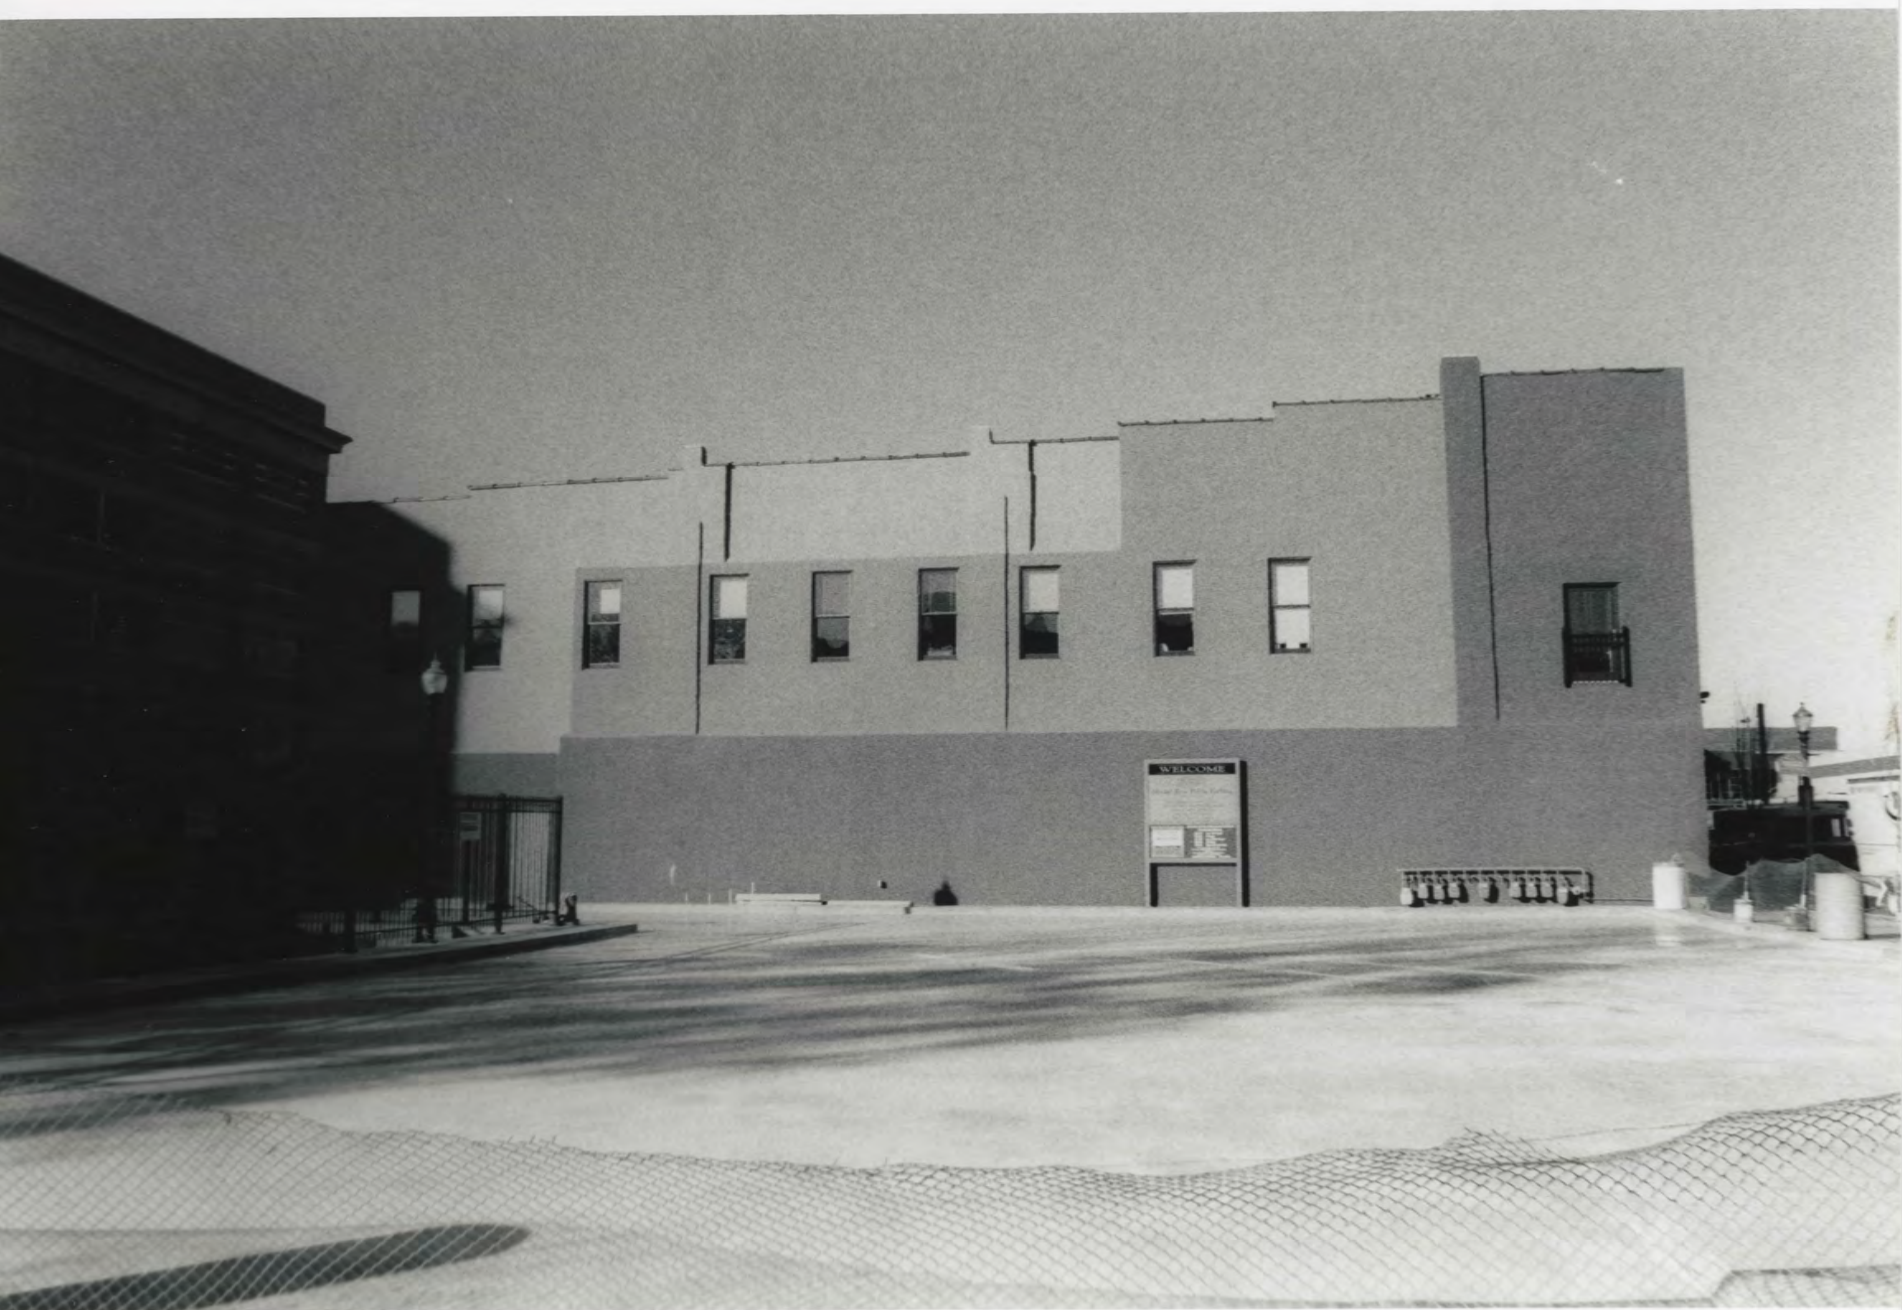
1. EAST MARKHAM STREET Historic District
2. Pulaski Cty. AR
3. Photo By Sandra Taylor Smith
4. December, 1998
5. negative on file AHPP
6. 323 E. Markham; View from the east

The buildings to the east in the block have been demolished, leaving the solid eastern wall of the Rosenbaum Building visible. From front (north) to back (south) the roof of the Rosenbaum Building slightly steps down. Parapet edges on the east side of the building are tile.
