National Register of Historic Places Registration Form

Historic name U.S. Inspection Station—Trout River, New York
Other names/site number Trout River Inspection Station; Trout River Border Station

*U.S. Inspection Station— Trout River
Franklin County, New York*

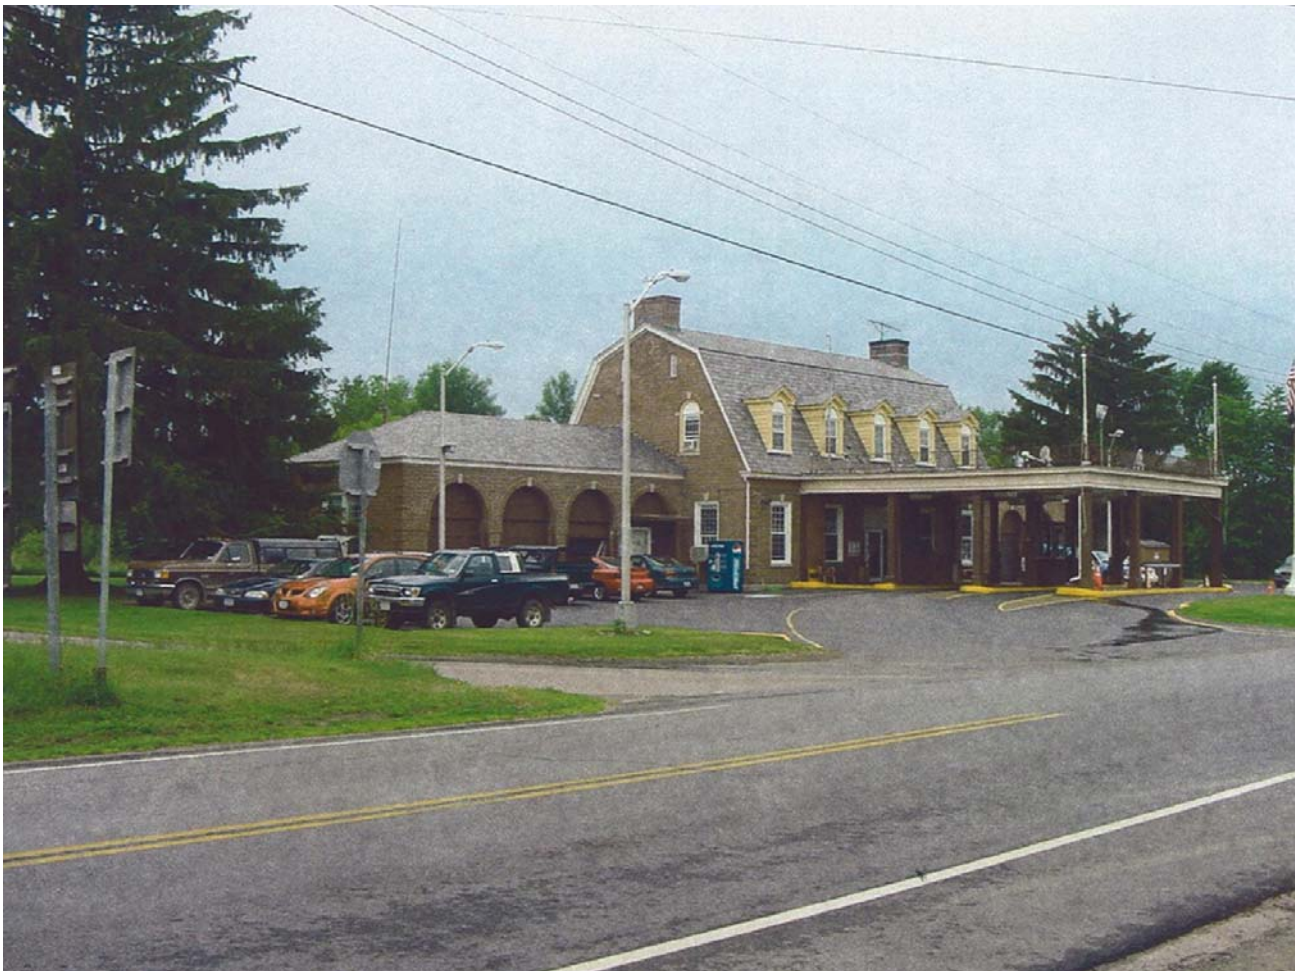
Photo number: NY_FranklinCounty_Trout RiverBorderStation1.tiff

Description of view: Front and side elevation, view: northwest

The Trout River Inspection Station is a rectangular plan, woodframe, 2-story inspection station designed in a Georgian inspired Colonial Revival design system. The 2-story center block (primary building) is side gabled with a gambrel roof, and on either side of the primary building is a one-story, 4-bay, hipped roof garage wing. Both wings and the primary building are clad in English bond brickwork and have roofs covered with green and purple slate tiles. A flat roofed porte-cochere that covers three bays is affixed to the front elevation of the inspection station. The front elevation of the inspection station faces northeast, and the total building program runs axially from northwest to southeast.

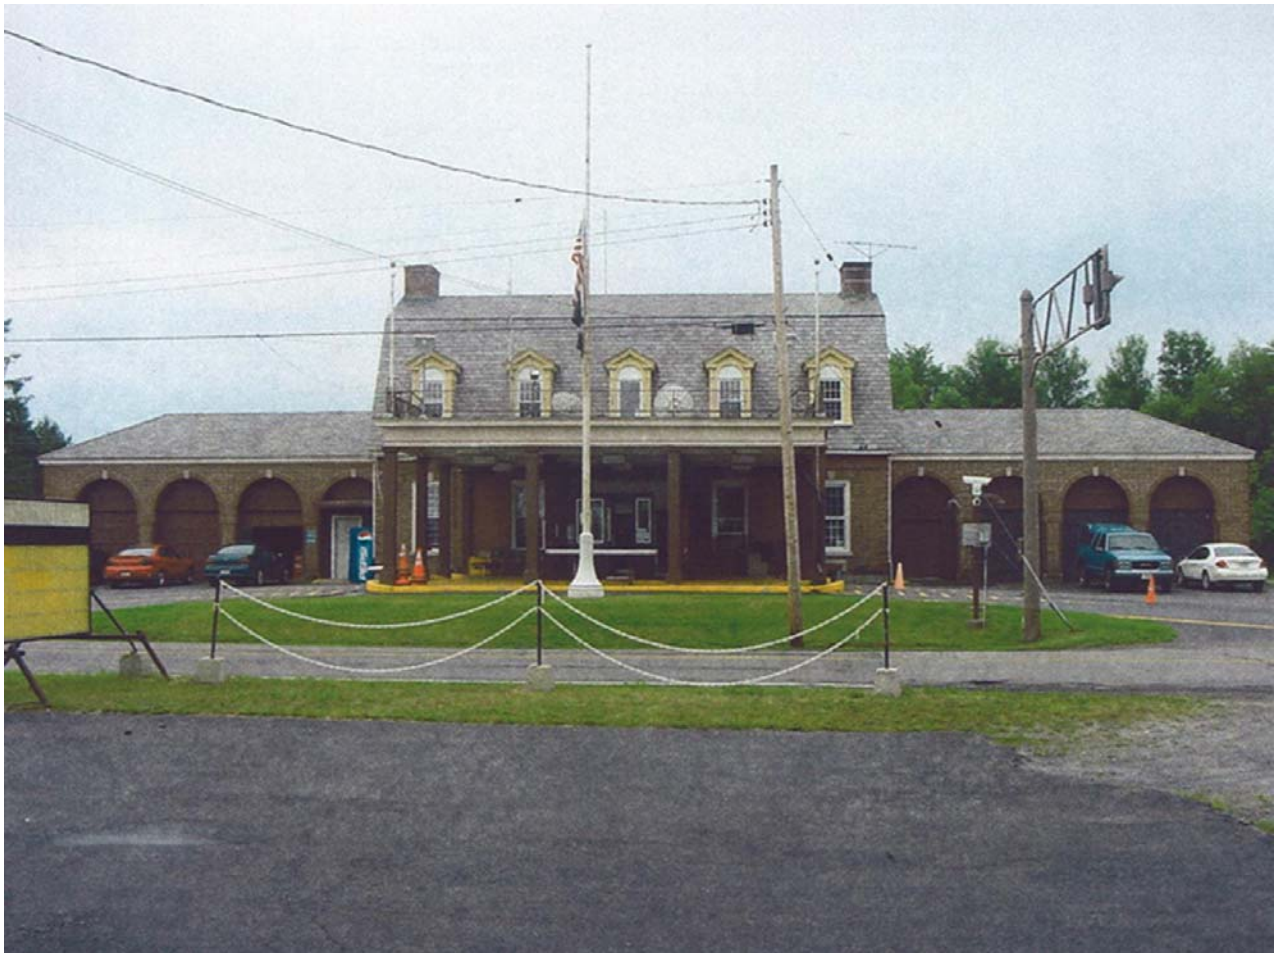
Photo number: NY_FranklinCounty_Trout RiverBorderStation2.tiff

Description of view: Front elevation, view: southwest

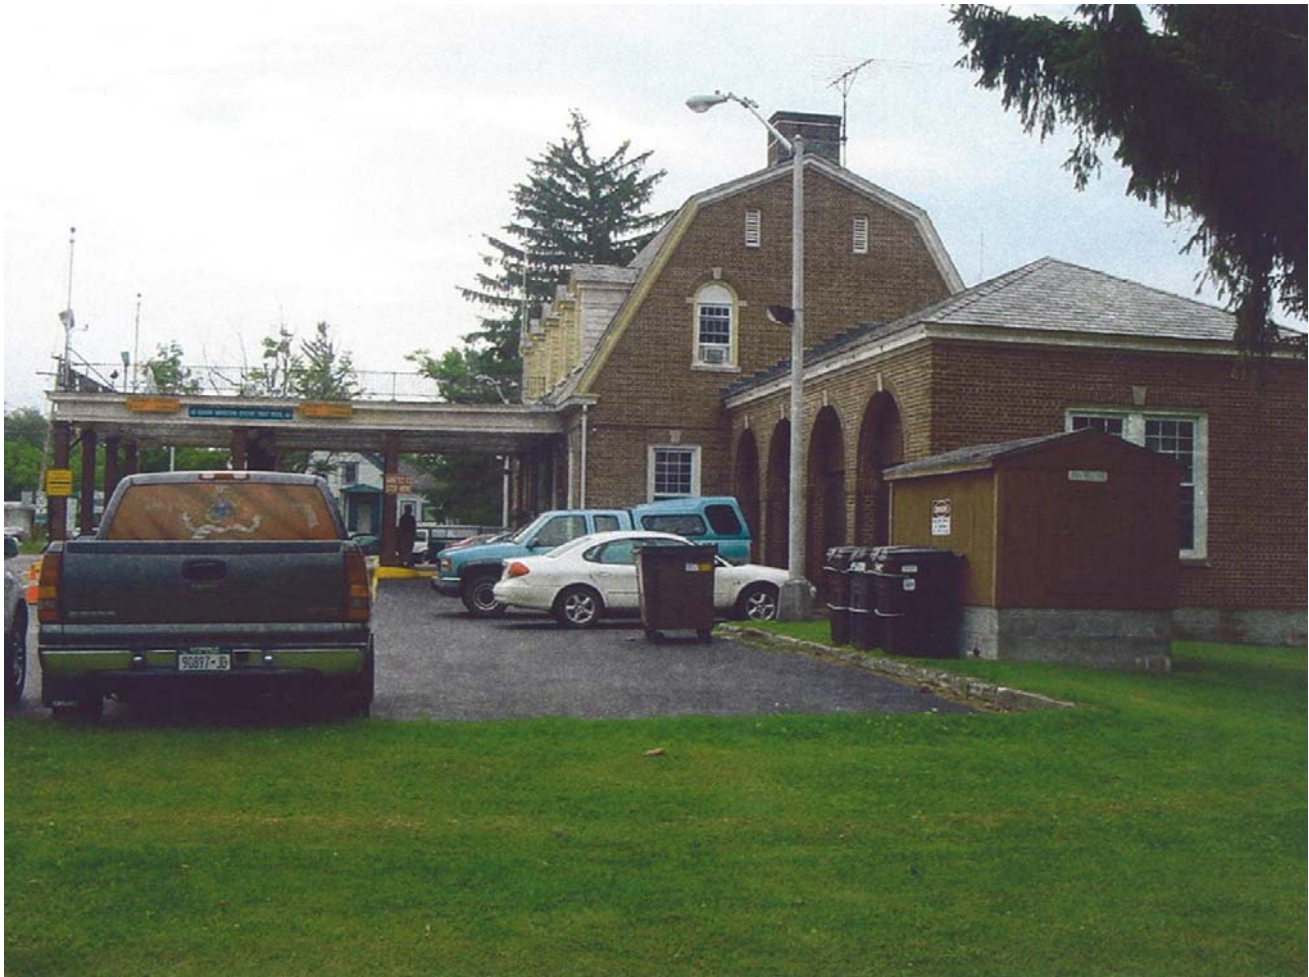
Photo number: NY_FranklinCounty_Trout RiverBorderStation3.tiff

Description of view: Side elevation, view: southeast

The front portion of each lower level side elevation features a woodframe multi-glazed double hung window. The rear portions of the Inspection Station's lower level side elevations are connected to the garage wings. Stepped copper flashing is present above where the roof of the garage wing meets the side elevation. In the upper front portion of the primary building's side elevations is an 8/8 woodframe double hung window topped by a latticed pattern lunette window head identical to those found in the dormers. The lunette portion is circumscribed in a soldier course voussoir with a marble keystone centered above it and smaller marble blocks at either spring end. Beneath the gable peak at each side elevation of the primary building are thin, vertical attic vents, each underscored with brick sills and crowned with flat arch work. Ogee style cornice molding underscores the gambrel roofline at each gable end. Below this are molded cornice returns that continue from the front and rear elevation molding.

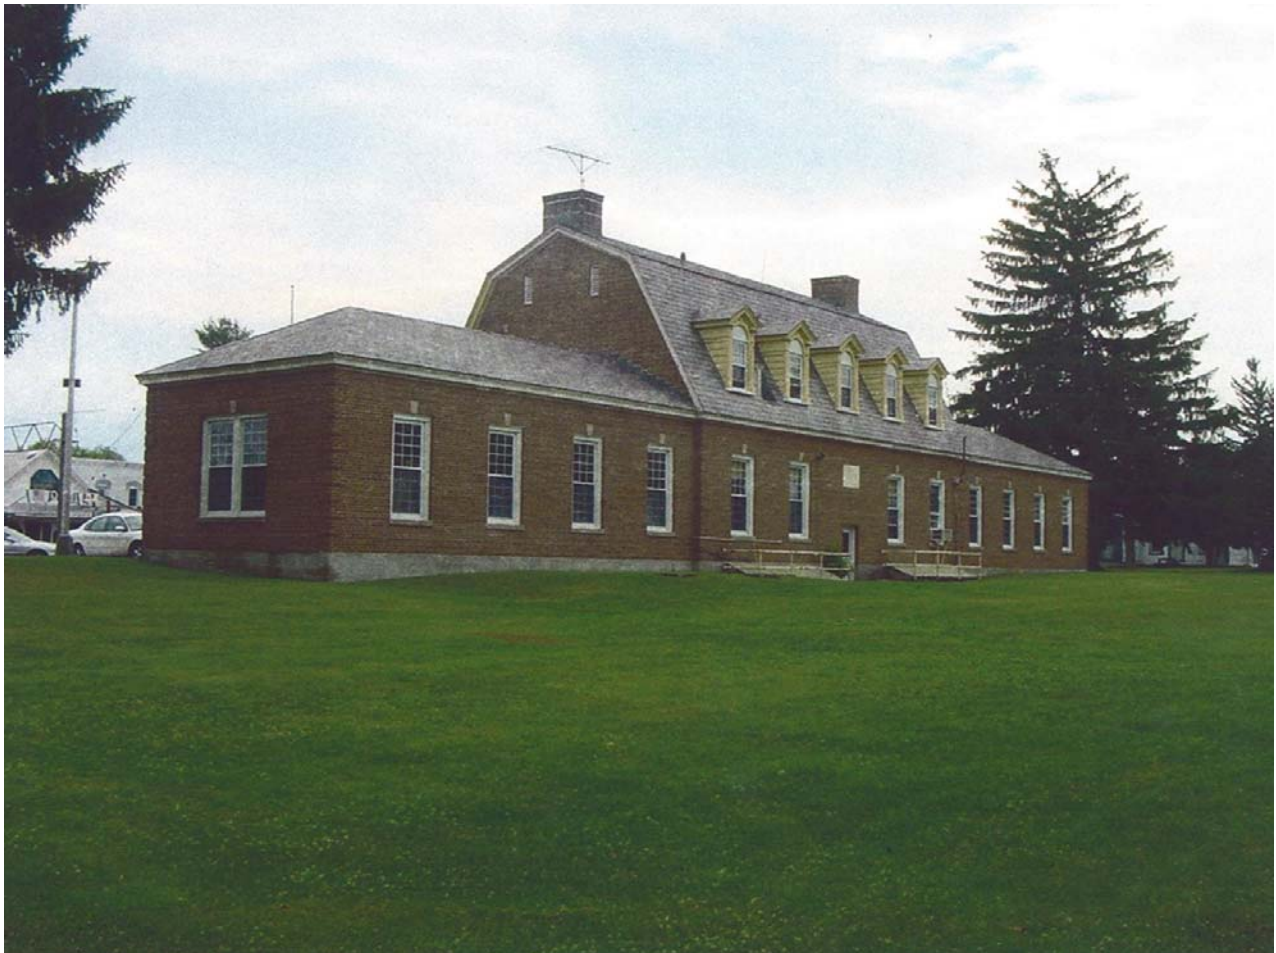
Photo number: NY_FranklinCounty_Trout RiverBorderStation4.tiff

Description of view: Rear elevation, view: southeast

The rear elevation of the Trout River Inspection Station primary building is five bays wide. A low, concrete watertable/foundation underscores the rear elevation of the primary building and the garage wings. The center bay of the rear elevation features a square marble slab about 2'x2' situated flush with the upper ranking of the adjacent window bays. In the two bays at either side of the center are 12/12 woodframe double hung windows accentuated in a manner similar to those at the front elevation. A centered basement entry is present at the rear elevation, and features a wood door with single unit upper panel glazing. Pipe railing runs parallel to the building at either side and above this entry. Basement access covers are also present on the ground at either side of the rear entry. The rear elevation roof contains five dormers of an identical design to those described atop the front elevation. A small dormer with a 1/1 window is present between the two northernmost front gabled dormers at the rear elevation.

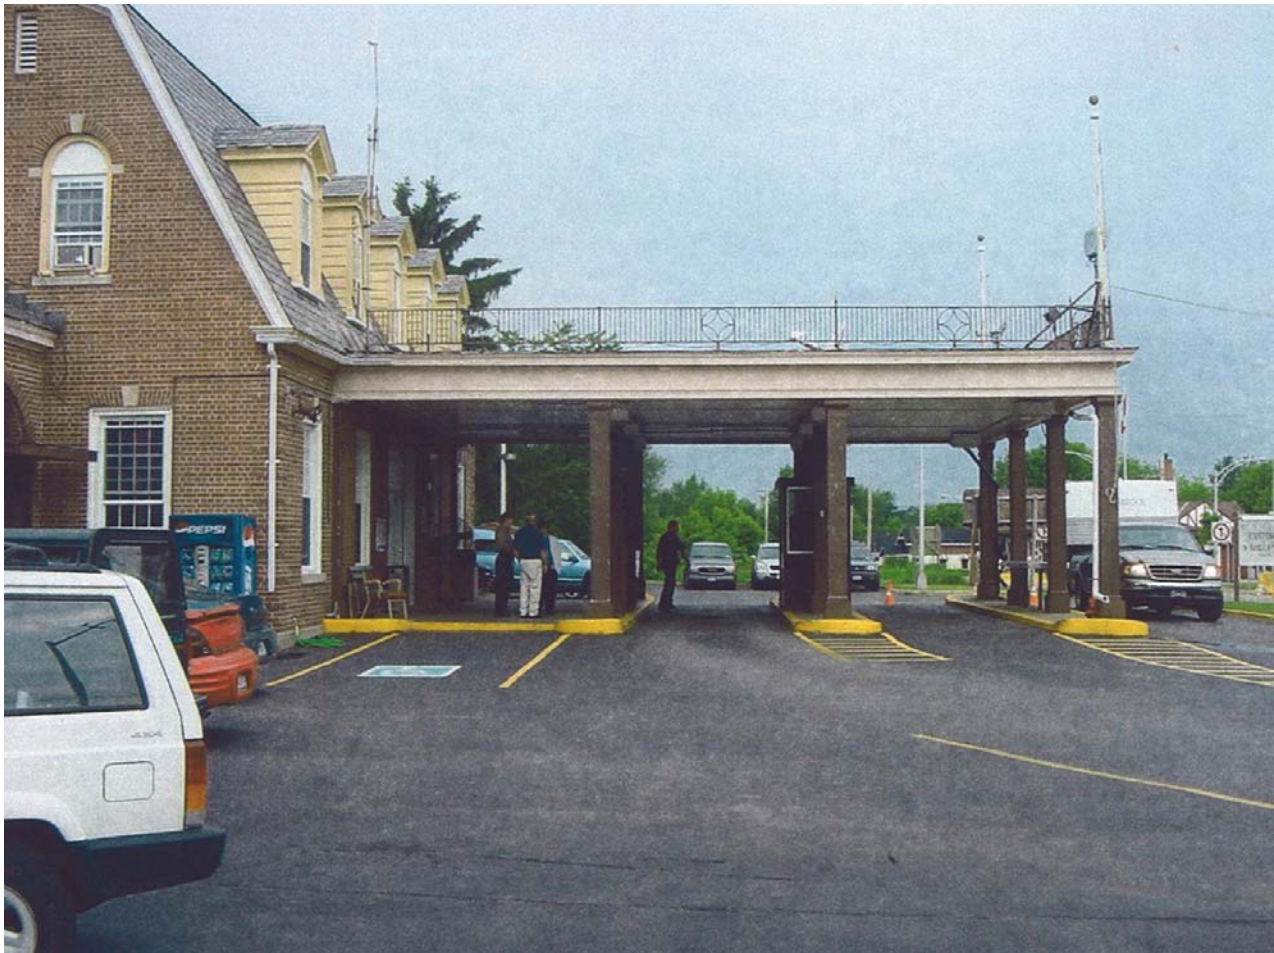
Photo number: NY_FranklinCounty_Trout RiverBorderStation5.tiff

Description of view: Port-cochere, view: north

Affixed to the front elevation of the Trout River Inspection Station is a flat roofed porte-cochere supported by sixteen square shaped columns and covering three bays. The columns and the porte-cochere roof are painted gold-yellow. Each of the columns features a square shaped capital. All of the columns rest on elevated concrete islands with rounded curbing. The four columns closest to the front elevation are engaged. Oversized cornice ogee cornice molding and a running fascia underscore the roof of the porte-cochere. Running atop the edge of the roof is a metal balustrade with a repeating concave diamond-in-circle motif. A short flag pole topped by a balloon finial is present at

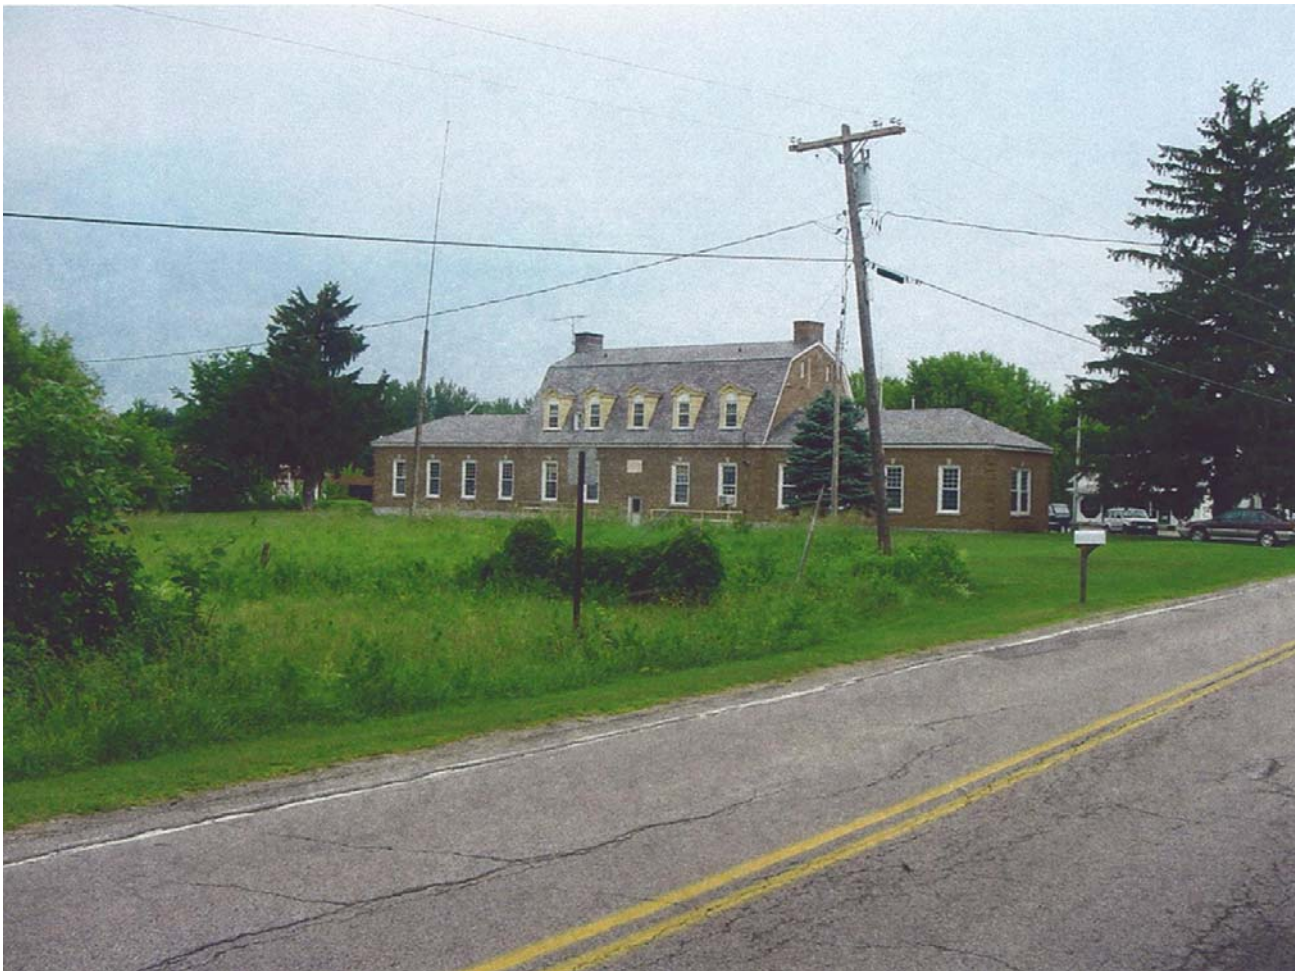
Photo number: NY_FranklinCounty_Trout RiverBorderStation6.tiff

Description of view: Rear yard and rear elevation, view: northeast

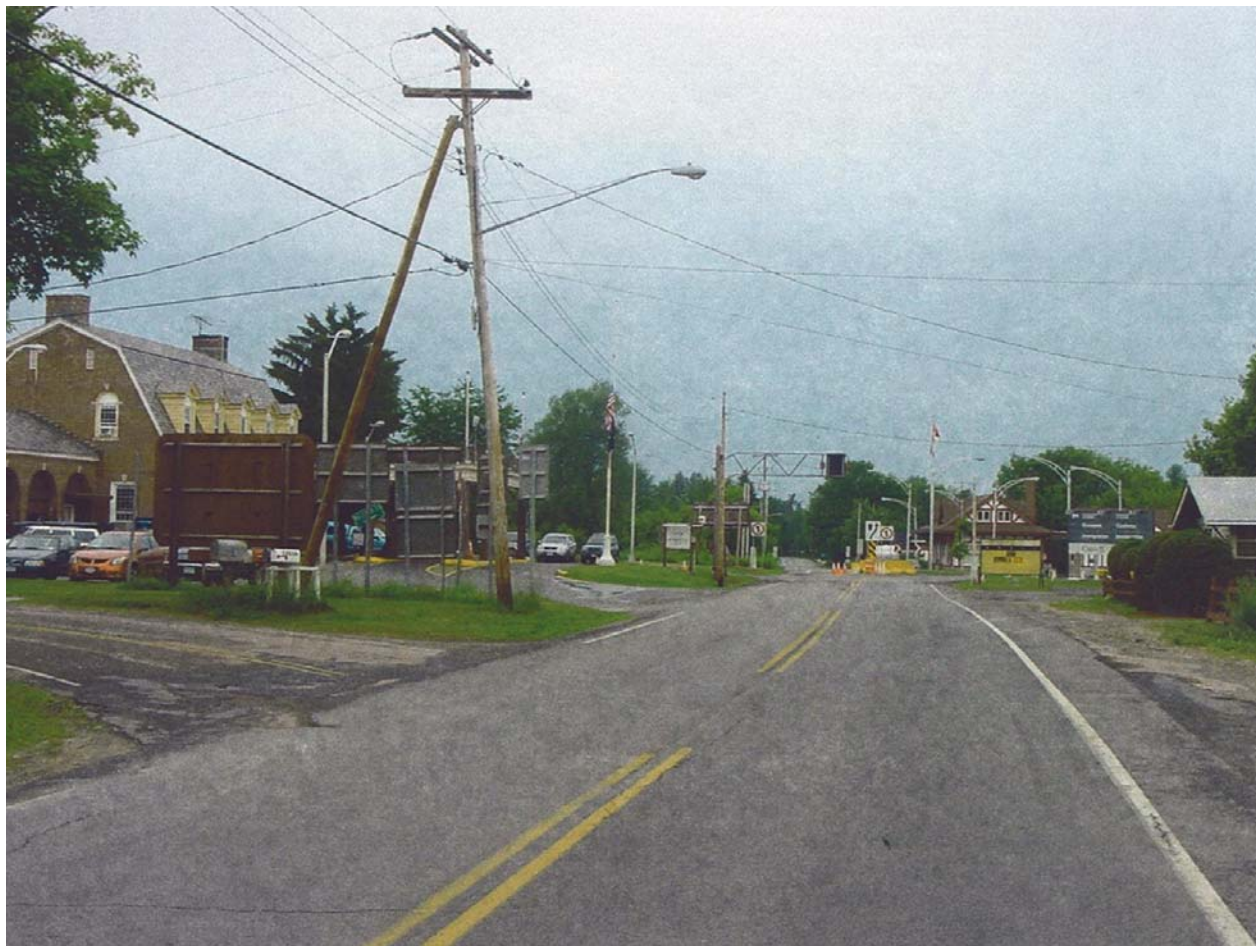
Photo number: NY_FranklinCounty_Trout RiverBorderStation7.tiff

Description of view: From State Highway 30 toward Canada, view: northwest
