National Register of Historic Places Registration Form

historic name Christian Kupke Farmstead

other names/site number The Farm at Long Lane / Ne HRSI #CC00-365

Cass County, Nebraska
County and State

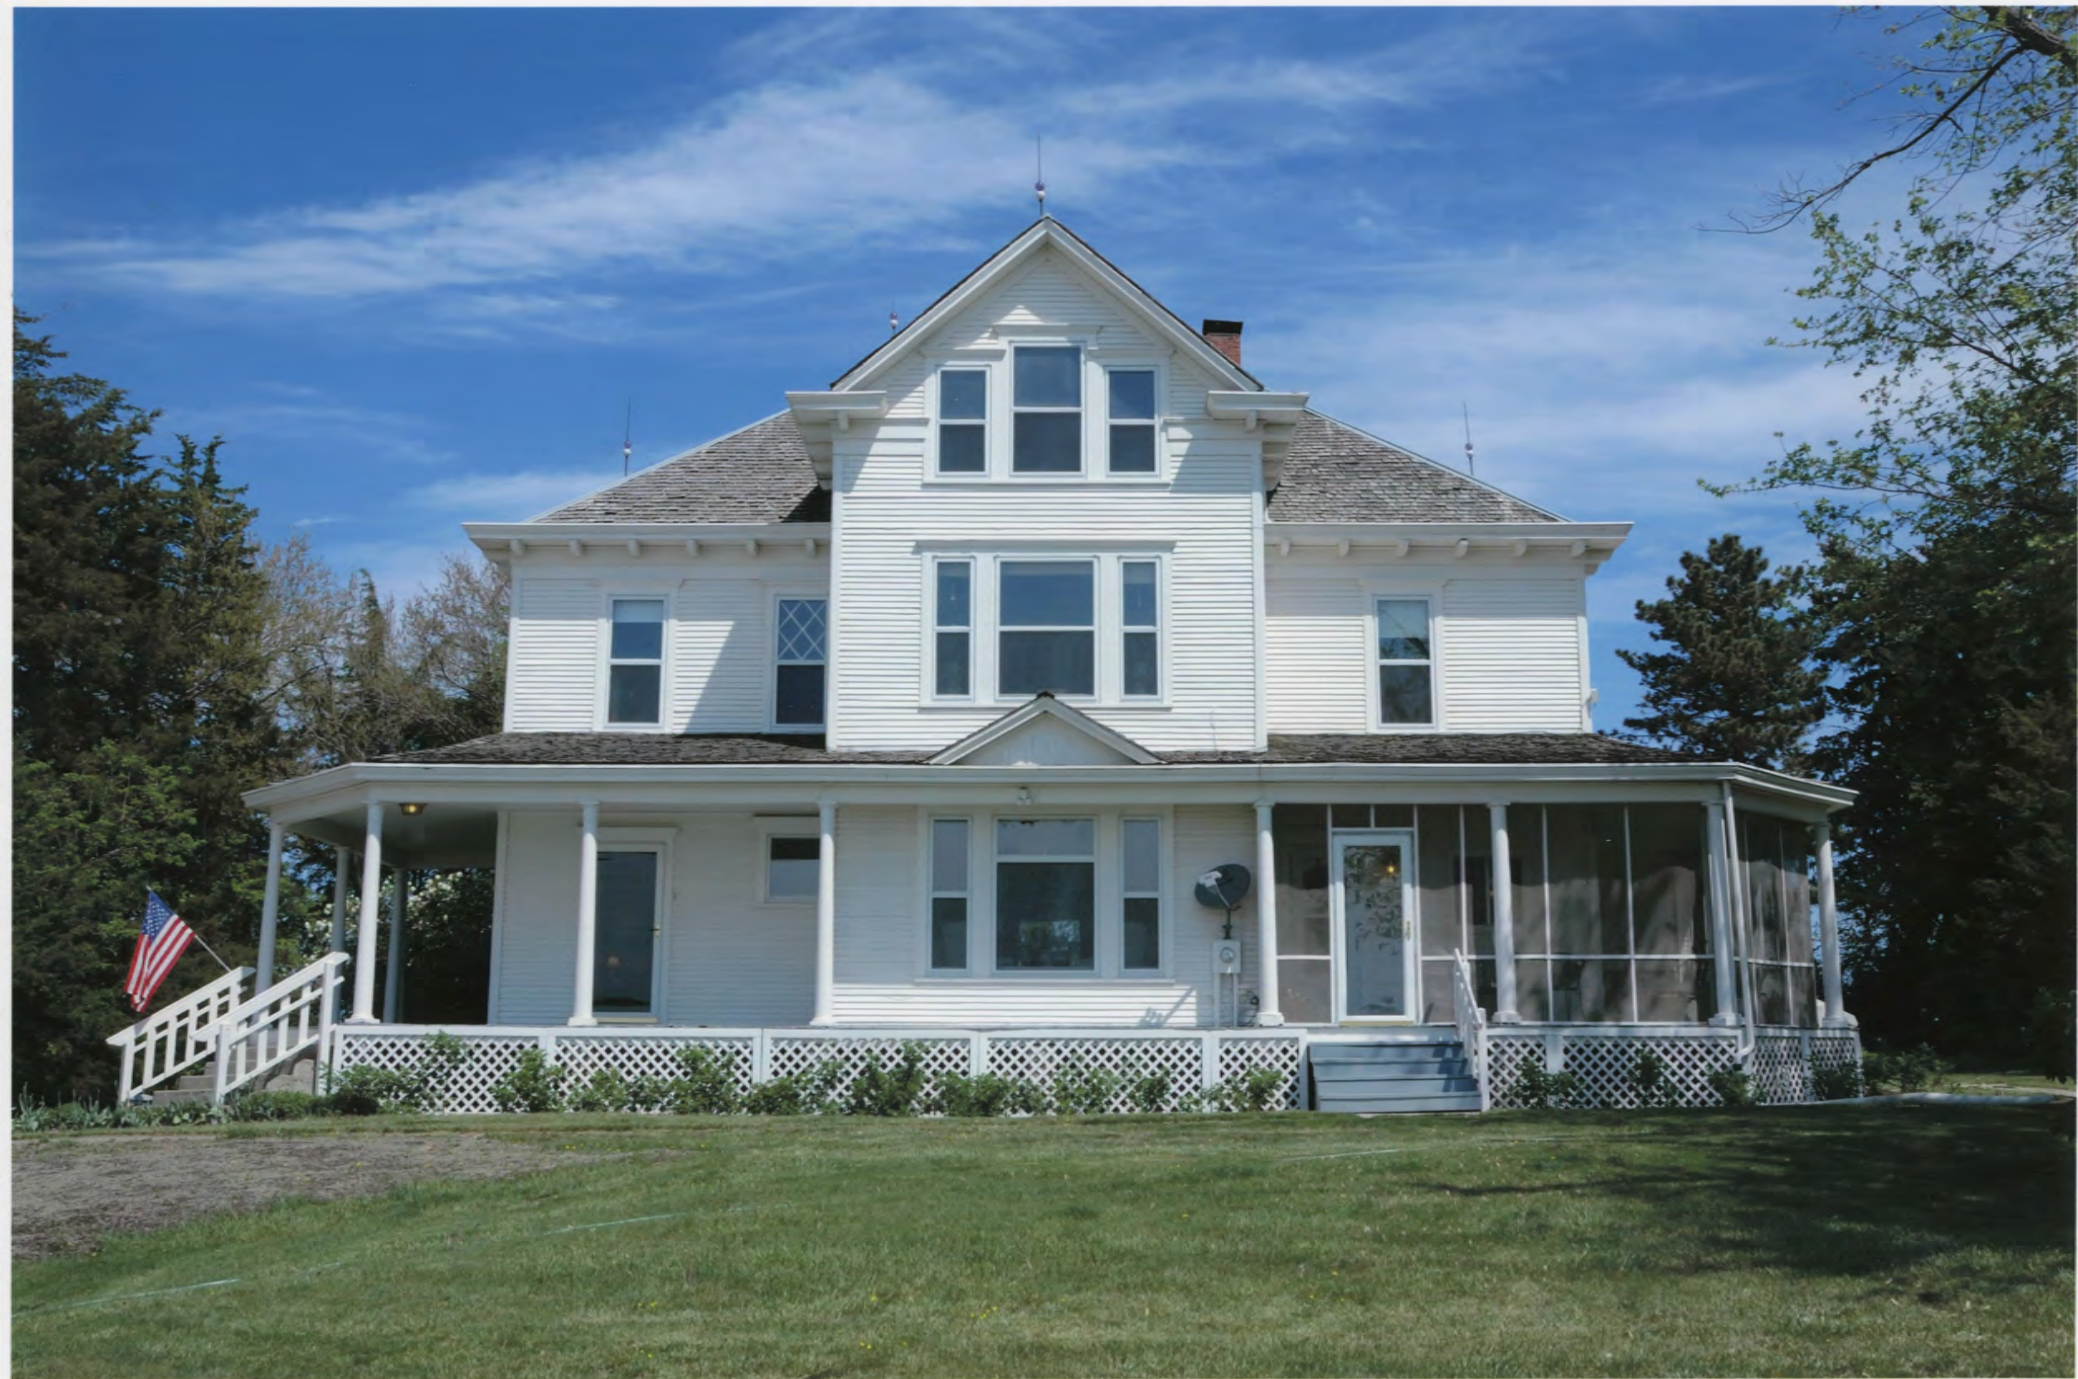
Farmhouse, camera facing north.

Christian Kupke's son, Charles, constructed the farmhouse in c.1910. The exterior footprint of this house has remained unchanged, and minor remodeling efforts have left the interior room layout intact as well. The front façade of the house faces south looking out down the quarter-mile lane that runs north-south from Church Road. The farmhouse is a two-and-a-half story structure that is three ranks wide with the original horizontal white painted wood clapboard siding. The style of the home is Colonial Revival featuring a strong symmetrical design and a full width, wrap-around porch. The front door is not centered on the structure; instead, two main doors are offset to the left and right sides of the front building face. There

The house has a prominent, projecting centered front gable with a high, flat-topped, cedar shake-shingled, hipped roof. Perpendicular to the south-facing center gable are two cross gables facing the east and west. Original amethyst-colored glass balls still grace the lightening rods on the roof. The house features deep eave overhangs that are designed with prominent, simple brackets and wide trim pieces below. The majority of the eave-brackets occur at the roof union at the second story and no brackets are in place at the first story. On the corners of the nearly square structure there are modest, slender pilasters in which there is carved a basic router design. Columns on the front porch were originally unfluted Ionic with bases. The existing columns are now unfluted Doric.

Incorporated into the front porch façade is a low-profile pediment over the first story set of triple windows. As is the case with most Colonial Revivals, the windows are double-hung and rectangular. Triple windows also are common in the revival form.¹ Within the essentially three-story front of the center gable, there are three pairs of triple windows, each positioned directly over those of the story below. The triples at the top are located in the attic. The center window here is slightly higher than the two side windows flanking it, thus creating a pseudo-Palladian window effect. Throughout the first and second story, the majority of windows are original as evidenced by their wavy glass. The majority of these windows are over-sized. All of the original storms have been replaced with new aluminum storm windows (c. 2011).

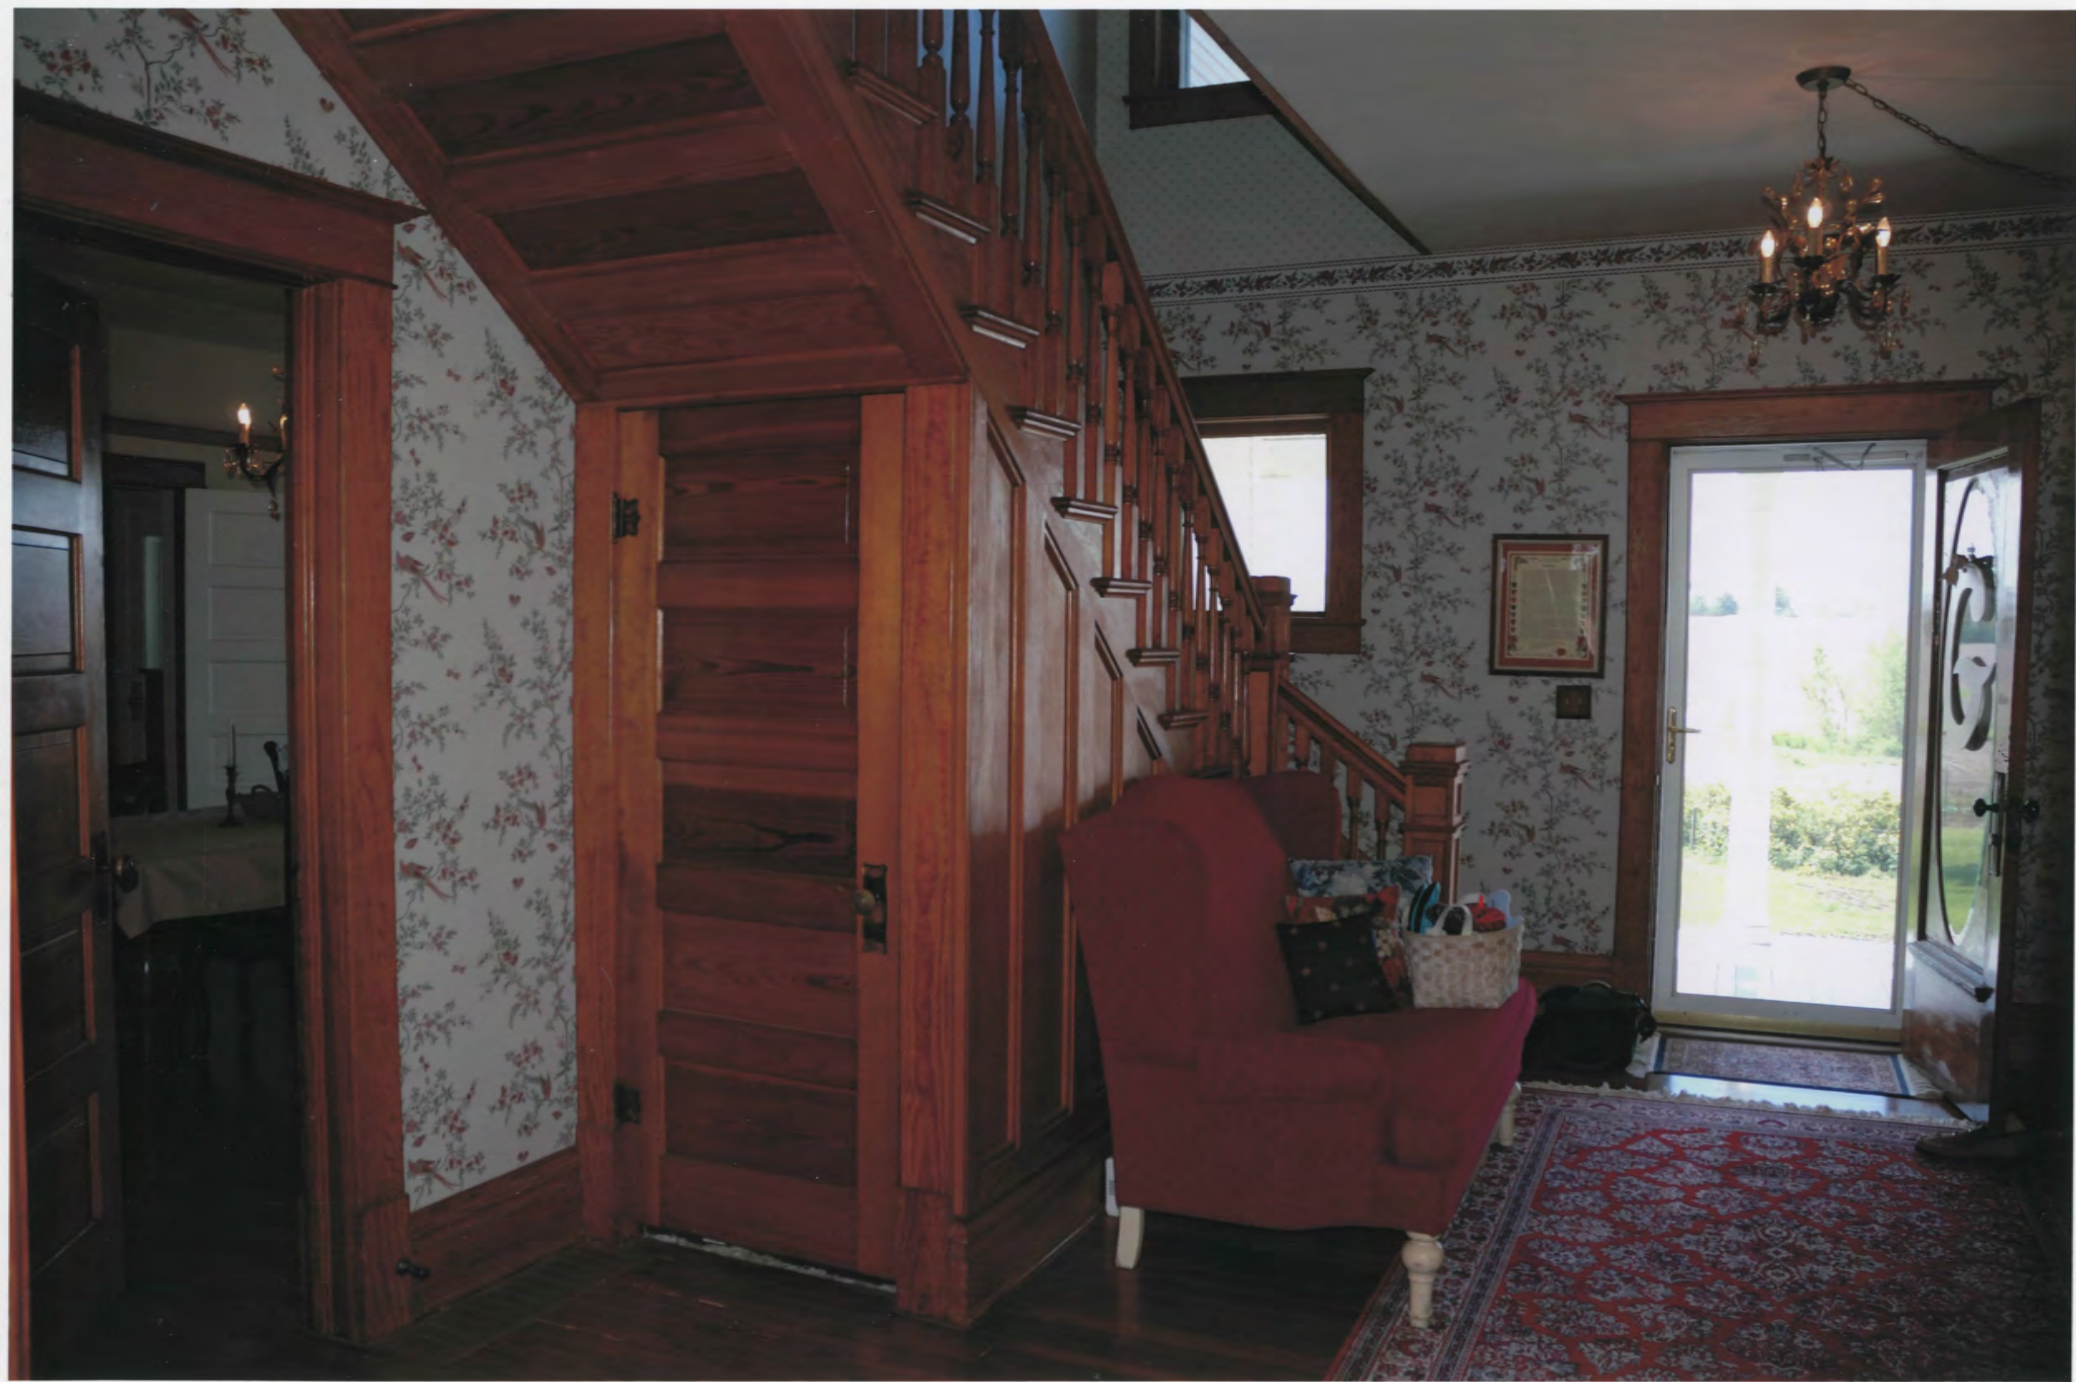
Photo 5 of 16

Farmhouse interior, entryway. Camera facing south.

When entering the house through the formal wood with beveled-glass entry door, to the left of the central gable, the first room encountered is the entry hall. This room has large west and south-facing windows including one window with a leaded glass transom. To the right is a two-story open staircase with original woodwork. Woodwork on the stairs is continued on the wall below to create a solid wall of wood paneling beneath the banister to the floor. This room leads to either the dining room or the formal parlor. Like all ceiling light fixtures on the first floor, there is no internal wiring due to the house being built prior to electricity. This absence of internal wiring necessitates externally swaged wiring for such ceiling fixtures throughout the first floor.

The entry hall and formal parlor are separated by ornate woodwork that divides the spaces. The wood decoration includes fluted Ionic Victorian wood columns and two low, small knee walls – also in wood. The parlor has large west and north-facing windows with leaded glass transoms. It also features one set of functioning wooden pocket doors that lead to the smoking room. The smoking room has one large north-facing window with leaded glass transom. This room connects with adjacent rooms by way of two sets of large wooden pocket doors on both interior walls dividing it from the formal parlor (to the west) and dining room (to the south). This room also has a door to the back stairwell.

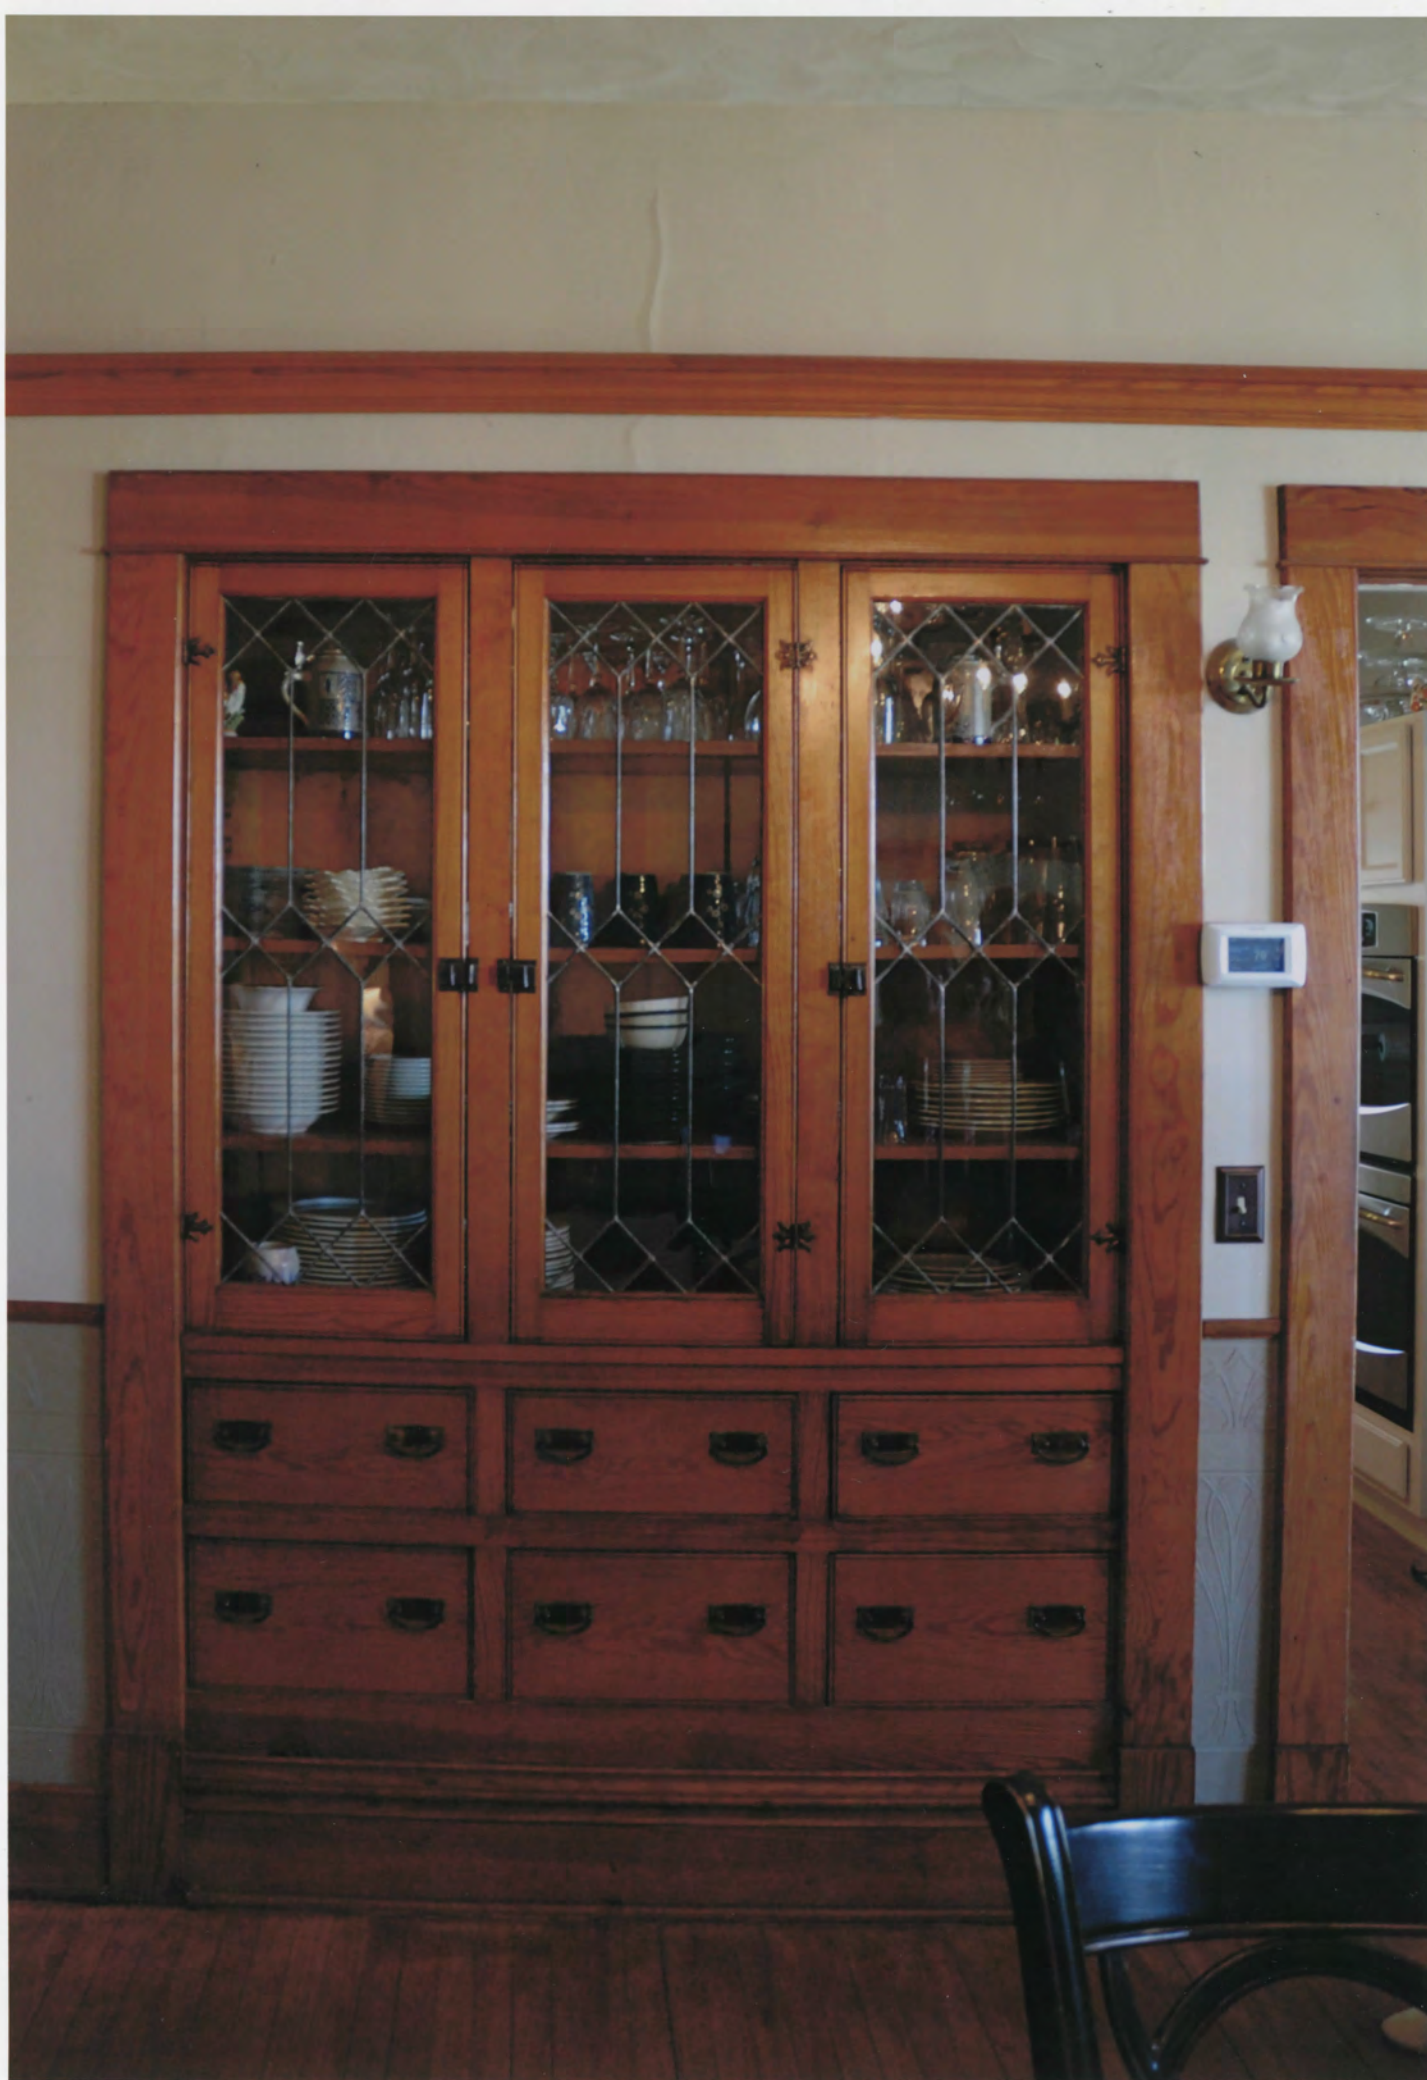
Farmhouse interior, built in dining room hutch. Camera facing east.

Entering the dining room from the smoking room, the focal point of this large room is the incredible view of the front lane looking south of the first story set of central triple windows. Here the center window has a leaded glass transom. On the walls there is antique wainscoting in a thick, high relief wall covering with an Arts and Crafts-style design. It appears to be Lincrusta, a composition like linoleum, based on linseed oil. On the east wall there is a built-in, pass-through china cabinet with leaded glass doors that match the Prairie School pattern found on all of the window transoms. Aside from the glass-front cabinets, three wood drawers also are accessible from either the dining room or the kitchen. From this room, access may be had to the entry hall or kitchen.

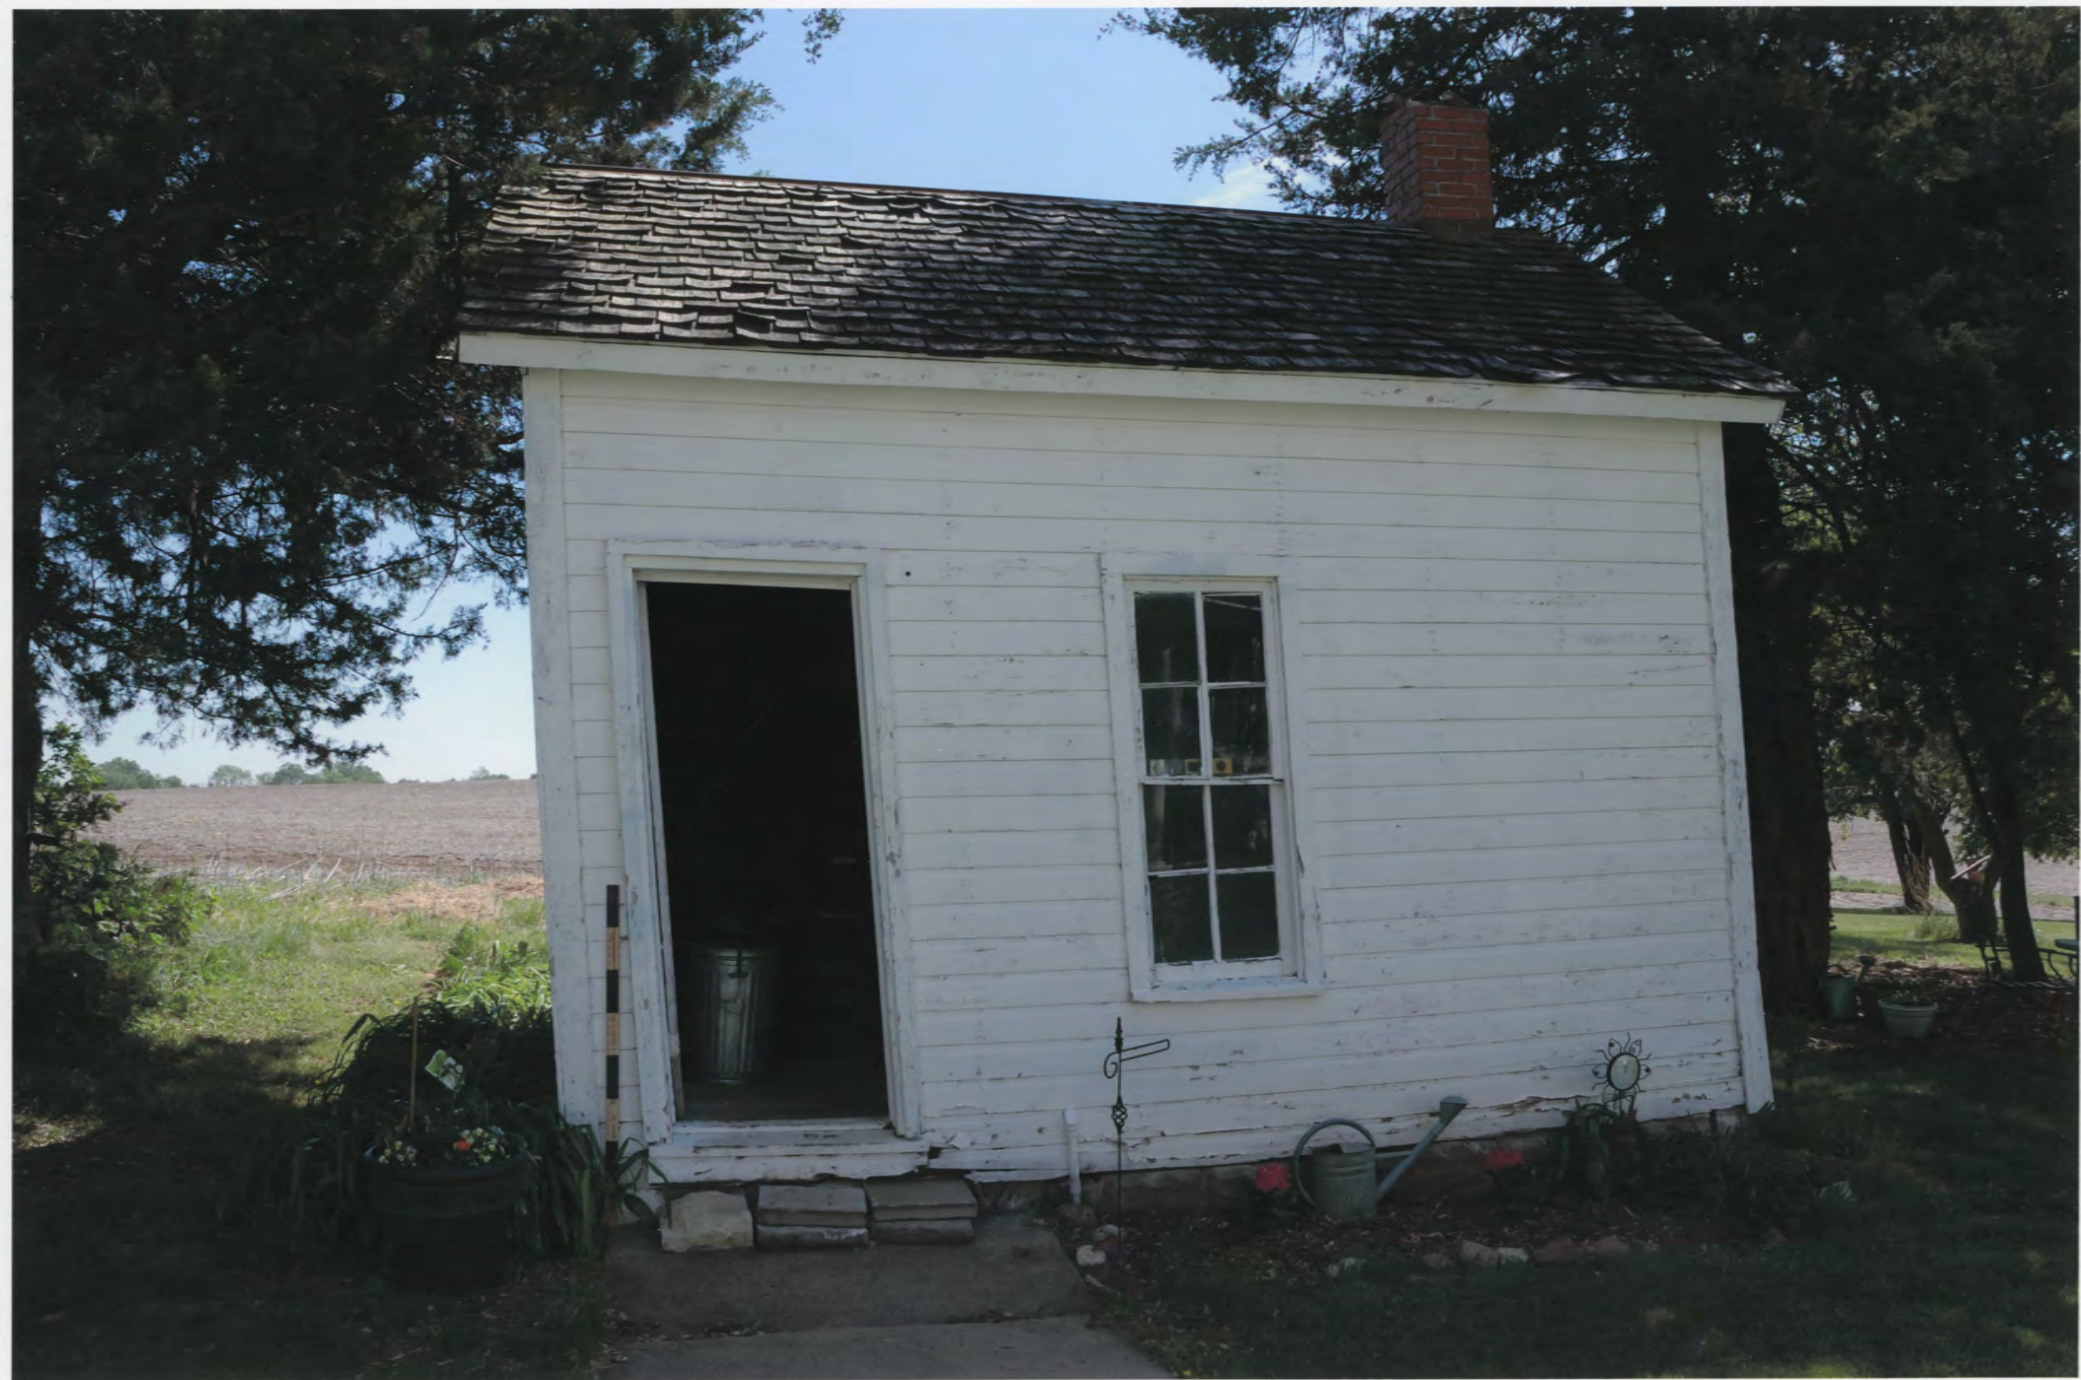
Summer Kitchen, camera facing east.

Just a few steps to the east of the farmhouse is the petite summer kitchen, a painted white structure with original wood clapboard siding. The box-like building has doors to the south and the west and windows to north, east, and west. The floor is tongue and groove wood plank. The walls and ceiling are bead board and overhead there is a full, floored attic. This building was also the ice house and has a basement accessed by lifting cut planks in a small section of floor. On the south wall, there is a brick chimney that runs halfway down the interior wall. A now missing wood stove was hooked into the brick stack to heat water for laundry and cooking. This little building is nestled between the eastern end of the windbreak and two cedar trees to the south. There is an open field to the east and meadow, orchard, and lawn to the southeast. To the south is the garden and fields.

The construction of the farmhouse in c.1910 necessitated two important domestic structures: the summer kitchen and the outhouse. Both buildings are finished with the same horizontal clapboard as the farmhouse and the summer kitchen's visible block foundation is the same as the farmhouse. Both buildings are arranged in close proximity to the kitchen doors. Important domestic activities were conducted more conveniently with these structures close to the house that was the hub of all domestic activity. The most distinctive aspect of the outhouse is that it features two seats, arranged side by side.

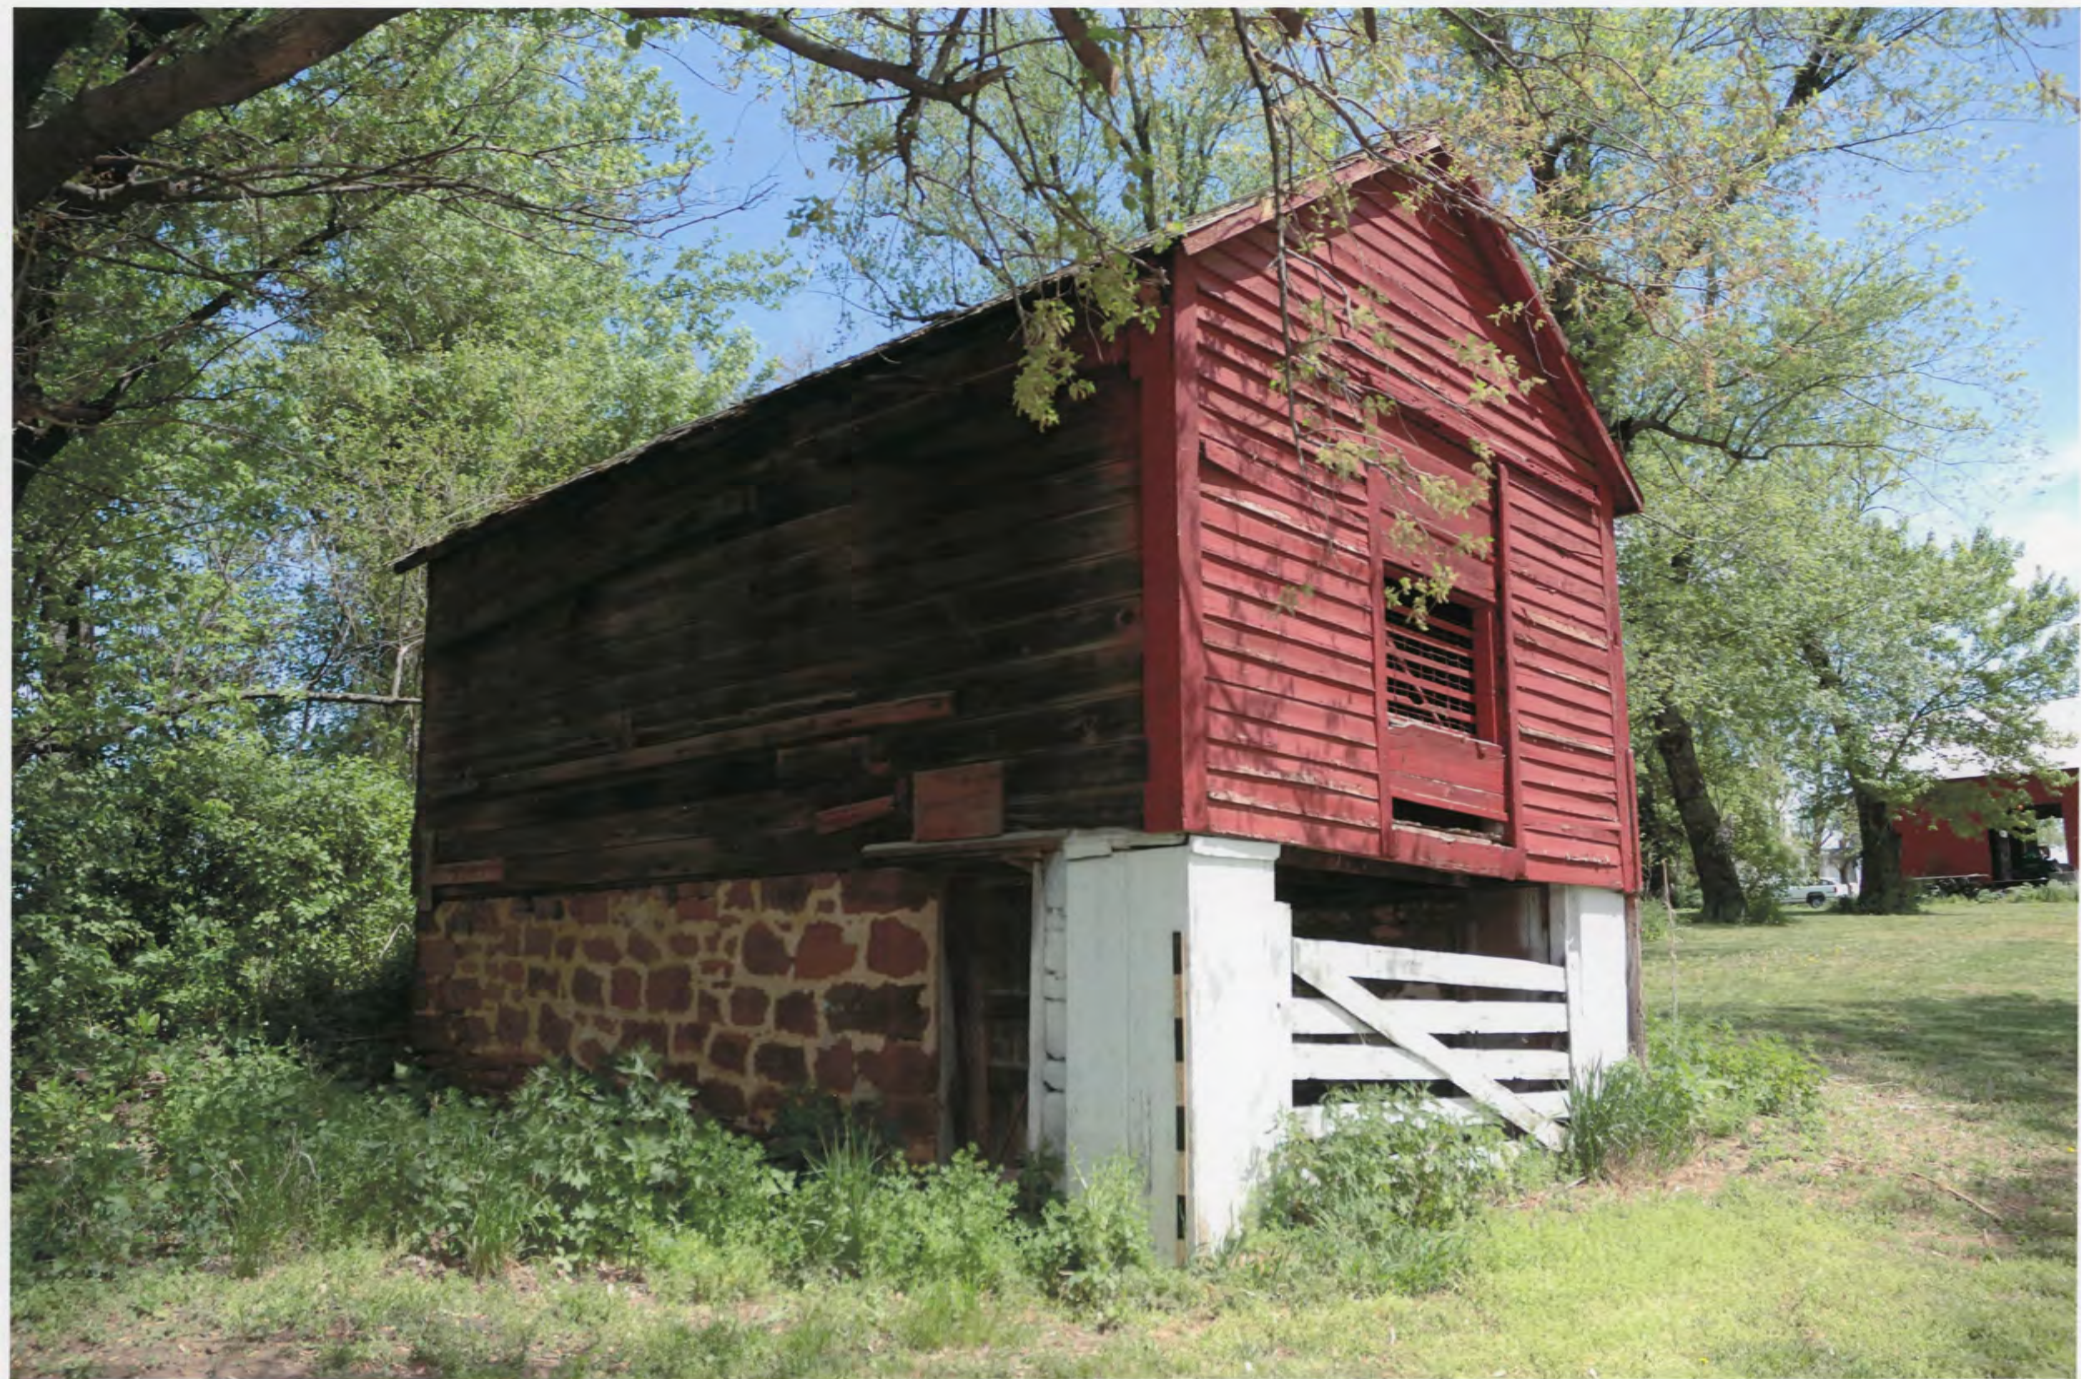
Hen House, camera facing northeast.

The hen house is a structure built into a bank. Painted red and outfitted in horizontal clapboard, the doors open on the upper-floor to the south and east. Original nesting boxes and other chicken-raising ephemera are still installed in the coop. The foundation of the building is made of limestone and the taller western stone wall remains unpainted. Underneath the structure there is a sheltered area with a dirt floor where pigs were once kept. There is a primitive small door to the west side of the pigsty as well. This structure has an open meadow to the south, but the north and west sides of the building border the property's north woods.

Frozen in time is the hen house with its simple gabled roof structure. Due to holes and deterioration of its cedar shake roof, the structure has sustained water damage that compromised the flooring, portions of the eastern limestone wall, and the roof itself. Despite this, the building is incredibly intact. Like the bank barn to the west, this building is also built into a bank, offering two distinct levels for housing animals. Pigs were kept in the cool limestone basement with a south-facing opening and wooden gate. This dirt-floored under story had a window to the west and a small Dutch door at the south end of the west wall. The upper story is a generously sized chicken house with a wire mesh partition between the southern and northern sections of the room. The nesting boxes are still in place and various accoutrements used for chicken husbandry can be found scattered in the space. With doors to the east and the south, the hen house would have surely been important to the family as they raised the birds for both eggs and meat.

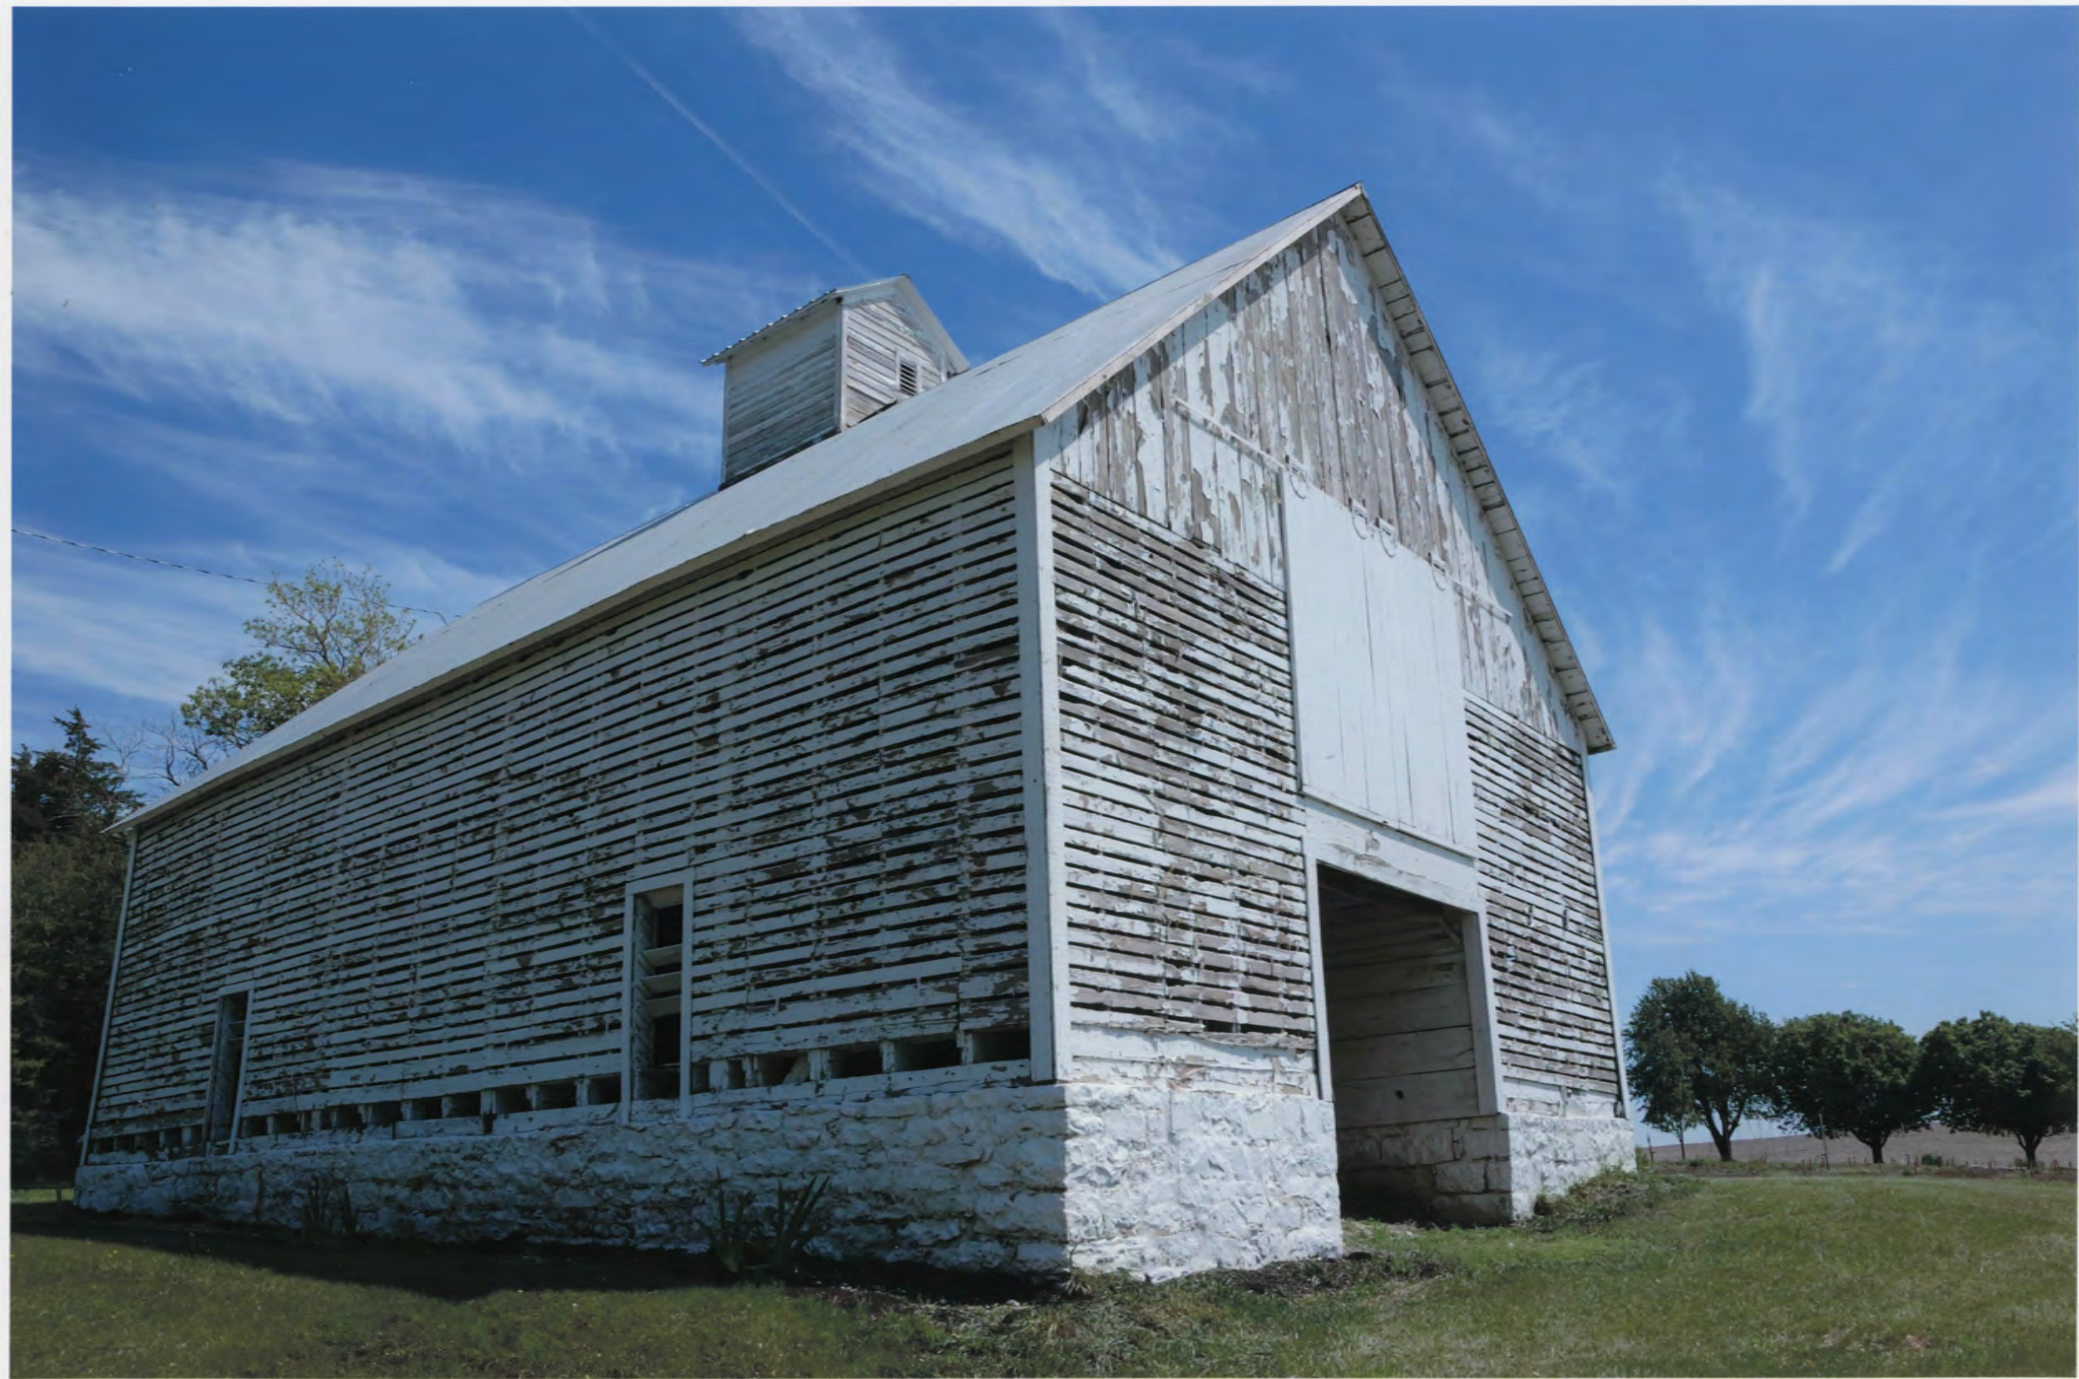
Corn Crib, camera facing northeast.

This two-story painted white structure with gapped horizontal wood slats for airflow, is a drive-through style. Ground-floor openings are found to the north and south. On the second story, the doors have the original "D-shaped" door hardware. Looking into that second story, its intricate construction can easily be seen in upper-floor structure bracing. The foundation is made of limestone. Exterior access to four separate quadrants is by way of low, slat-filled door openings and hinged hatches. This structure is also a main feature of the property and is seen along with the house when coming down the lane. It is surrounded by a tear-drop shaped lawn bordered by a gravel loop of lane.
