National Register of Historic Places Registration Form

historic name Christian Kupke Farmstead

other names/site number The Farm at Long Lane / Ne HRSI #CC00-365

Cass County, Nebraska
County and State

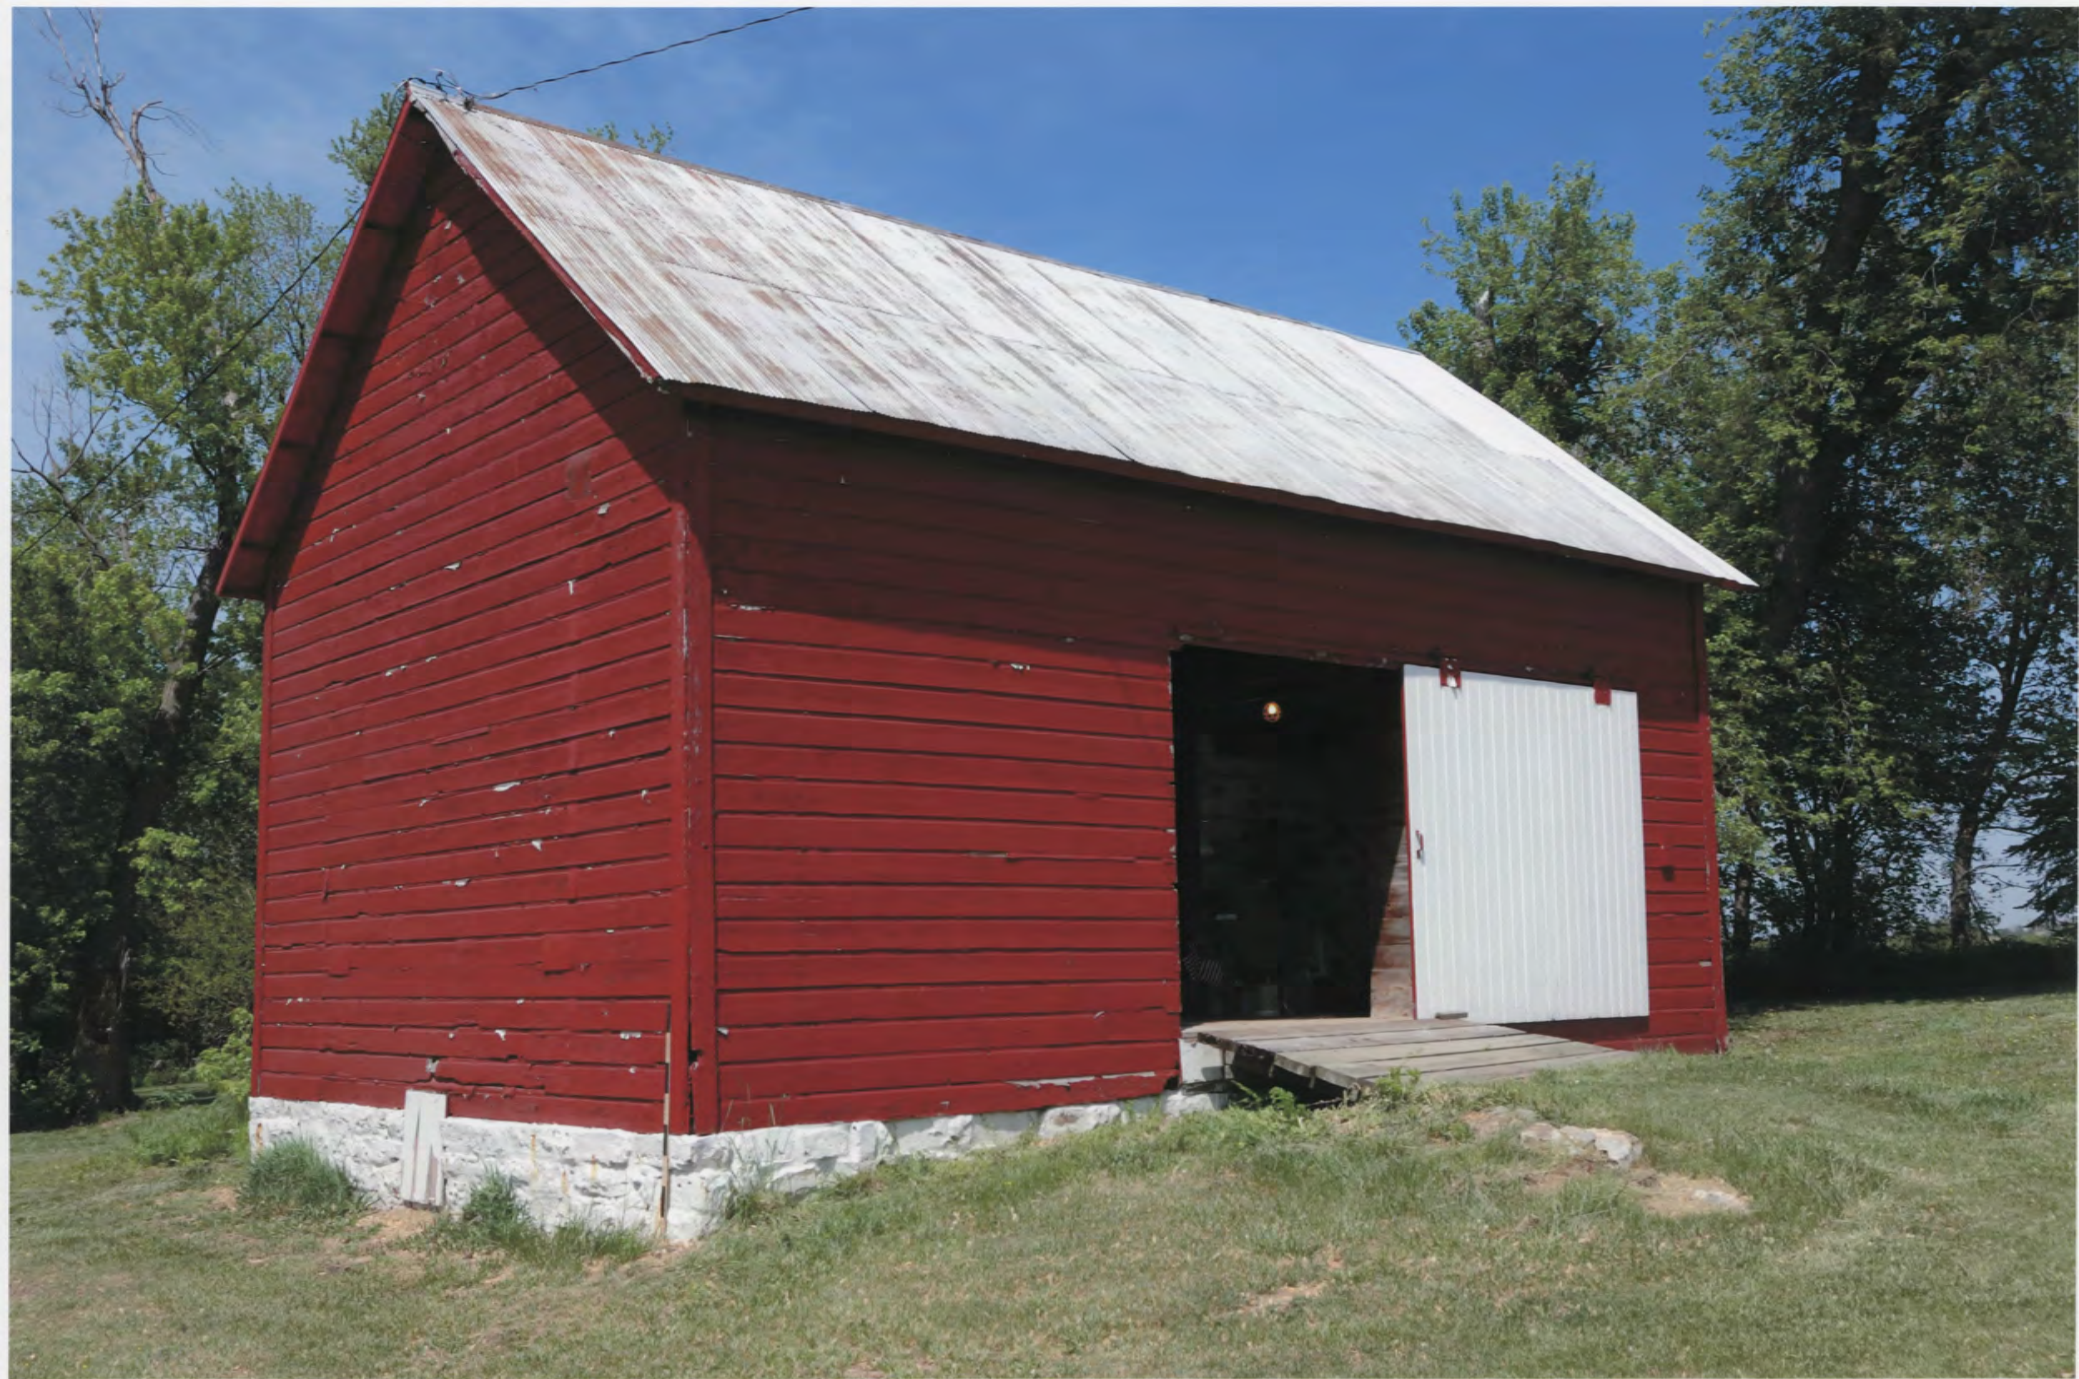
Granary, camera facing northwest.

This structure has wide horizontal wood siding, painted red. The limestone foundation has a low crawlspace; there is a low ramp leading up to the building on the east side. The central threshing floor has thick, wide planks and the barn doors open to the west and east. Inside the granary are four rooms off of the central threshing area. Originally enclosed storage rooms, these four rooms have been opened up by enlarging their doorways. The attic is fully floored and it still stores an old fanning mill that was used to clean and separate grain. This building stands just to the west of the corn crib, in an open spot of land. There is a park-like area of lawn to the west of it.

The granary has also been referred to as the garage.⁵³ As a commercial agricultural outbuilding fairly close to the house, it appears to have been adapted to housing an automobile instead of grain once small grain storage became less relevant in the evolving agricultural era. Originally the granary would have been used to store wheat and other small grains. The building has double doors on both the west and east sides to allow for airflow with four areas to collect the grain. The wood floor is similar to the bank barn's with thick, wide planks. Between the cracks, it is still possible to see small bits of wheat and chaff that were presumably threshed in the central aisle way. One relic of this time is a primitive wood and metal fanning mill that is still stored in the attic above. Like most of the outbuildings, the precise date of construction is not known. There are two interesting autographs carved into the wood walls. The first is "Arthur Lehr 1917" and the second is a pin-poked "Louis Kupke."

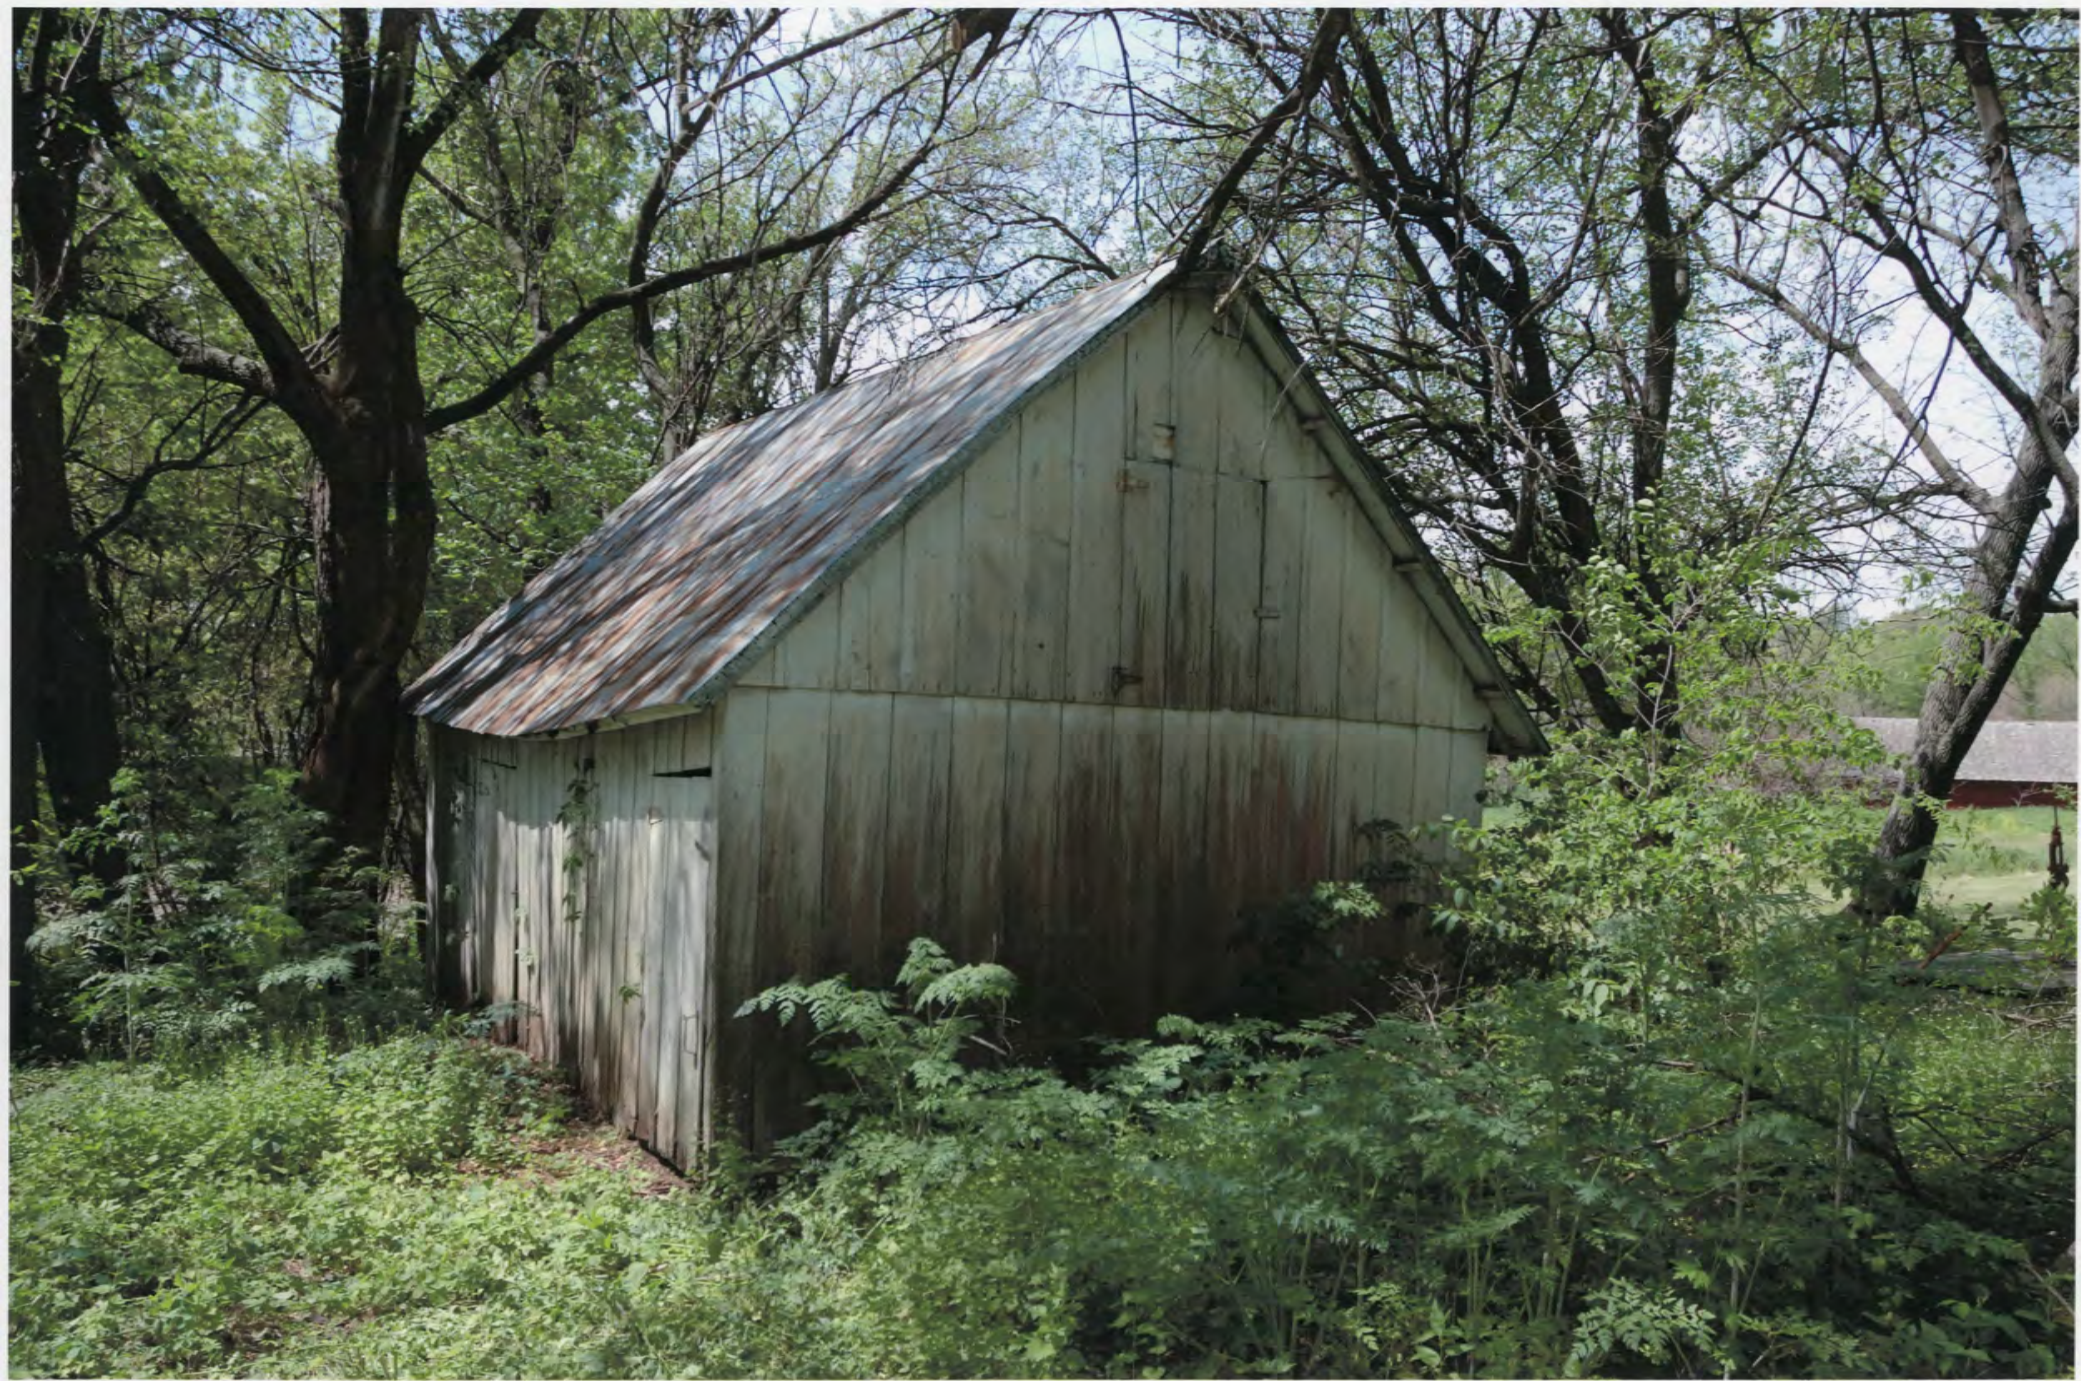
White Barn / Tool Shed, camera facing southwest.

This white barn/tool shed has little paint left on it; now it resembles a grayish-white color. Two barn doors open to the east – both facing the site of the original house in the woods. There are also windows facing the north and the west. Inside there are two sections divided by a wooden partition with a dirt floor. This building is just a few feet away from the Original House Foundation Site and it is surrounded by woods to the south and east with open meadow to the west.

The white barn/tool shed also had a simple gabled roof and has been thought to possibly be the original barn on the property. An examination of the structure's nails indicates the use of primarily wire nails, dating the property to 1890 at the earliest.⁵¹ Of all of the outbuildings, this is the most primitive structure with no brick or stone foundation. The wood siding essentially meets the earth at ground level and the floor is hard-packed dirt. The building may well have housed livestock. Louis Kupke, however, used the building as a toolshed where he had a workbench and tools set up in the northern half. The southern half functioned as a storage room.

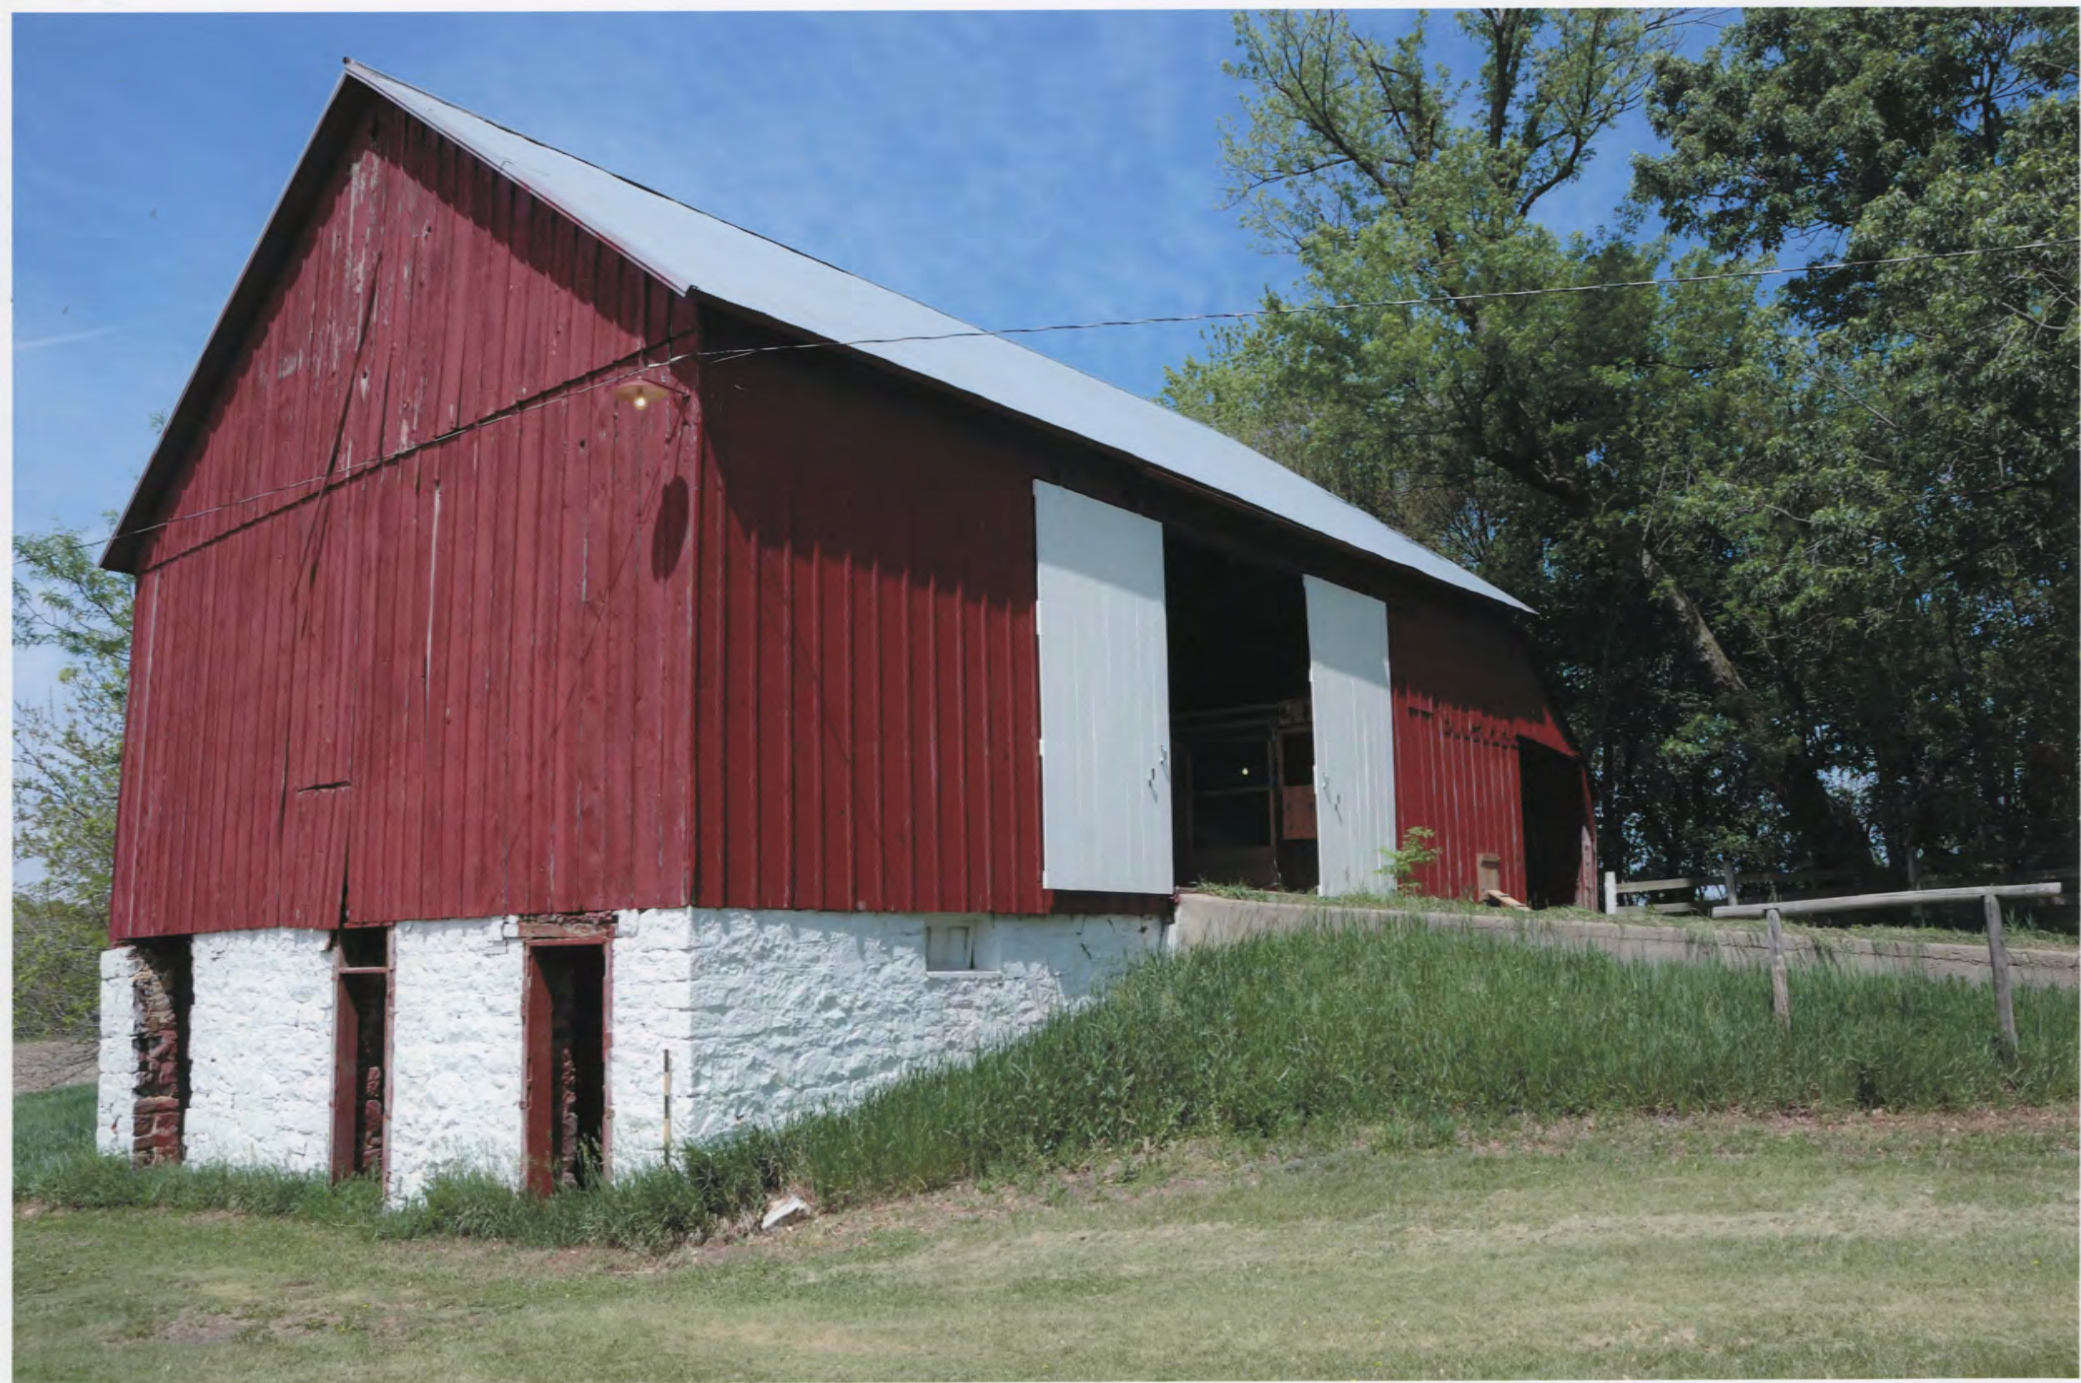
Bank Barn, camera facing northwest.

The large red vertical board wooden structure is built into a hill, thus allowing a full basement beneath the barn's limestone walls. The main level of barn is accessible via a ramp to the east that leads to the eastern double-doors. Opposite of these double-doors, there used to be an identical opening to the west. Now, this western opening has been partially walled and filled with windows looking west. Inside the main level, there are thick, wide wood plank floors. Off the central section, there are sections to the south and the north. The section to the south is completely open. The intricate post and beam construction of the barn is exacting, which reflects German craftsmanship. The section to the north is open in the northwest corner and the remaining third of the barn is a feed room and tack room (now used as a chicken coop). Above the feed and tack rooms there is a hay loft. Doors to the tack and feed rooms are original as are the pulls and metal hardware. In the feed room there is a trap door in the floor where feed would have been dropped down below to feeding troughs in the basement of the barn. Beneath the barn, cattle and horses were once kept in this space of high headroom and dirt floors. Three doors facing south give access to the basement, with windows to the east, south, west, and north. This large building faces south and east where it is surrounded by open meadow. To the north, the North Woods border it. To the west, a thicket of wild mulberry trees and tall grasses surround it.

Among the commercial agricultural outbuildings found on the farm, the bank barn is the largest and most impressive structure. With its exposed rough-hewn wood posts, wooden peg construction, and exposed king posts in the trussing; the barn gives an accurate view of how early German settlers constructed barns. Like the corn crib, granary, and hen house, the foundation of the bank barn is made of limestone. This barn allowed the farm to shelter, feed, and store food for its livestock, all in one efficiently designed building. Furthermore, both levels of the barn could be accessed from the ground. Bank barns were associated with an agricultural economy that emphasized grain and livestock systems.⁴⁹ Agricultural specialization and new thinking about health related to livestock husbandry decreased the bank barn's popularity by the late 19th and early 20th century.⁵⁰

In the upper story of the bank barn the large double doors facing east would allow easy approach for doing chores. An identical set of double doors facing west, due to the hill, opened a story off of the ground. This would have allowed for a wagon or truck to back up to those doors for loading or unloading of materials. These west doors are now fixed. The hayloft to the north provided ample space for storing loosely cut hay at a time before bales became the standard storage form. A Dutch door replete with its original hinges beneath the hayloft was the likely spot for a tack room with access to the feed room next door. In 2010 this room was retrofitted to house chickens. The barn floor is comprised of thick, variable width wood planks up to 17" wide, fastened with Type B cut nails. The north and south-facing ends of the barn's gables each have a martin hole that's shape is best described as a cross between a primitive diamond and quatrefoil.

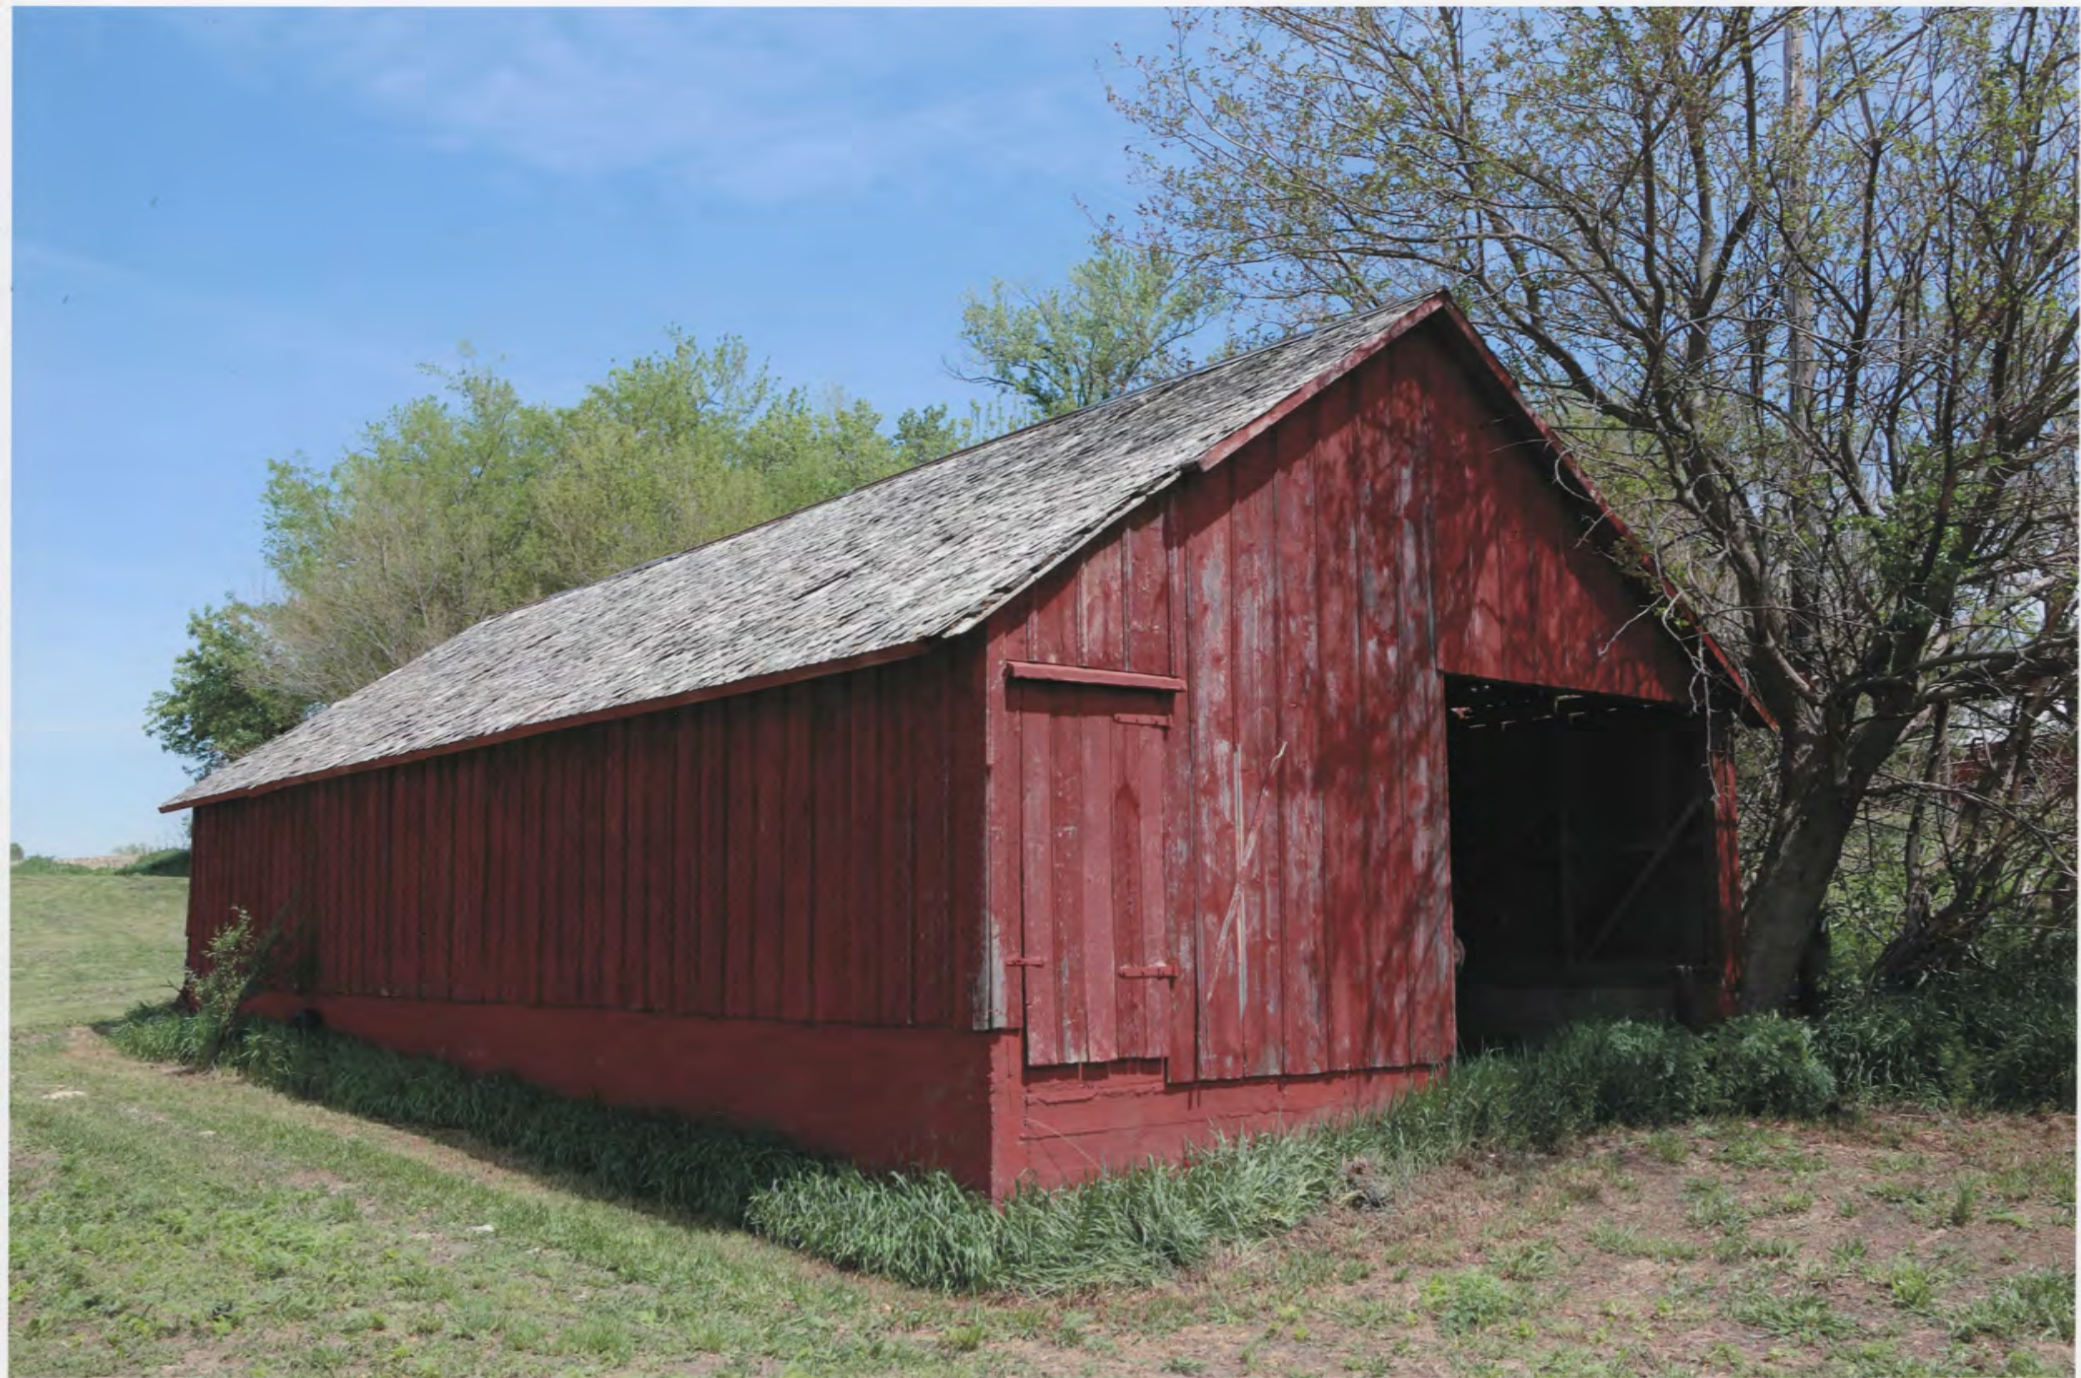
Calving Shed, camera facing northeast.

At the most western end of the property stands a red painted wooden structure with poured concrete foundation and dirt floor. This is the only outbuilding that does not have a limestone foundation and its concrete foundation indicates that this structure was perhaps newer than the others, with an estimated construction date between 1930 and 1950. The main opening faces south and has no door at this time. Inside the shed are two wooden swinging gates that were used to direct and corral cattle. One gate directs animals to a smaller door where they could be loaded into a truck or wagon bed. This is the western-most structure, situated at the edge of the property just a few yards from a deep stream, fed off of Fountain Creek. There is open field to the west and mowed meadow to the east and north. To the south there is an area of high grasses leading to the stream.

The western-most structure, sited just a few feet from a spring, is the calving shed and a similarly sized outbuilding foundation site. The calving shed is different from the other outbuildings because it is the only one that has a poured concrete foundation instead of one made of limestone. This immediately suggests that the structure may be newer than the others. Careful inspection of the outbuilding foundation site shows small gravel and rectangular limestone blocks flush to the ground, all just steps away from the current calving shed and the identical footprint size. Presumably the outbuilding foundation site was the original livestock shed that, for some reason, was replaced by the current calving shed. Inside of the calving shed the wooden dual gate system used to corral livestock into different areas of the structure appears quite old. It could be that these components were simply moved from an older building to this current one. Also, large wood beams resting at the top of the poured concrete foundation look similar in appearance and age to the rough-hewn posts and beams found in the bank barn. Interestingly, these posts appear to be re-used because one post has been laid so that it shows notches where this post would have been secured structurally to another wooden member of a previous structure.
