NATIONAL REGISTER OF HISTORIC PLACES PROPERTY PHOTOGRAPH FORM: NEW HAMPSHIRE

Photographer: Christopher Williams

Negative with: W. M. Design Group

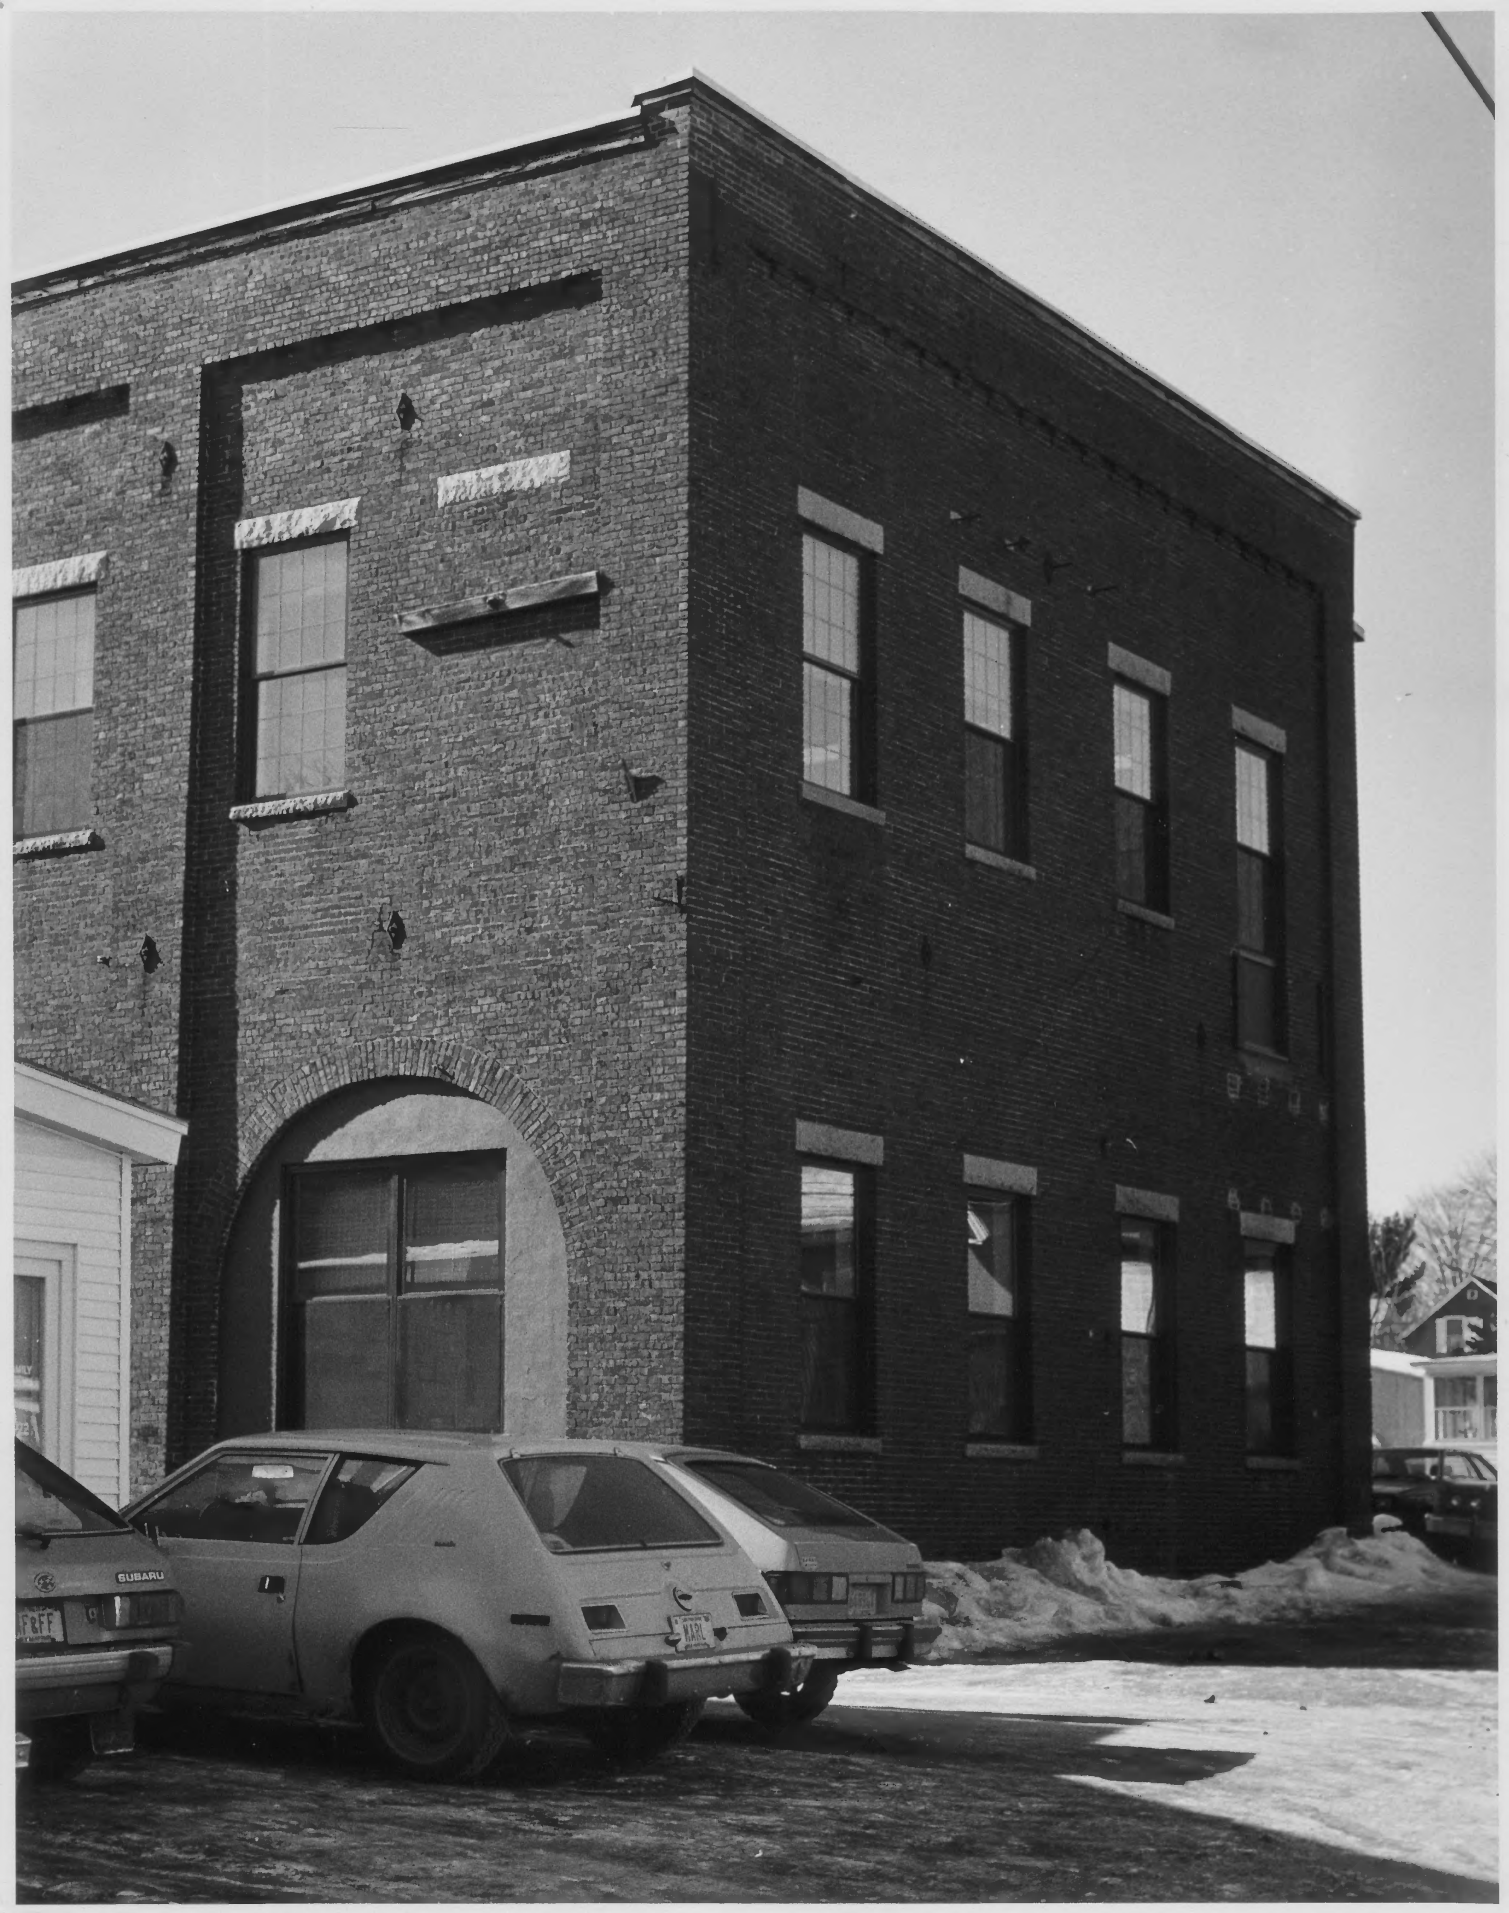
Photographer facing N NE E SE S SW W NW Photo Date: February 26, 1982 Photo Number 1 of 8

Tremont St. end of building with arched masonry openings in the 1868 cabinet shop addition. Also note the blocked in masonry opening up above.

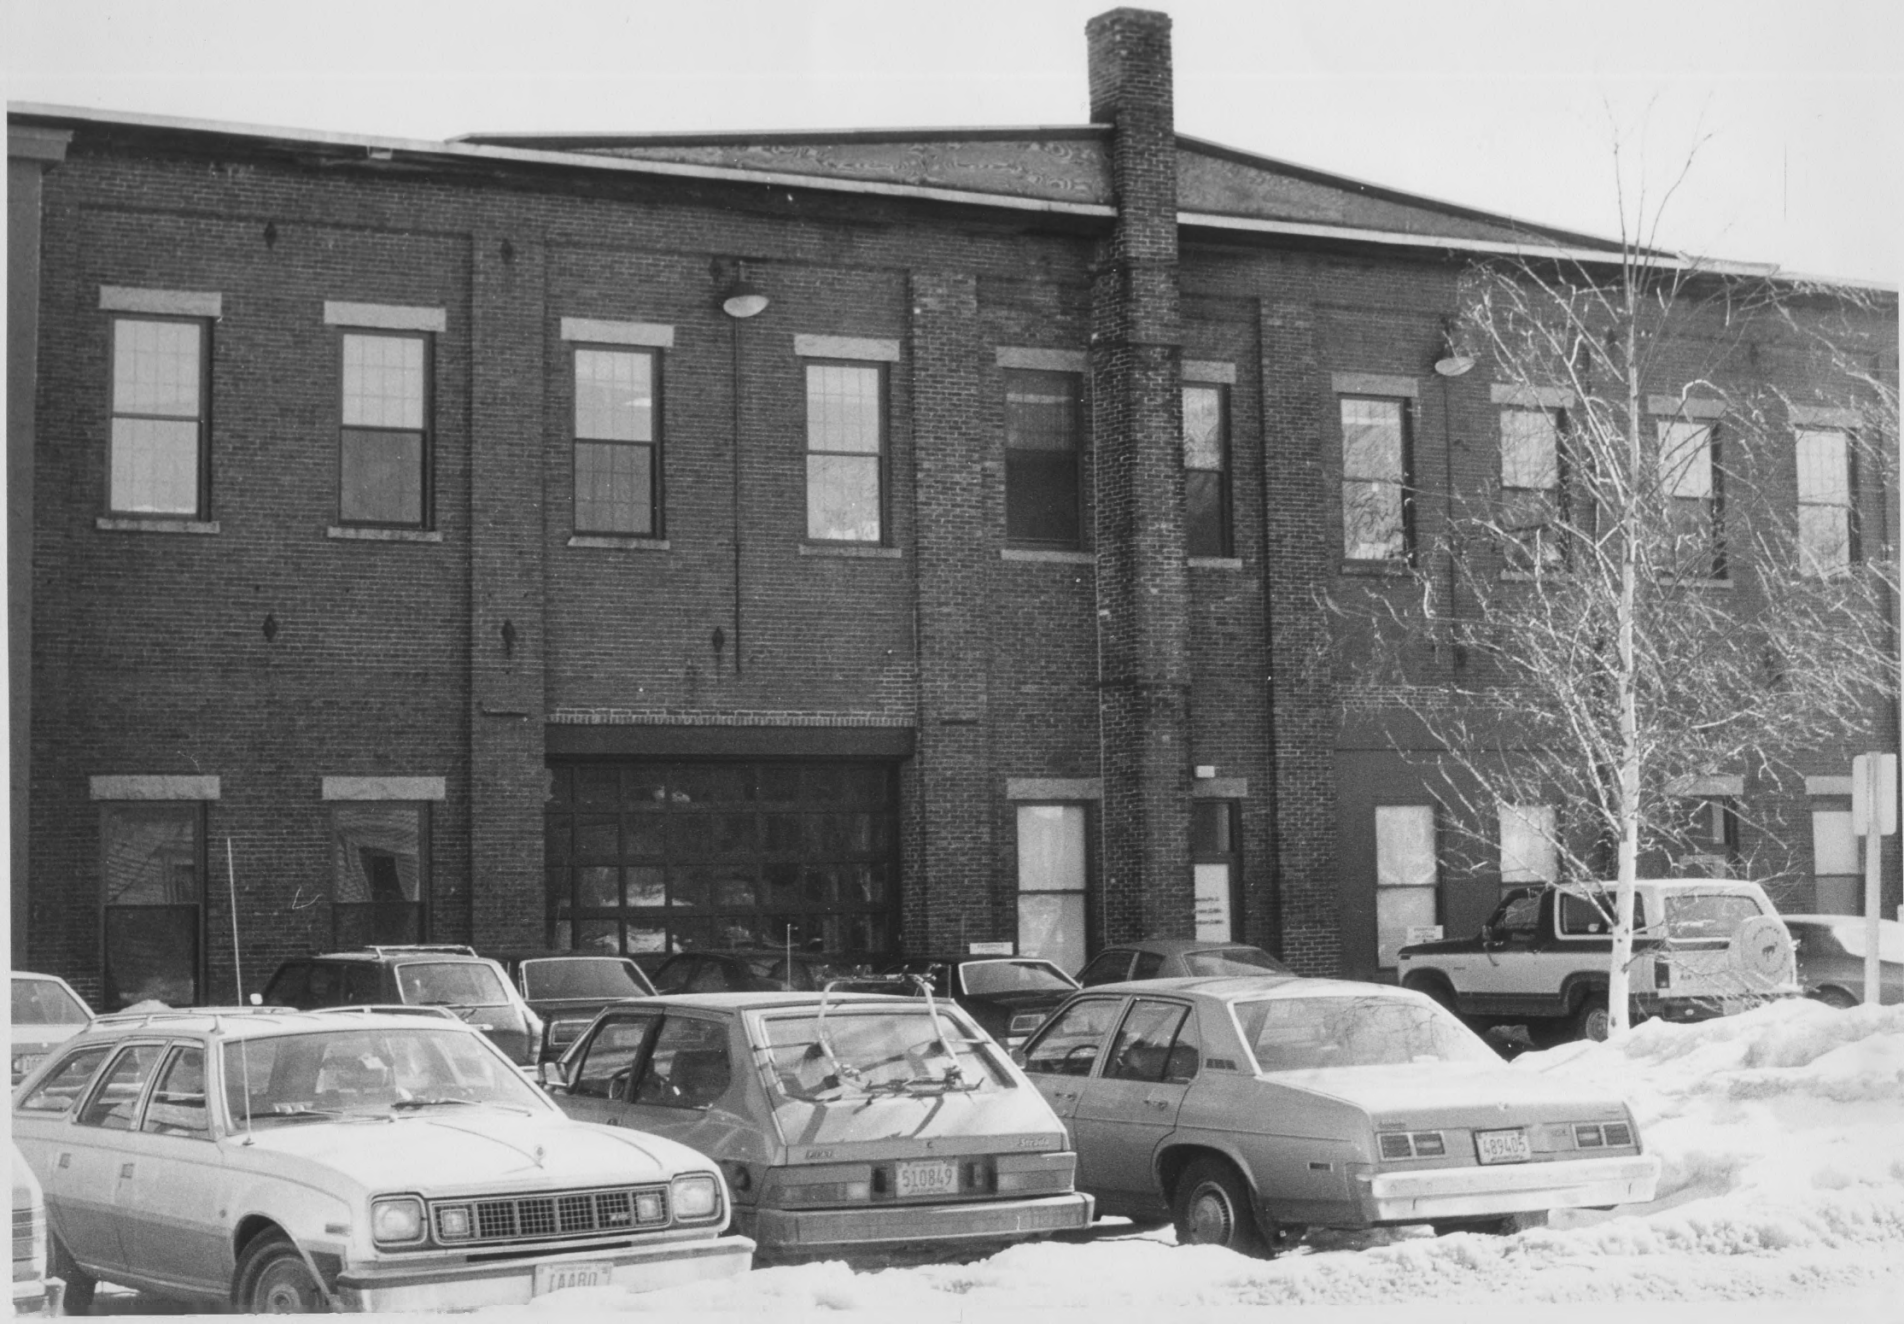
Photographer facing N NE E SE S SW W NW Photo Date: February 26, 1982 Photo Number 2 of 8

Description: West side of the building showing the wall area which was modified earlier this century to provide an overhead door for vehicular access to the building, the block elevator shaft and the gentle gable at the original boiler chimney.

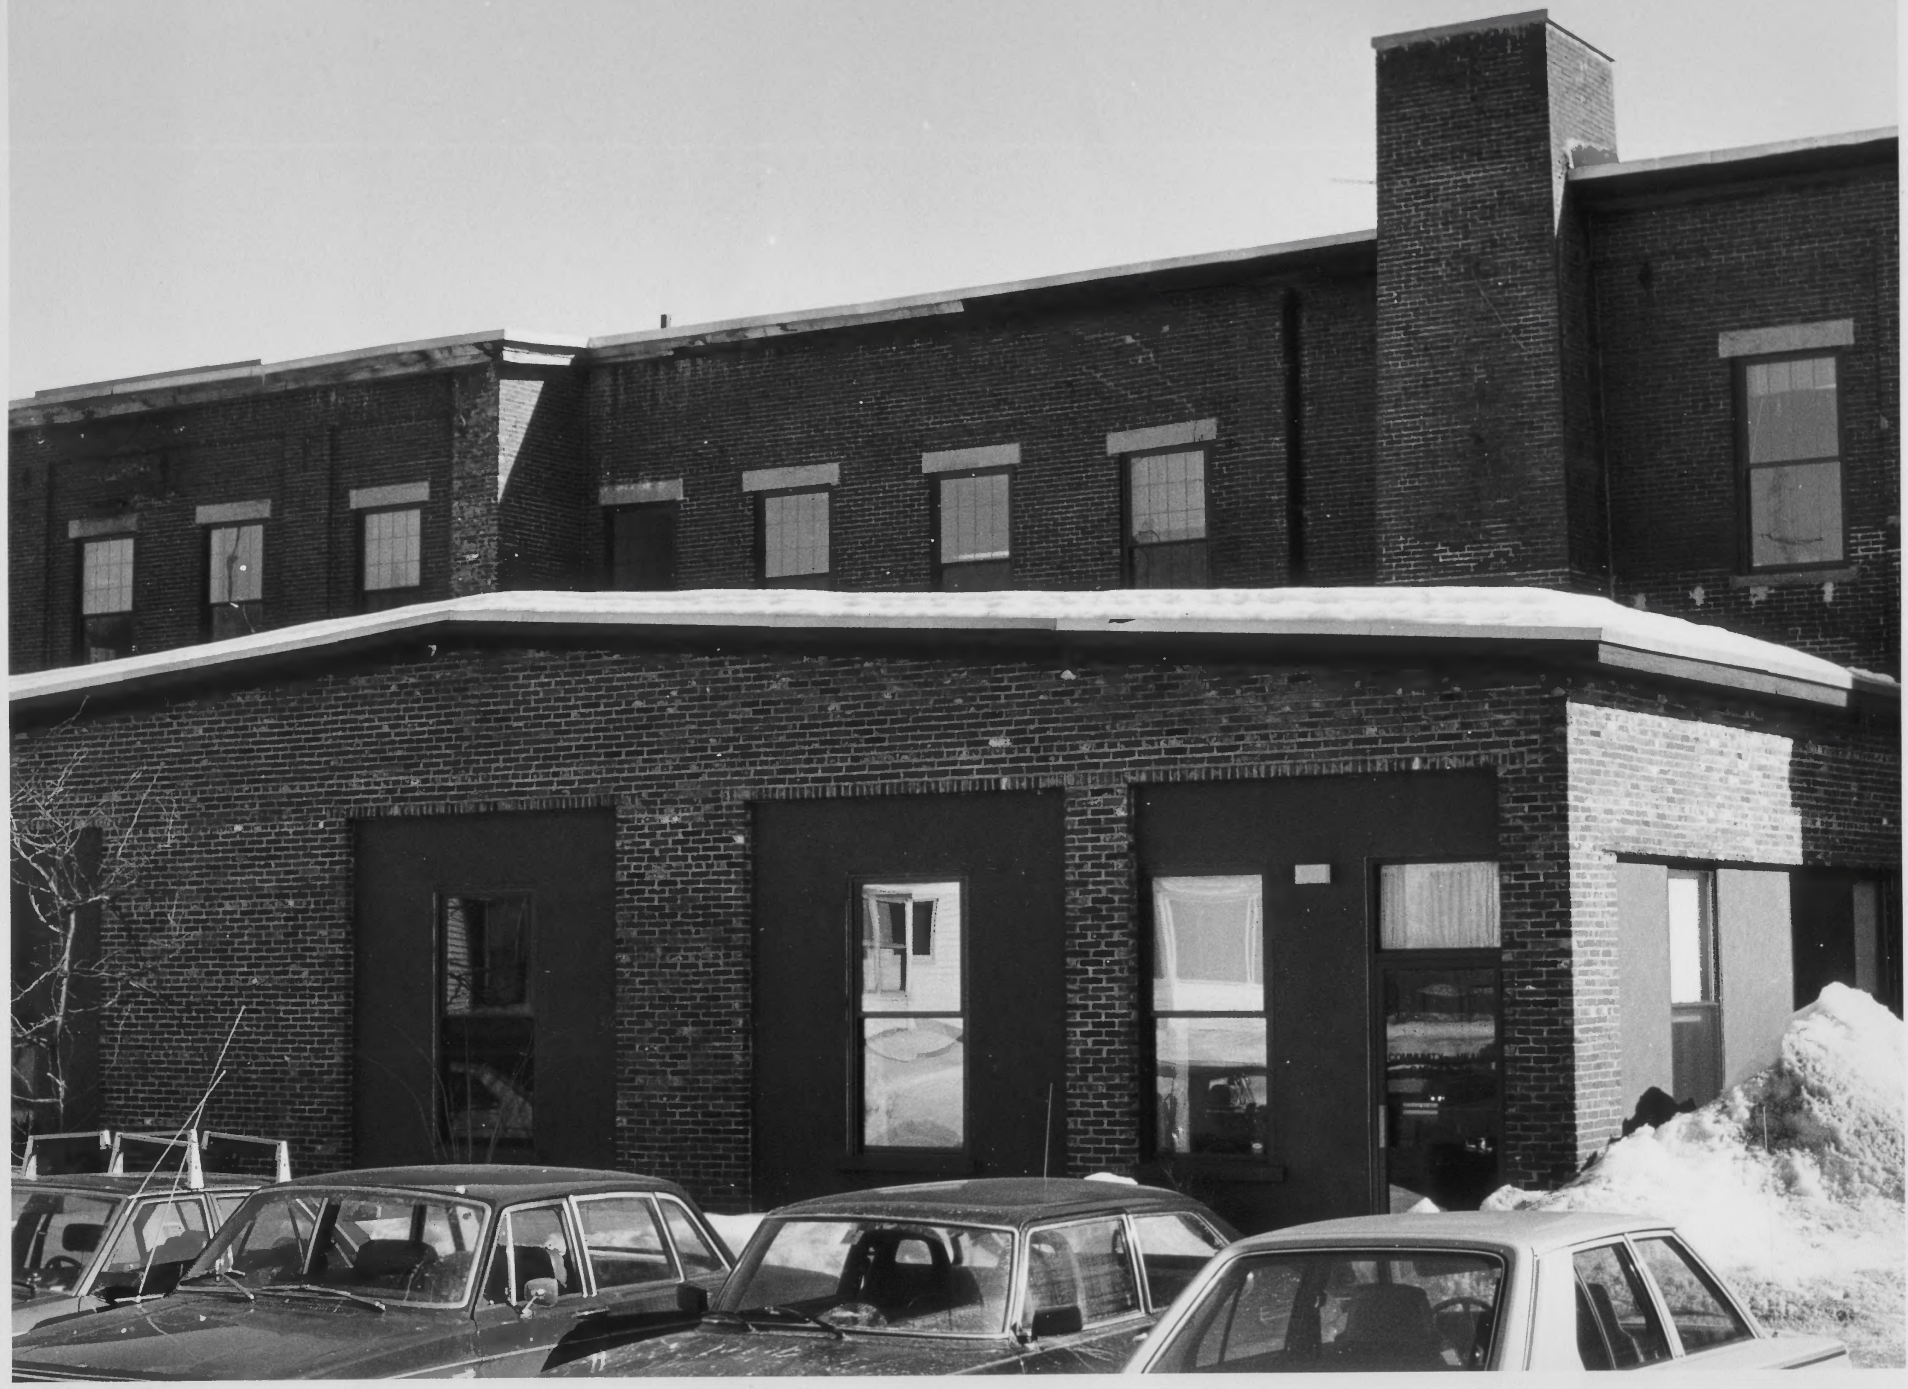
Photographer facing N NE E SE S SW W NW Photo Date: 26 February 1982 Photo Number 3 of 8

Description: The 1868 low "drying room" addition to the prison shop building. This addition was heavily modified during the building's use as a car dealership when this area was utilized as a showroom. Also note boiler room chimney.

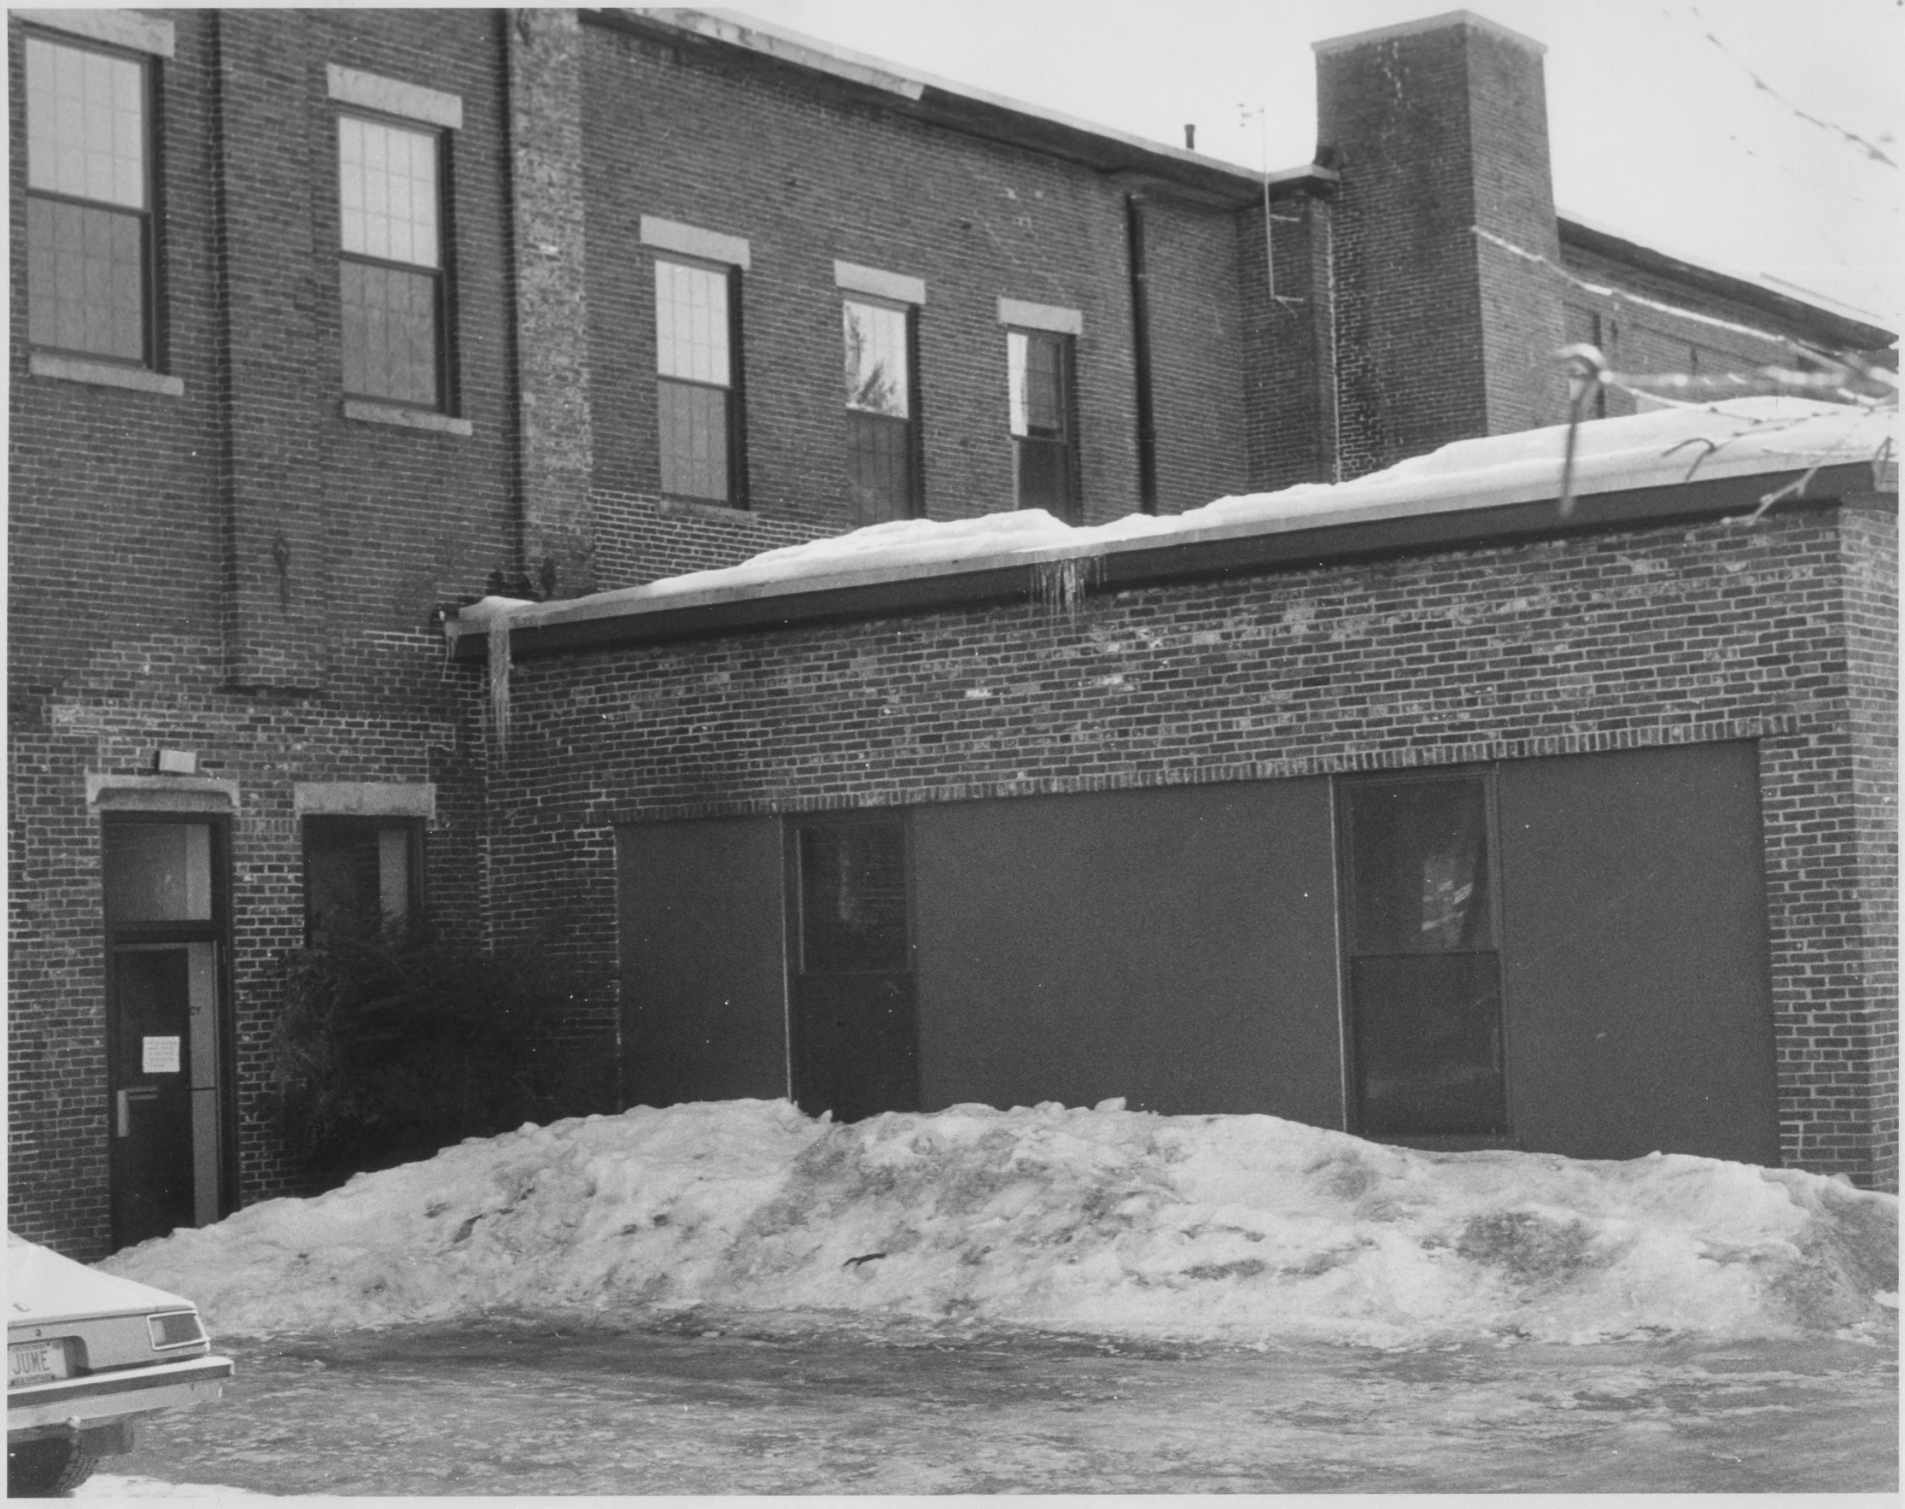
Photographer facing N NE E SE S SW W NW Photo Date: 26 February 1982 Photo Number 4 of 8

View from northwest showing 1868 one story boiler and drying room addition and joint in main building between 1860 and 1868 buildings where brick color changes occur. (Pipe at wall)

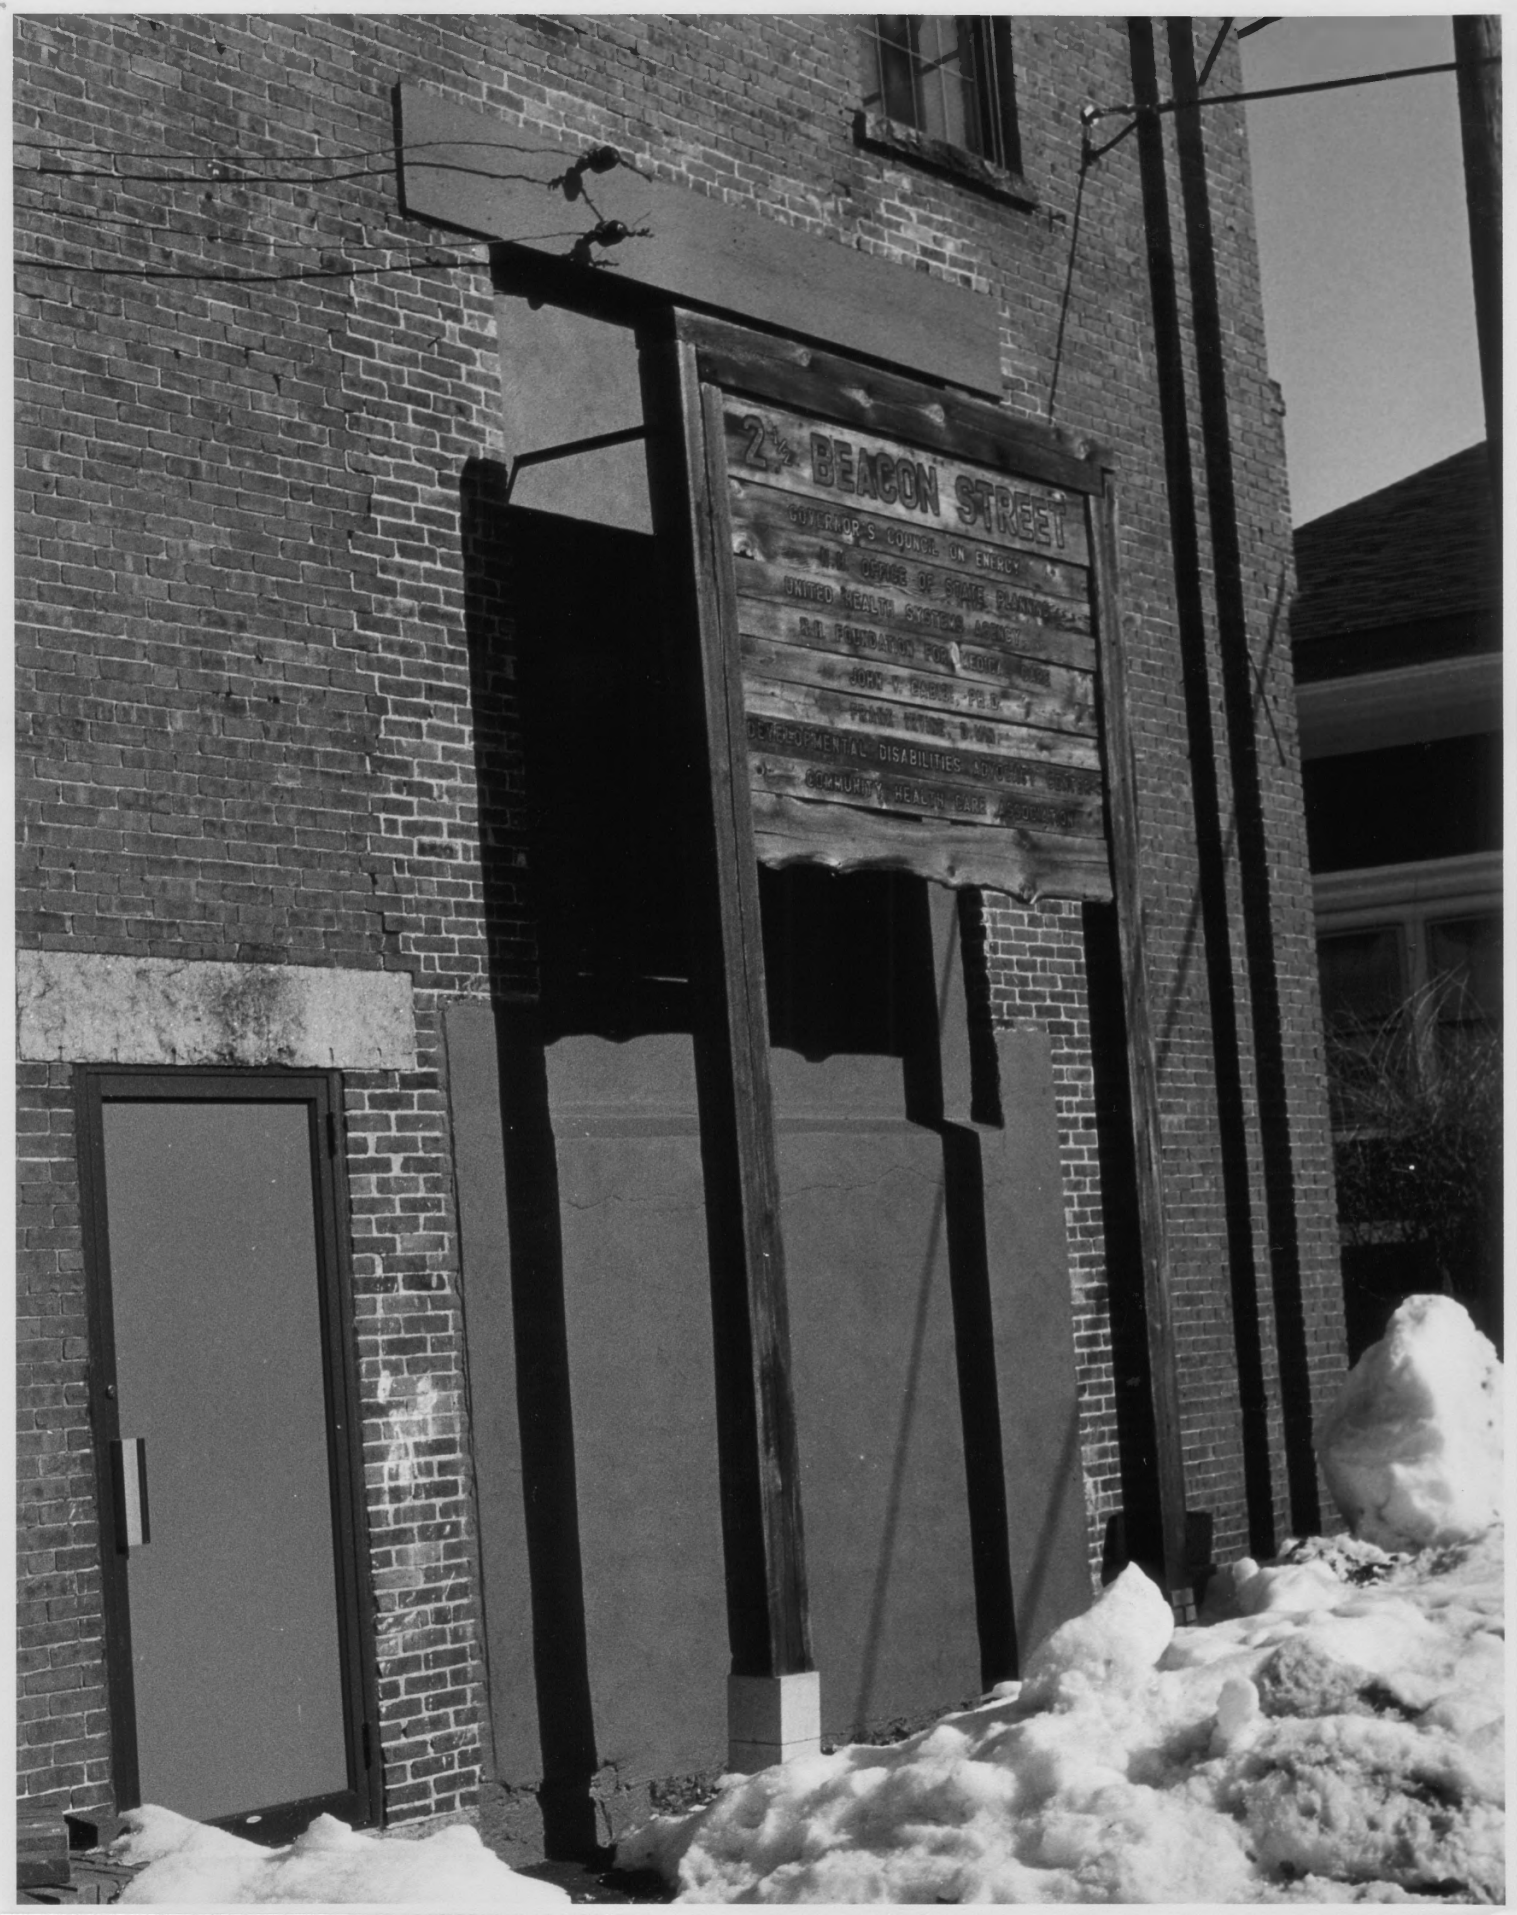
Photographer facing **N** **NE** E SE S SW W NW Photo Date: 26 February 1982 Photo Number 5 of 8

Description: South side of building showing former location of raised entry ramp for cars to upper level (behind sign) as installed when building was used as a Buick Garage.

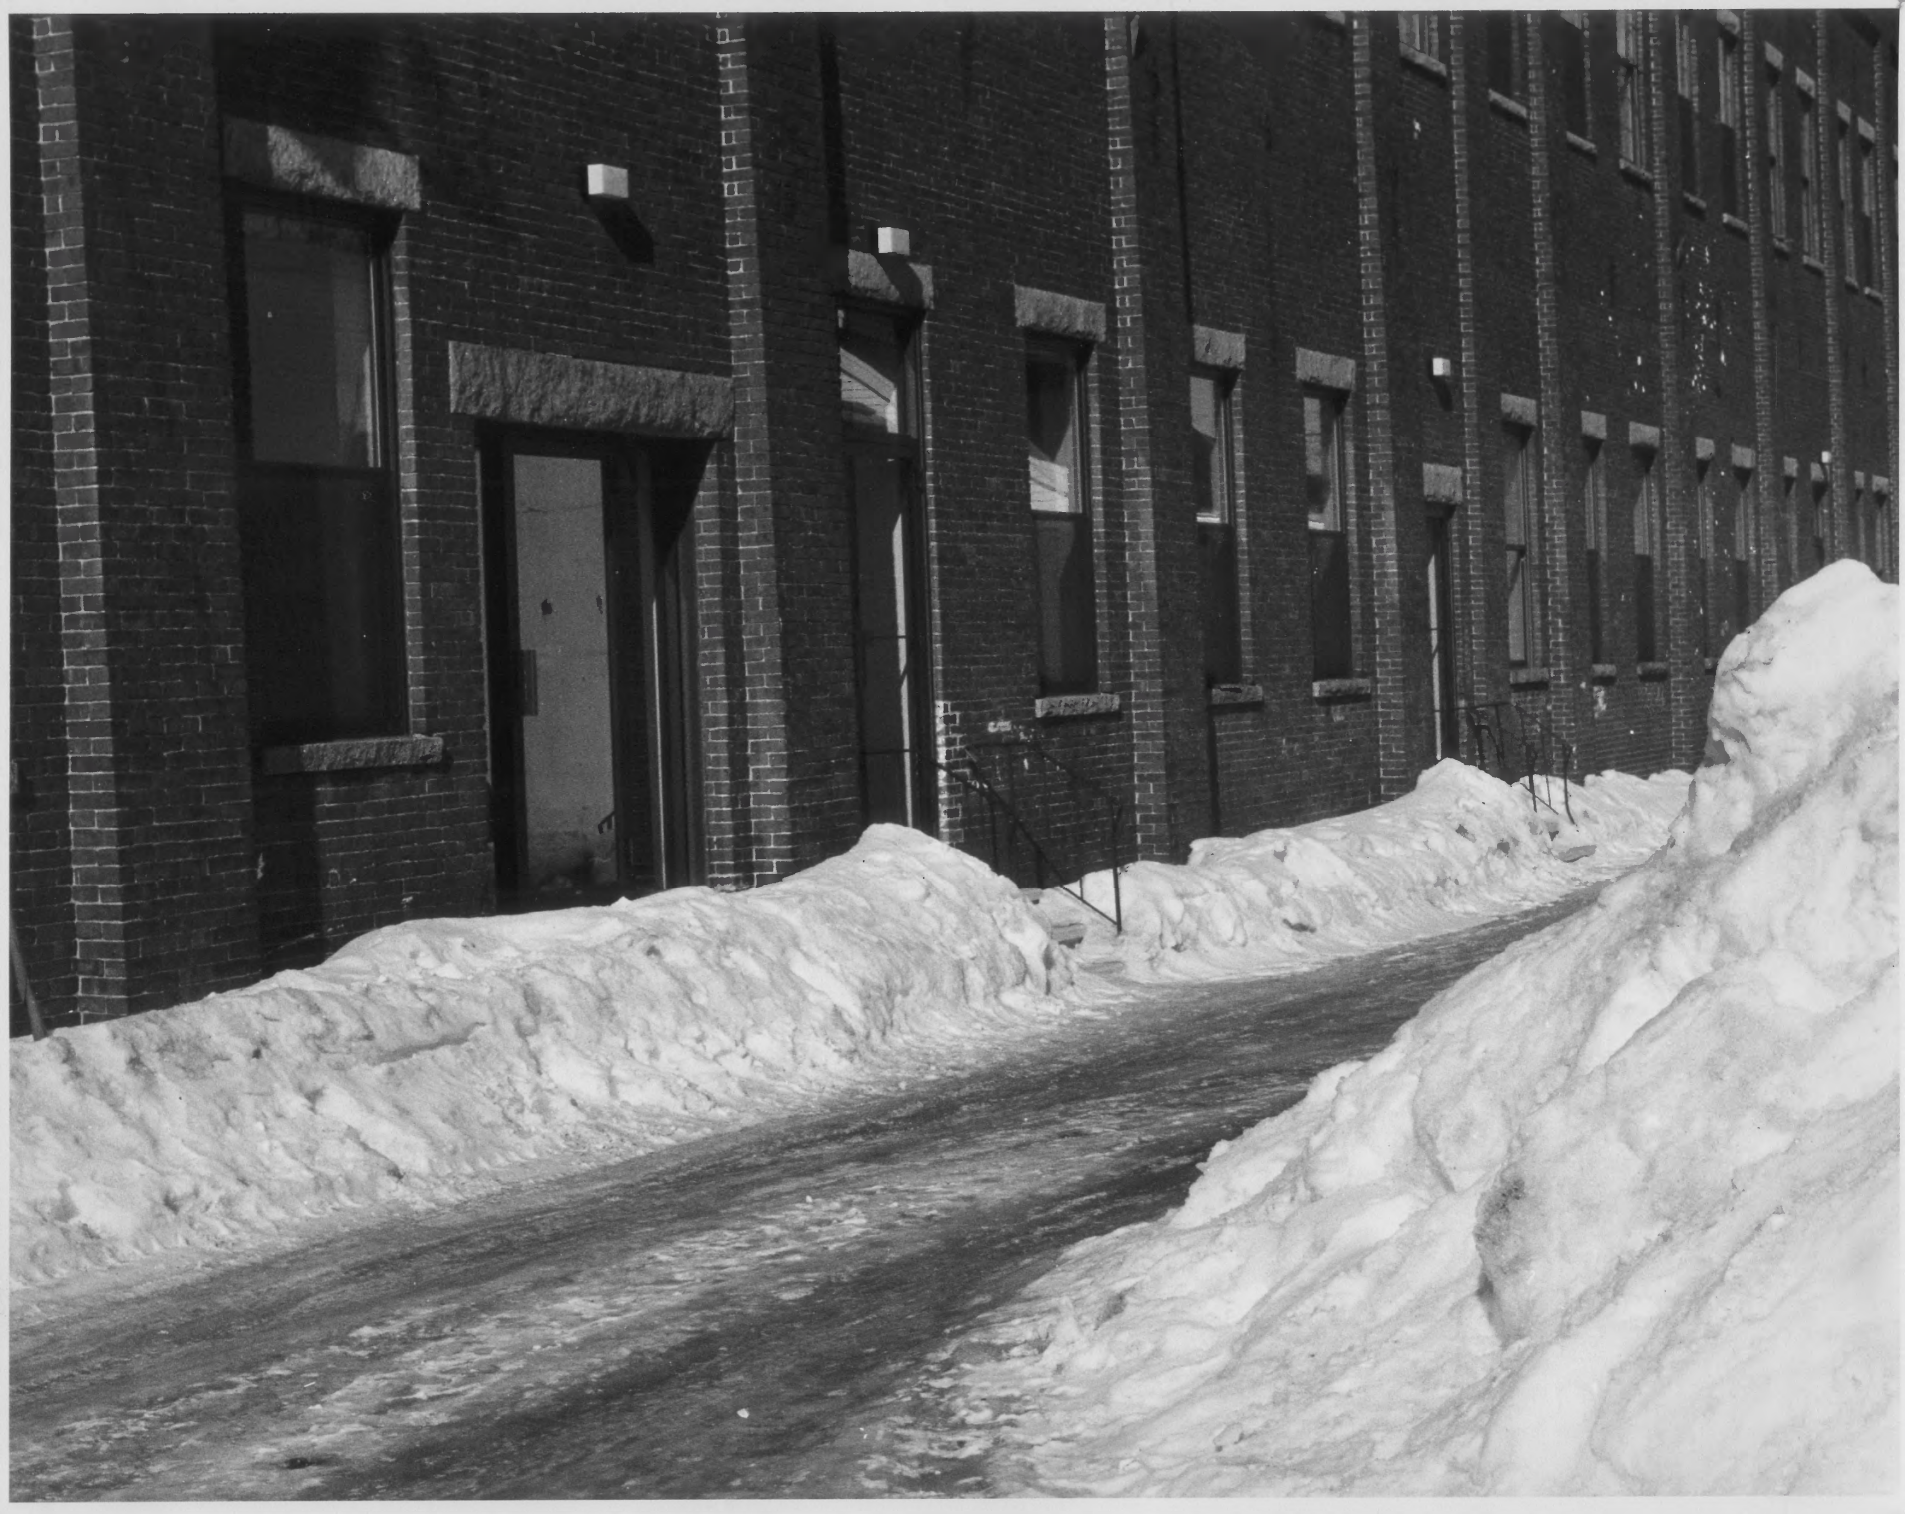
Photographer facing N NE E SE S SW W NW Photo Date: 26 February 1982 Photo Number 6 of 8

Description: East elevation of building showing typical bay detailing. Note low stone lintels over doors which originally faced the prison courtyard. Lintels below snow line were for basement windows and beams from 1819 workshop building.

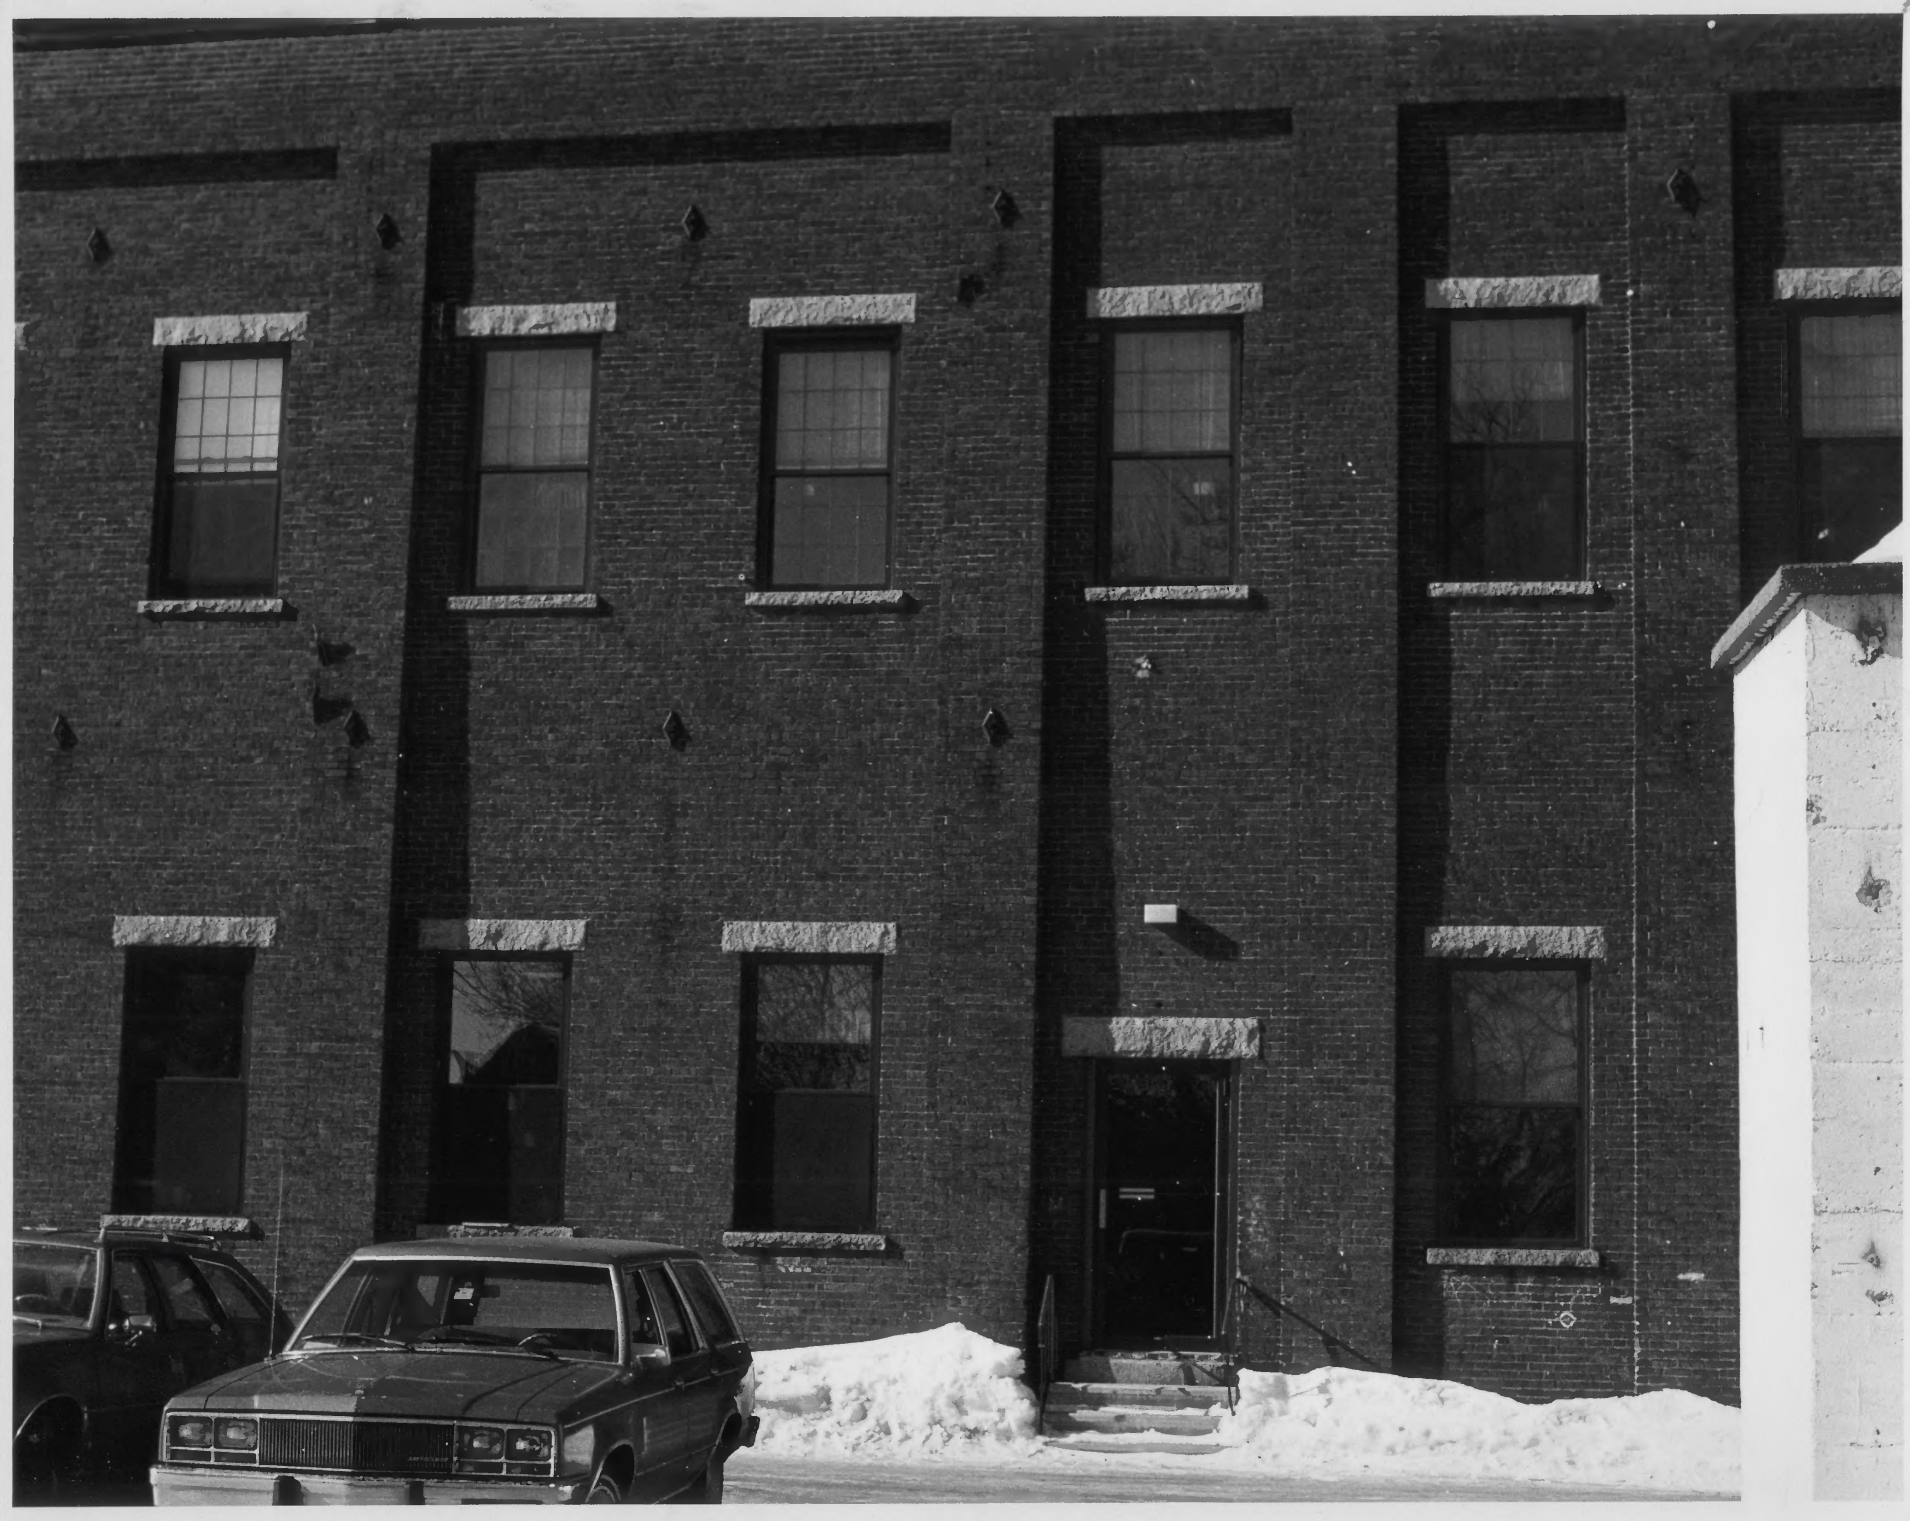
Photographer facing N NE E SE S SW **(W)** NW Photo Date: 26 February 1982 Photo Number 7 of 8

Description: View of east elevation at tenth bay in from the south end of the building, showing the extra pilaster where the 1860 and 1868 construction phases abutt.

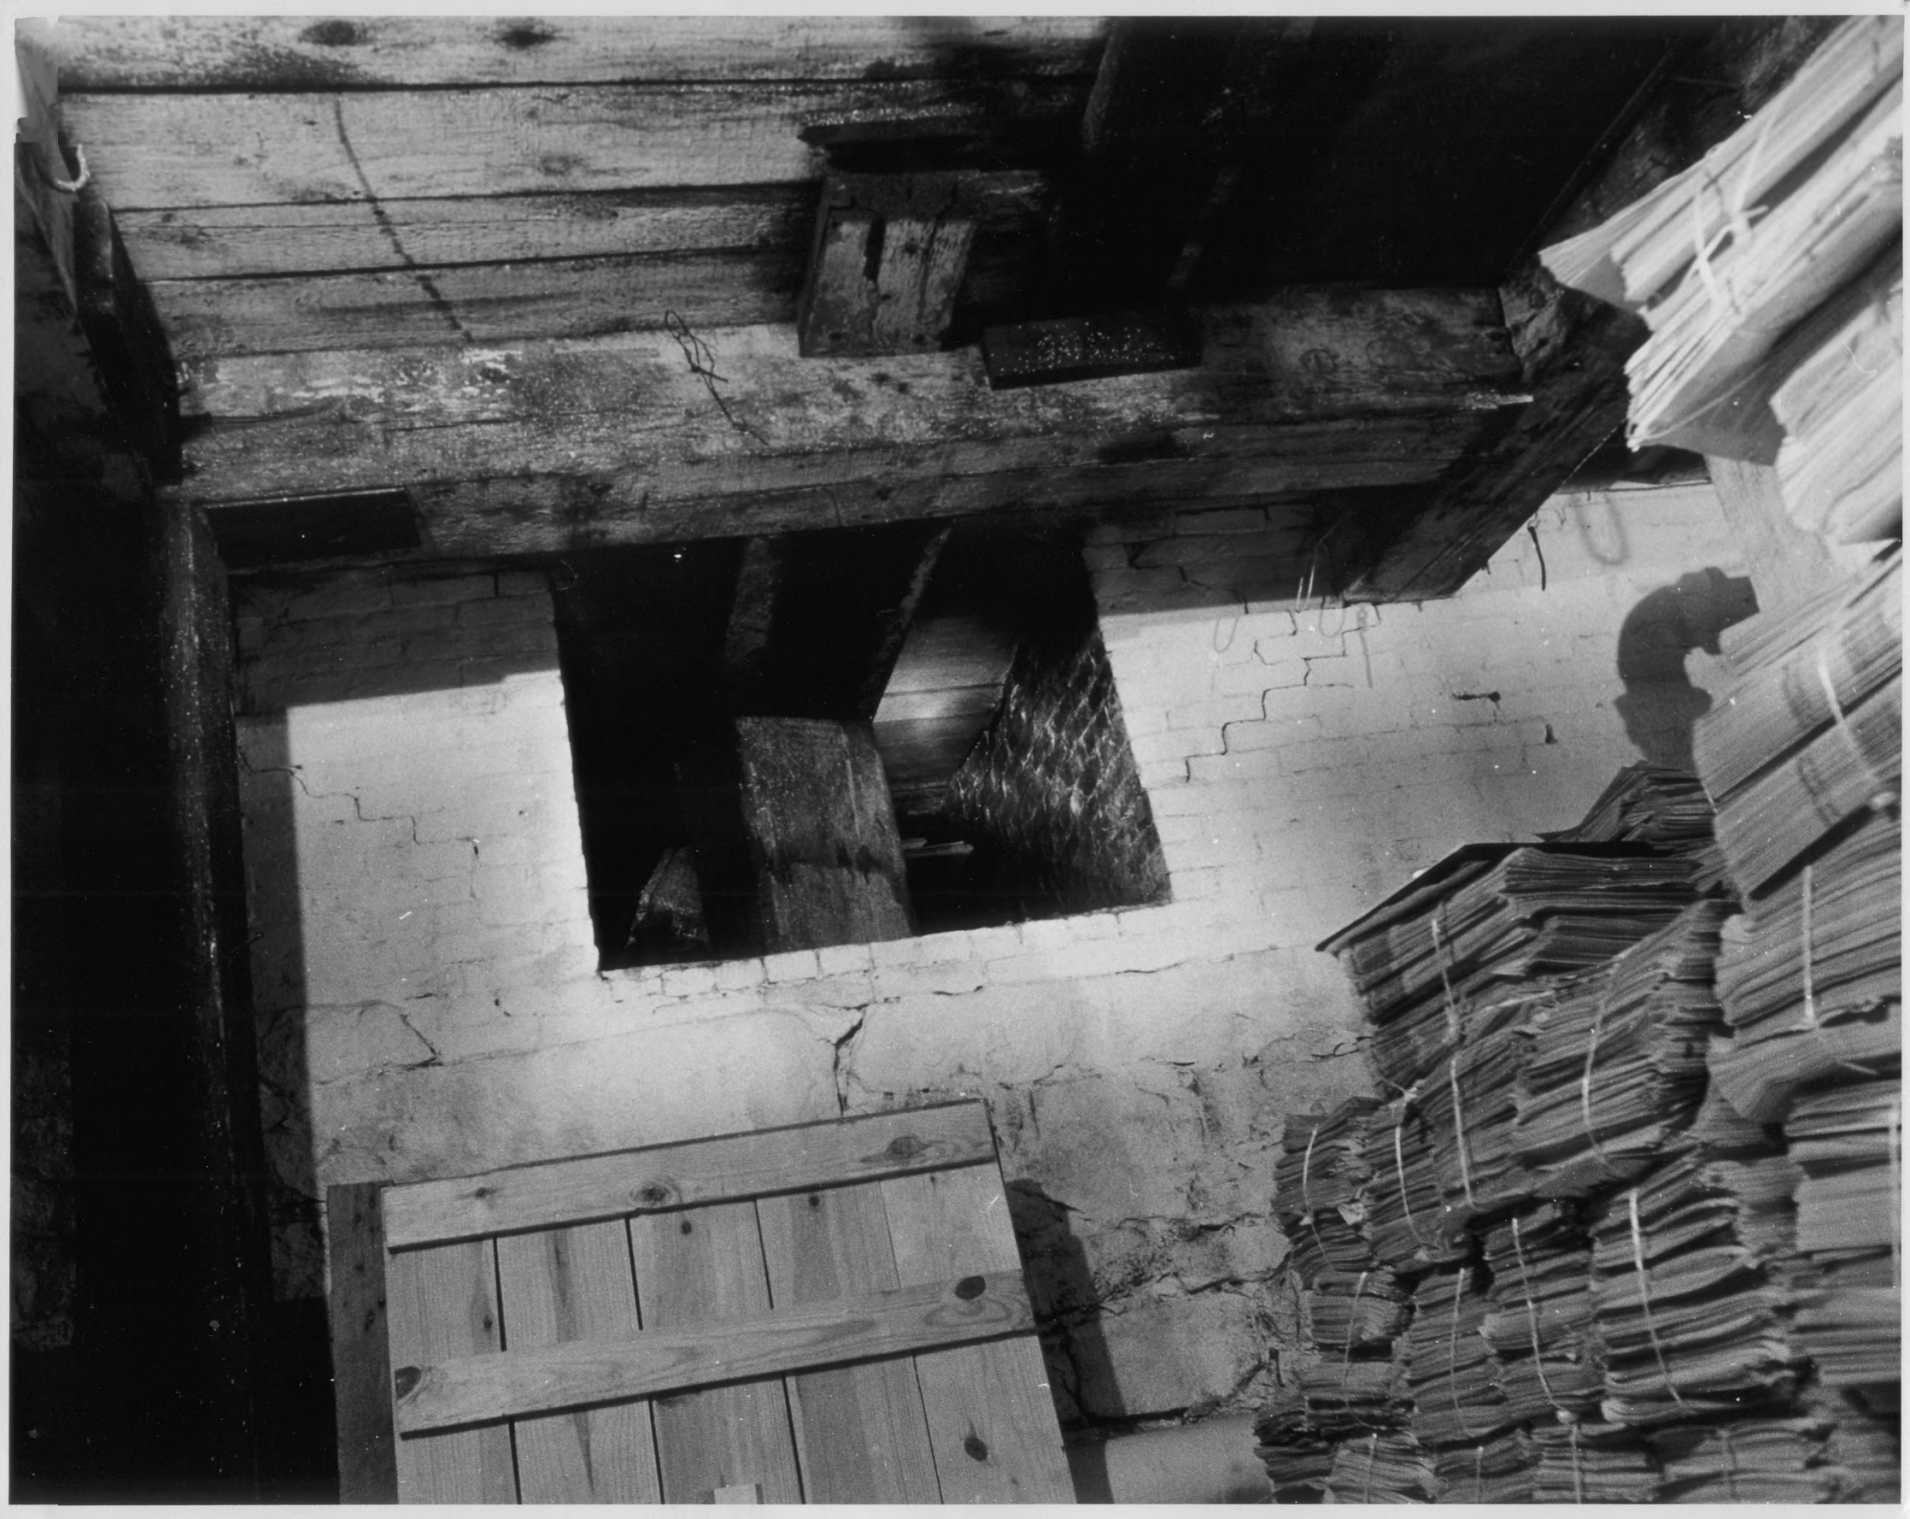
Photographer facing N NE E SE S SW W NW Photo Date: 26 February 1982 Photo Number 8 of 8

Description: Basement level view toward exterior window showing portions of beam structure of the 1819 workshop intact. On site inspection shows that the beam is sawed off at either end and has bearing plate marks on its underside from when a post was placed under it.
