Adams Farm
Property Name

Somerset
County

National Register of Historic Places Registration Form

historic name Adams Farm
other names/site number Old Adams Farm S-338

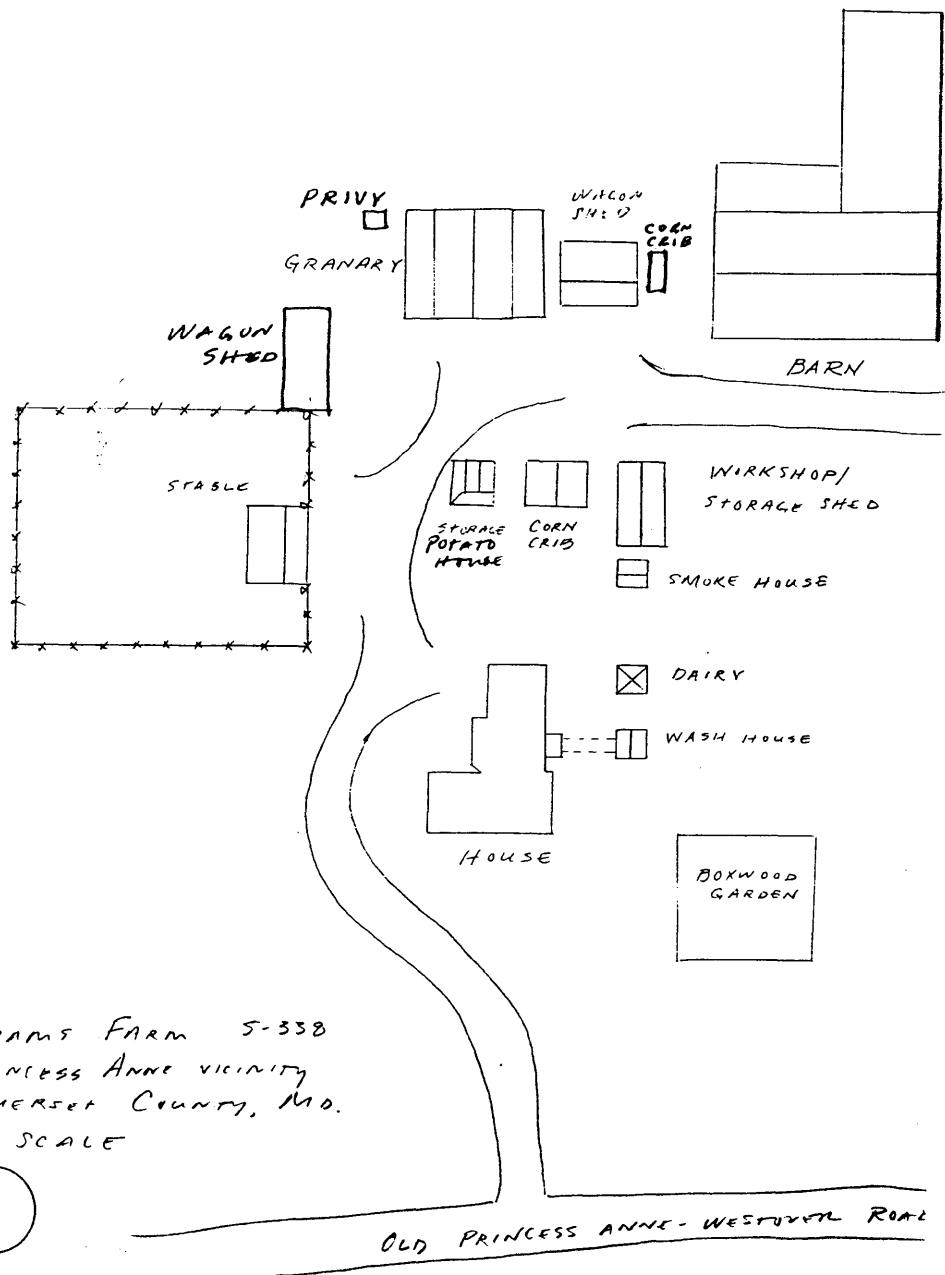
RESOURCE SKETCH MAP
1988

ADAMS FARM S-338
PRINCESS ANNE VICINITY
SOMERSET COUNTY, MD.
NO SCALE

Surrounding the farmhouse are over a dozen outbuildings, a boxwood garden and a lawn containing mature shade trees. Connected to the house by an open colonnade is a frame nineteenth century wash house supported by a brick foundation and covered with a wood shingle gable roof. Piercing the front wall is a board-and-batten door topped by a louvered vent. Six-over-six sash windows light the east and west walls, and a shed addition is attached to the south side. The interior has been reworked and is now covered with wall board.

The other outbuildings include a one story frame shed-roofed privy, probably nineteenth century, a modern stable, and another wagon shed, possibly turn of the century. Located southwest of the house is a four-square boxwood garden which is estimated to date to the 1930's or 1940's.

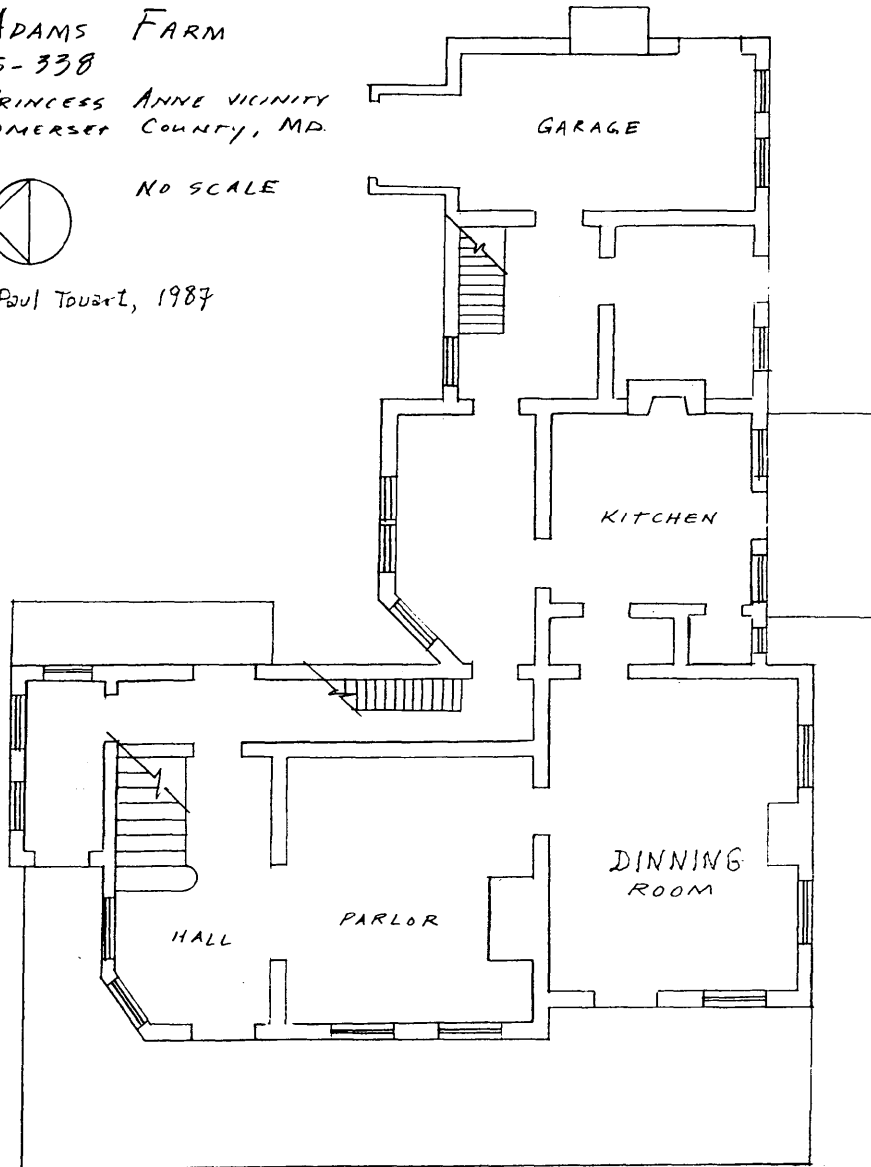
FLOOR PLAN - FIRST FLOOR

ADAMS FARM
S-338
PRINCESS ANNE VICINITY
SOMERSET COUNTY, MD.

The interior of the main block is divided unconventionally with a side hall to the north, a parlor and dining room to the south and a back hall — connecting the rooms across the rear. The interior finishes largely date from the late Victorian period, but some woodwork in the dining room survives from the c. 1835-1840 period. In addition, some remodeling was accomplished during the 1950's in the parlor and dining room.
