National Register of Historic Places Registration Form

Historic name: Amos Goodin House

Other names/site number: David Goodin House; DHR #053-0468

Street & number: 37738 Wright Farm Drive

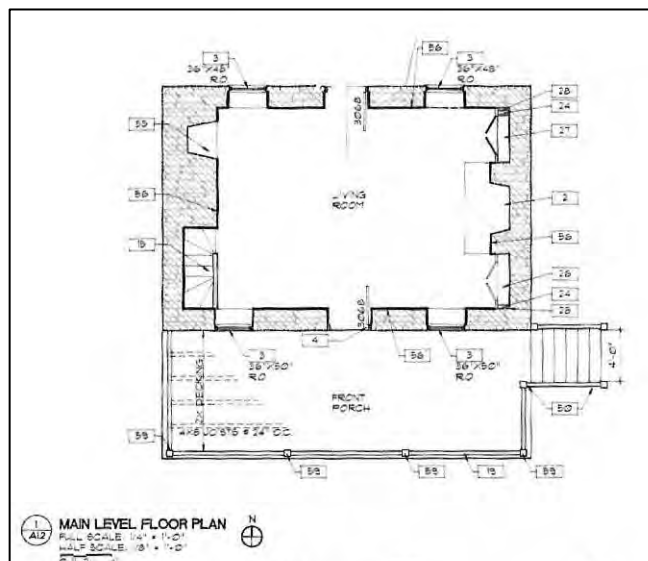
The Amos Goodin House's interior plan reflects the English Plan with the typical "hall room" and winder stair, but had a single room off of it instead of the two rooms with center canted fireplaces as shown in the example at left. The wall that once separated these two spaces has been removed, but for stubs that indicate the original configuration. In the Goodin plan (see below), the fireplace on the west side of the "hall room" is not centered, but is situated off-center on the west gable end wall, with a most unusual small cupboard above the fireplace and on the south wall. The winder staircase is adjacent to the left of the fireplace. The east fireplace is

A front door and less formal rear door provide access to the space. In the southwest (front) corner of the room is a boxed, winder stair leading to both the cellar and the attic floor bedroom. This stair configuration uses considerably less space than a centrally located stairway due to its winding configuration that efficiently accommodate a 180-degree change in direction. All utilities for HVAC, plumbing, and electric run up and down behind the original built-in cabinet, leaving the interior with few visible signs of modernization other than several outlets, which are required by building code. Vertically-oriented, raised-panel, wood doors replaced the ca.1805 entrance doors to

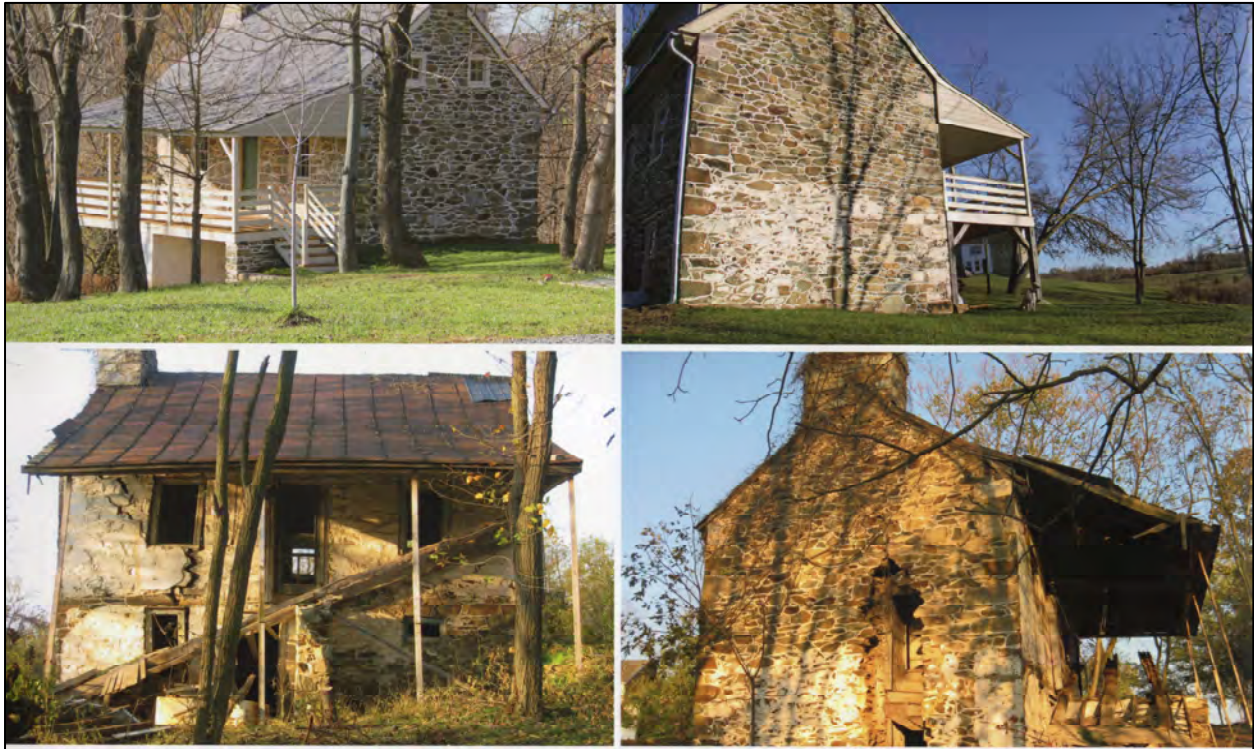
Figure 1. Amos Goodin House, “After and Before, Restoration; photos taken in 2015 (top) and 2010 (bottom). Photos by Matthew Parse.

The ca. 1805 Amos Goodin House is a three-story dwelling constructed of irregularly coursed Short Hill fieldstone and topped with a gabled roof covered in oak shingles that replaced the existing tin roof. The exterior house dimensions are 29' x 19', and the approximately 24-inch-thick walls are finished in fine cornerstones. The building had been vacant for many years prior to a restoration project. Doors and window sash were missing and the mortar in the stone walls was failing. The historic porch also was deteriorated. Enough historic materials remained, however, to provide a basis for replacement-in-kind of missing elements. At the end of this section, Figure 1 shows how the house looked before and after restoration work.

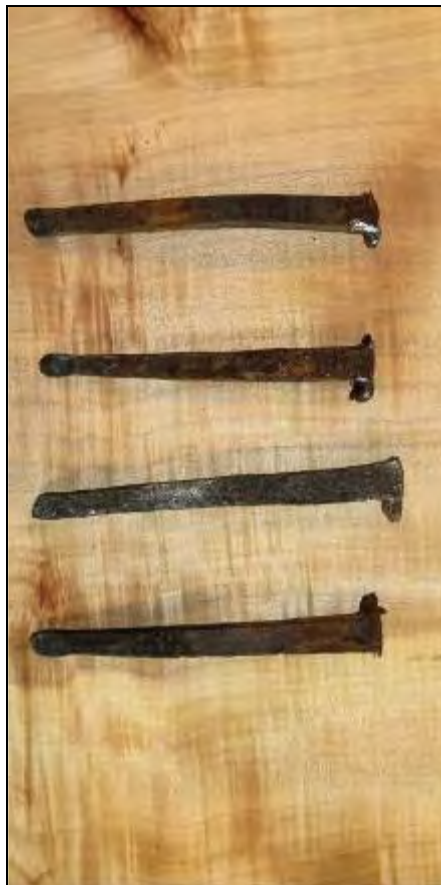
renovation process. Analysis of these nails finds they were most likely manufactured in the 1775-1800 time period.³

Figure 2. Original Hand Wrought Nails, 2010, Photo by Matthew Parse.

² Although the period of significance dates the house to the early 19th century, some of its details hint that the building may have been constructed between 1775-1800. The period of significance begins ca. 1805, but the nails that were found and reused in the building appear to have been made before 1800. Willie Graham, Curator of Architecture at Colonial Williamsburg Foundation, has confirmed that these nails were from 1775-1800 via email correspondence. Additional clues that point to the possibility of an earlier construction date are that Amos Goodin purchased the property from Mahlon Janney in 1760, and the deed notes, "Together with all houses orchard ways water courses and all other appurtenances with the rents issues and profits thereof (sic)." The structures transferred with this deed were, most likely, built of wood since almost every old stone house in Loudoun was preceded by an earlier temporary log building (Hertz). The "houses orchards and edifices and all other appurtenances (sic)" were also listed in a previous indenture (lease and release) between Mahlon Janney and blacksmith John Hatcher on 6 November 1753, at the same property. In a Virginia Historic Landmarks Commission survey form, #53-468, completed in 1975 by John G. Lewis, he states, "many aspects of this structure appear much earlier than the 1805 date of construction." Amos Goodin died in 1801, and in his will (written in 1798), he stated, "I give devise and bequeath unto my Son, David Goodin, my Plantation whereon I now live be it more or less the same to hold to him his heirs and assigns forever;(sic)." During restoration, there was absolutely no indication that there had been a previous building on the site or any additions to the extant house. Therefore, Amos Goodin, most likely, lived in an earlier previous log house transferred with the Mahlon Janney deed but he may have been able to build the current stone dwelling before his death in 1801. The ambiguity in the historic records and construction materials, however, mean that currently only an estimated date of construction for the house is possible.

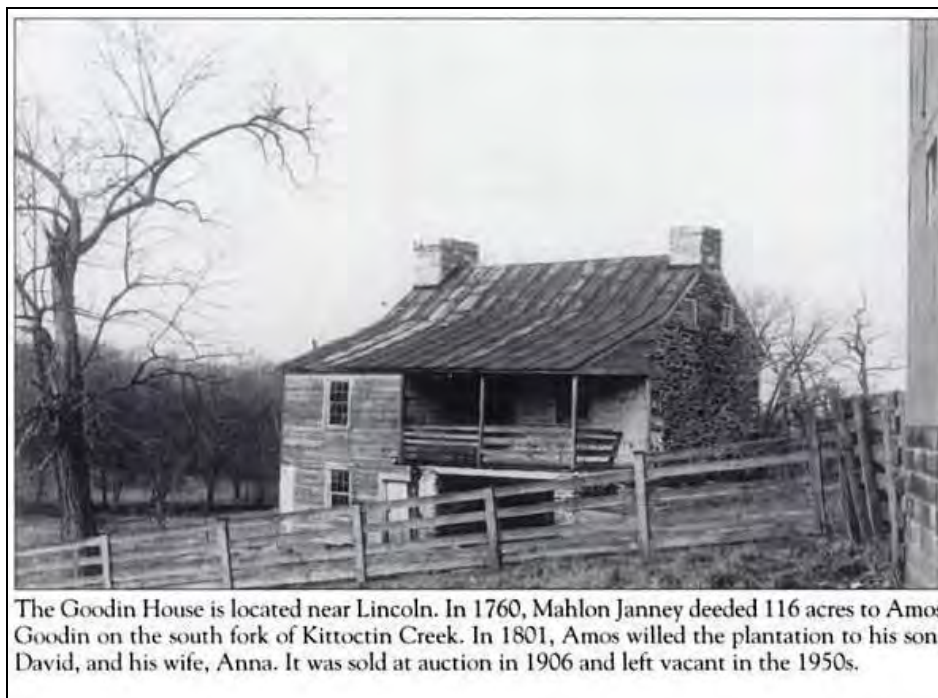
undated photo (below) in Solange Hertz's book, *Old Stone Houses of Loudoun County, Virginia; an Illustrated Tour*, shows how the house appeared around that time. Nothing was done to restore or renovate the house (through a number of owners) until 2010, when Matthew Parse purchased the property and began restoring the house.

Figure 4. Image, Amos Goodin House. Date, photographer, and original source unknown.¹⁶
