National Register of Historic Places Registration Form

Historic name: Mount Cammerer Fire Lookout

Other names/site number: White Rock Fire Lookout

Historic Resources of Great Smoky Mountains National Park

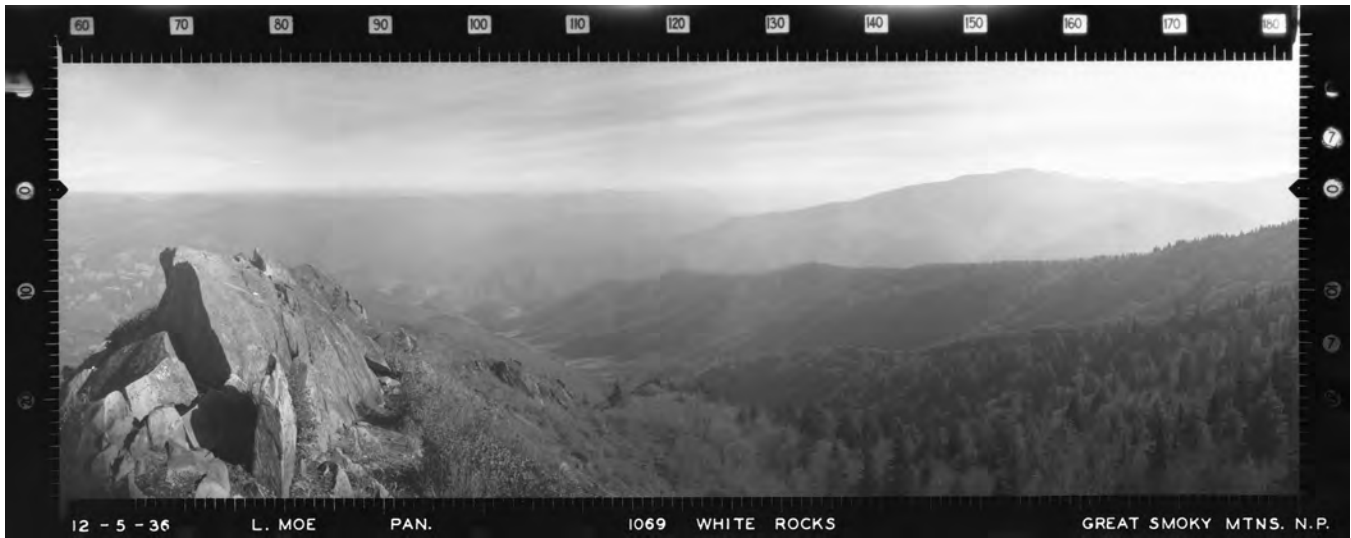
Figure 3. Photograph from White Rocks prior to construction of Mount Cammerer Lookout, 1936. One of three photos which together provide a 360 degree view from this point (source: GSMNP, Collection Preservation Center, Townsend Tennessee).

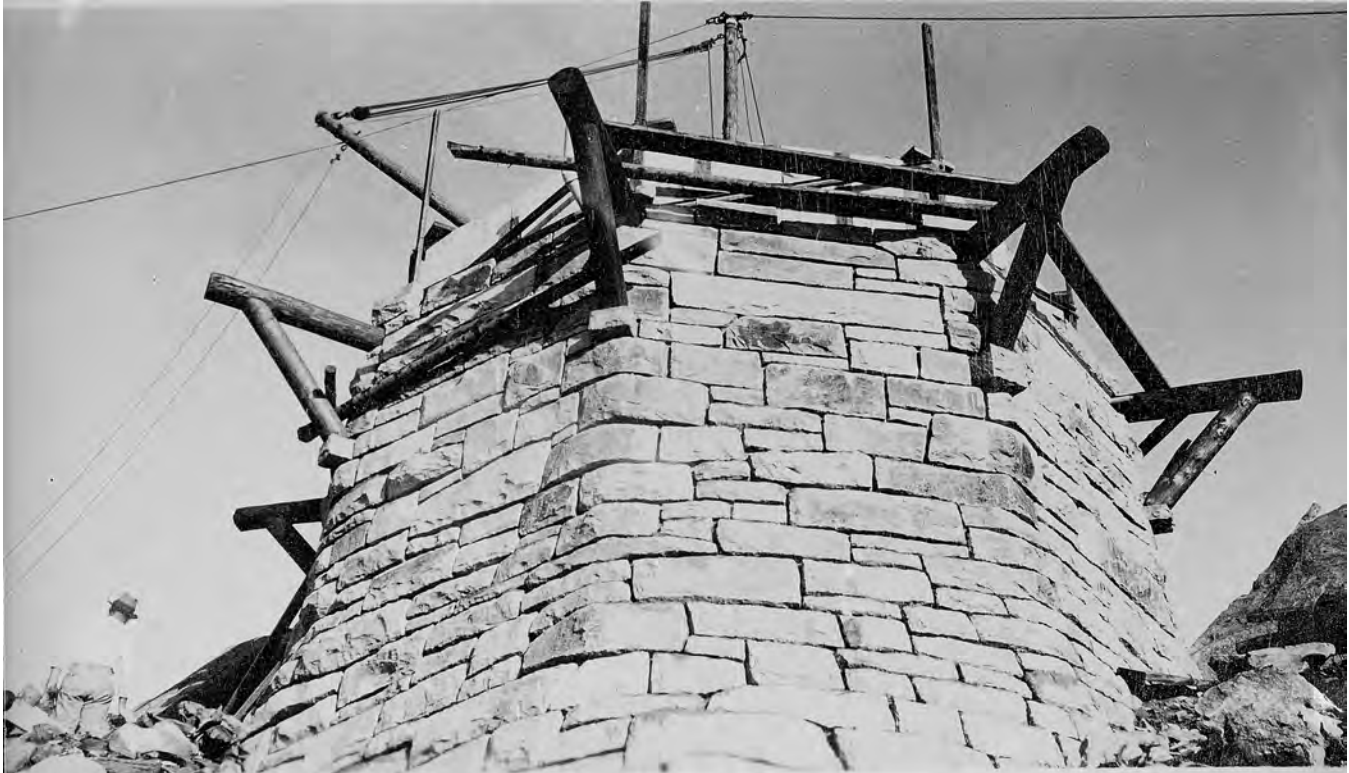
Figure 7. Photograph of Mount Cammerer Fire Lookout under construction, supports for catwalk in place, 1937 (source: GSMNP, Collection Preservation Center, Townsend Tennessee).

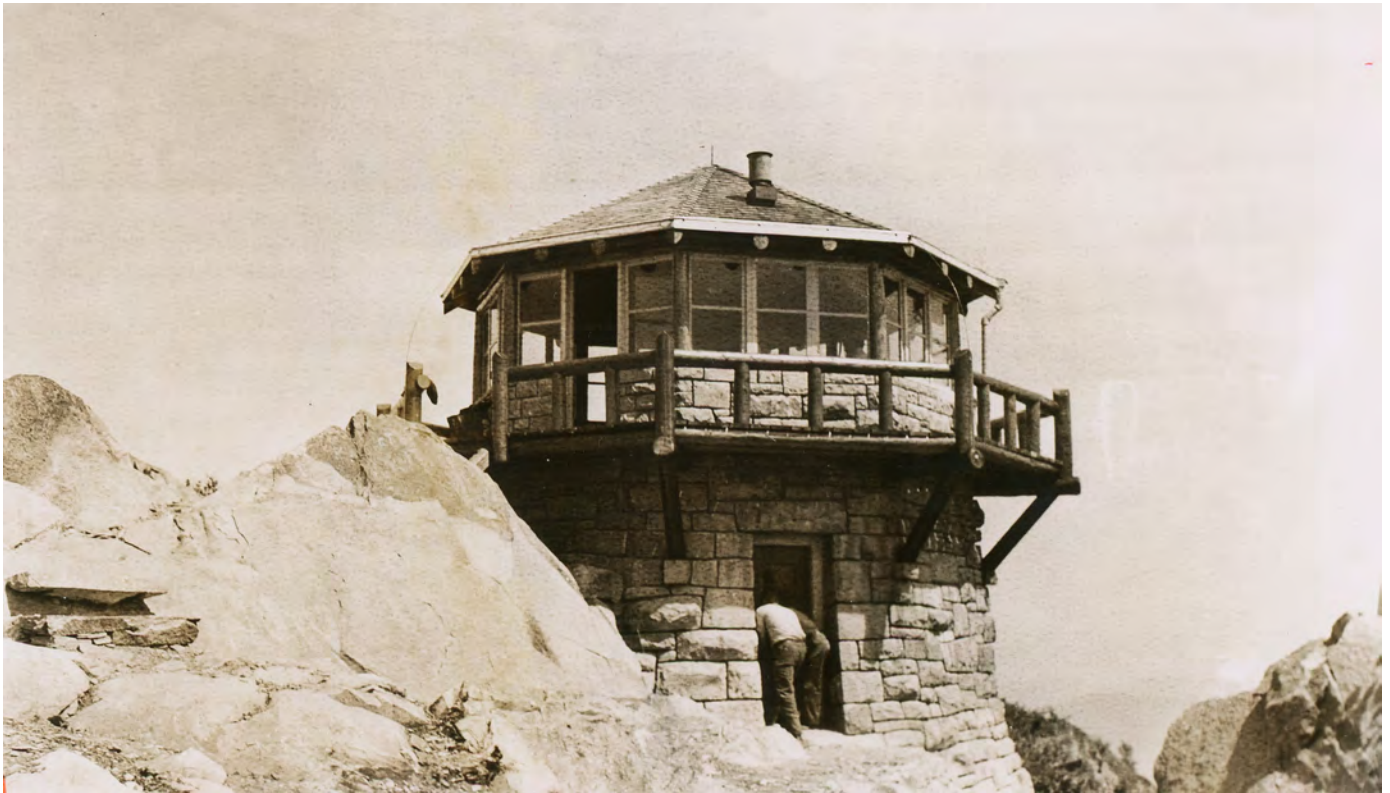
Figure 8. Photograph of Mount Cammerer Fire Lookout after completion, undated (source: GSMNP, Collection Preservation Center, Townsend Tennessee).
