NATIONAL REGISTER OF HISTORIC PLACES  
REGISTRATION FORM

historic name Joseph W. and Ida Guest House

other names/site number Rosemont (preferred), CRS# N14434

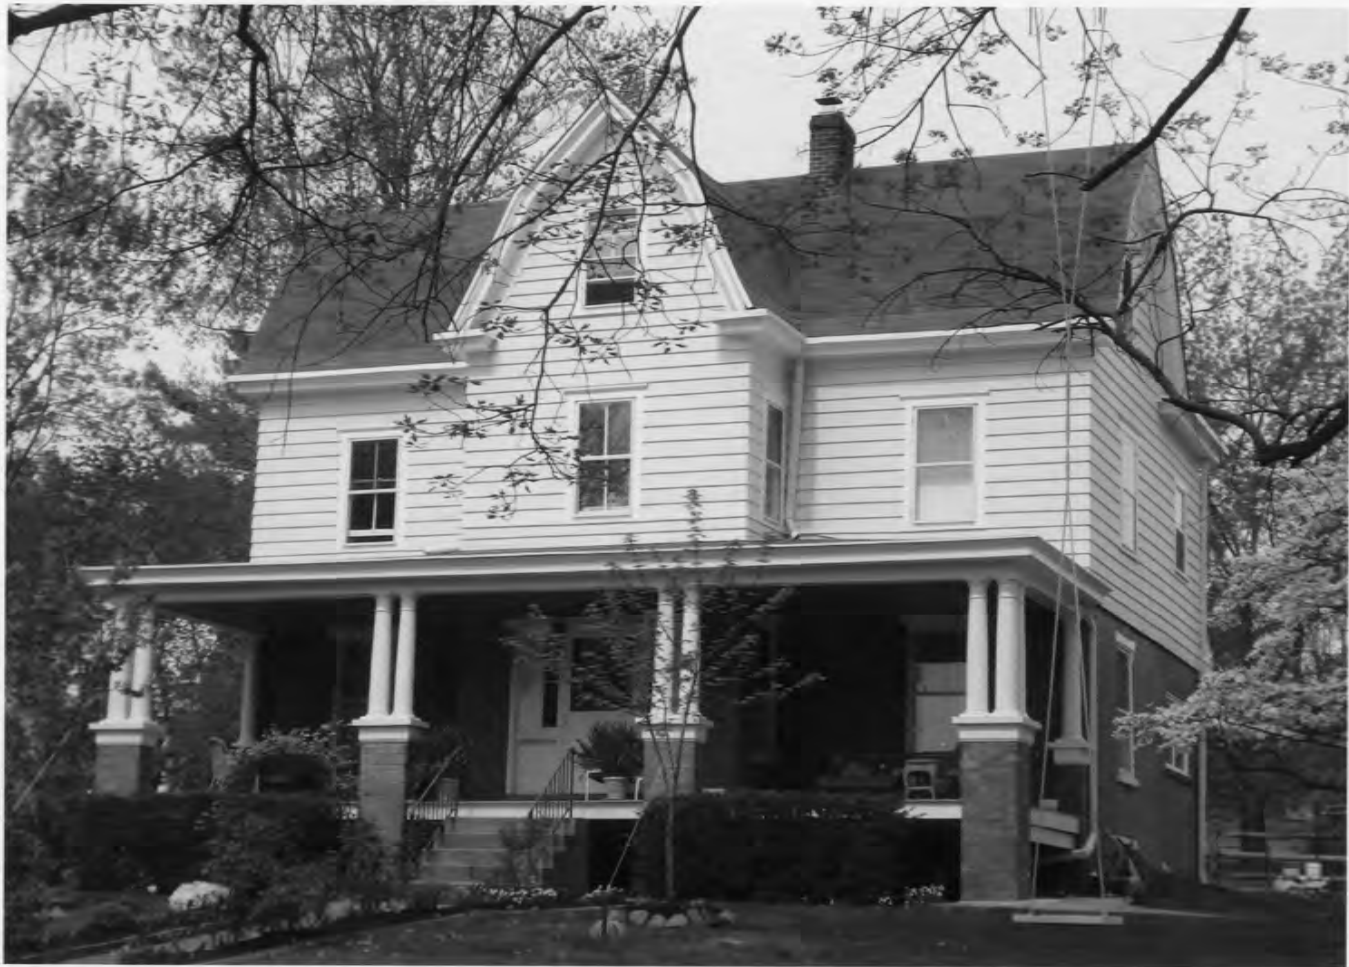
Photo 1 of 13

Facade + north elevation, Facing SW

The façade of Rosemont is three bays wide with a central cross gable reinforced with the entire bay projecting east from the main block edge a full bay in width. The first floor is veneered with unbonded brick with the upper levels sheathed in weatherboard with a wide reveal. The entrance is centered in the central projecting bay and is composed of a single leaf Colonial Revival door with panels below and glass above flanked by unadorned glass sidelights. To complete the surround the sidelights have solid wood panels on either side. There is no transom, just a wood lintel over the doorway. Regularly placed two over two double hung sash wood windows punctuate the bays across the rest of the building with the exception of the projecting bay where original windows in a 1/1 configuration survive which are smaller in width than those across the remainder of the façade. The wood have simple wood lintels and lug sills. The moldings are more detailed on the first floor displaying a large bead in the surround. The windows are also longer on the first floor than the floors above. The first level displays a full width porch with clustered truncated Tuscan columns on brick pedestals. There is no porch railing present. The decking and roof are replacement in kind of original fabric which had deteriorated badly.

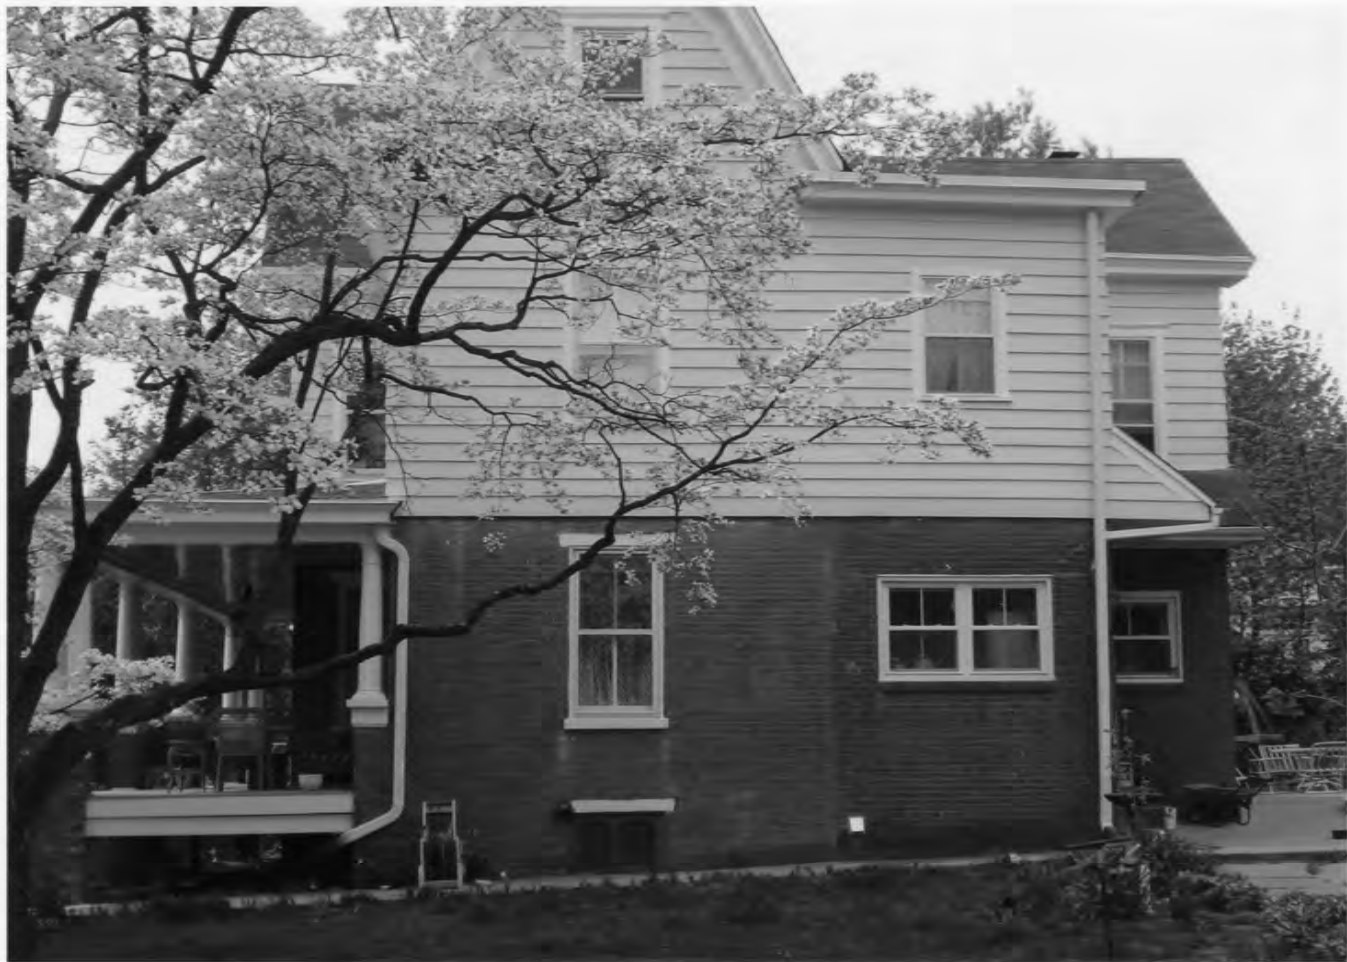
Photo 2 of 13

North Elevation, Facing South

The north elevation is similarly detailed in the main block from attic to roofline as the south elevation. The enclosed side porch is visible from this elevation.

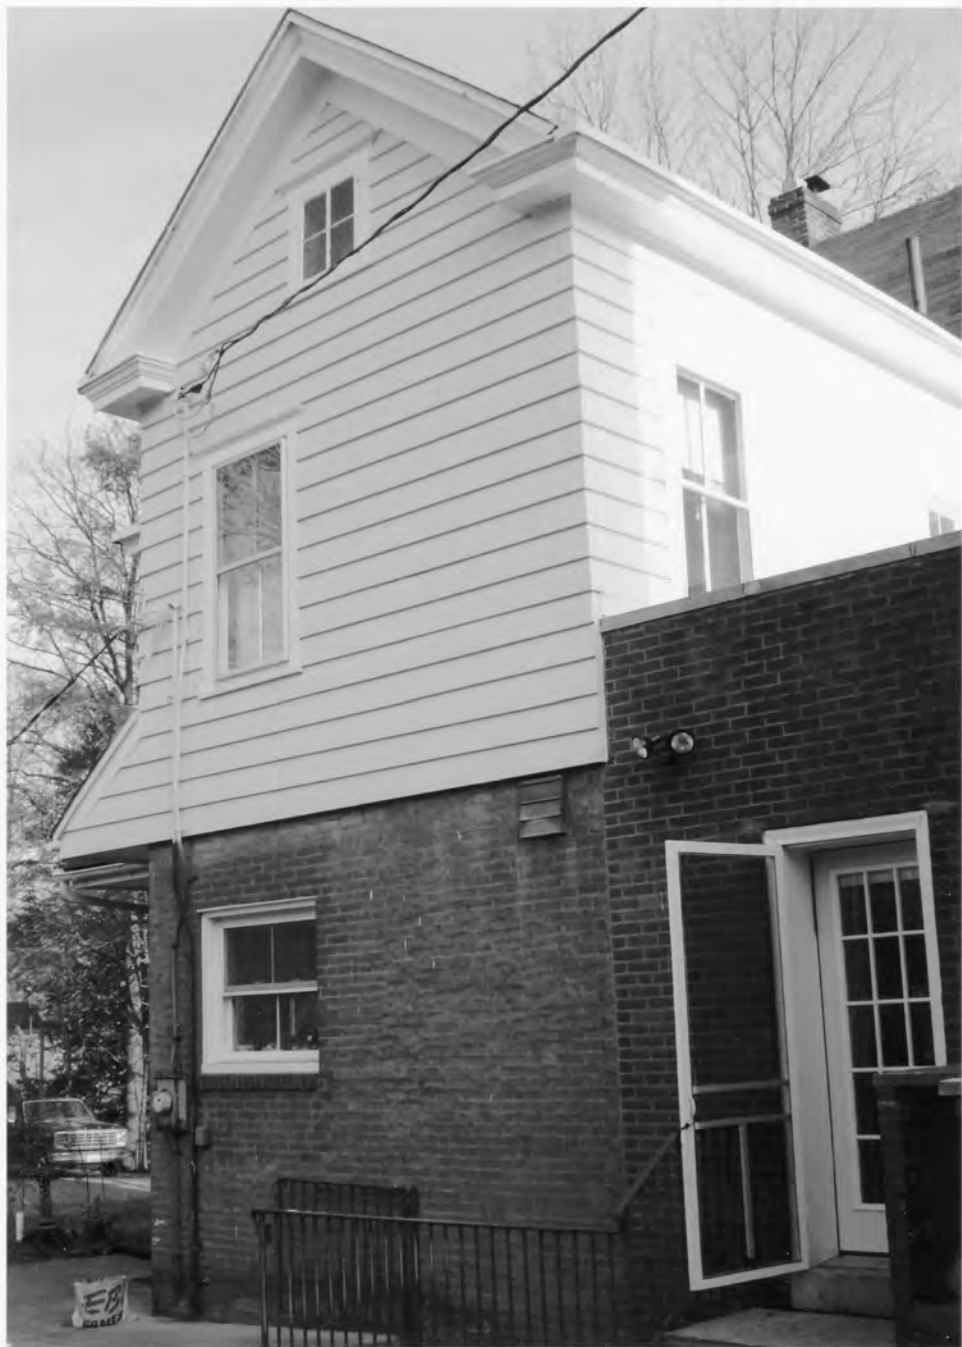
Rosemont, 15 1/2 Cragmere Rd  
Brandywine Hundred, New Castle County, DE  
Photo by: Robin Krawitz May, 2008  
Rear Elevation, Faculty NE  
Photo 3 of 13

The large chimney stack of the addition dominates the rear (west) elevation. The chimney is placed in the southern bay of this elevation and breasts to the exterior. A rear door is centrally located in the elevation in the addition and the cellar is accessed through a door sited a level below this door in this location that is accessed via a concrete staircase running parallel to the exterior wall. A modern replacement window is located in the historic period opening in the brick faced first level in the north bay of the elevation. The upper floor of this elevation displays the rear of the el which includes the single 2/2 double hung sash window placed directly above the window in the lower level, a four pane attic vent window centered in the gable end and the raking cornice with gable returns that outline the roof structure. The enclosure of the rear porch to expand the kitchen is visible from this elevation as well. The wood siding extends on the second level to fill in the side of the roof overhang of the former rear porch.

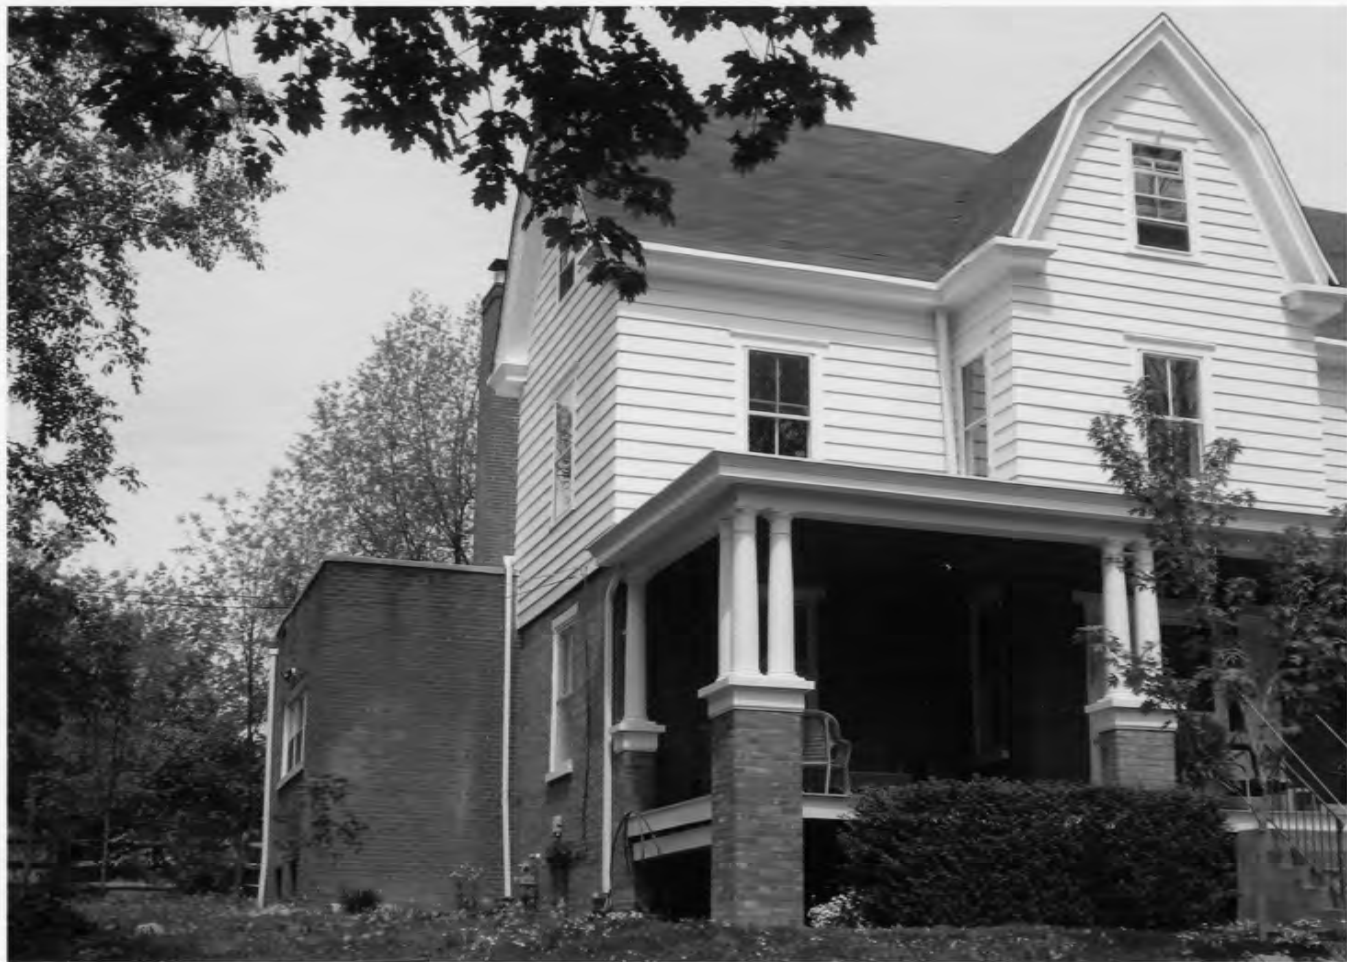
Photo 4 of 13

South Elevation + Façade, Facing NW

The south elevation of the building displays one 2/2 double hung sash window of identical size at each level of the main block of the building. The basement is vented with a screened wood panel decorated with a pair of simple arched moldings. The one story brick addition that houses the family room is evident on the first level of this elevation toward the west and displays a Chicago-style window. The upper floor of the rear el is visible above and displays two 2/2 double hung sash wood windows.

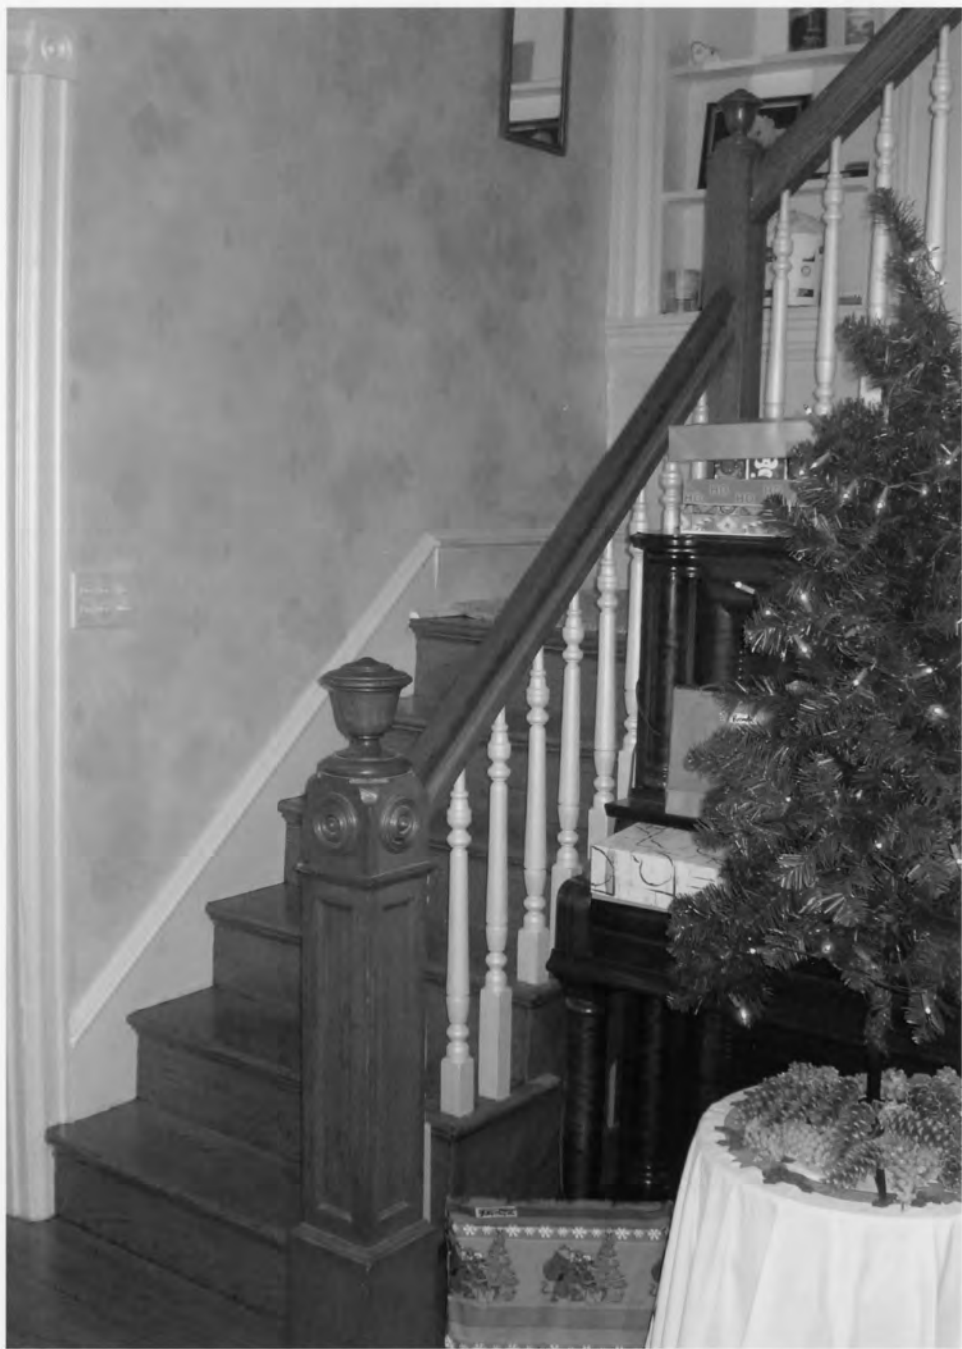
Rosemont, 15 1/2 Craymere Rd  
Brandywine Hundred, New Castle County, DE  
Photo by: Robin Kvanitz, DECEMBER 2007  
Interior detail, Entry Hall Newel Post  
Photo 7 of 13

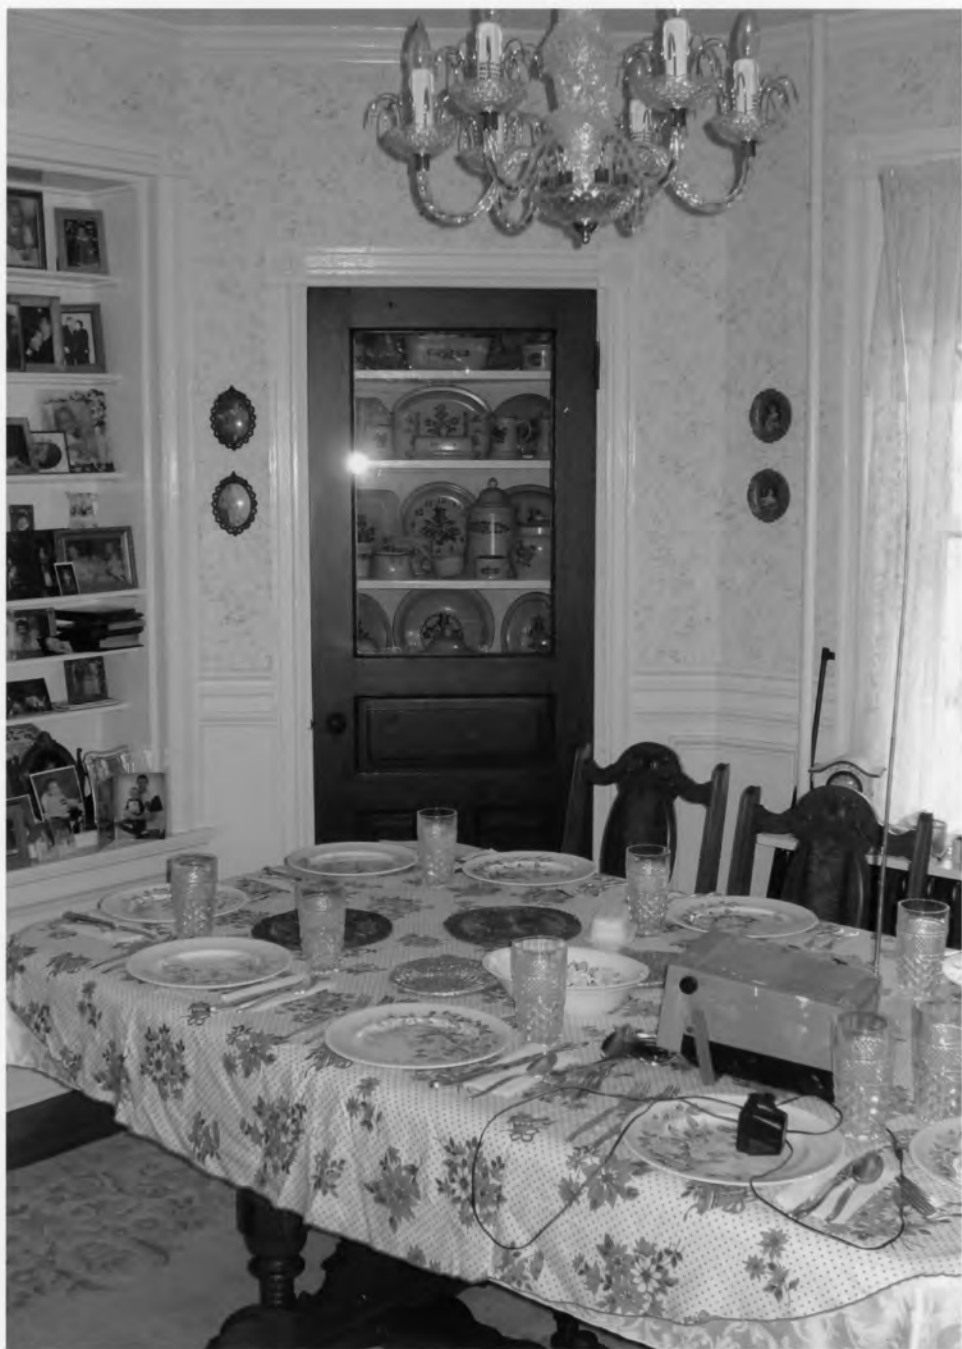
Photo 8 of 13

Interior Detail, Dining Room

The first floor interior room arrangement included the dining room, which is accessed from the north side of the entry hall. Surviving original features include a built-in corner cupboard and a swinging door from the kitchen area into the dining room which displays an aesthetic-movement-inspired hand plate. The parlor, located to the south side of the entry hall, retains its original massing and simple window treatment. The c. 1960 addition to the rear adjoins the house at this location, the site of what may have been an original window, elongated into a door. The evidence for the corner fireplace that was once located in this room survives in the ceiling framing in the basement. The kitchen displays mid-20<sup>th</sup> century cabinetry. In addition to the large open space that may have served as a sitting room, bedrooms are located over the parlor and dining room, as well as over the kitchen wing. The attic is accessed by a straight stair and contains finished rooms in the main block section of the house and unfinished attic space over the rear el. The full basement has high ceilings as well as brick and stone foundation walls. The stone is reputed to have been reused from an earlier building on the site. Overall integrity of the building is enhanced by the survival of the original 2/2 wood windows with bull's eye corner block molding surviving throughout as door and window trim.

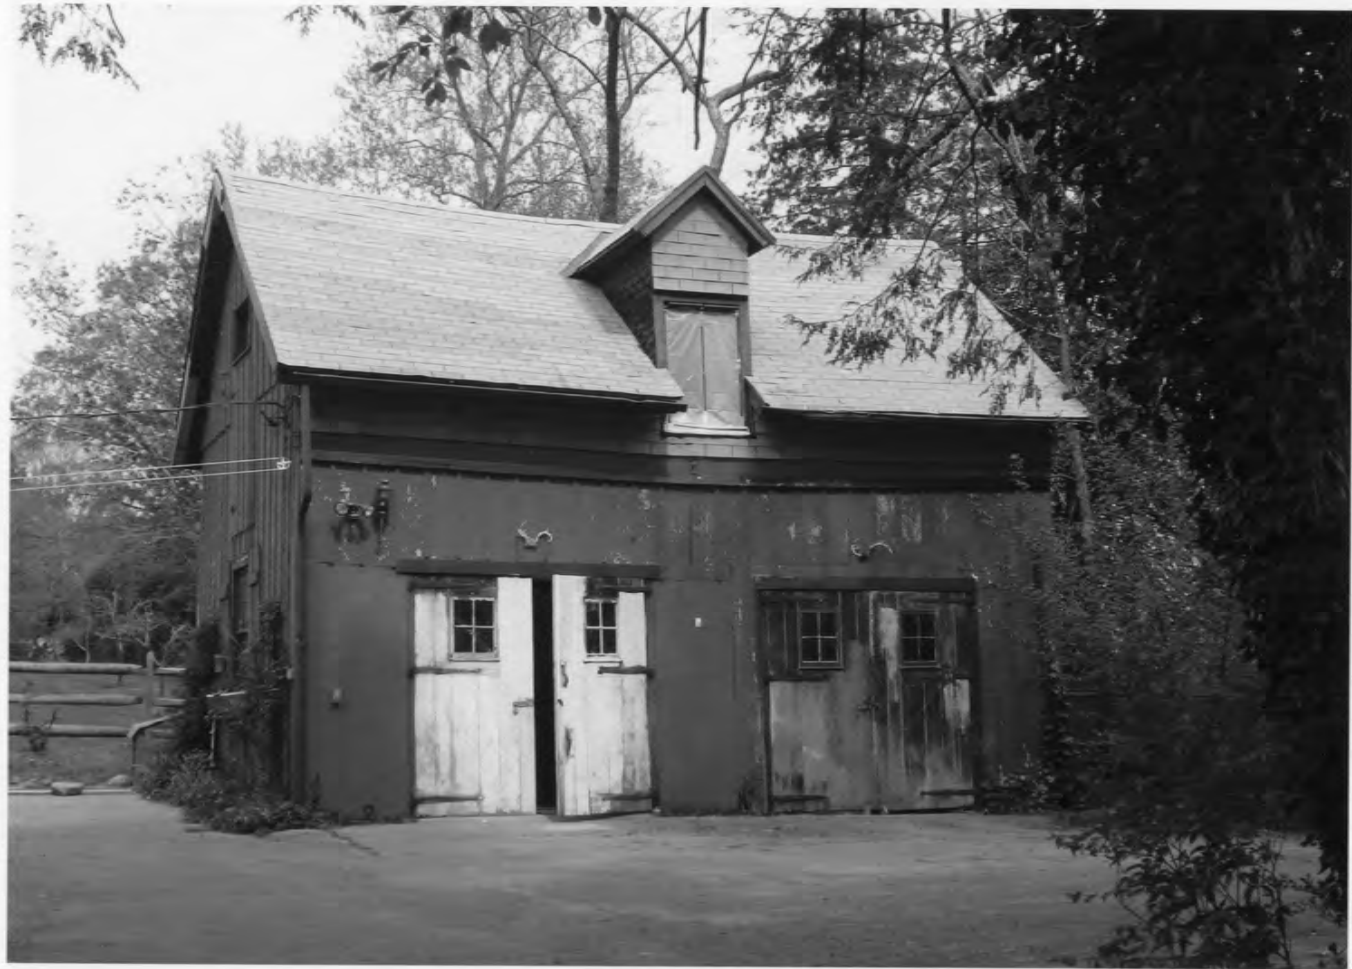
Rosemont, 15 1/2 Cragmere Road  
Brandywine Hundred, New Castle County, DE  
Photo by: Robin Krawitz, May 2008  
Carriage Barn, Facade + south elevation, Facing NW  
Photo 12 of 13

The carriage house is two and 1/2 stories high and two bays by one bay wide with a gable roof with dormers on the east and west roof slope to light the former living space in the second floor. The building has board and batten siding throughout and each bay of the eastern elevation (façade) displays a set of

double leaf doors with decorative metal hinges and a four light insert in each panel. The north and south elevations display one 6/6 wide double hung sash wood window centered on the elevation at the first level and a two pane awning window in the gable end. The construction of this building is contemporary with the construction of the house.

The frame carriage house is located to the north of the main house near the northwest corner of the property. The one-and-one-half story, two-bay, gable-roofed, board-and-batten-sided building retains a high degree of historic material including doors, windows and interior partitioning.

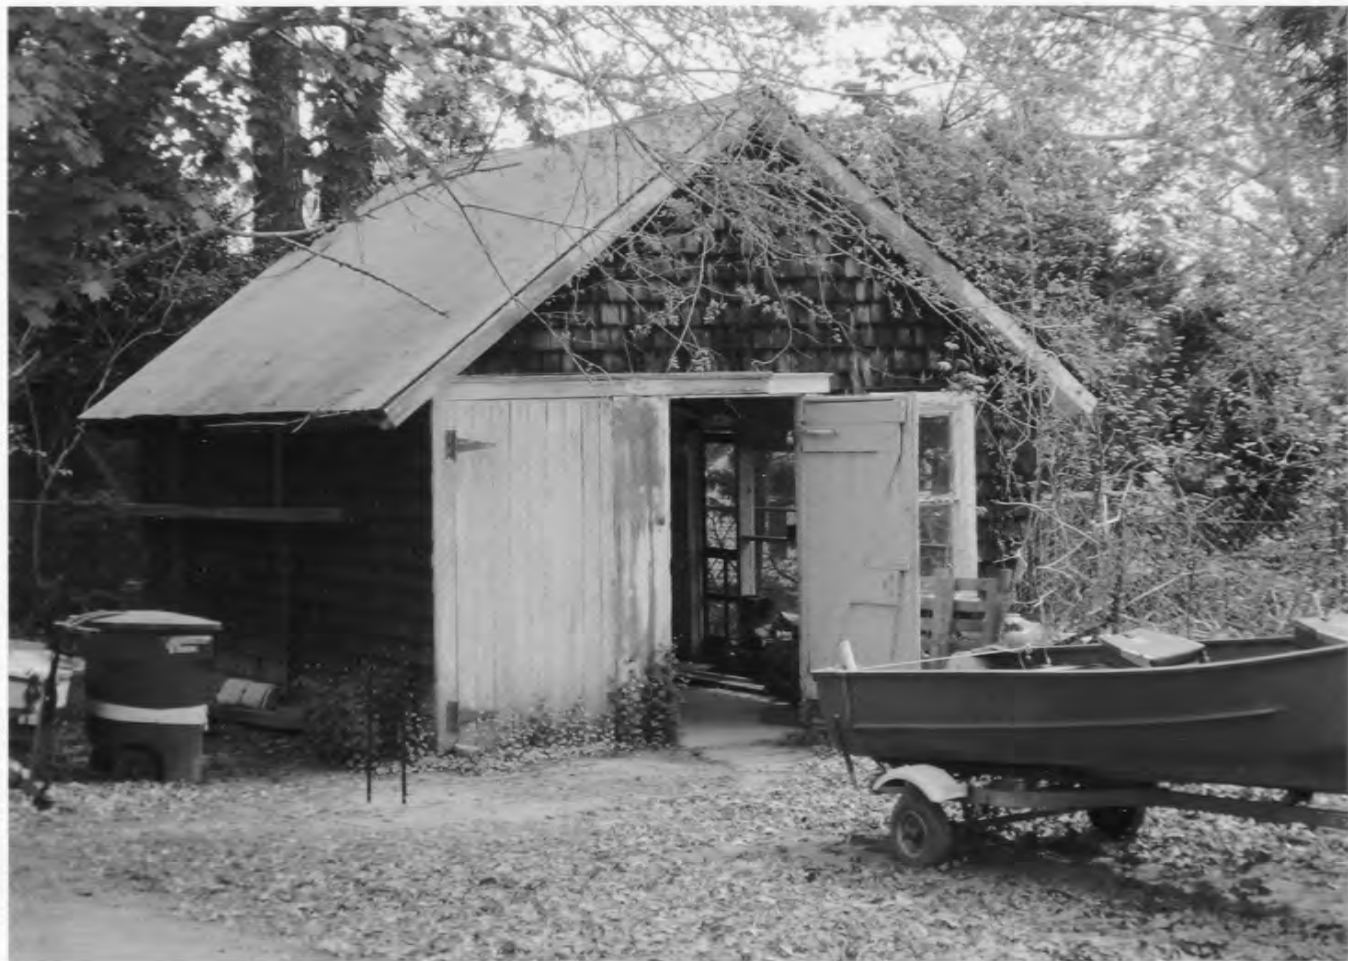
Photo 13 of 13

Facade and west elevation, Facing NE.

The shed, located at the bend in the driveway at the eastern end of the property is a one story, two-bay, gable roofed, cedar shake sided building with exposed rafter ends and a poured concrete floor. The east elevation sheathing was removed and screening placed between the studs. A frame door on the northern end of this elevation accesses the chain link fence enclosed garden area located down hill from the building to the eastern property line. This building was extant on the property by 1936 but is considered non-contributing because of the removal of the wall.

A third building remains on the site. A one story, gable-roofed, frame, cypress-shingle-sided outbuilding is located across from the entrance drive from Cragmere Road and may have served as a one-bay automobile garage at one time, based on the configuration of the doors on the south elevation. The building appears on the 1936 Sanborn Fire Insurance Company map that illustrates the property. The eastern wall has had the siding removed and the openings between the studs are screened in. It is used for storage. It no longer retains integrity and is therefore non-contributing.
