KENTUCKY HISTORIC RESOURCES INVENTORY

Site No. He - 149

1. Historic Name(s) <u>John Williams house</u>		22. ADD/County <u>Deergrass, Harrison</u>	
Original Owner <u>John Williams</u>		23. U.S.G.S. Quadrant (15'/75') <u>Shawhan</u> G.I.S. Mod.

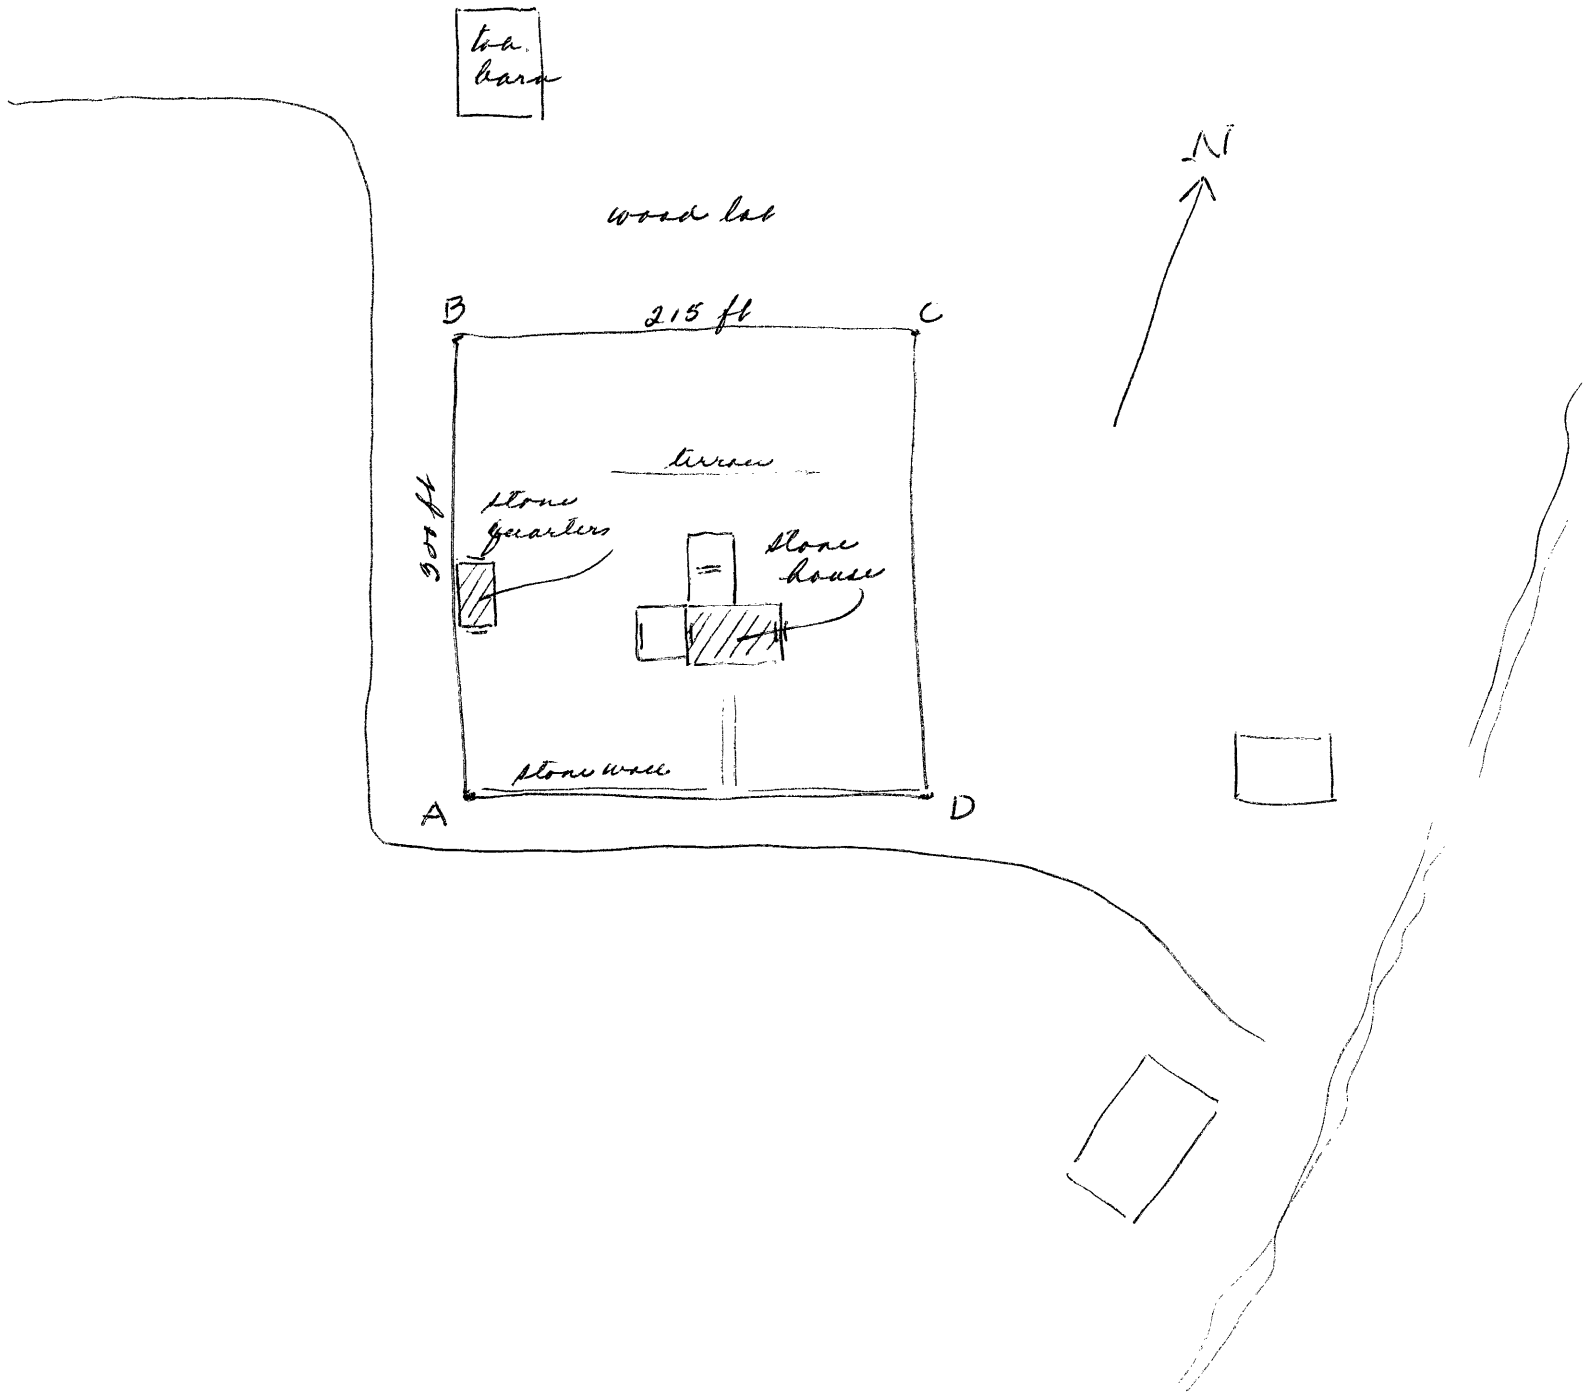
SKETCH MAP OF SITE SHOWING BOUNDARIES AND KEY BUILDINGS AND FEATURES WITH NORTH ARROW.

Beginning at ^A in the SW corner of the yard where fence meets stone wall, thence with fence 300 ft N to B, thence at right angles 215 ft E to C, 300 ft S to D at the stone wall, thence outside stone wall 215 ft W to the beginning, containing the stone house, ruin of quarters, stone walk, and stone wall - about 1 1/2 acre. (Dance 1861 map of ...)
