NATIONAL REGISTER OF HISTORIC PLACES  
REGISTRATION FORM

other name/site number: Pioneer House (preferred) / J00073

city/town: Clarksville

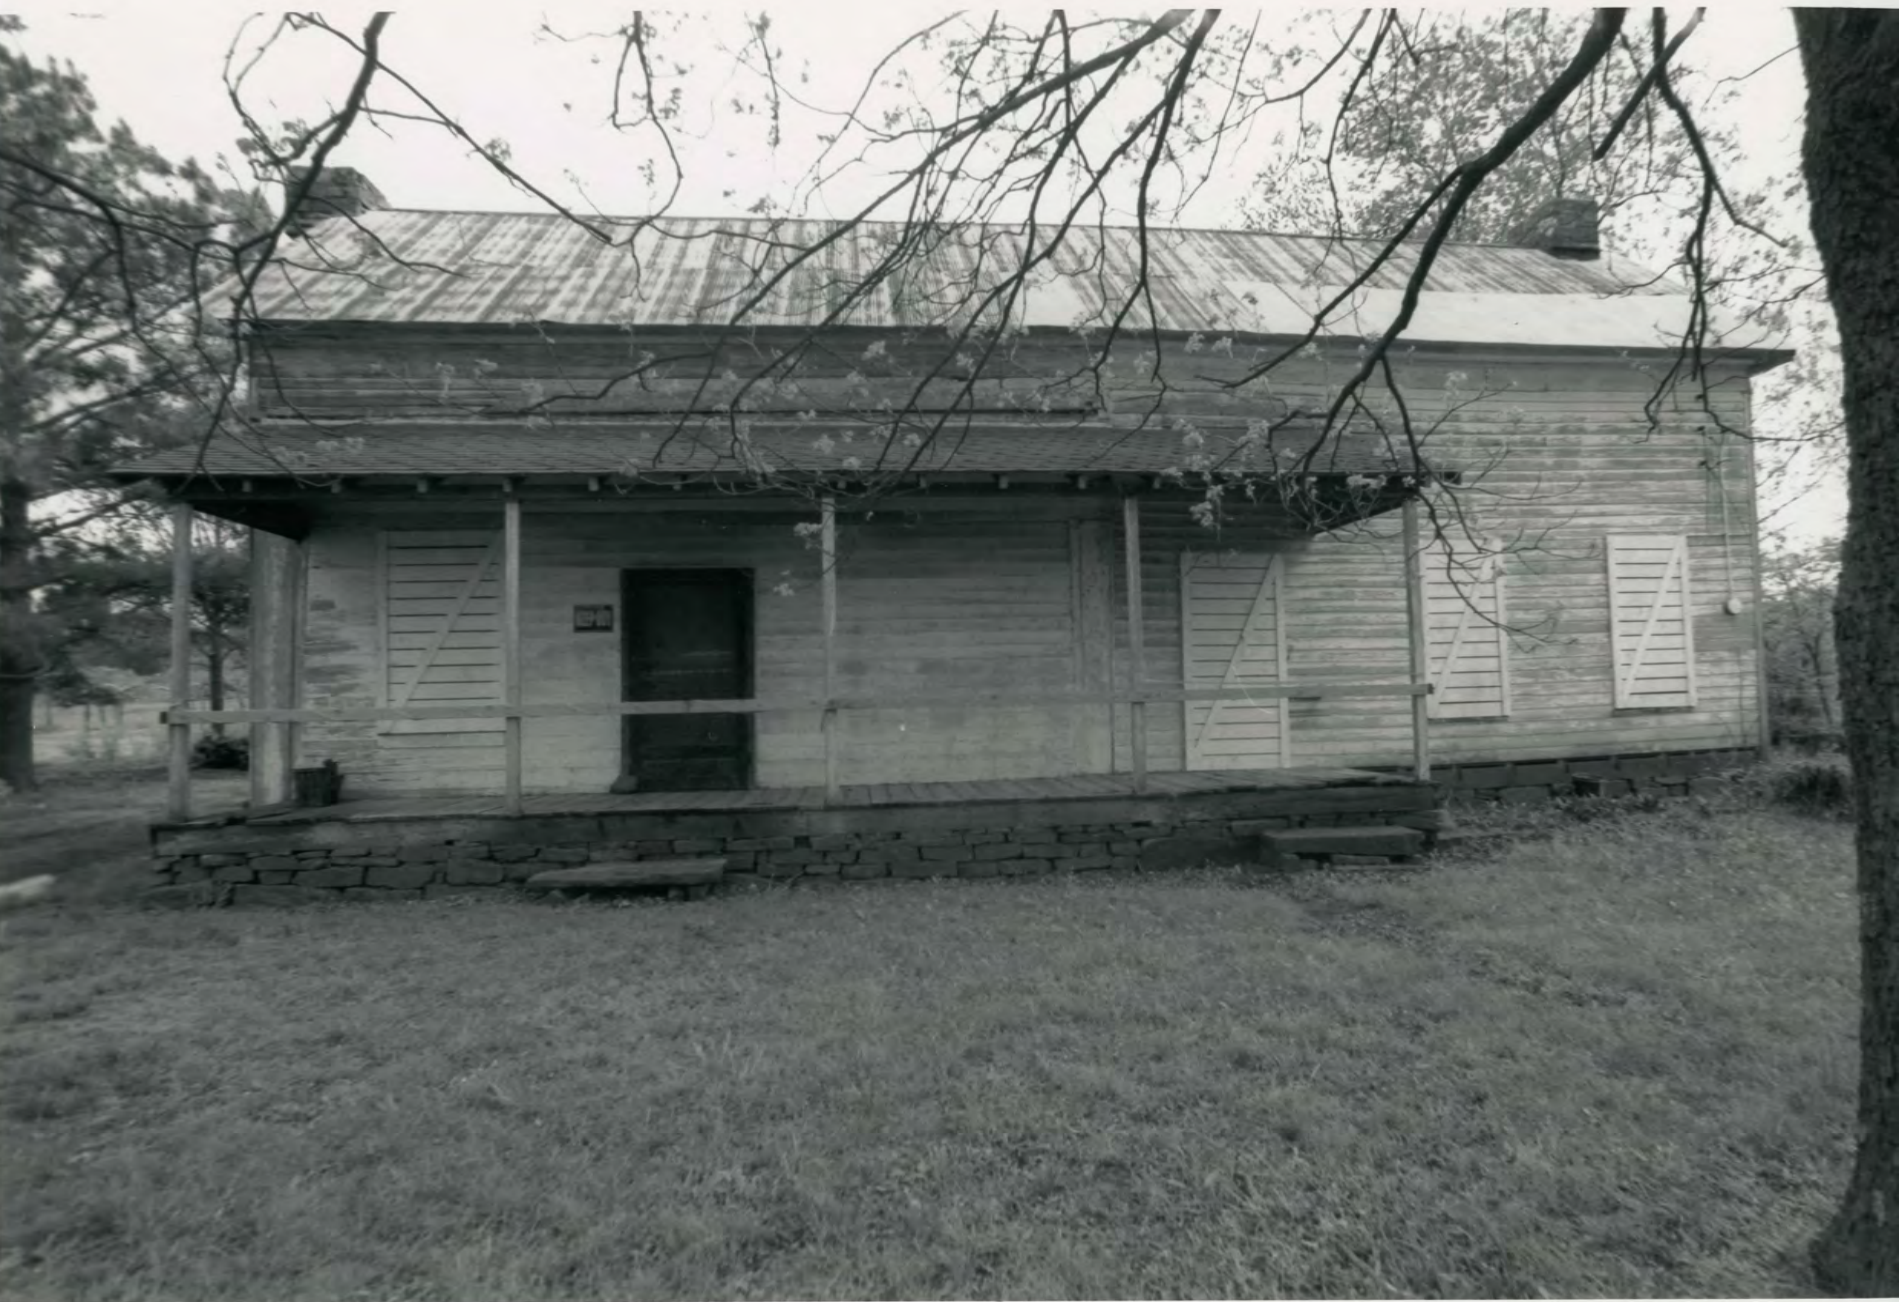
Pioneer House  
Clarksville, Johnson Co., Ark.  
Photo by T. Ferguson  
April 1992  
Neg. on file at AHPP  
View from the north

The northern, or front, elevation has a three-quarter length porch with a one-story shed shingle roof supported by five wood posts. Under the porch roof to the eastern side of the front elevation there is one window followed by a single-leaf entrance. At the far western end of the porch roof overhang is a second entrance which has been boarded over. Two window openings are found on the fourth quarter, or western end of the front facade. One boarded door-size opening is found on the southern end of the western elevation. The southern or rear elevation of the structure currently has two boarded entrances on the western side, one boarded window opening slightly to the east of center, and one single-leaf entrance on the far eastern end. The eastern elevation is dominated by a large native stone chimney.

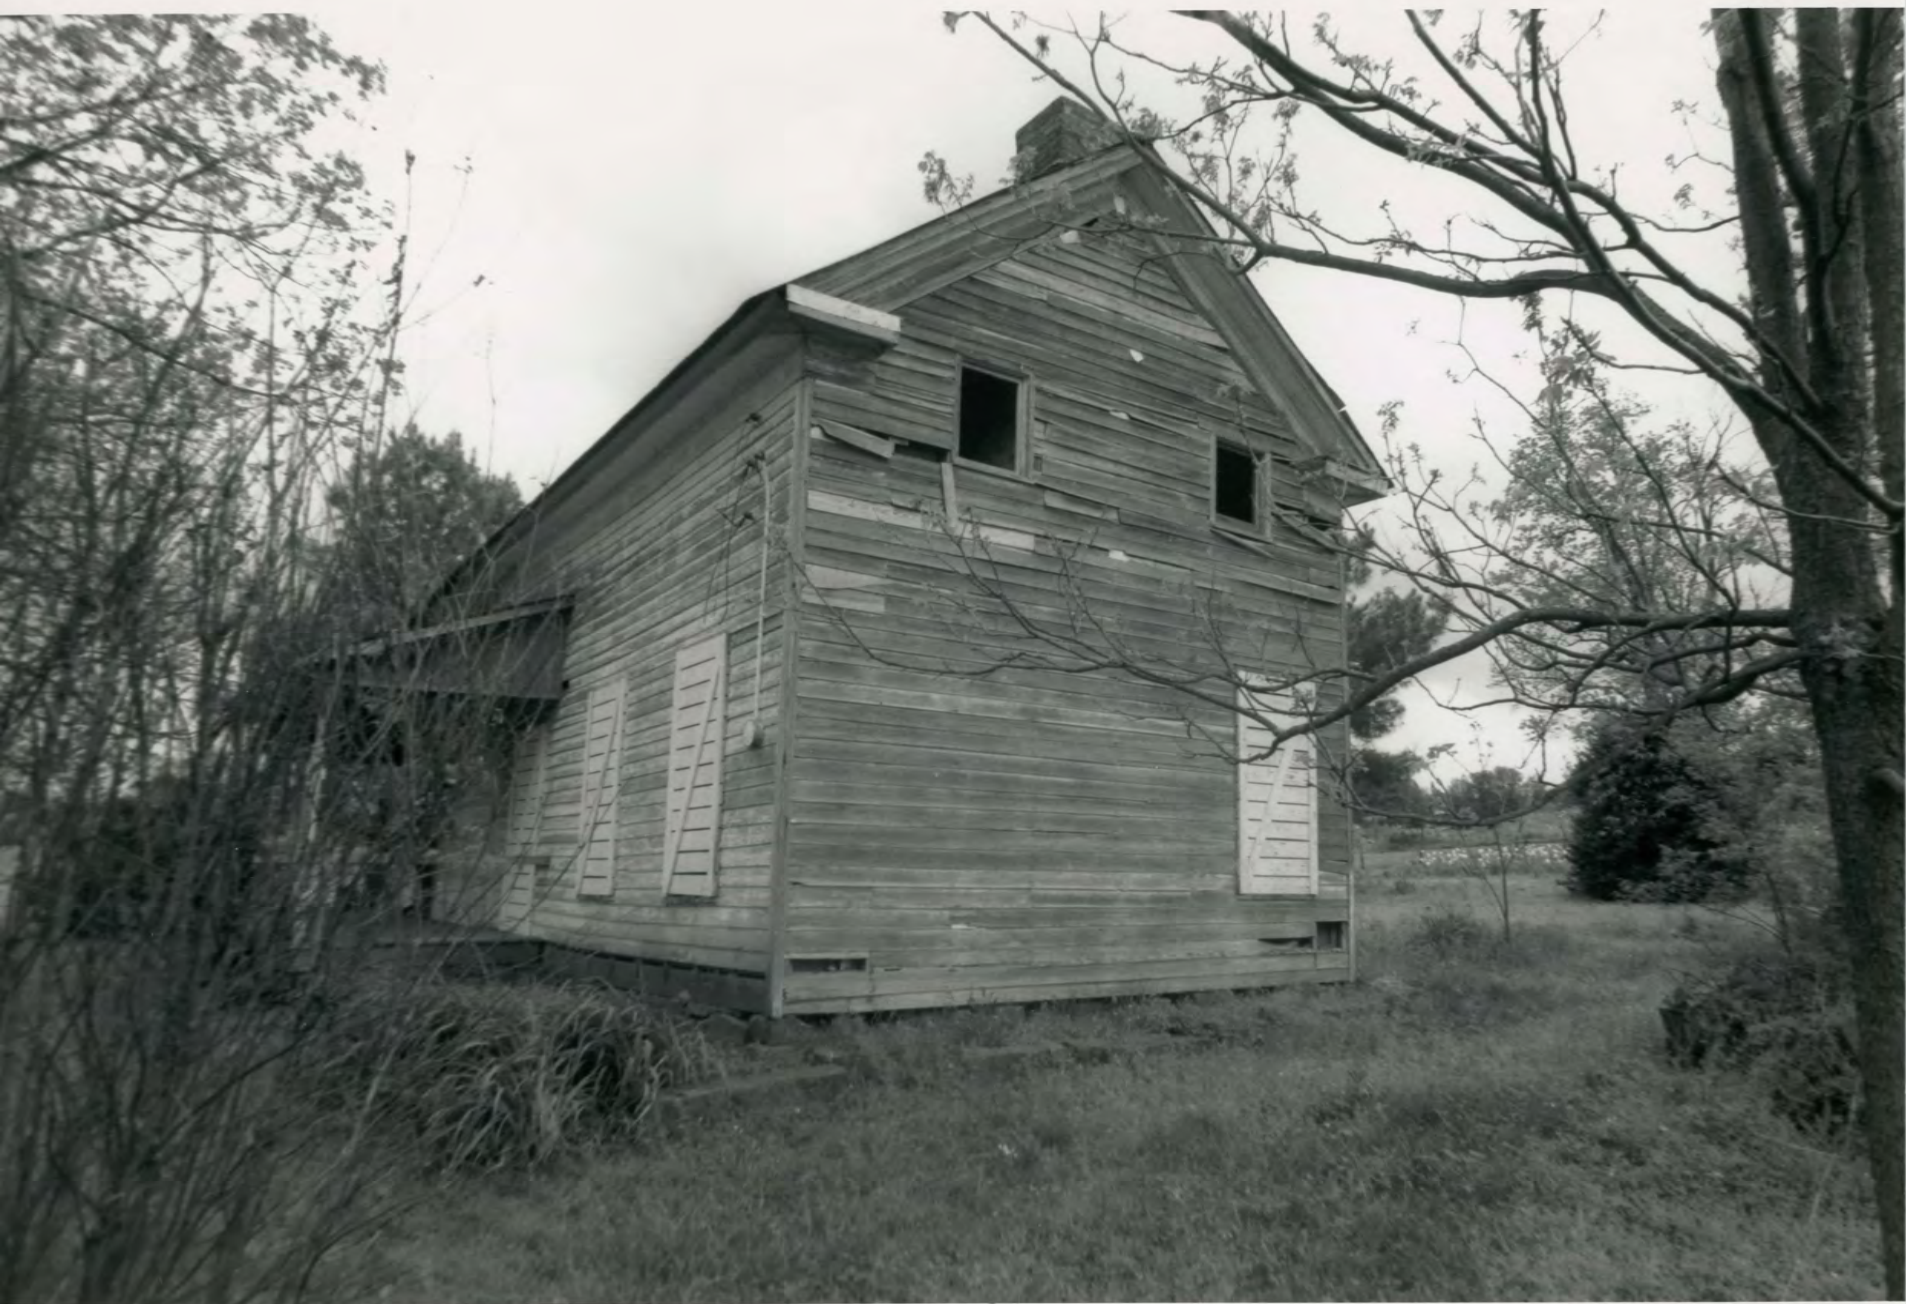
View from the west

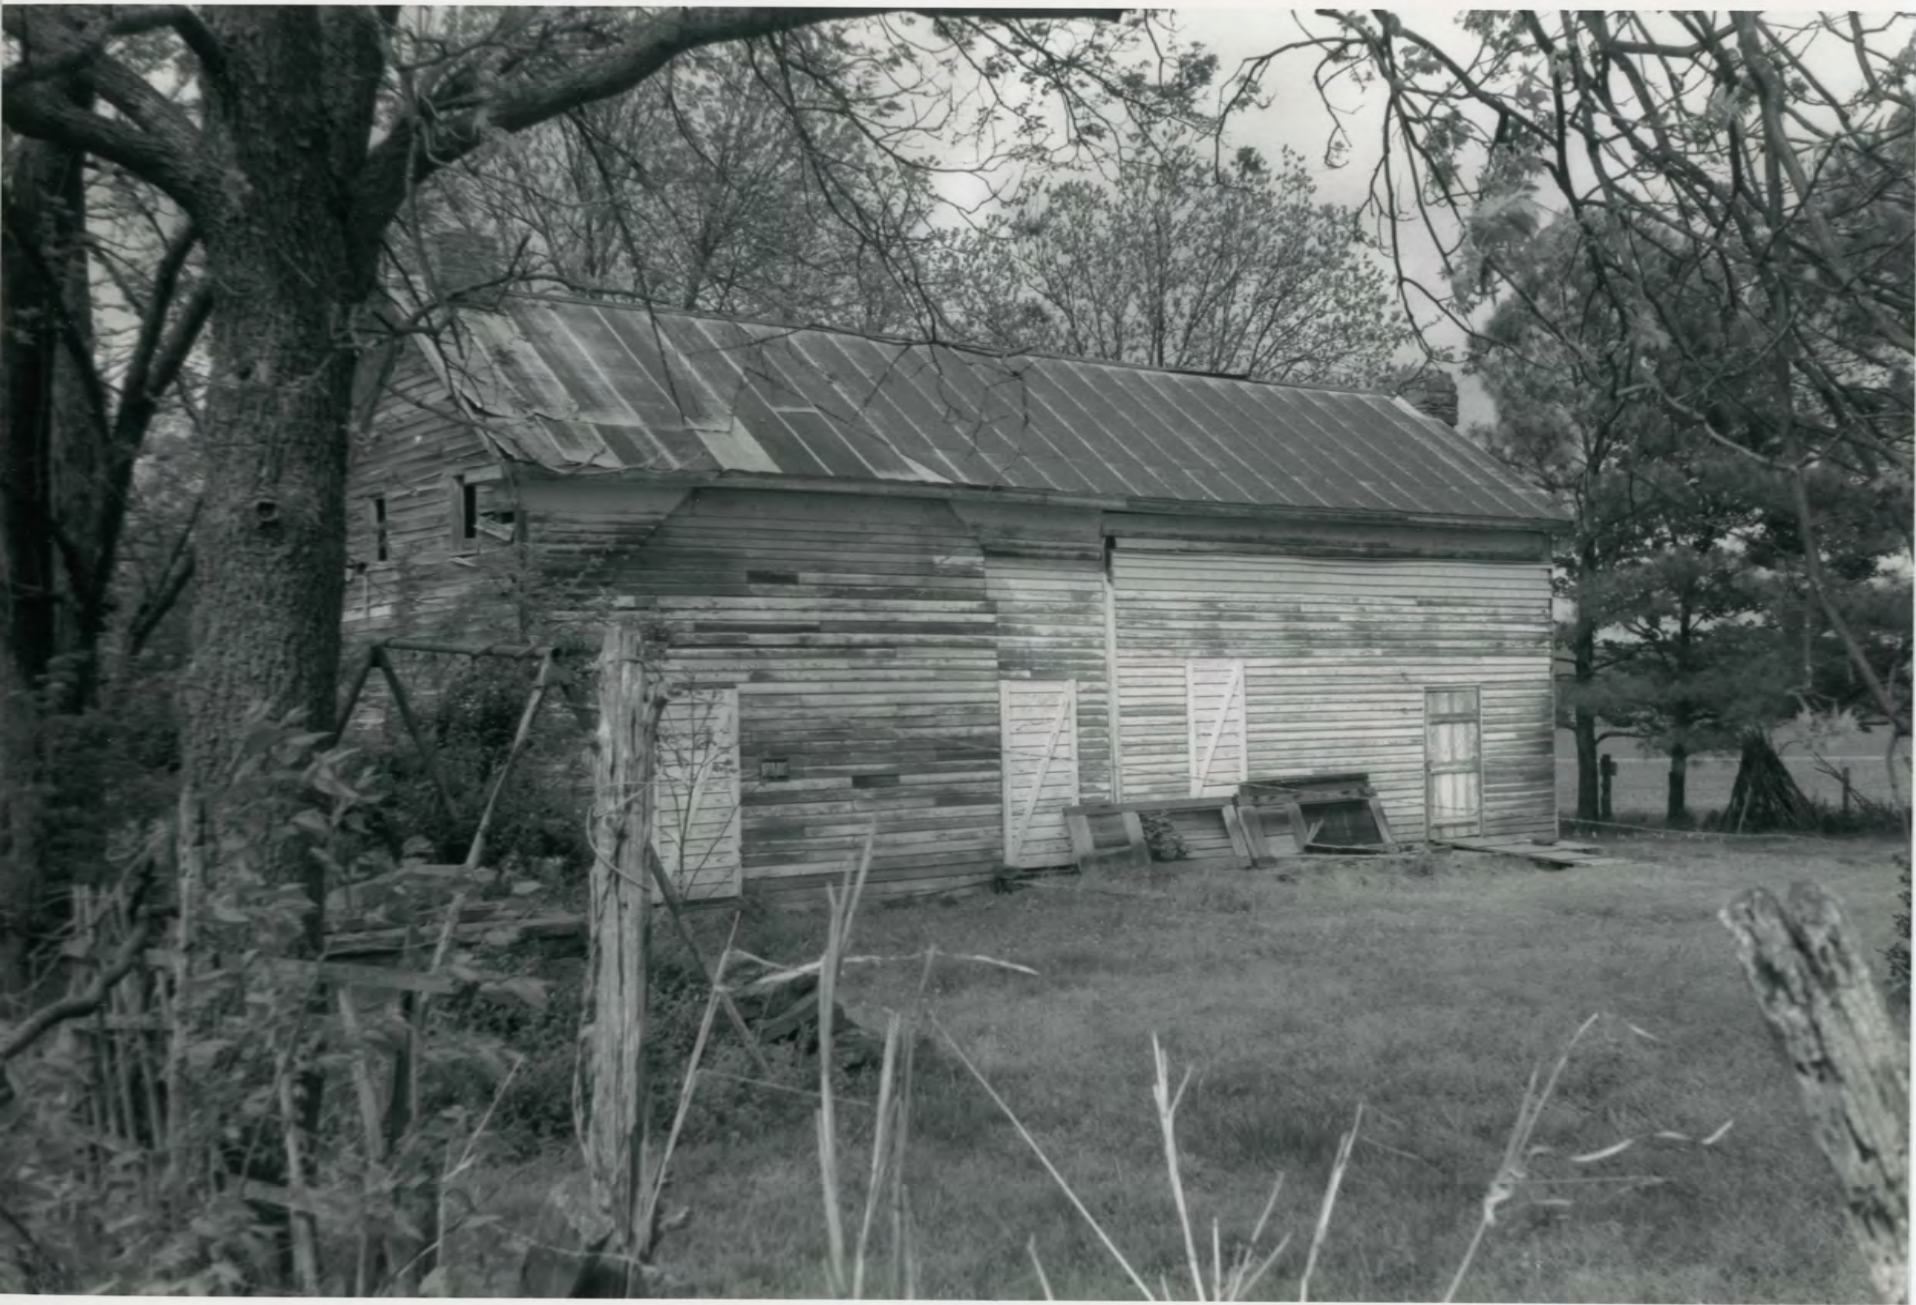
View from the southwest

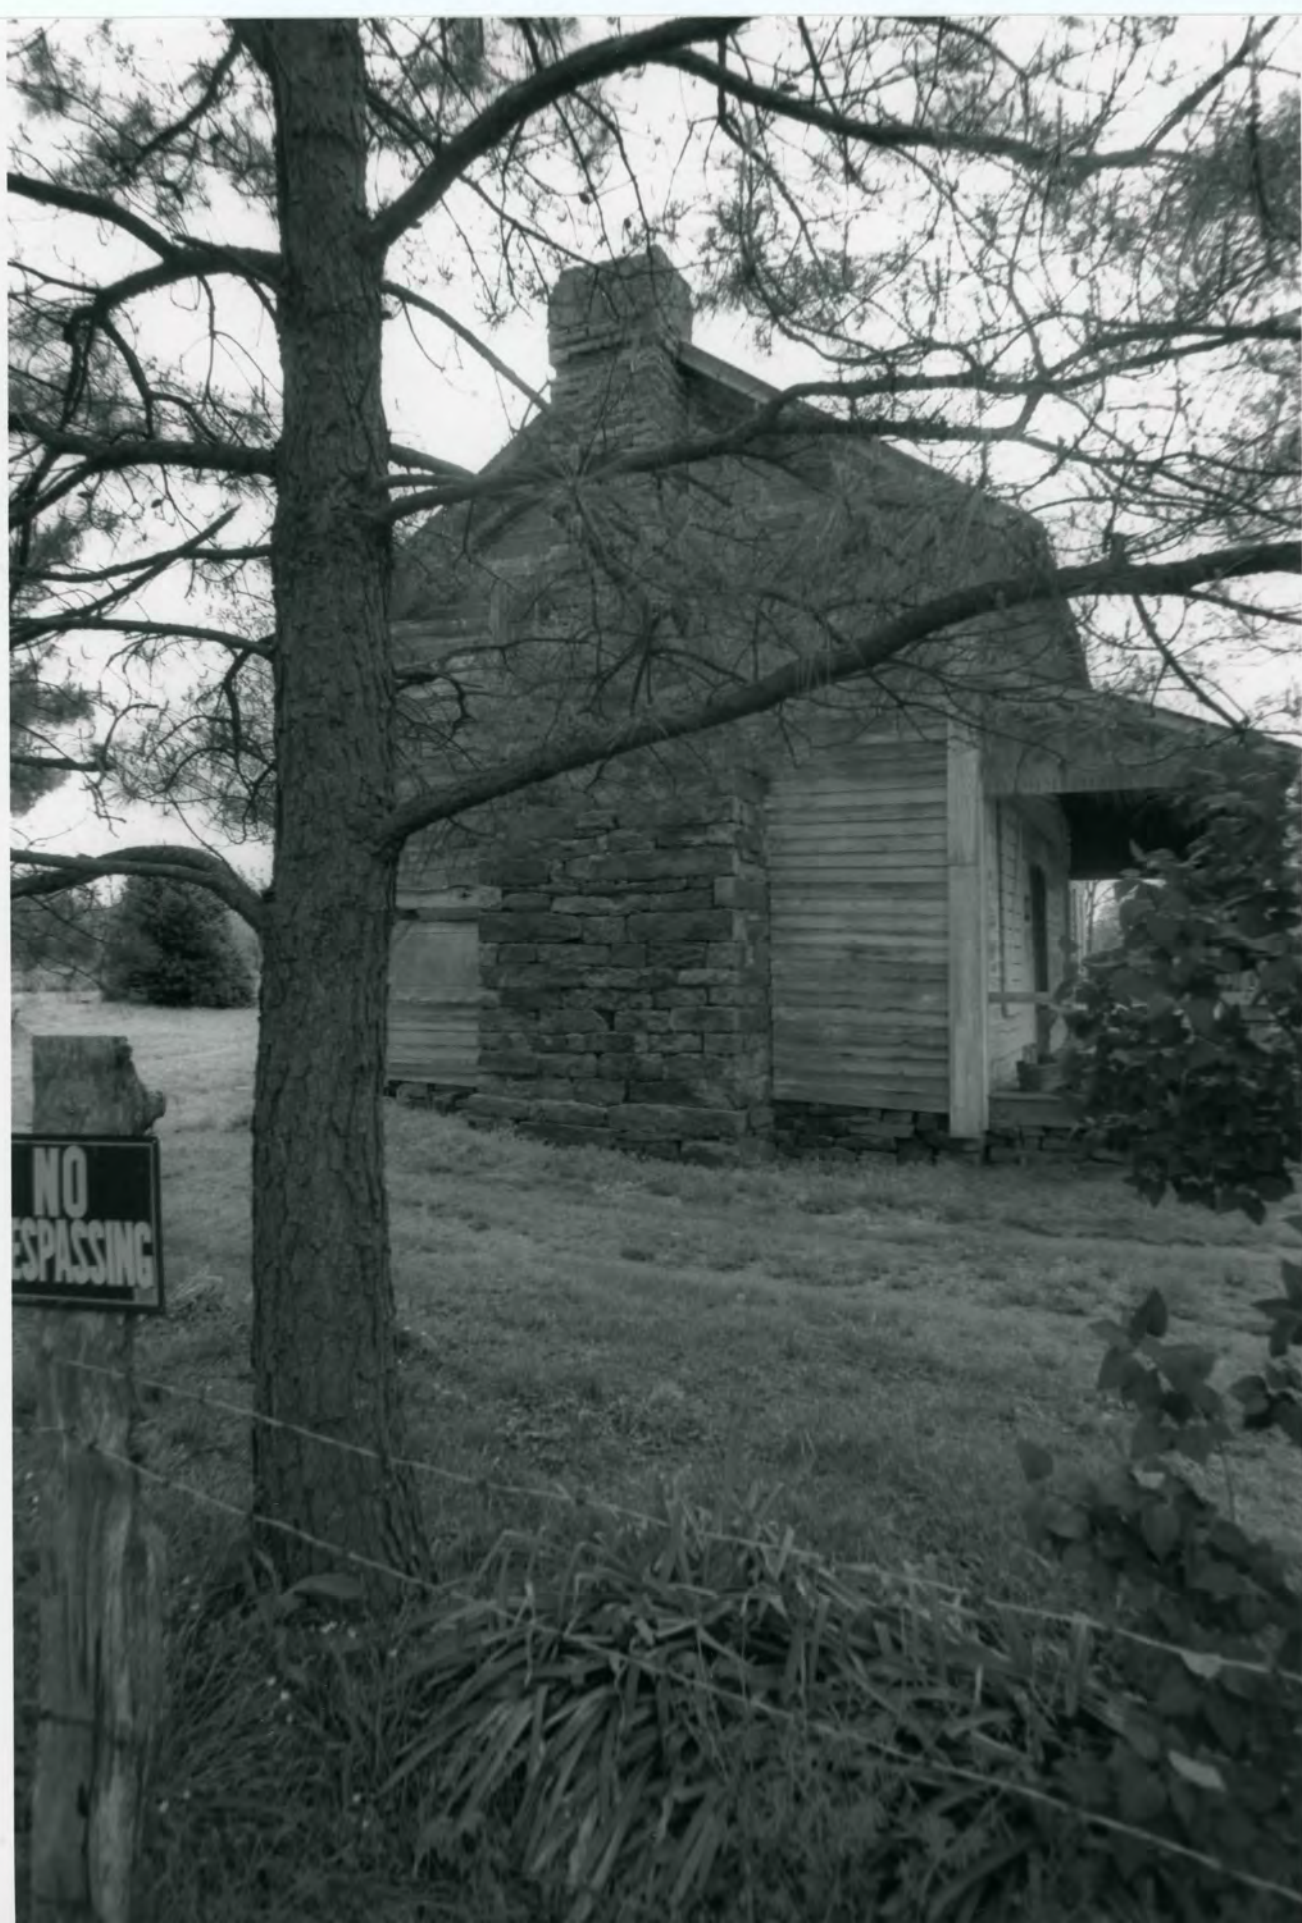
Pioneer House  
Clarksville, Johnson Co., Ark.  
Photo by T. Ferguson  
April 1992  
Neg. on file at AHPP  
View from the east

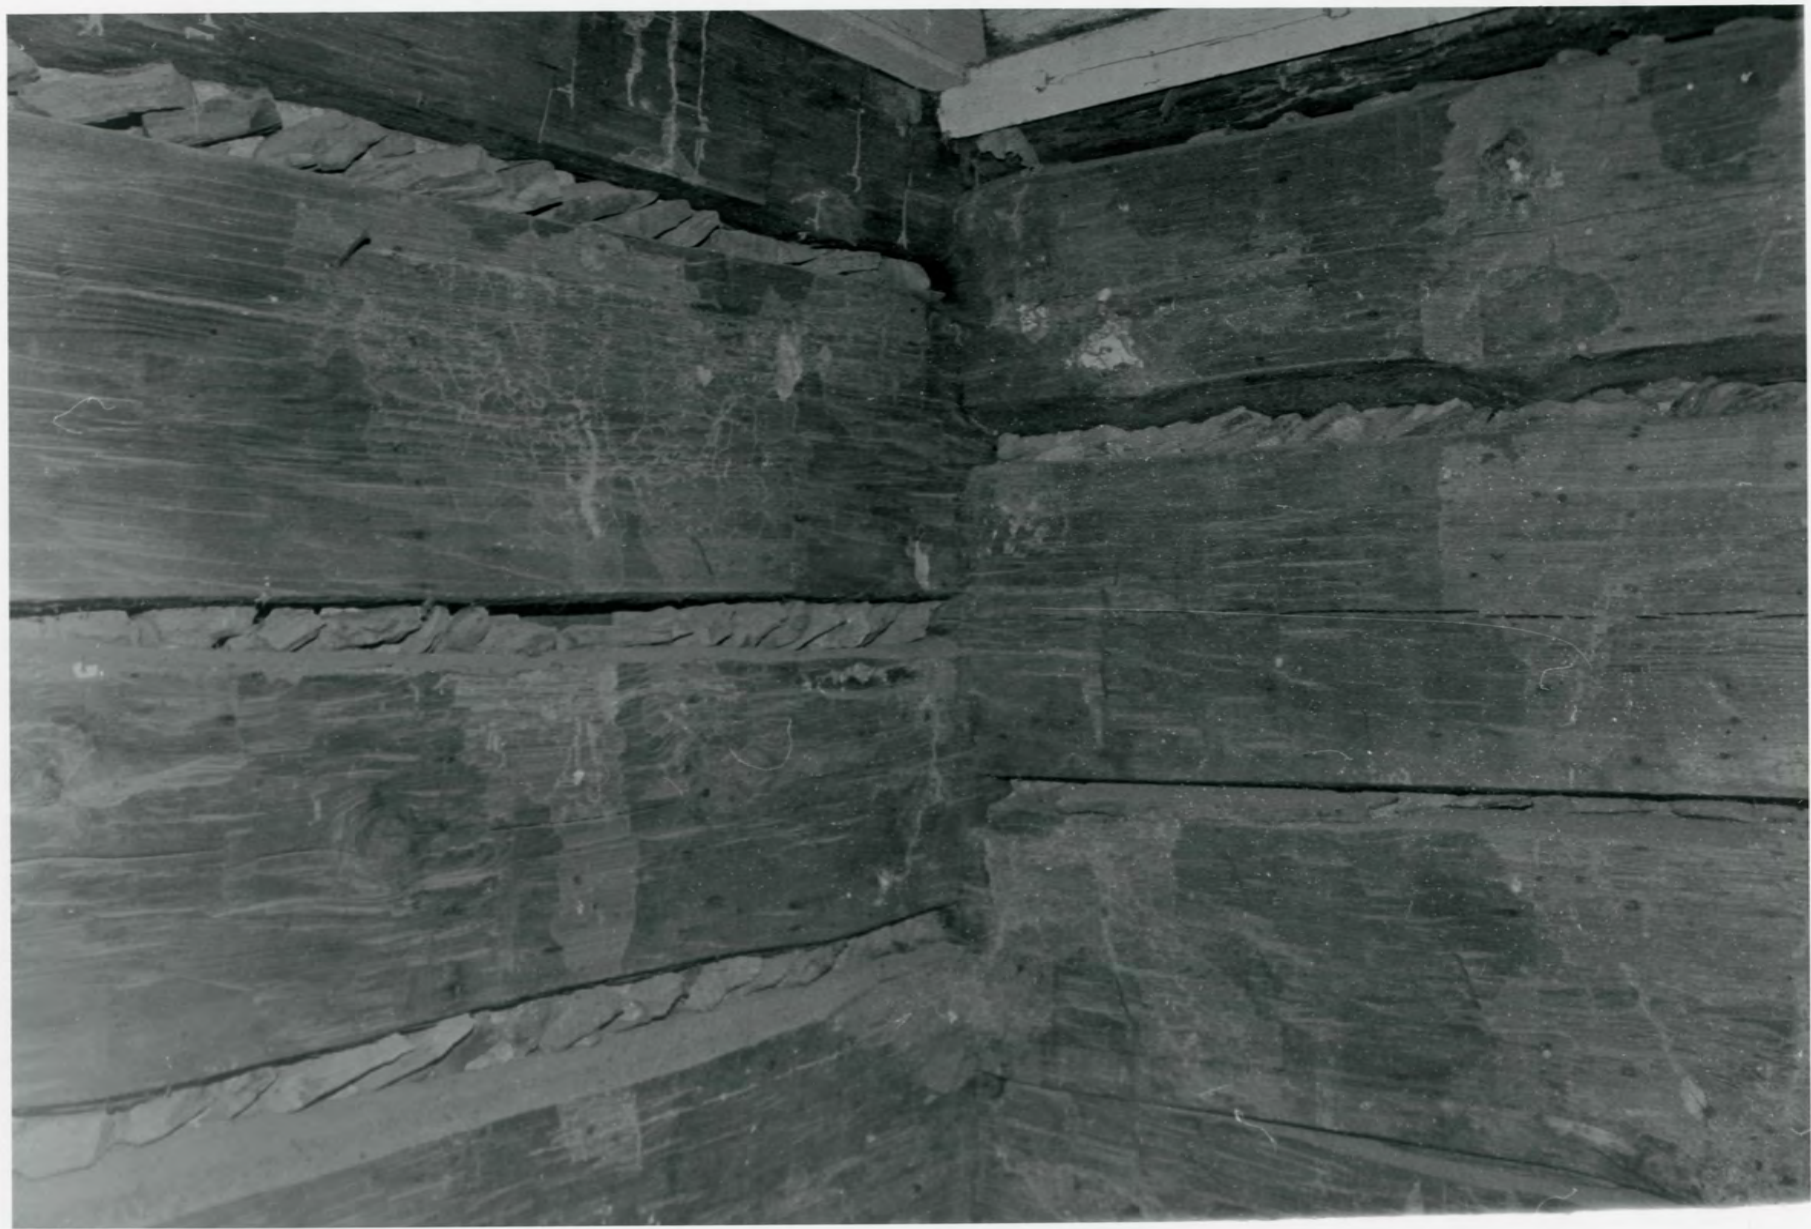
Pioneer House  
Clarksville, Johnson Co., Ark.  
Photo by T. Ferguson  
April 1992  
Neg. on file at AHPP  
View of log detail

The Pioneer House is a rectangular-plan, log and frame structure that rests upon a dry-laid stone foundation and is covered by a corrugated metal-covered gable roof. All exterior walls are covered in weatherboard siding. The log portion at the eastern end of the structure is constructed of half-hewn southern yellow pine wall logs that are joined with half dovetail corner notches and covered by weatherboard siding. The timbers, visible from the interior, measure approximately sixteen by five inches, and were hewn on the interior and exterior faces only, leaving the bark on the top and bottom. Chinking material found between the logs includes sandstone cobbles, split boards, and mortar. The top wall logs in the eastern and western walls, and the sills found beneath the windows in the northern and southern elevations are oak. The western side of the structure is of frame construction. An exterior chimney of native field stone is found on the eastern wall. An interior brick chimney is located against the western wall of the frame addition. All window glass has been lost, and the openings are boarded up.

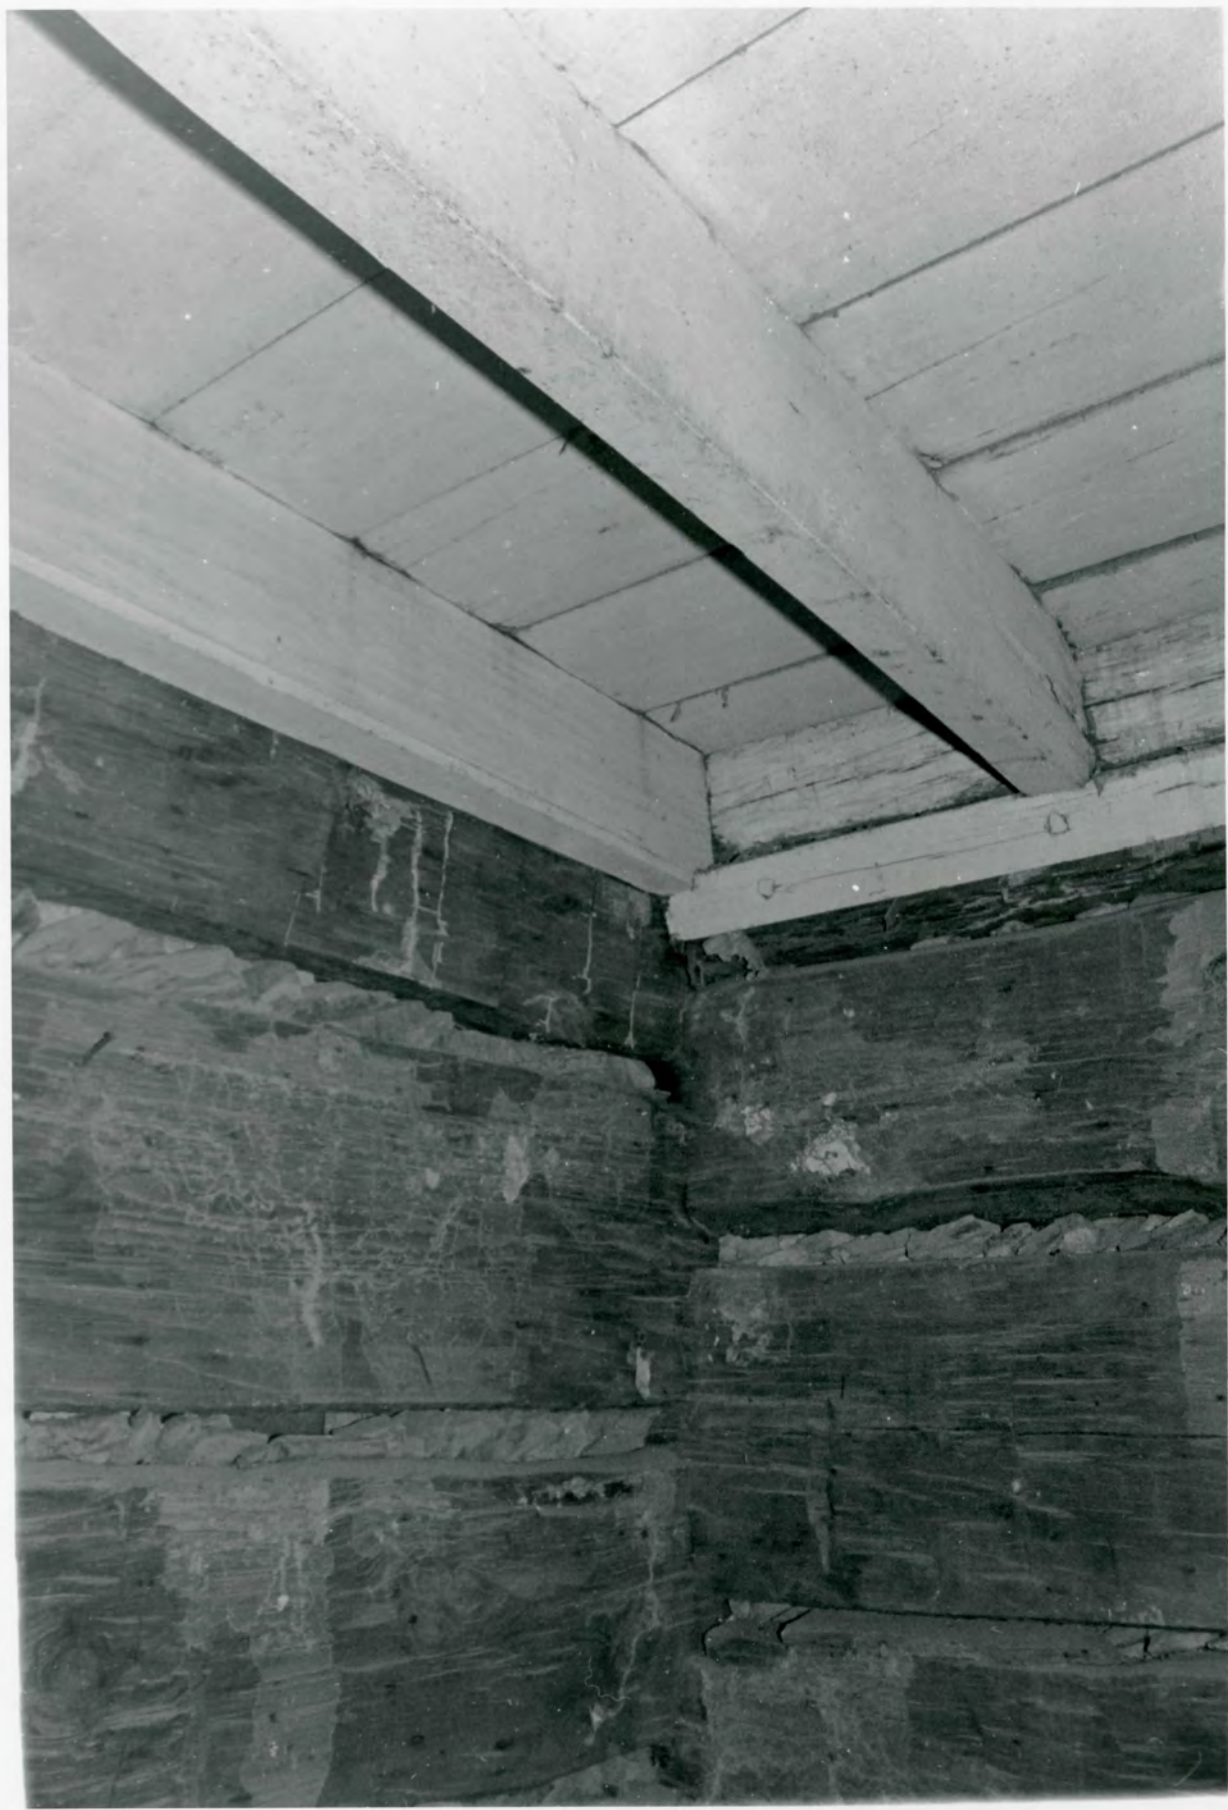
Pioneer House  
Clarksville, Johnson Co., Ark  
Photo by T. Ferguson  
April 1992  
Neg. on file at AHPP  
View of log corner/ceiling  
Junction
