HISTORIC RESOURCES INVENTORY
BUILDING AND STRUCTURES

1. BUILDING NAME (Common) (Historic)
 John Rogers House

3. STREET AND NUMBER (and/or location)
 690 Leetes Island Road Map K9, Block 3, Lot 4; .46 acres

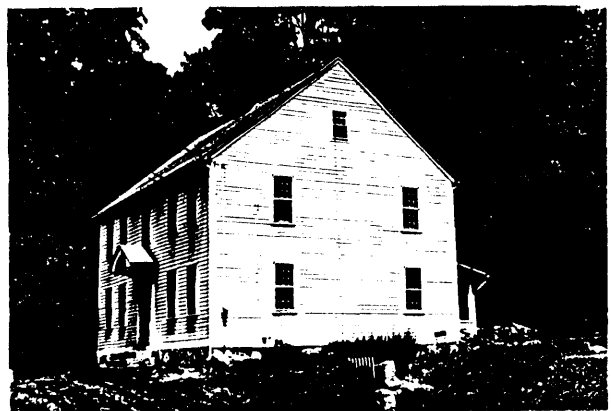
Constructed on a rectangular plan with its ridge parallel to the street, this structure has a steeply pitched roof with minimal overhang at the cornice. Small dentil moldings are featured below the cornice. Its brick center chimney straddles the ridge. It has a nine-window facade and a five-window gable. Windows have twelve-over-twelve sash except the attic window which has six-over-six sash. Its entry door is protected by a gabled hood with an arched ceiling, supported on large curvilinear brackets.

PHOTO	PHOTOGRAPHER Jane P. Bouley	DATE 3/18/86
	VIEW South & East Elevations	NEGATIVE ON FILE CHC-File 44 Neg 23
COMPILED BY	NAME S. Ardis Abbott & Robert B. Hurd	DATE May, 1986
	ORGANIZATION Architectural Preservation Trust of Branford, Inc.	
	ADDRESS 226 East Main St. Branford, Ct 06405
