**NATIONAL REGISTER OF HISTORIC PLACES  
INVENTORY -- NOMINATION FORM**

Mount McKinley National Park Headquarters District

Denali National Park and Preserve Headquarters

2014 Addendum to the  
Historic Structure Report  
Mt. McKinley Park Headquarters Historic District &  
Wonder Lake  
(1987)

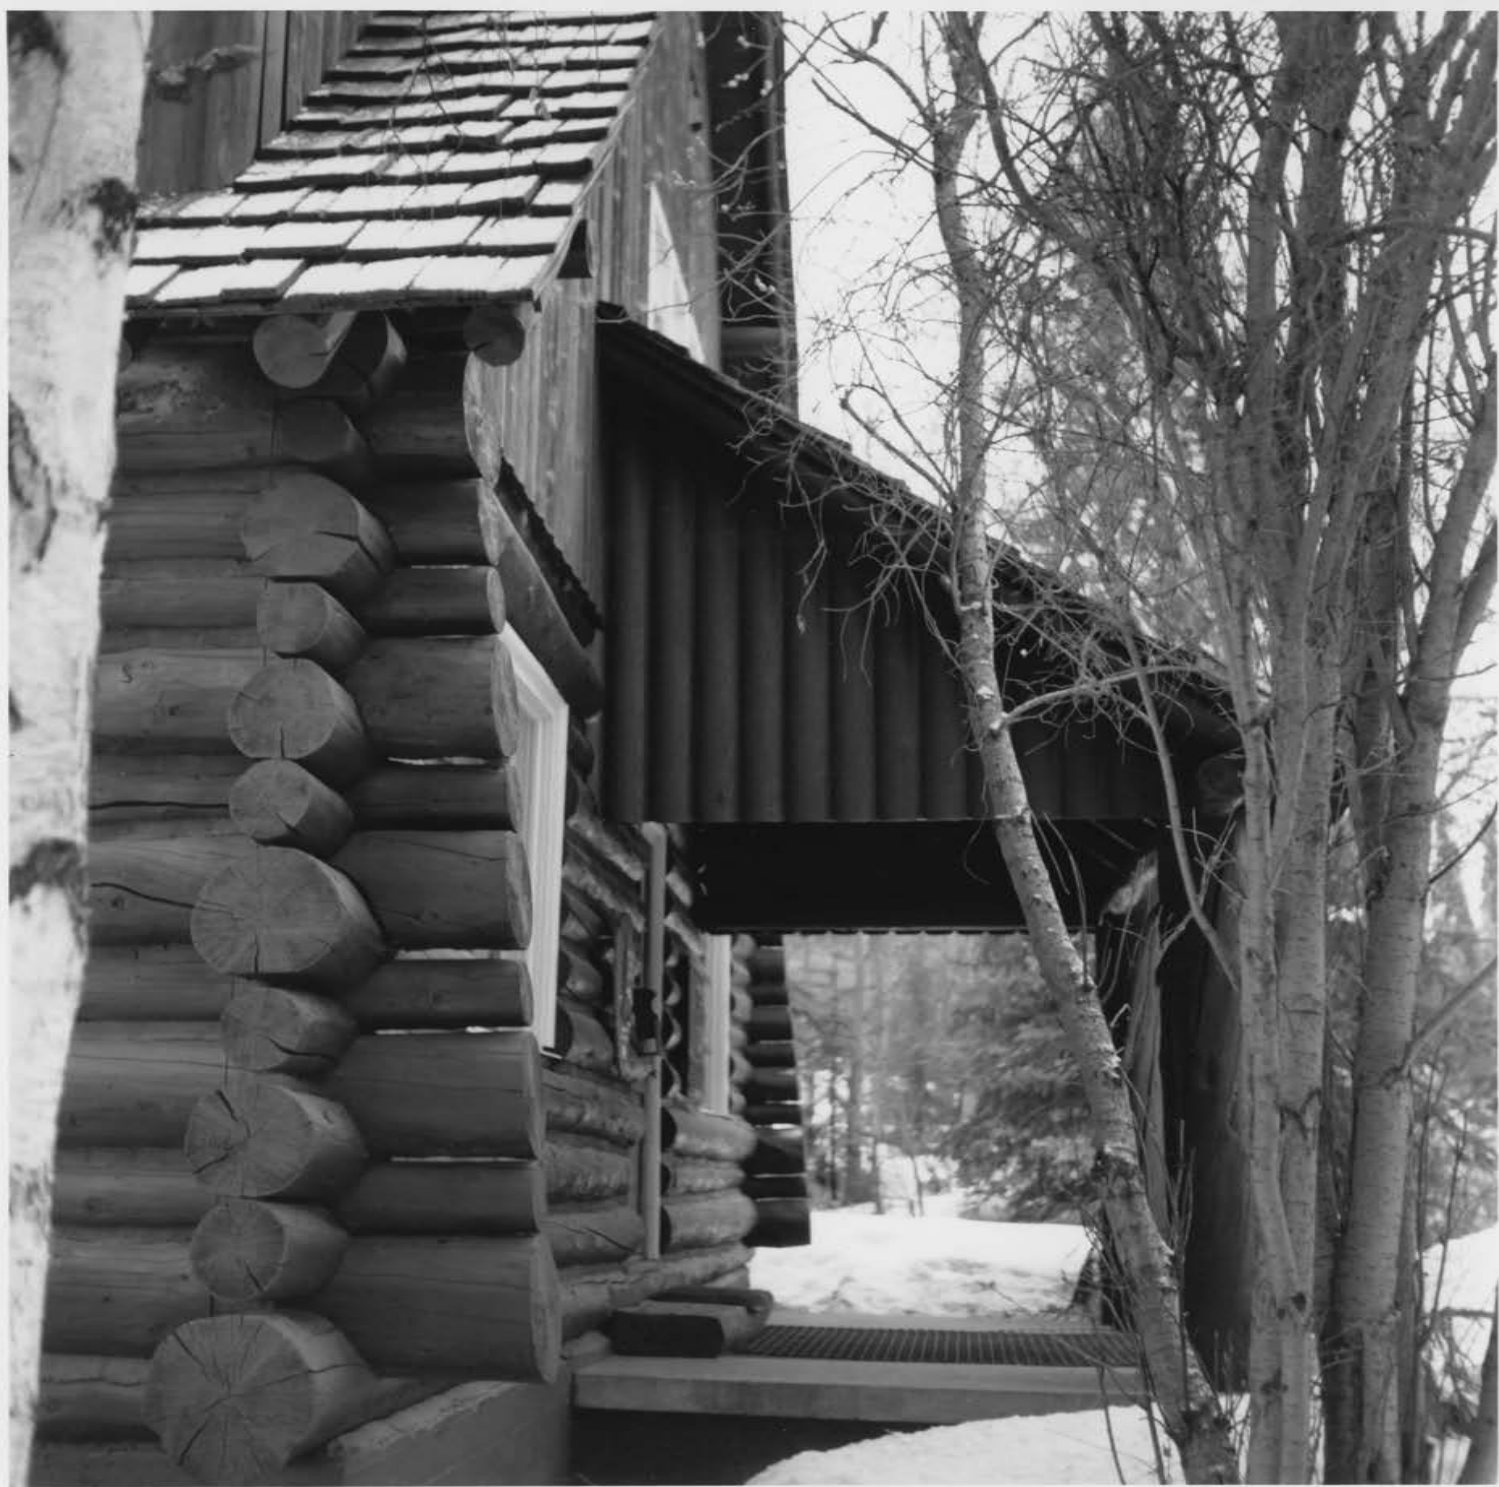
Rangers' Dormitory (No. 21), battered log ends  
and porch entry on east elevation, Mount  
McKinley National Park Headquarters District  
Denali National Park and Preserve, Alaska  
Photographer: Kathleen Lidfors  
Date: 13 May 1985  
Negative: Alaska Regional Off., Anchorage, NPS  
Photo No. 21-2

No. 21: Rangers' Dormitory. 1934-1935; designed by National Park Service; built by park personnel and contracted labor. Horizontal peeled logs with saddle notching (ground floor) and vertical rounded planks over frame construction (second floor); log ends sawn and battered; painted dark brown; 34' x 34'; two stories; gable roof with wood shakes; poured concrete foundation with daylight basement; single light casement and picture windows; doors on east and west elevations. Alterations: interior alterations beginning in 1954; recent placement of multi-light windows with single pane casement windows; introduction of three picture windows on ground floor; wood shakes instead of original metal roof; exterior walls painted. (Photo Nos. 21-1 to 21-4.)

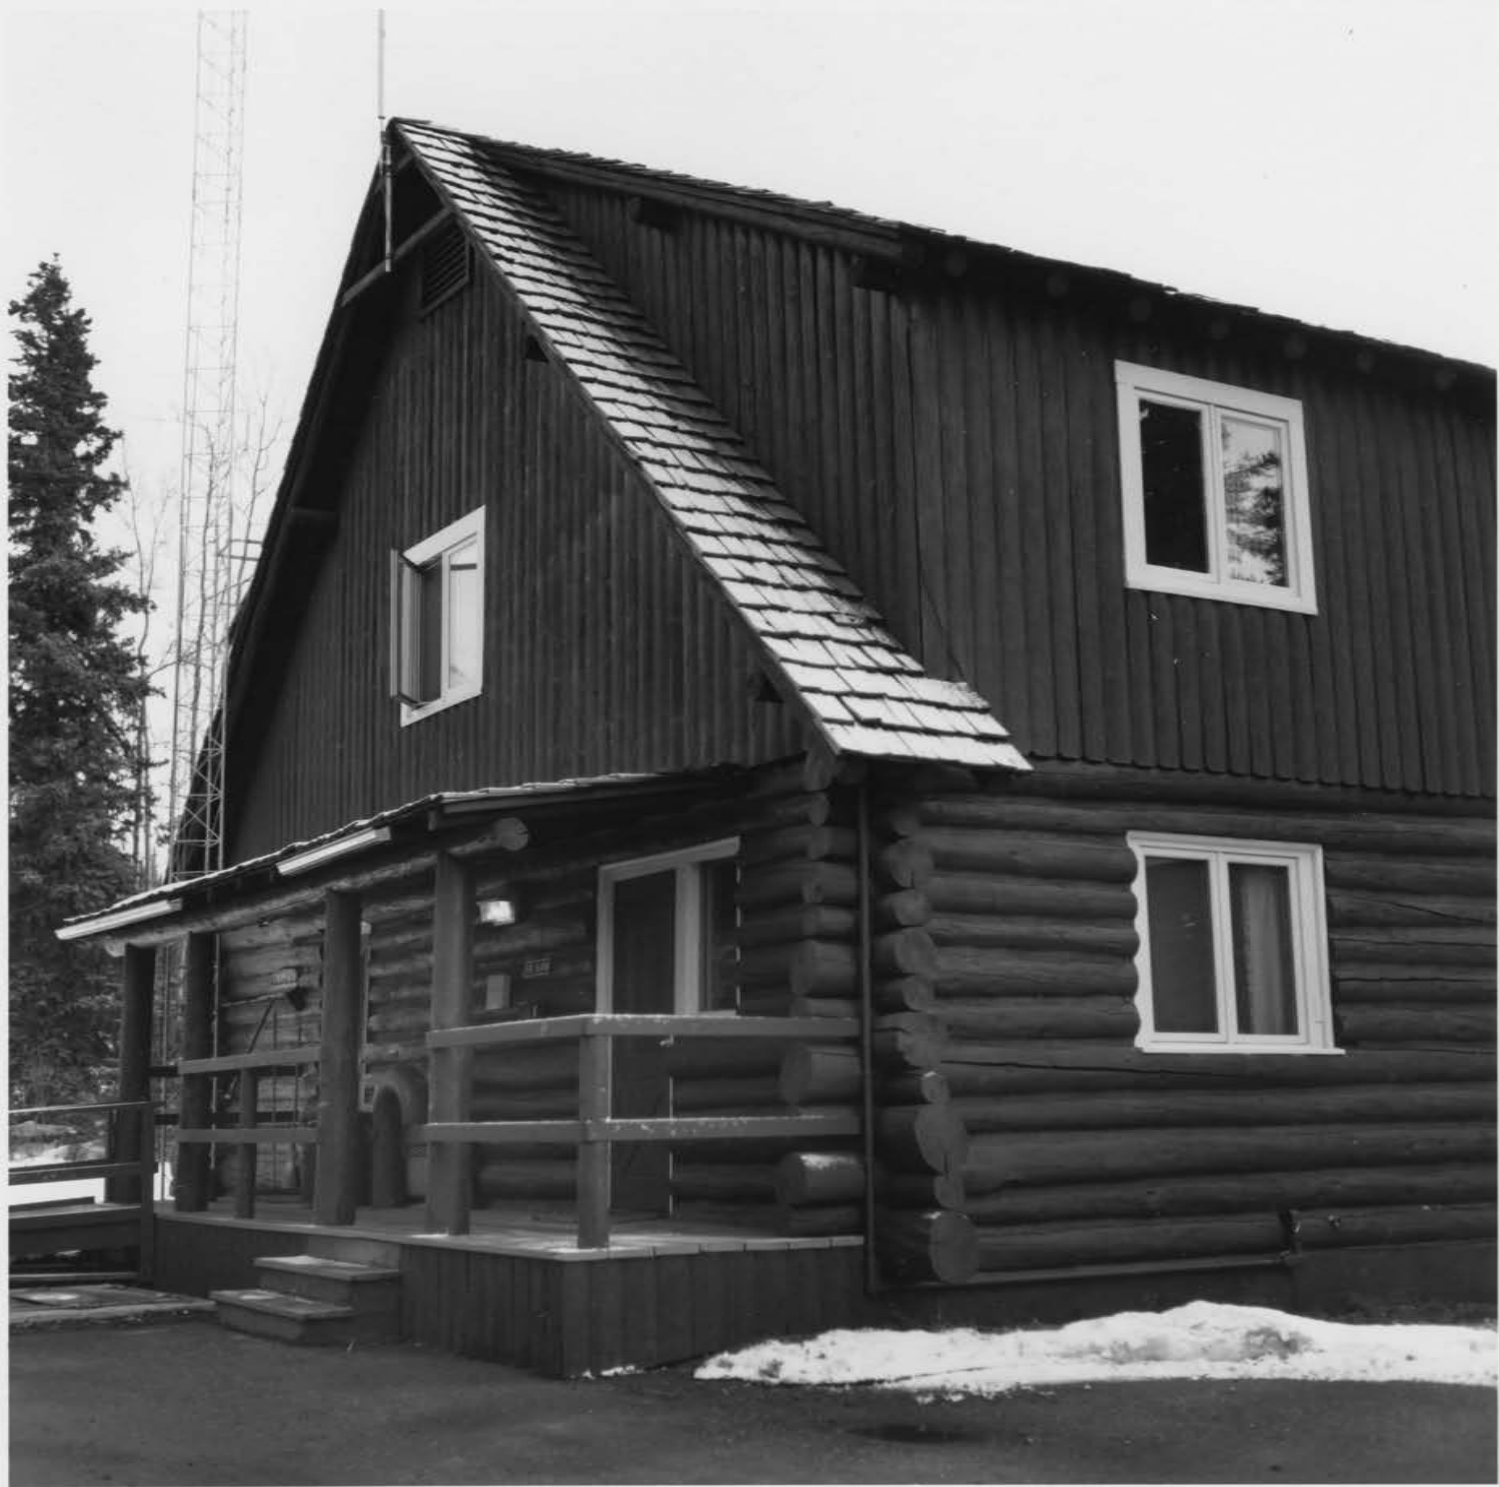
Rangers' Dormitory (No. 21), west elevation with  
porch modification, Mount McKinley National  
Park Headquarters District  
Denali National Park and Preserve, Alaska  
Photographer: Kathleen Lidfors  
Negative: Alaska Regional Off., Anchorage, NPS  
Date: 13 May 1985  
Photo No. 21-3

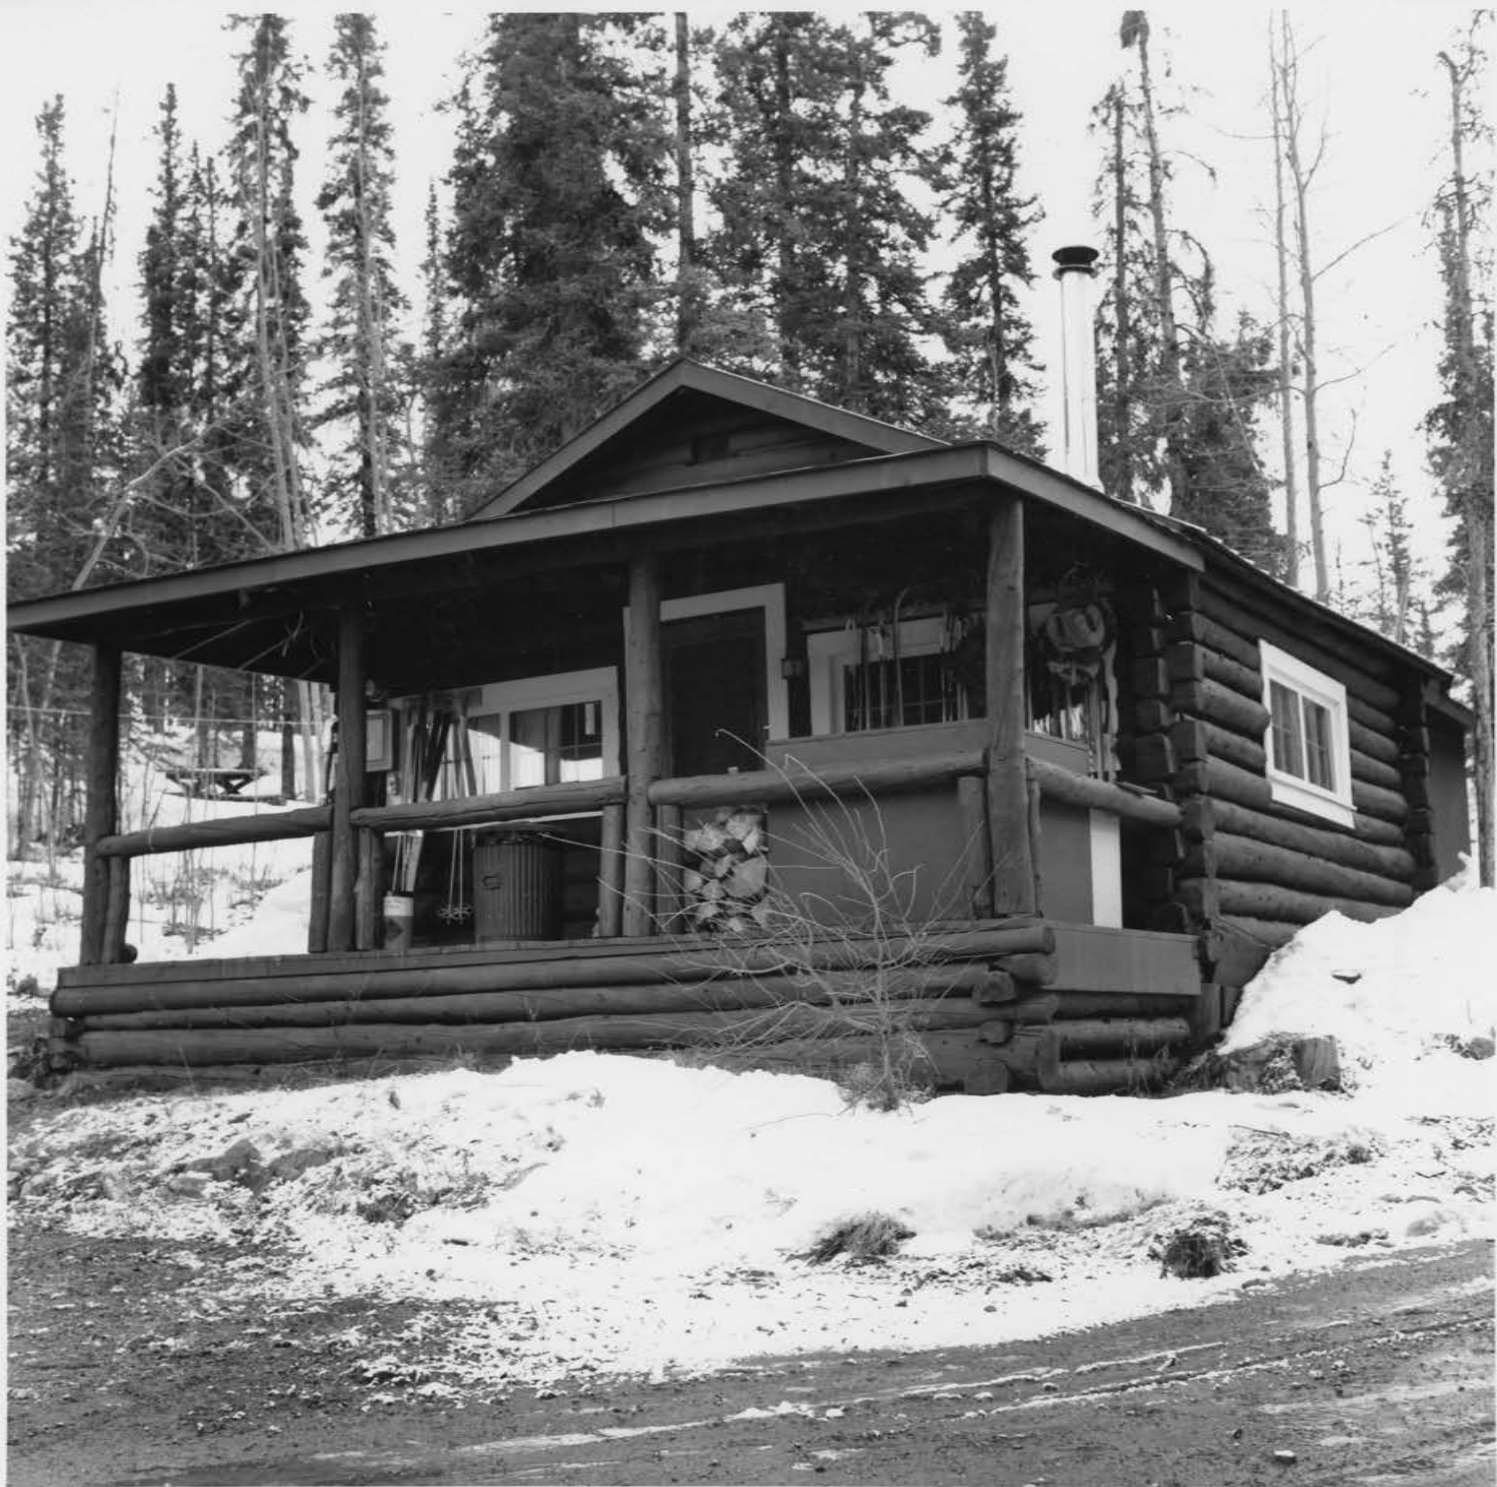
Office Building (No. 22), south and east elevations, Mount McKinley National Park Headquarters District  
Denali National Park and Preserve, Alaska  
Photographer: Kathleen Lidfors  
Date: 13 May 1985  
Negative: Alaska Regional Off., Anchorage, NPS  
Photo No. 22-1

No. 22: Office Building. 1926; architect unknown; built by park personnel. Horizontal, peeled log exterior walls with double square corner notching; painted dark brown; 20'6" x 19'6"; one story; gable roof with ribbed metal sheathing; no foundation; six-light, paired windows. Alterations: building moved in 1950 and again in 1952; log walls peeled, porch reconstructed; recent frame board and batten, shed roof addition on rear, north elevation; exterior walls painted. (Photo No. 22-1).

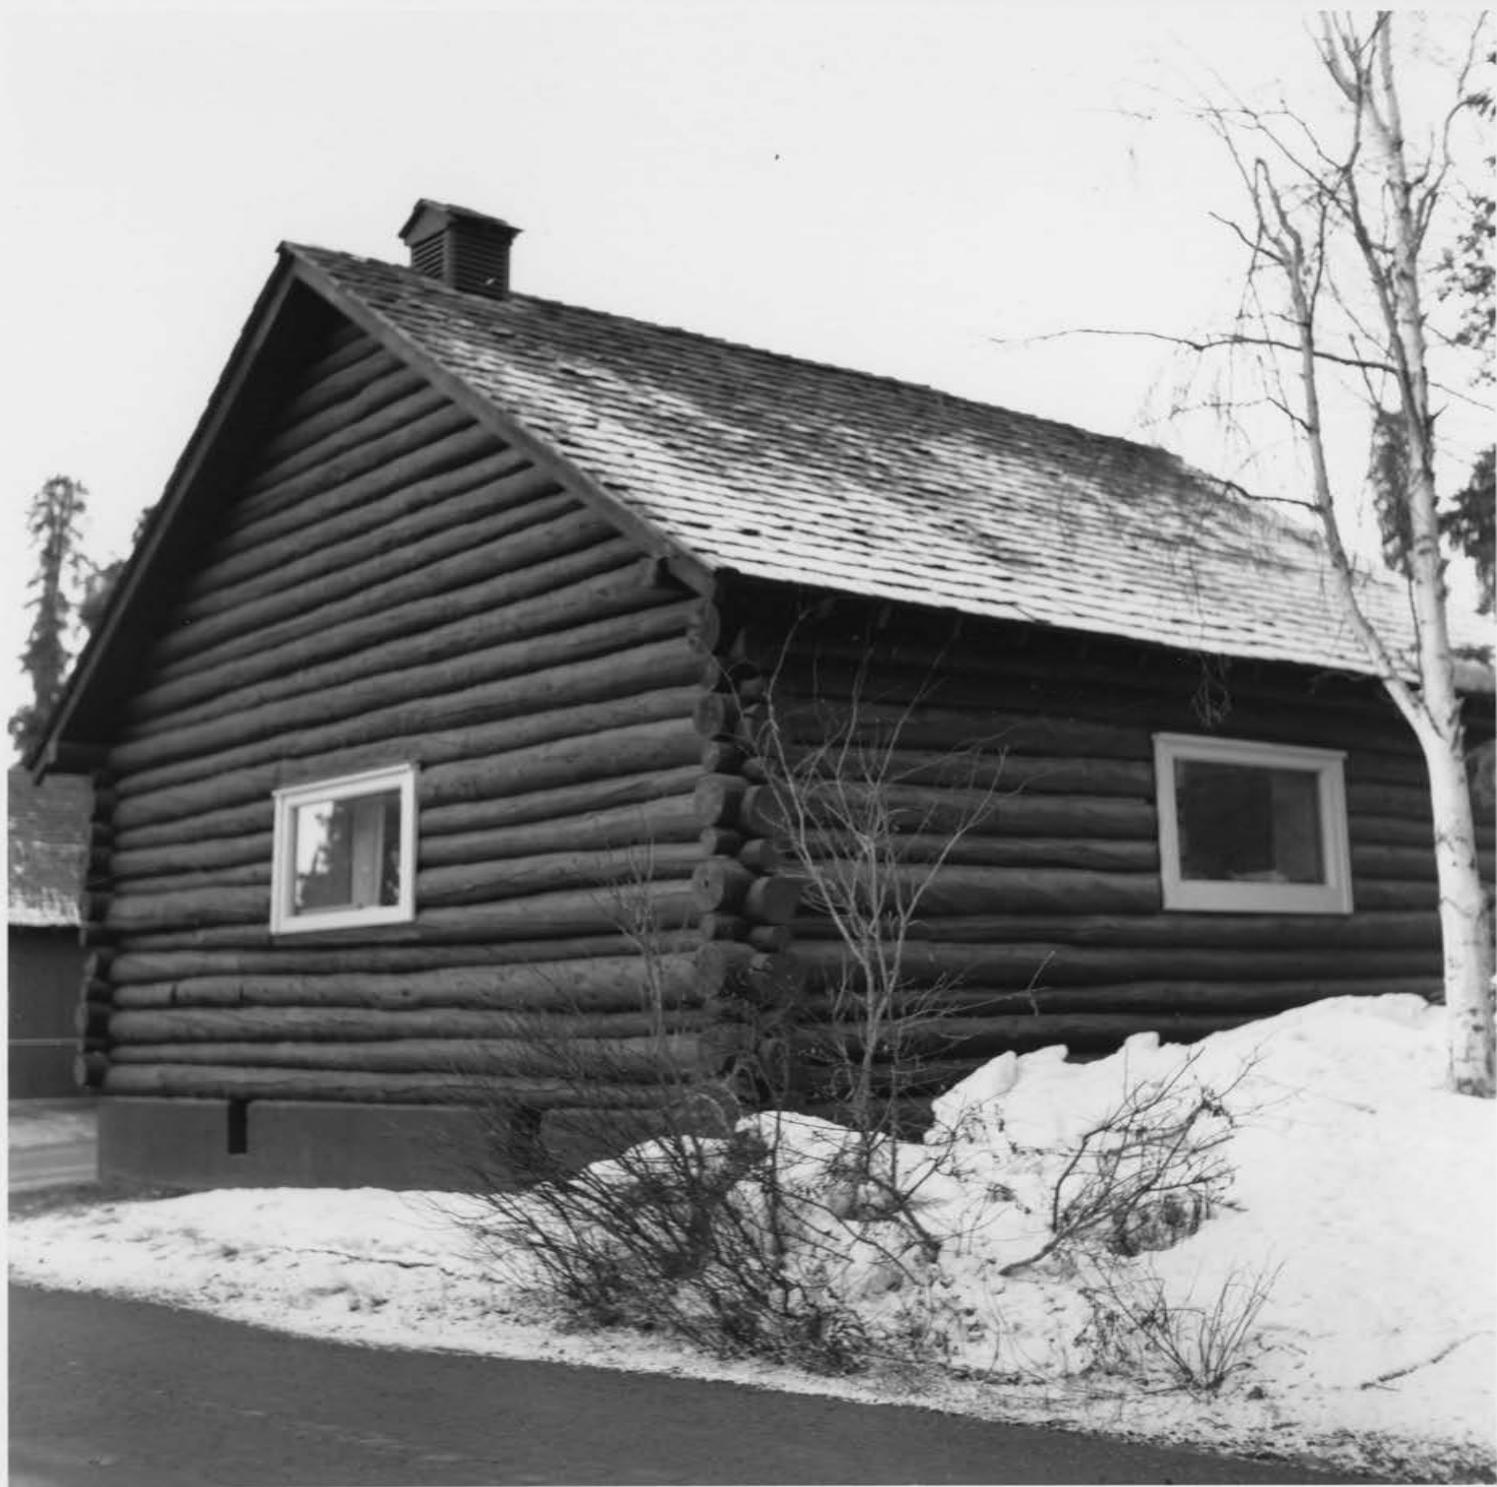
Warehouse (No. 101), south and east elevations,  
Mount McKinley National Park Headquarters  
District  
Denali National Park and Preserve, Alaska  
Photographer: Kathleen Lidfors  
Date: 13 May 1985  
Negative: Alaska Regional Off., Anchorage, NPS  
Photo No. 101-2

No. 101: Warehouse. 1928; designed by National Park Service; built by park personnel. Walls of horizontal, peeled logs; 32' x 32'; 1 1/2 stories; gable roof with wood shakes; poured concrete foundation; single light windows; two pedestrian doors on west elevation. Alterations: tar paper replaced by metal roofing in early 1950s; wood panel infill of garage door opening on south wall; new pedestrian doors on west wall; new foundation and interior rehabilitation in 1982; recent addition of wood shakes on roof; exterior walls painted. (Photo No. 101-1 to 101-3.)

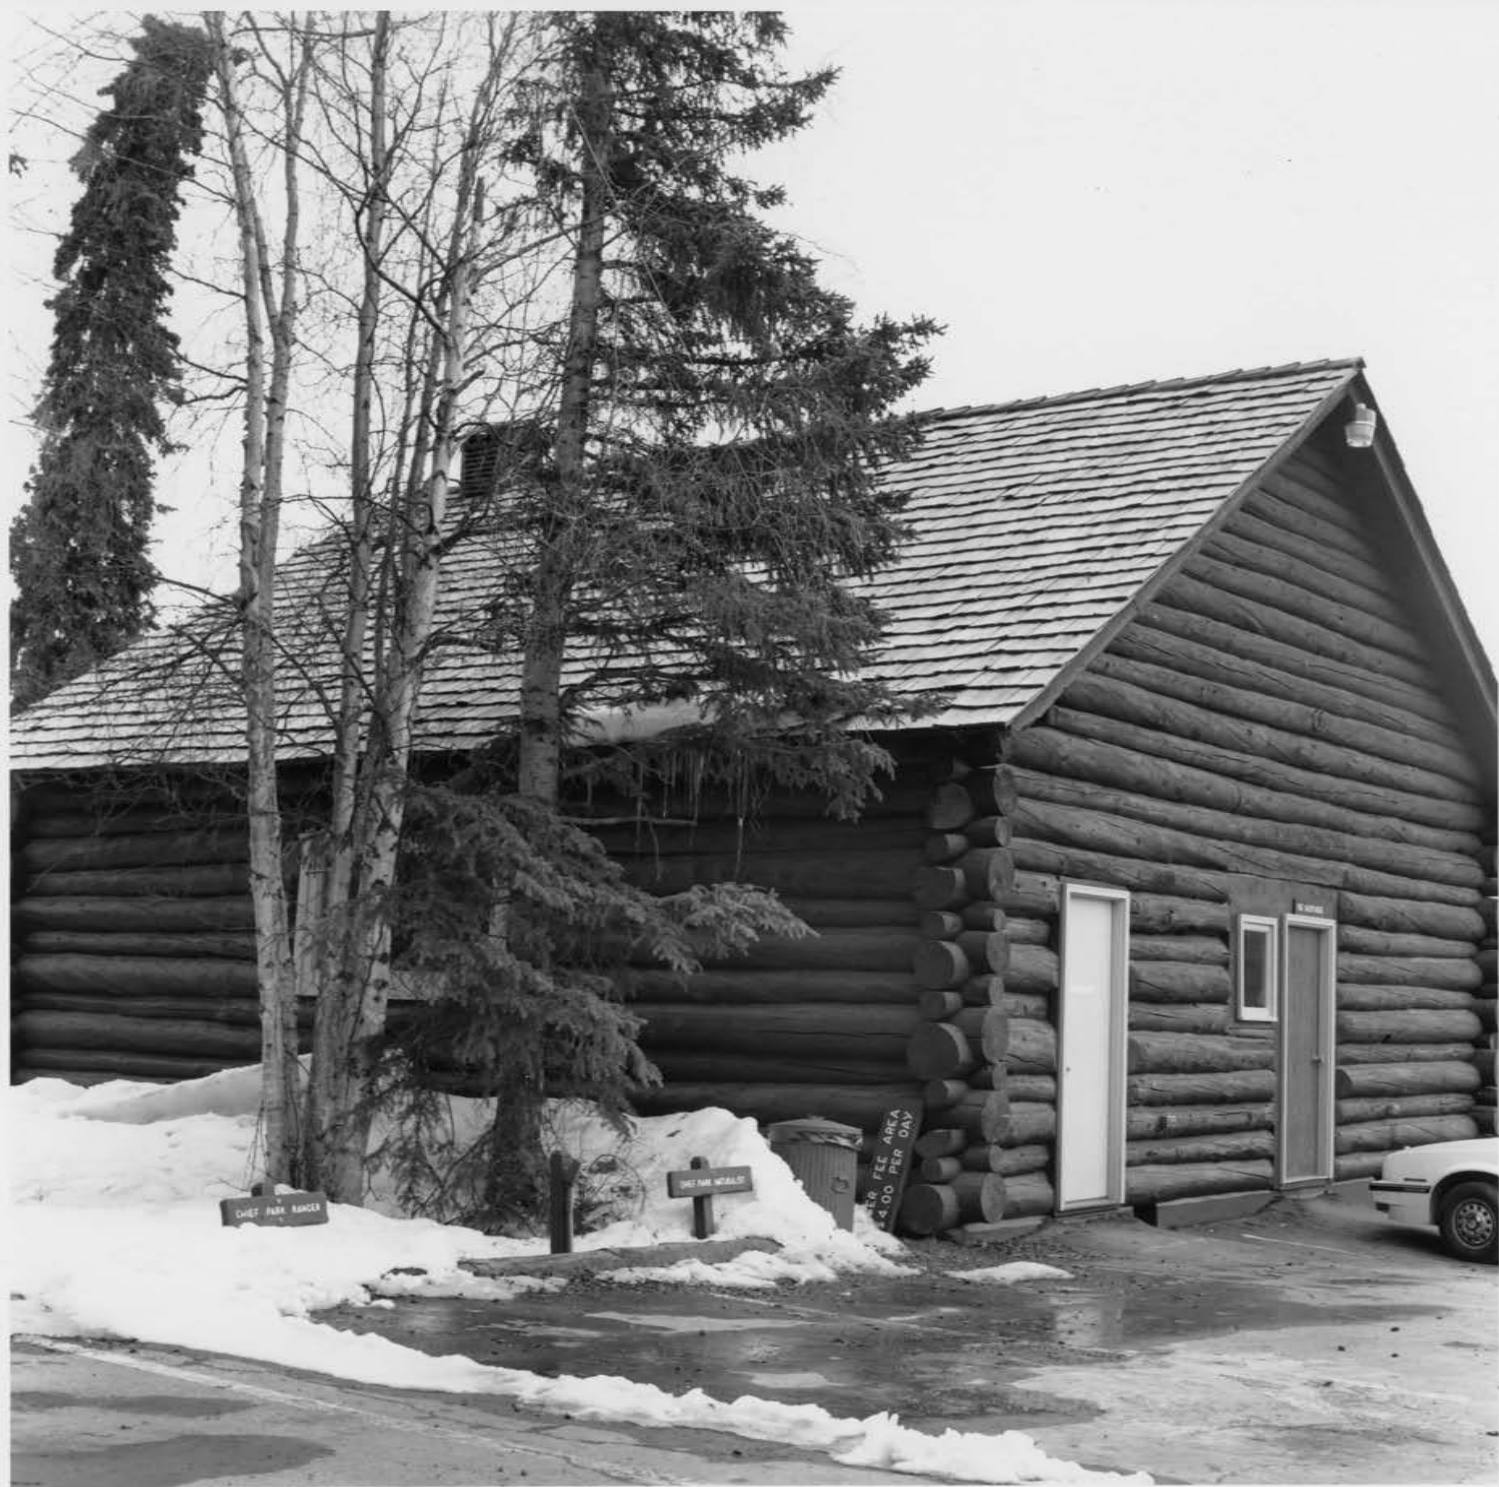
Warehouse (No. 101), north and west elevations,  
Mount McKinley National Park Headquarters  
District  
Denali National Park and Preserve, Alaska  
Photographer: Kathleen Lidfors  
Date: 13 May 1985  
Negative: Alaska Regional Off., Anchorage, NPS  
Photo No. 101-3

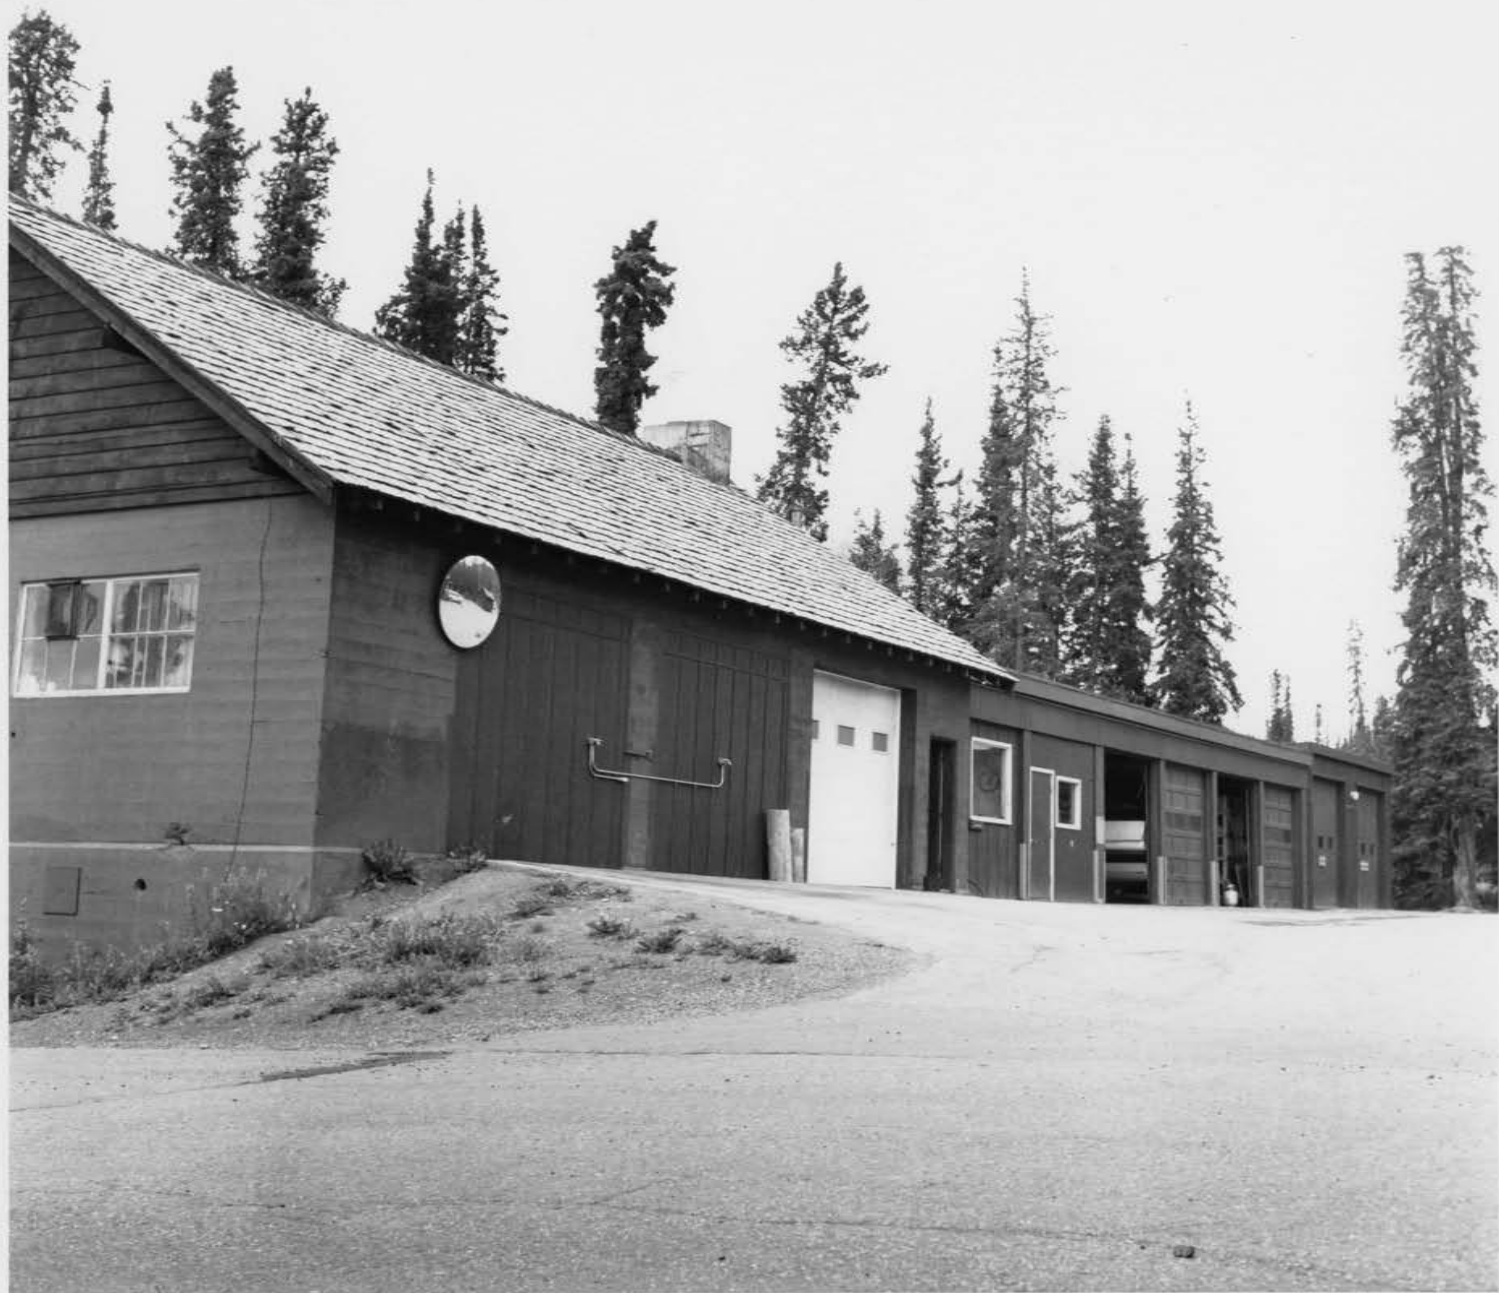
Garage and Repair Shop (No. 102) with noncon-  
tributing addition, north elevation, Mount  
McKinley National Park Headquarters District  
Denali National Park and Preserve, Alaska  
Photographer: Gail Evans  
Date: 22 July 1985  
Negative: Alaska Regional Off., Anchorage, NPS  
Photo No. 102-1

No. 102: Garage and Repair Shop (Machine Shop and Garage). 1939; designed by National Park Service; built by Civilian Conservation Corps. Reinforced concrete wall construction with horizontal wood siding in gable ends; painted dark brown; 46' x 30'; two stories; gable roof with wood shakes; reinforced concrete foundation; multi-light casement windows; three vehicle bays and pedestrian door on north facade. Alterations: major concrete block addition

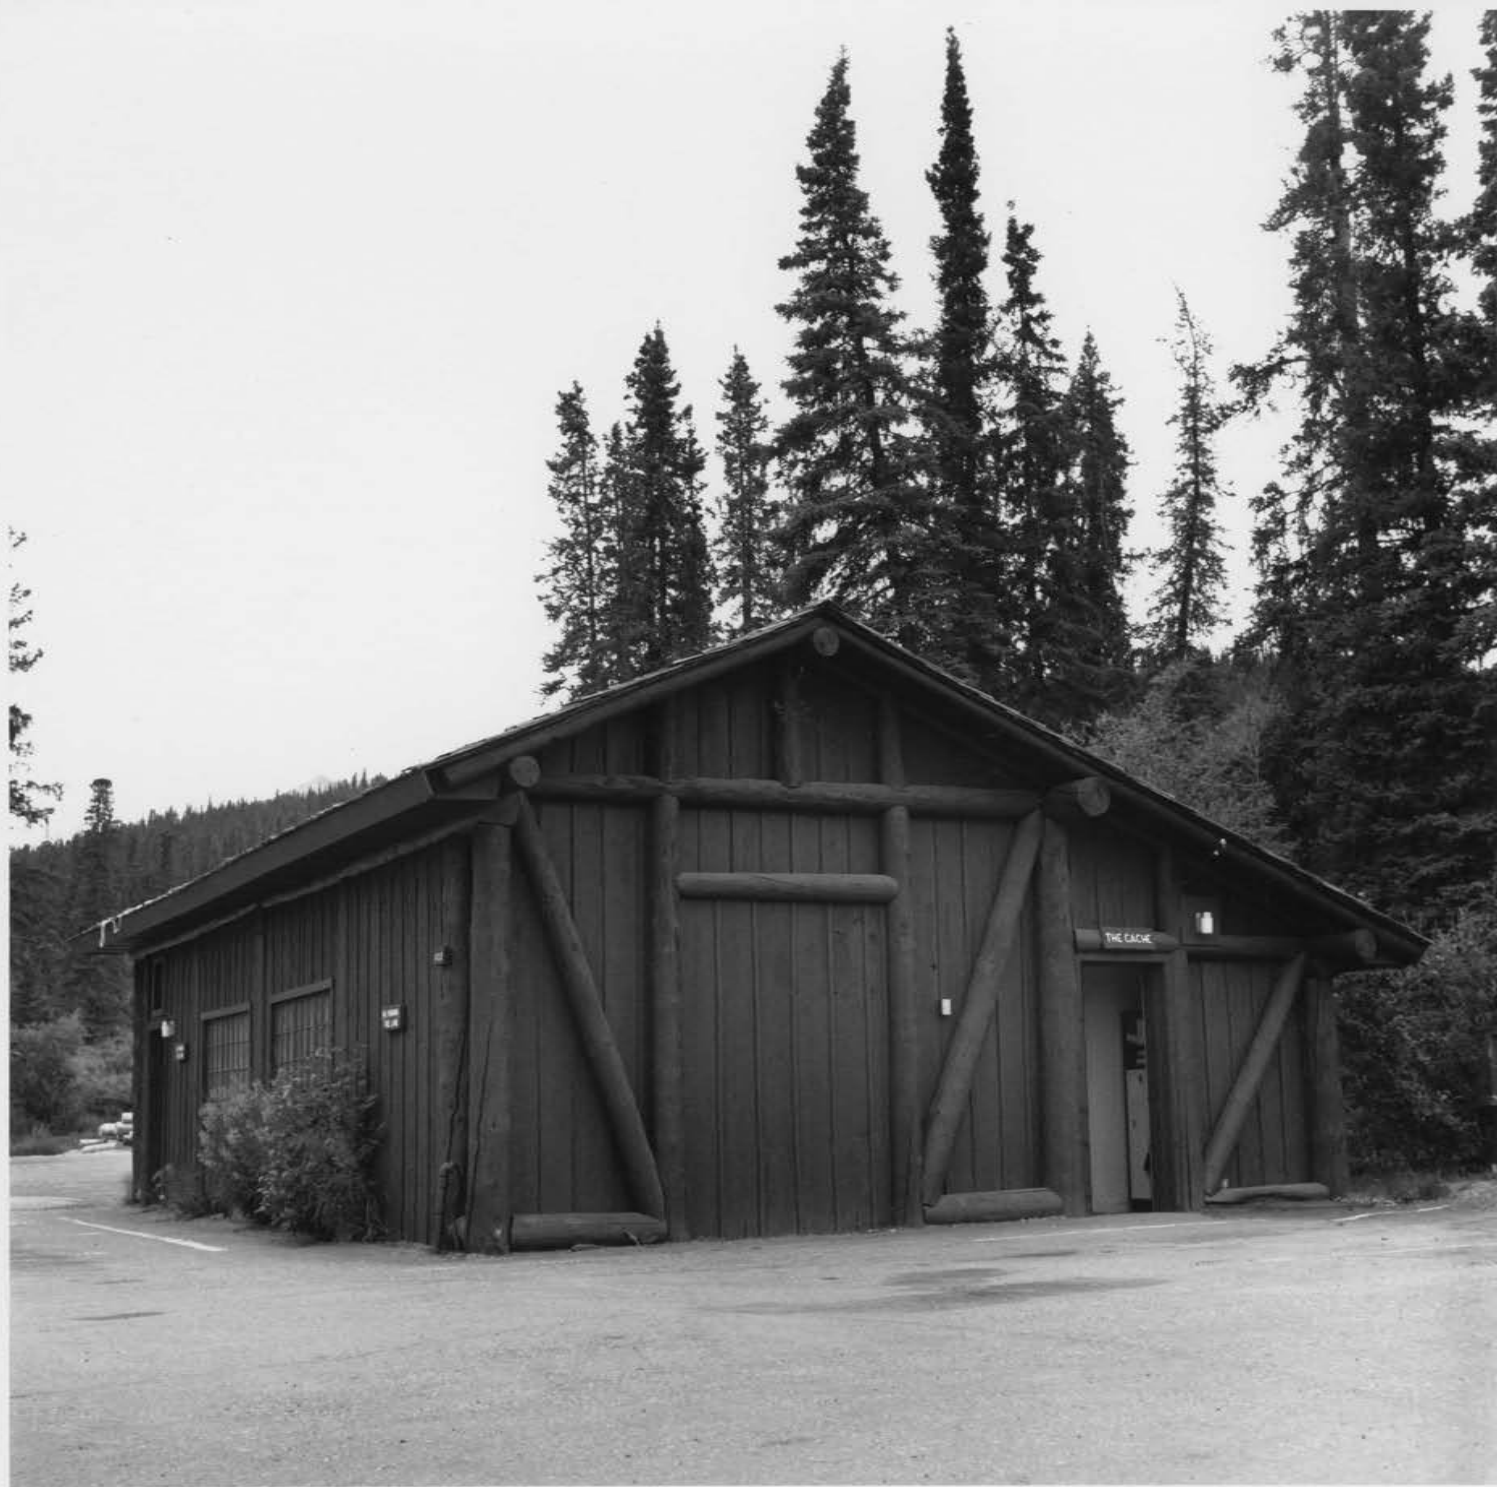
Garage (No. 103), south and east elevations,  
Mount McKinley National Park Headquarters  
District

No. 103: Garage. 1931; designed by National Park Service; built by park personnel and contracted labor. Peeled log frame with vertical board-and-batten exterior walls; painted dark brown; 25' x 42'2"; one story; salt-box type roof with wood shakes; concrete slab foundation under portions; six-light casement windows; pedestrian door (east elevation) and single garage door (west elevation). Alterations: infill of garage doors on south wall between 1950 and mid-1960s; interior repartitioning in late 1970s and in 1984; recent shake roof; exterior painted. (Photo Nos. 103-1 to 103-3.)

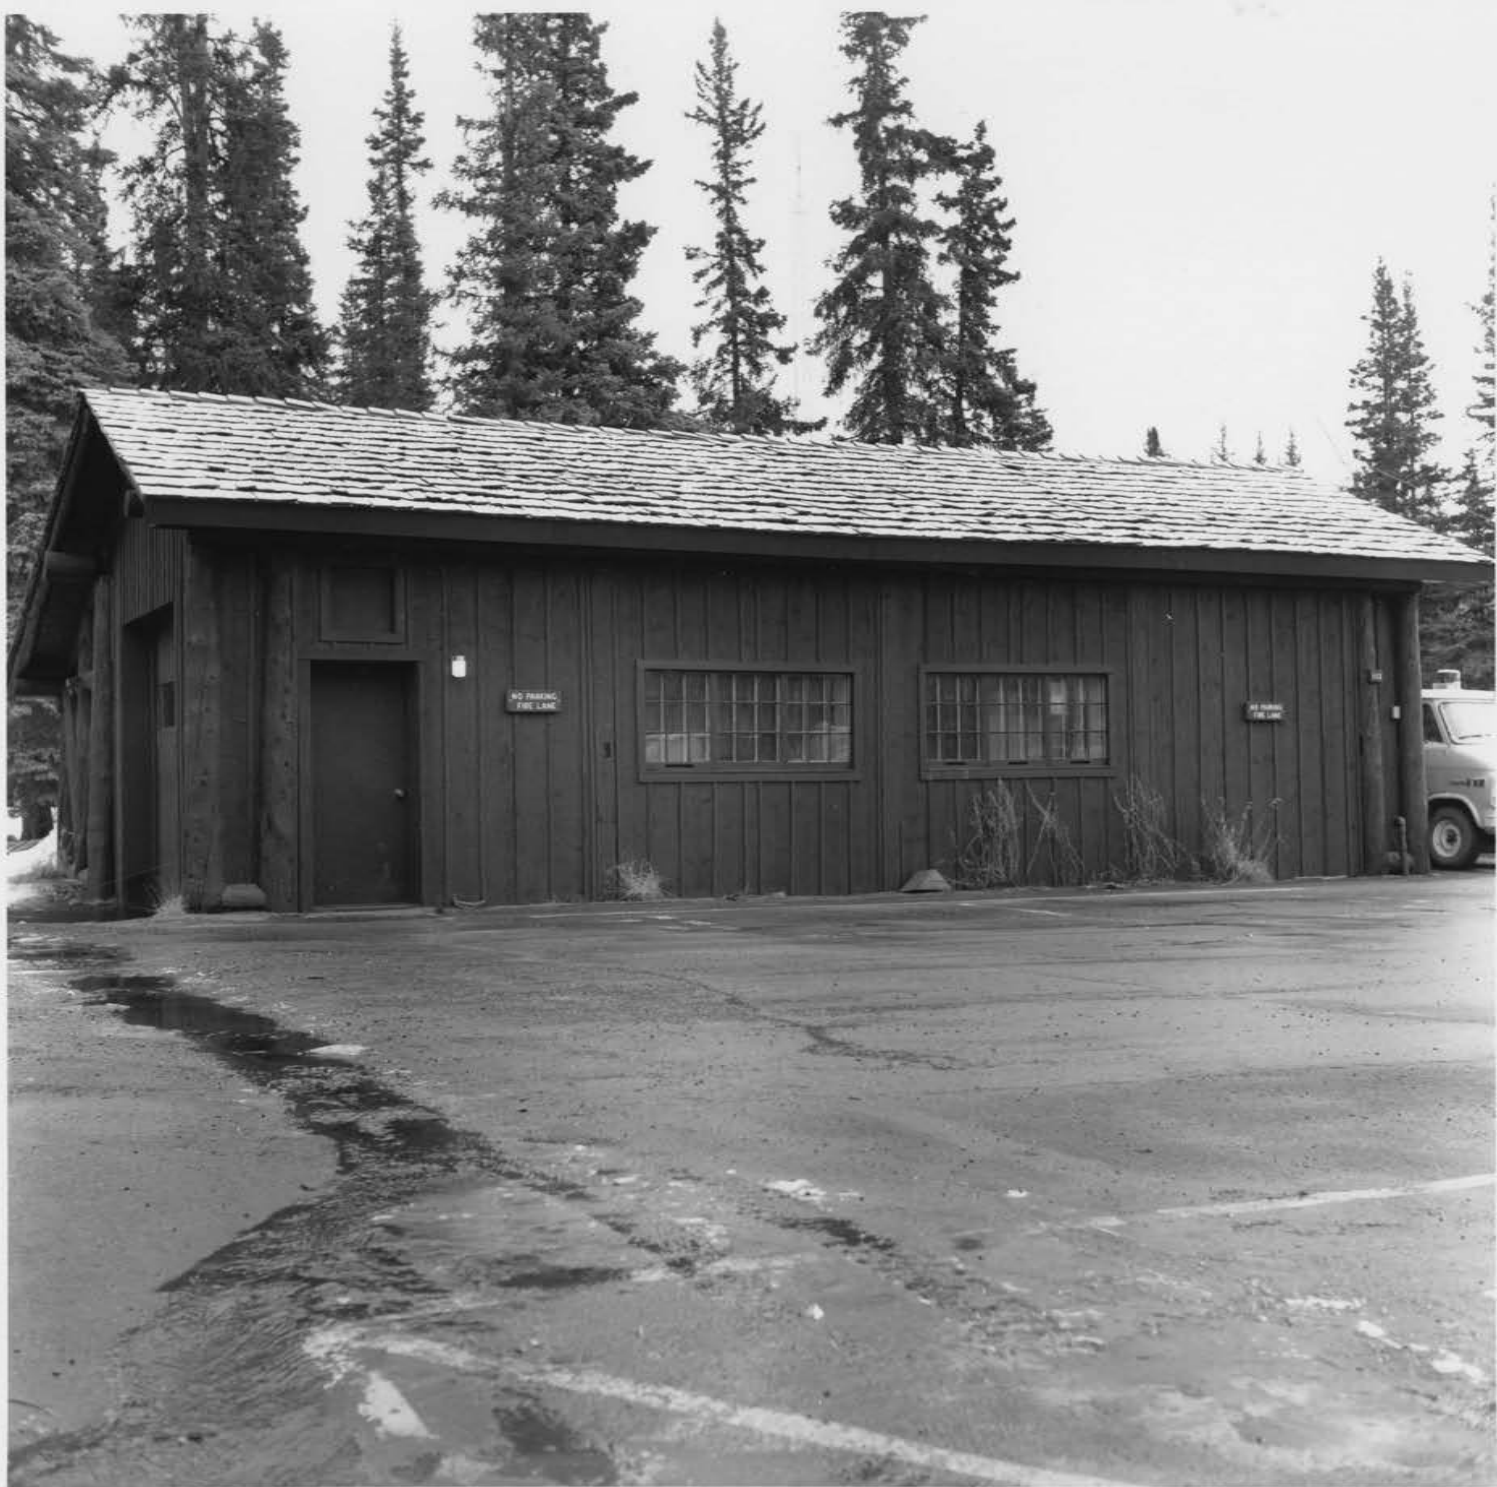
Garage (No. 103), south elevation, Mount McKin-  
ley National Park Headquarters District  
Denali National Park and Preserve, Alaska  
Photographer: Kathleen Lidfors  
Date: 13 May 1985  
Negative: Alaska Regional Off., Anchorage, NPS  
Photo No. 103-2

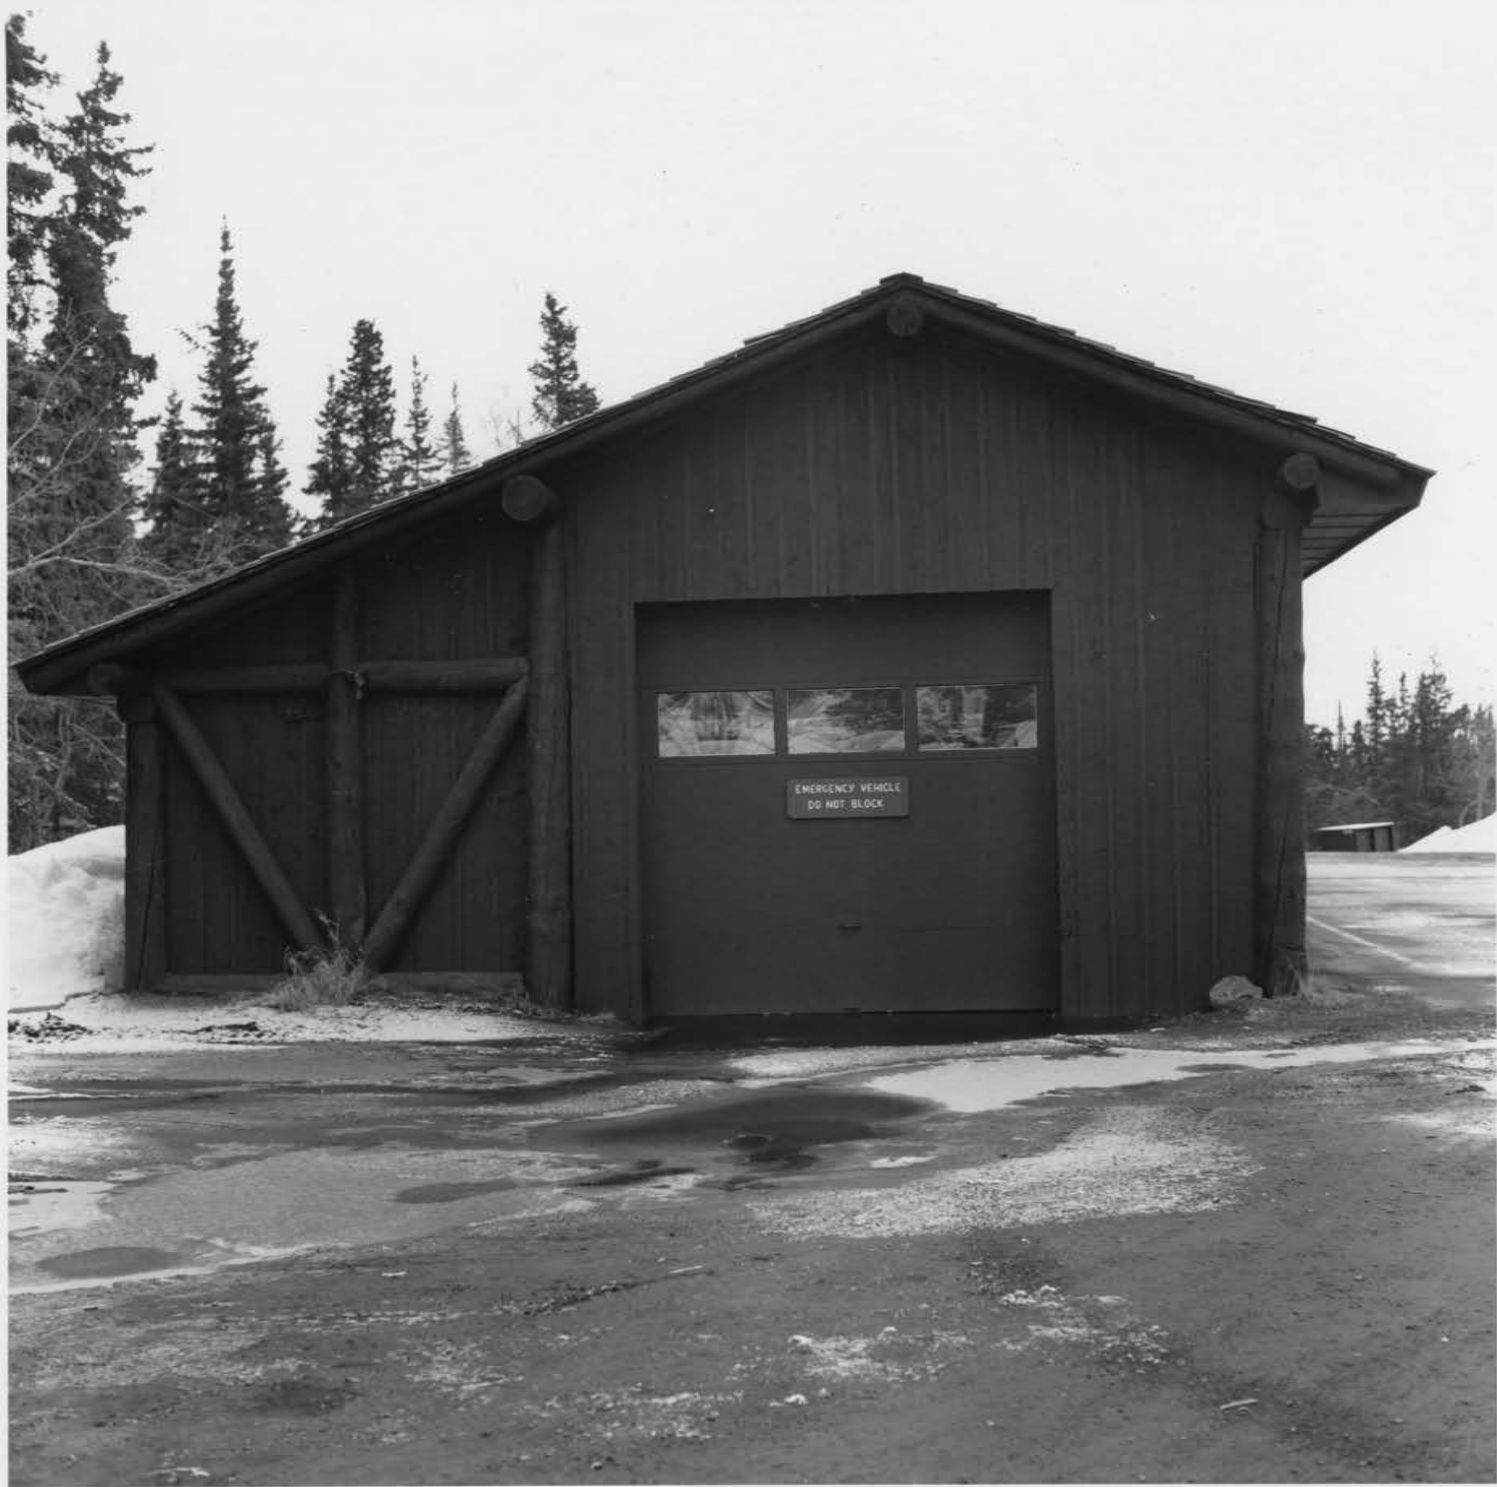
Garage (No. 103), west elevation, Mount McKinley  
National Park Headquarters District  
Denali National Park and Preserve, Alaska  
Photographer: Kathleen Lidfors  
Date: 13 May 1985  
Negative: Alaska Regional Off., Anchorage, NPS  
Photo No. 103-3
