**NATIONAL REGISTER OF HISTORIC PLACES  
INVENTORY -- NOMINATION FORM**

Mount McKinley National Park Headquarters District

Denali National Park and Preserve Headquarters

2014 Addendum to the  
Historic Structure Report  
Mt. McKinley Park Headquarters Historic District &  
Wonder Lake  
(1987)

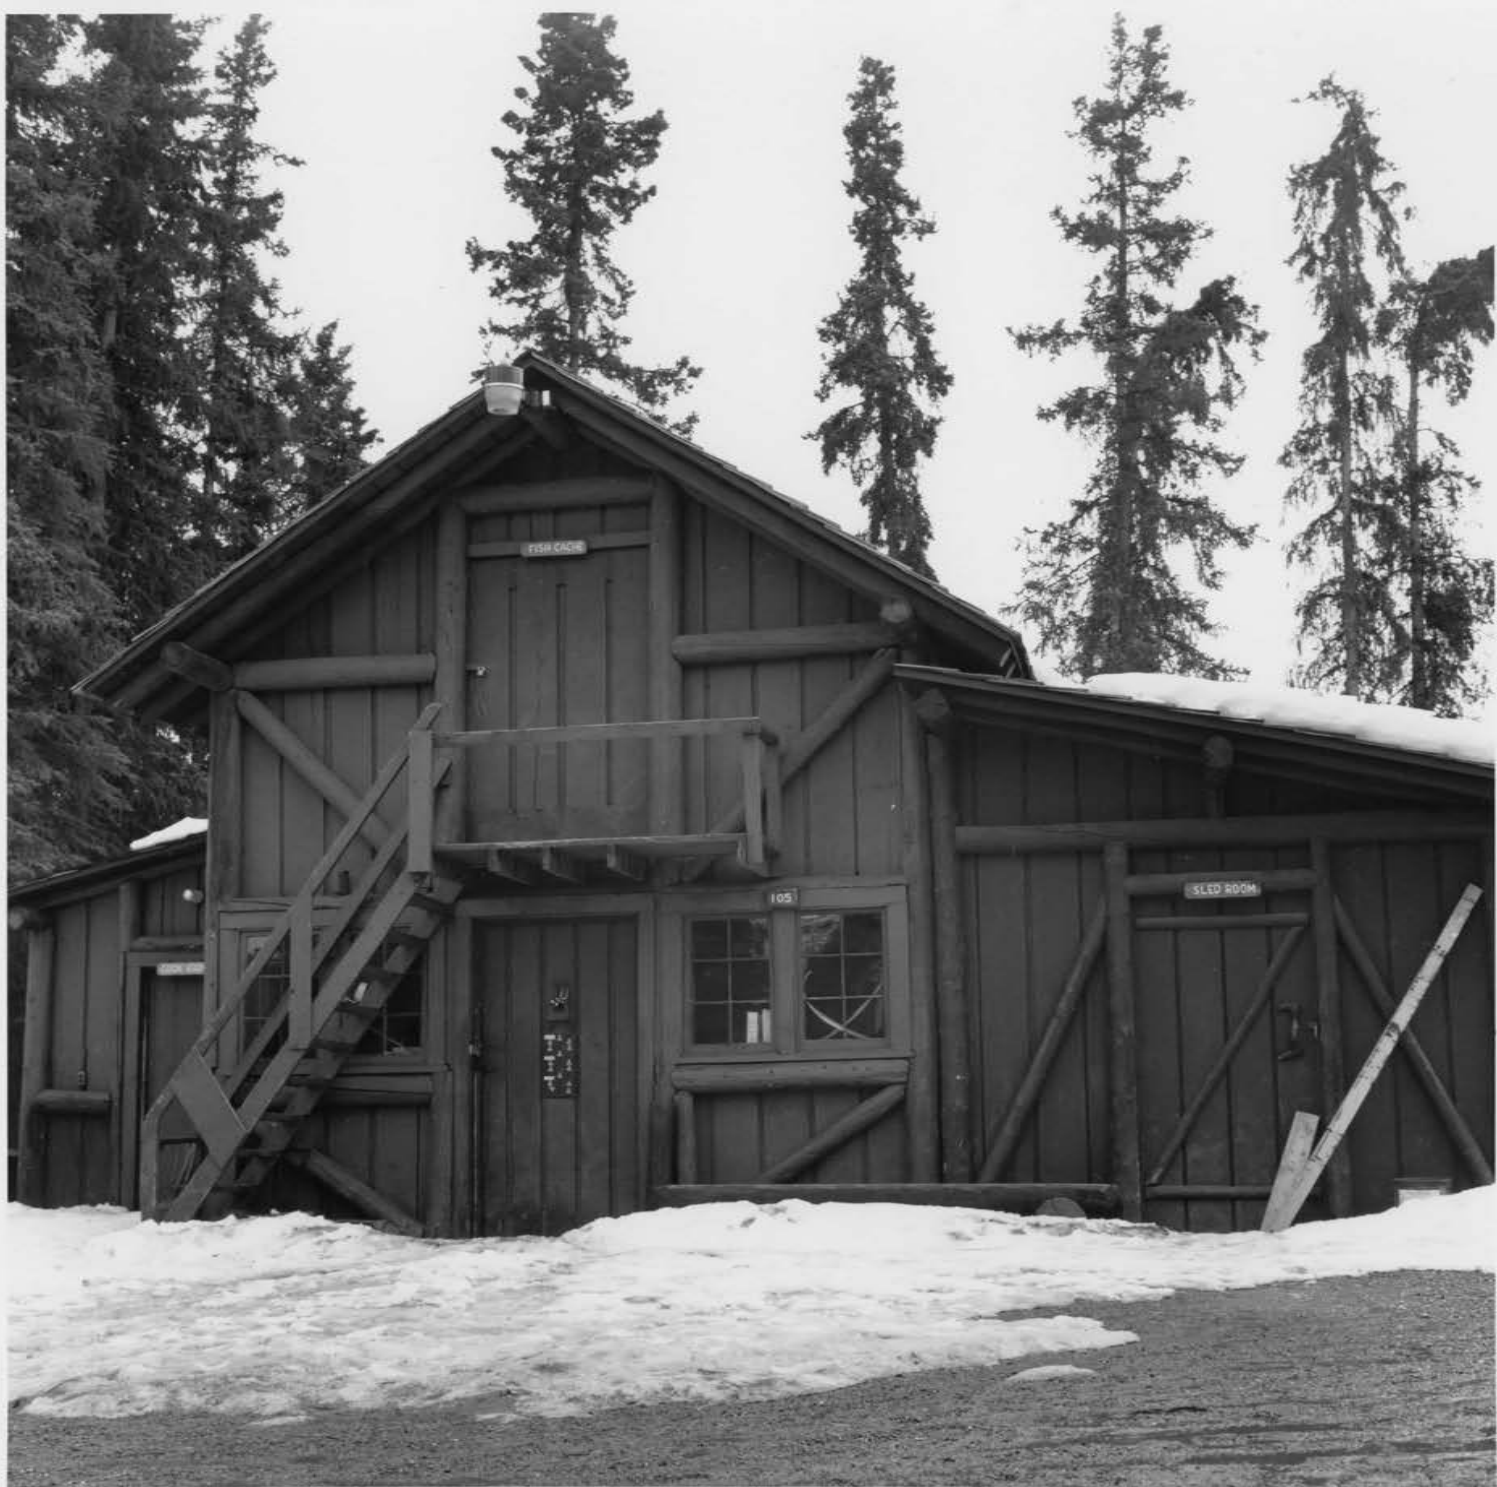
Dog Feed Cache and Sled Storage (No. 105),  
north elevation, Mount McKinley National  
Park Headquarters District  
Denali National Park and Preserve, Alaska  
Photographer: Kathleen Lidfors  
Date: 13 May 1985  
Negative: Alaska Regional Off., Anchorage, NPS  
Photo No. 105-1

No. 105: Dog Feed Cache and Sled Storage. 1929-1930; designed by National Park Service; park personnel probable builders. Peeled log frame with reversed board-and-batten siding; painted dark brown; main portion, 14'10" x 24'10"; 1 1/2 stories; gable roof; two smaller adjoining sections are one story with shed roofs; all roofs sheathed with wood shakes; concrete slab foundation under two portions; six-light casement windows; solid wood doors on north elevation. Alterations: building moved in 1938; shed roof

addition on west wall of central portion in 1976; recent replacement of metal roof with wood shakes; exterior walls painted. (Photo No. 105-1, 105-2.)

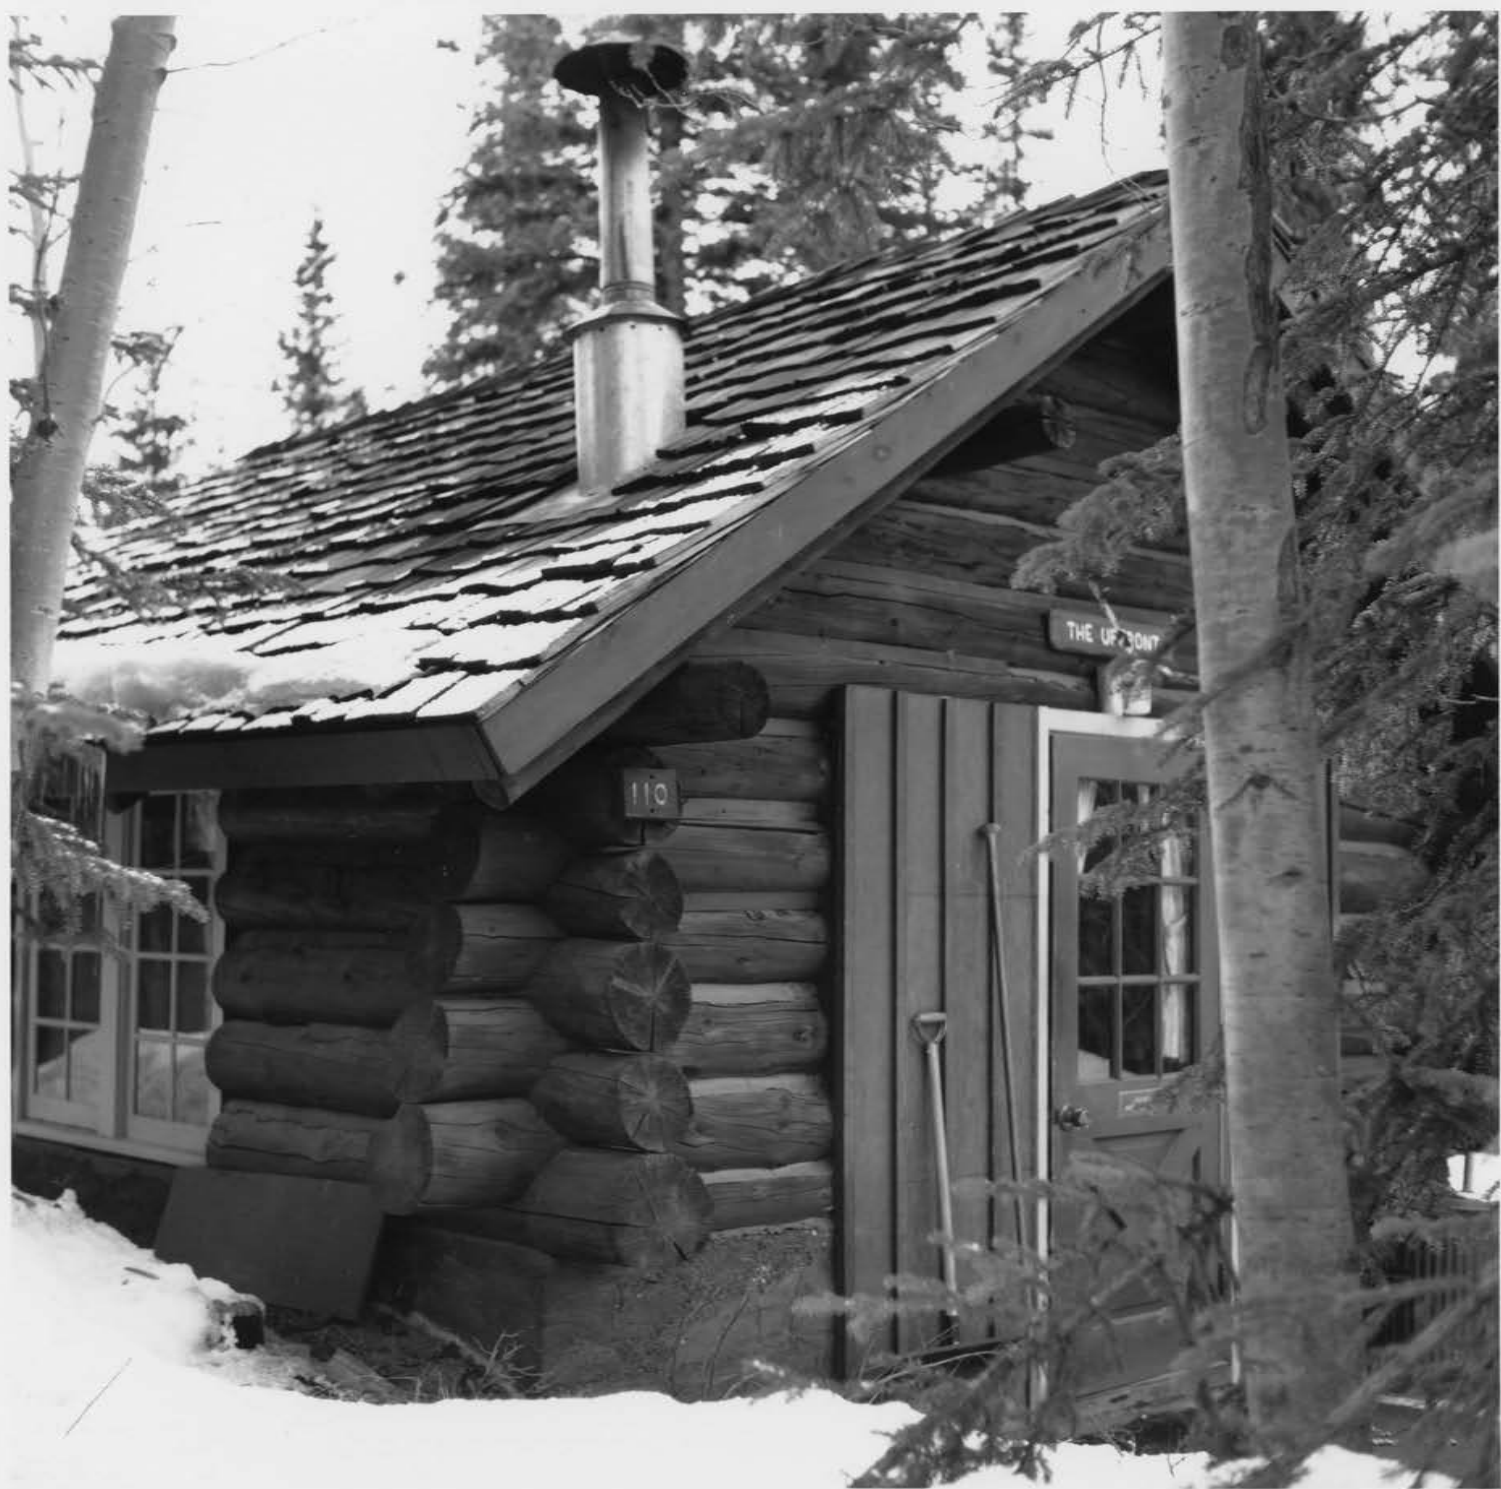
Power House (No. 110), battered log ends at  
northwest corner, Mount McKinley National  
Park Headquarters District  
Denali National Park and Preserve, Alaska  
Photographer: Kathleen Lidfors  
Date: 13 May 1985  
Negative: Alaska Regional Off., Anchorage, NPS  
Photo No. 110-1

No. 110: Electric Light Plant (Power House). 1930-1931; architect unknown; park personnel probable builders. Horizontal, peeled log and poured concrete (lower one-third) wall construction; saddle corner notching with sawn and battered log ends; painted dark brown; 14' x 16'; one story; gable roof sheathed with wood shakes; concrete foundation; eight-light casement windows; pedestrian door on west elevation. Alterations: replacement of single garage door with pedestrian door; replacement of corrugated metal roof with wood shakes; exterior walls painted. (Photo Nos. 110-1 to 110-3.)

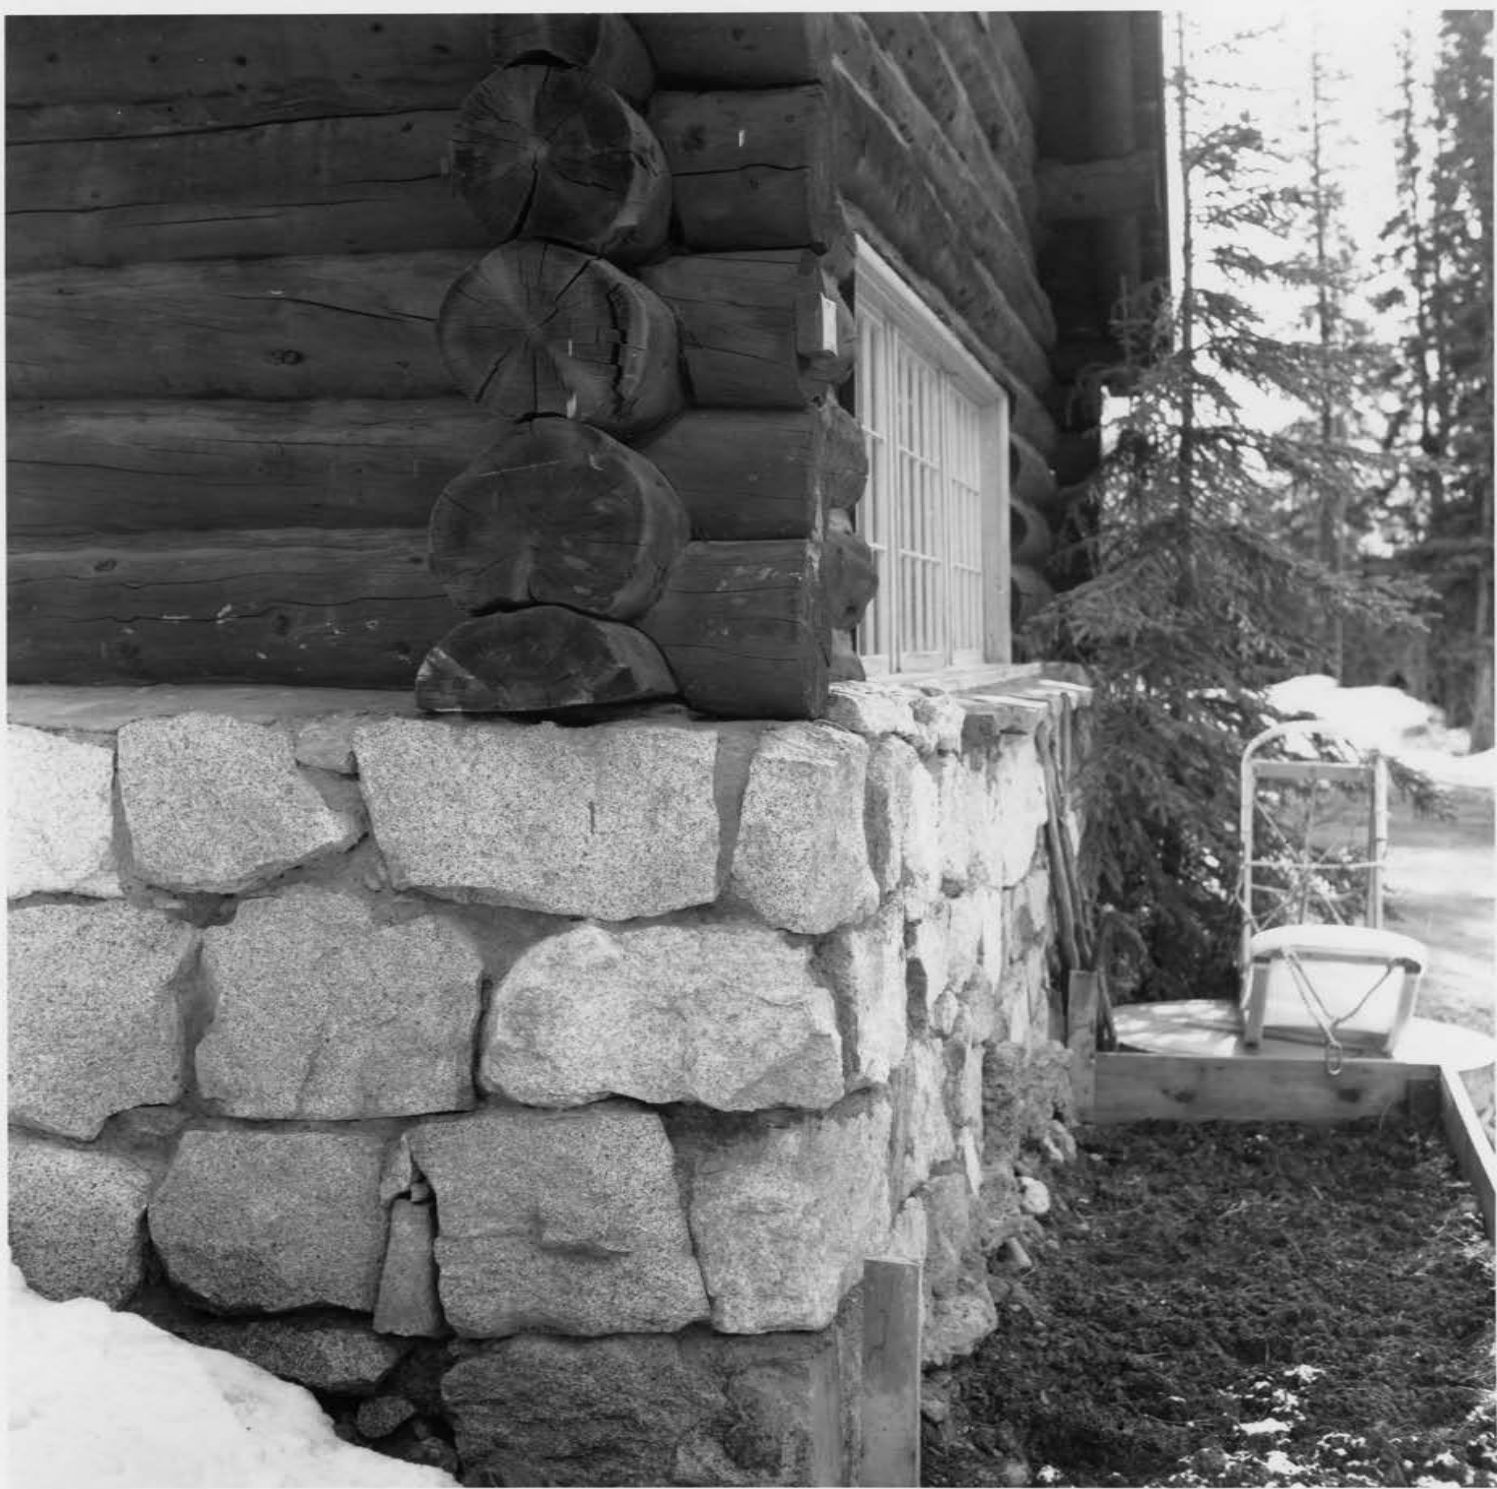
Superintendent's Garage (No. 111), stone work,  
west and south walls, Mount McKinley National  
Park Headquarters District  
Denali National Park and Preserve, Alaska  
Photographer: Kathleen Lidfors  
Date: 13 May 1985  
Negative: Alaska Regional Off., Anchorage, NPS  
Photo No. 111 - 2

No. 111: Superintendent's Garage. 1939; designed by National Park Service; built by Civilian Conservation Corps. Horizontal peeled log walls above poured concrete with stone veneer exterior walls; log portion painted dark brown; L-shape; measures 24'6" x 33'6" and 15'6" square; one story; intersecting gable roof with corrugated metal sheathing; concrete slab foundation; 12-light sash windows. Alterations: compatible addition constructed on west wall in 1943; infill of garage doors on east elevation; and interior repartitioning in 1943; interior remodeling in 1960 and early 1980s; new metal roof installed 1984. (Photo Nos. 111-1 to 111-3.)

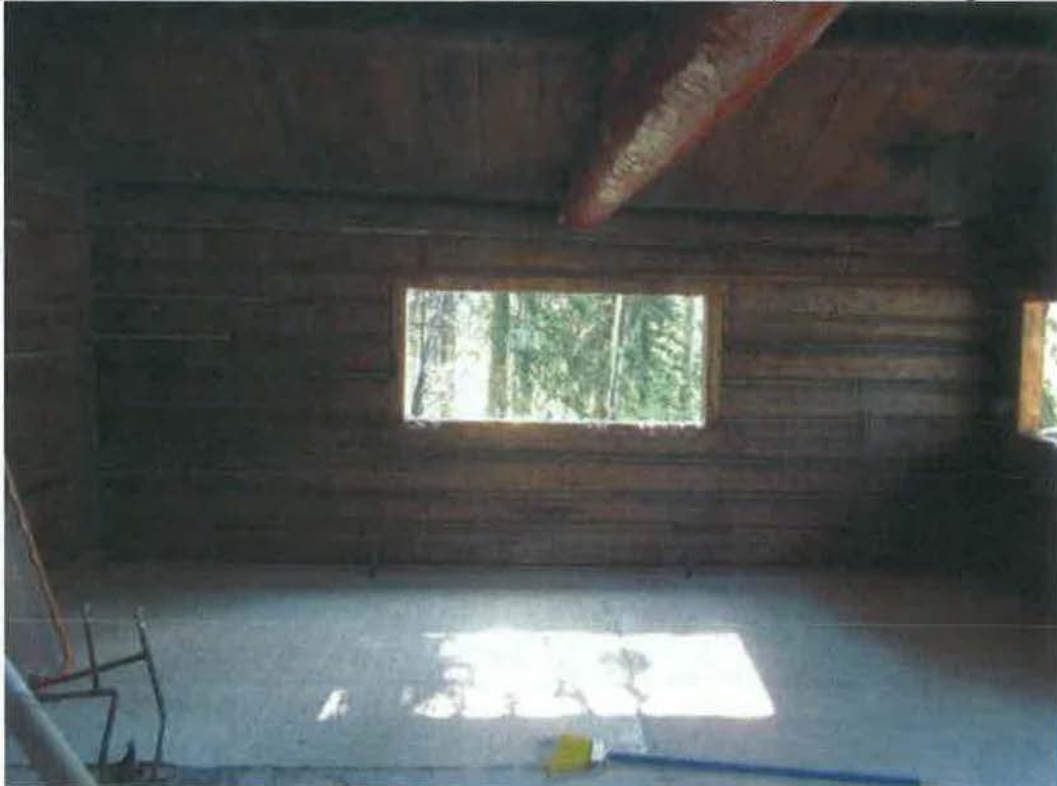
Figure 100- East Elevation. Historic logs and roof are in excellent condition (NPS Photo, August 2013).

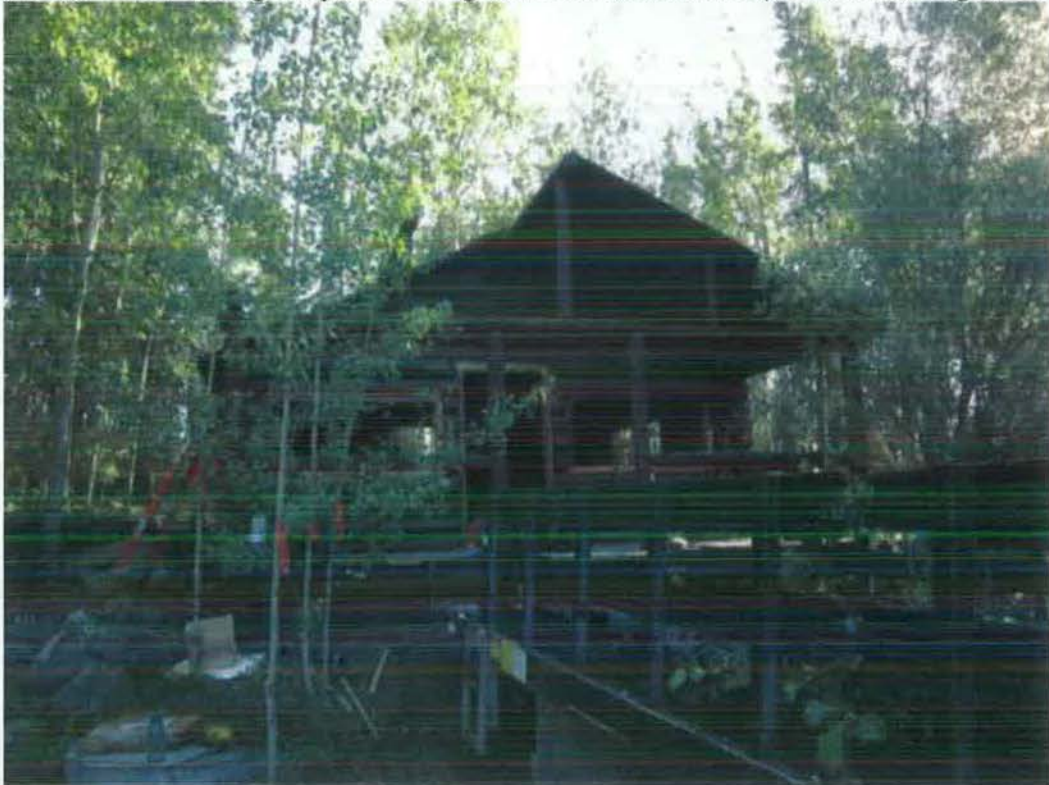
Figure 102- Removal of porch in progress. After relocation the porch will be reassembled (NPS Photo, August 2013).

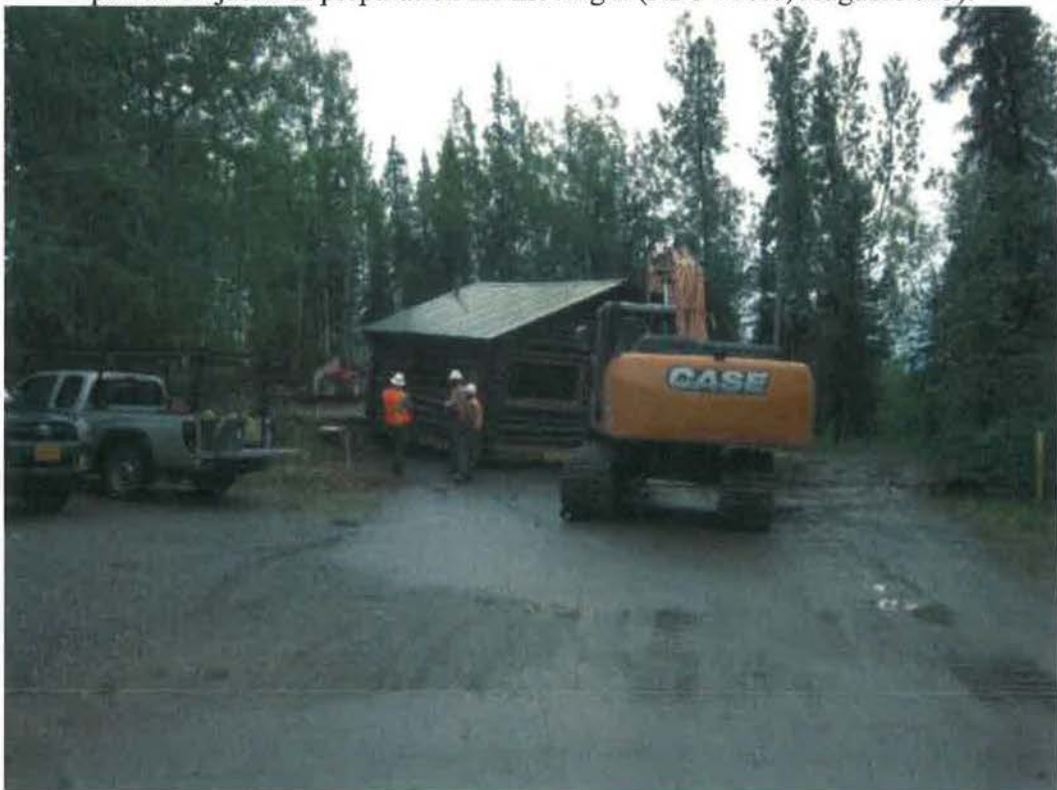
Figure 104- P-22 being moved off its foundation (NPS Photo, September 2013).

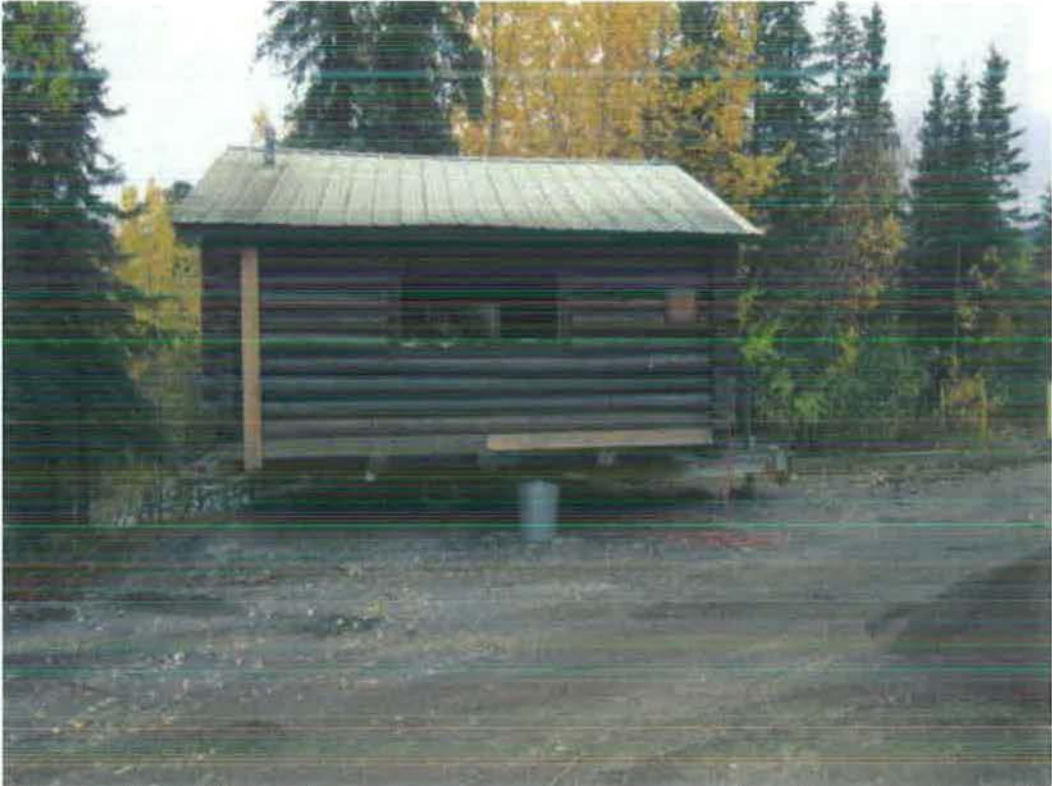
Figure 105- P-22 on trailer waiting to be moved to the maintenance yard for safe storage (NPS Photo, September 2013).
