Jackson Park Historic District

Name of Property
Dubuque County, IA
County and State

Property Name: Jackson Park Historic District

**National Register of Historic Places
Inventory—Nomination Form**

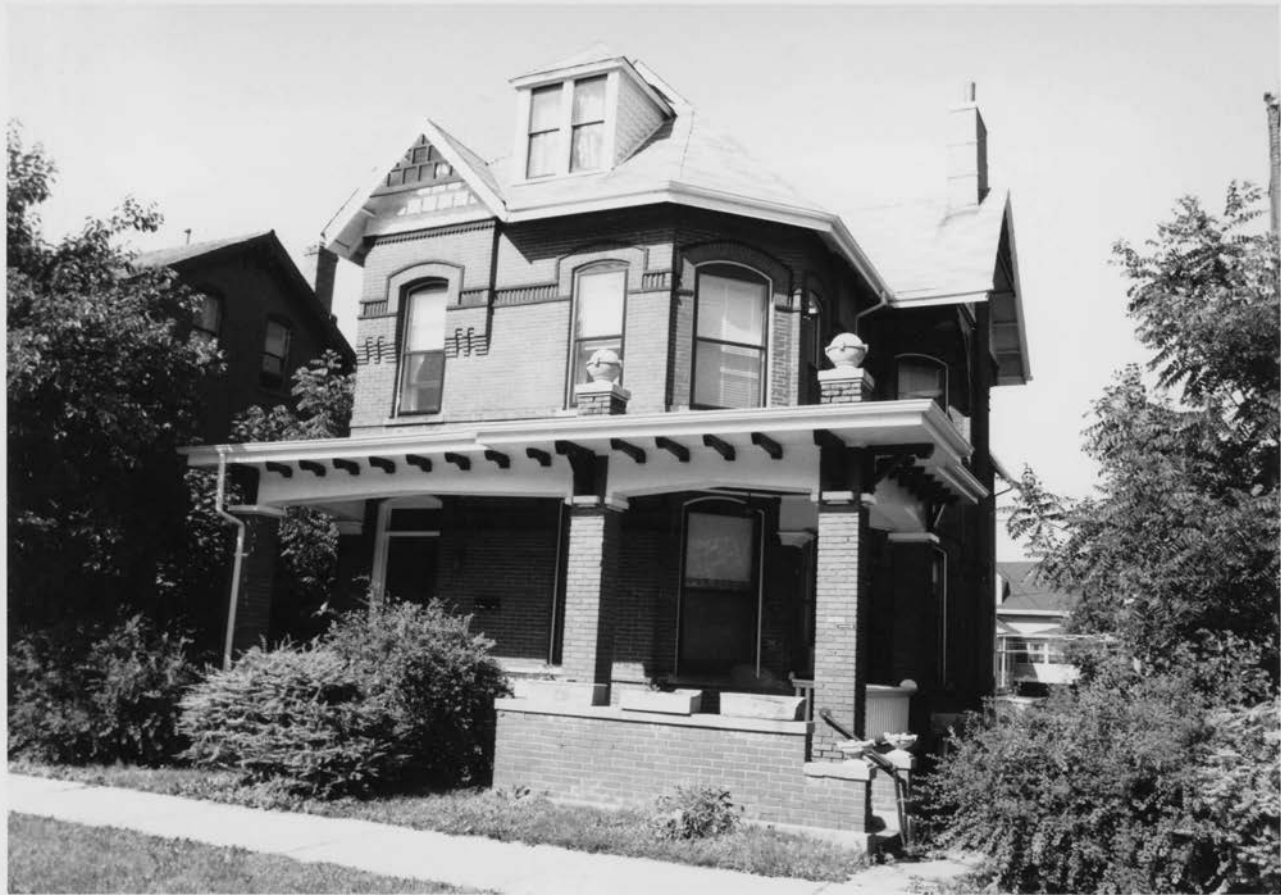
ADDRESS: 1576 Locust

VIEW: NE

On page 10 of the nomination the property at 1576 Locust was listed as an "intrusion" in the historic district due to the porch, which is not original for the district's period of significance that ends in 1900. The house, built in 1886, is substantially intact, the c.1915 porch being the only significant change. The porch is not an unsympathetic feature on a house with distinctive Victorian massing and brick detailing. The latter includes polychromatic brick, label moldings, corbelling, and decorative gable treatments characteristic of the late nineteenth century.

With this SLR the house can be included as a contributing resource in the Jackson Park Historic District.
