National Register of Historic Places  
Registration Form

historic name Hildreth-Robbins House

street & number 19 Maple Road N/A not for publication

city or town Chelmsford N/A vicinity

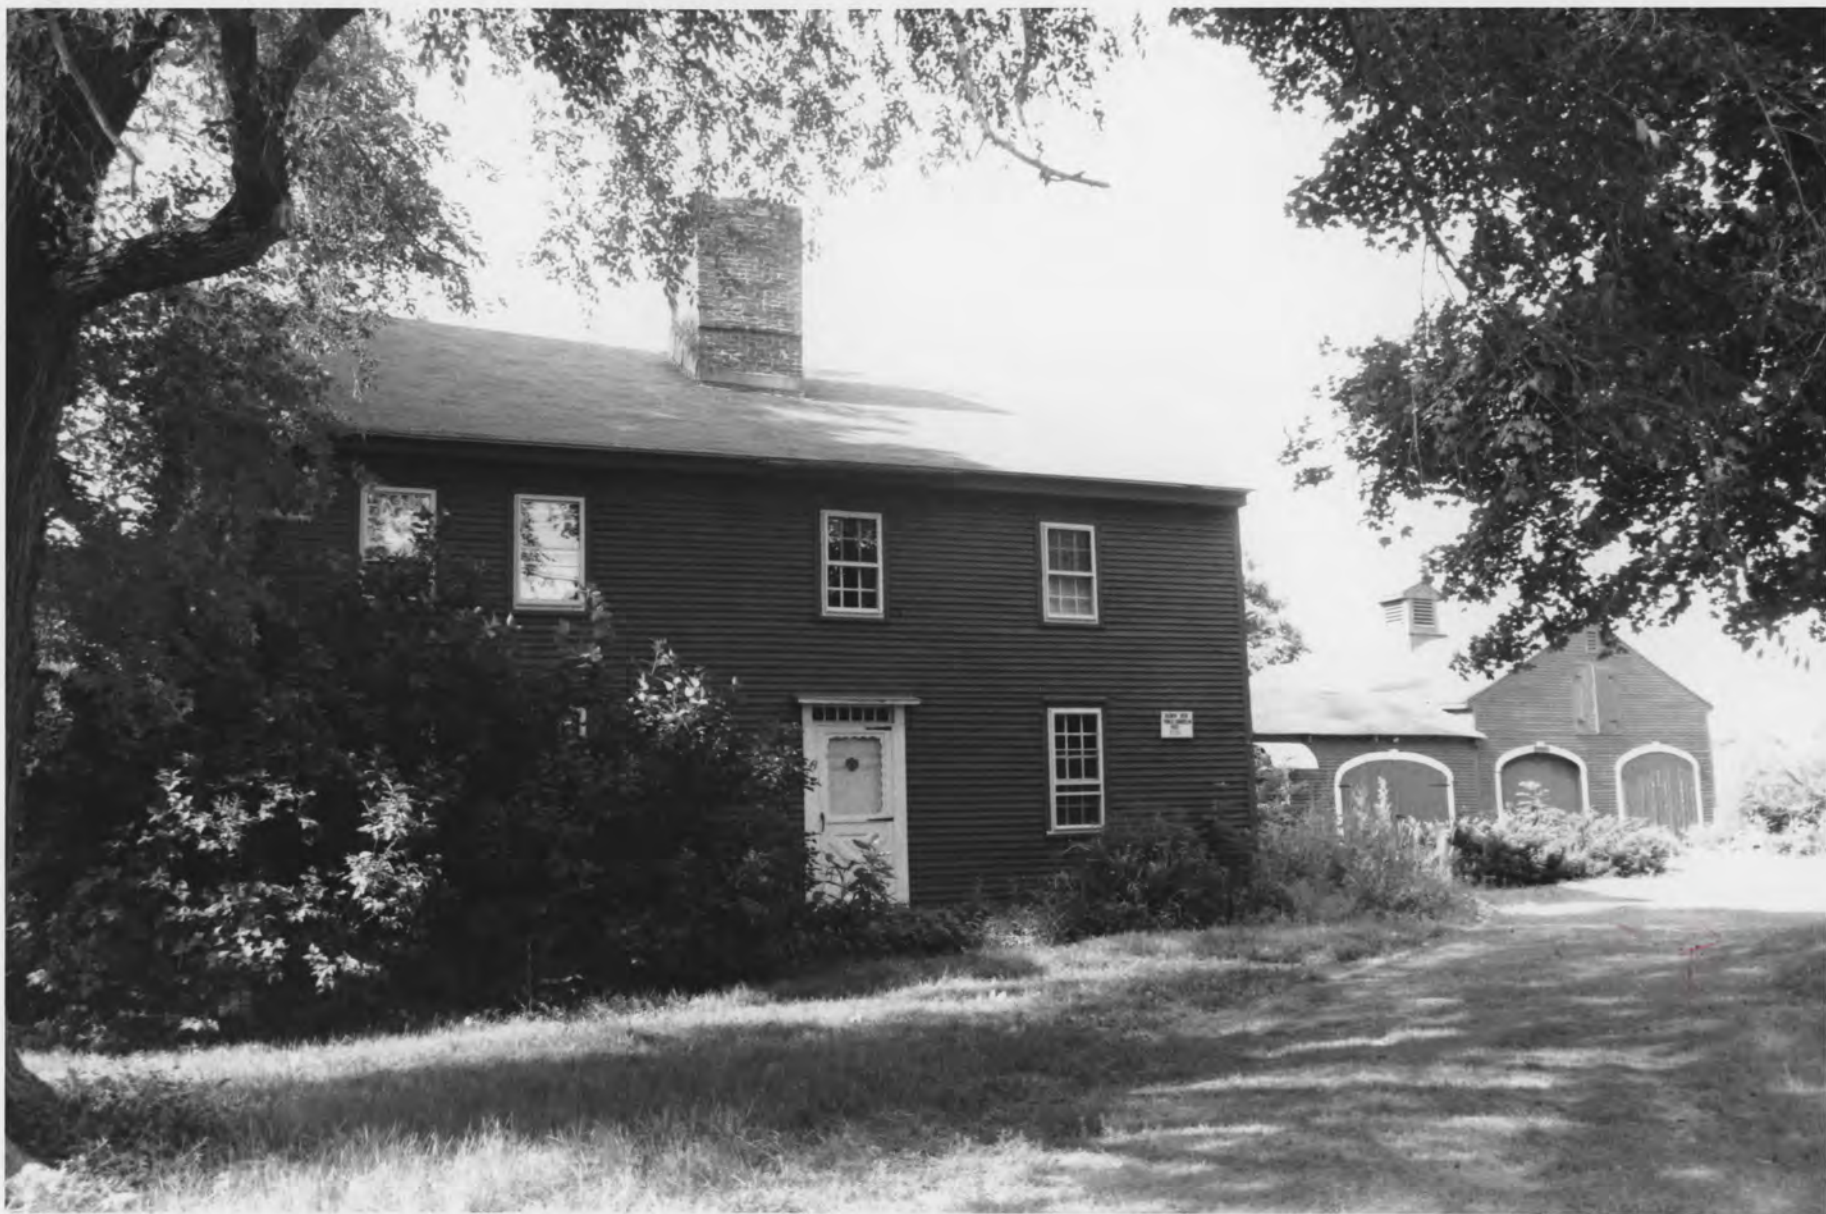
1- HUDROTH - ROBBINS HOUSE  
CHAMSFORD, MA

The south façade of the main block (Photos #s 1, 2) is four bays long, with two windows aligned at first and second stories west of the entry, and one window at each story to the east, reflecting the interior arrangement in which the rooms west of the chimney are considerably larger than those east of it. The entry, and a single 6/6 sash window above it at the second story, are set slightly east of center, in front of the chimney. The general appearance of the main entry, which has a double-thick 6-panel door under a 6-part transom, is likely to have been part of an extensive update during the early Federal period. However, the present plain-board entry surround, the small "bulls-eye" glass panes in the transom, and the narrow horizontal, slightly projecting door hood all appear to be 20<sup>th</sup>-century alterations. The window sash on the façade, and throughout the building, most of which are 9/6 at the first story, with 6/6's at the second, are products of the 20<sup>th</sup> century and lack the projecting plank frames characteristic of the Colonial and Federal eras.

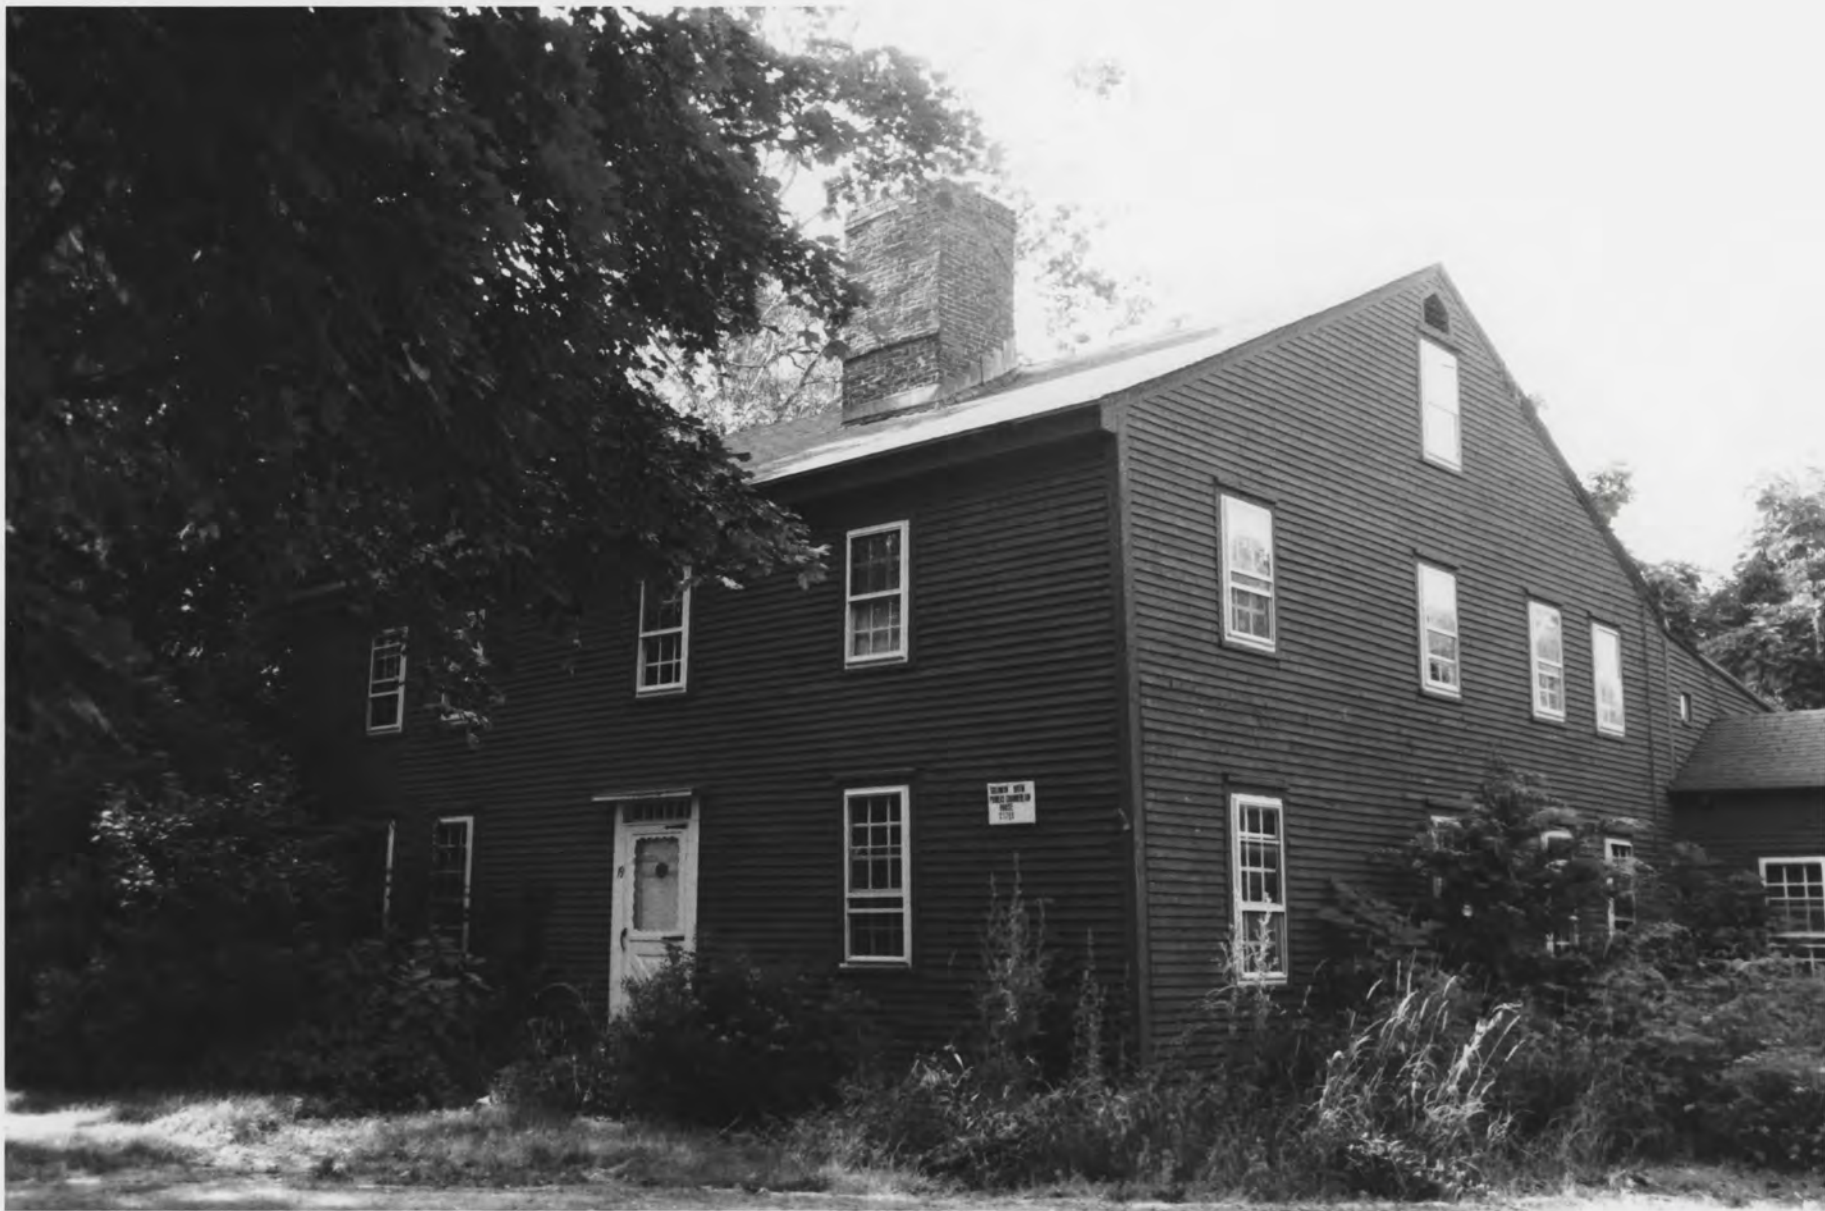
2 HILDBETH-ROBBINS HOUSE  
CHAMSFORD, MA

The east side of the main block (Photo #2) is four bays deep, with windows aligned above each other at both stories, and a single 6/6 sash window positioned at attic level in the gable peak with a louvered vent above it. The east elevation also displays the side of the shed-roofed mid 20<sup>th</sup>-century room above the west end of the ell. Two small square single-pane windows, one above each plane of the lower east-west ell roof, pierce this later wall.

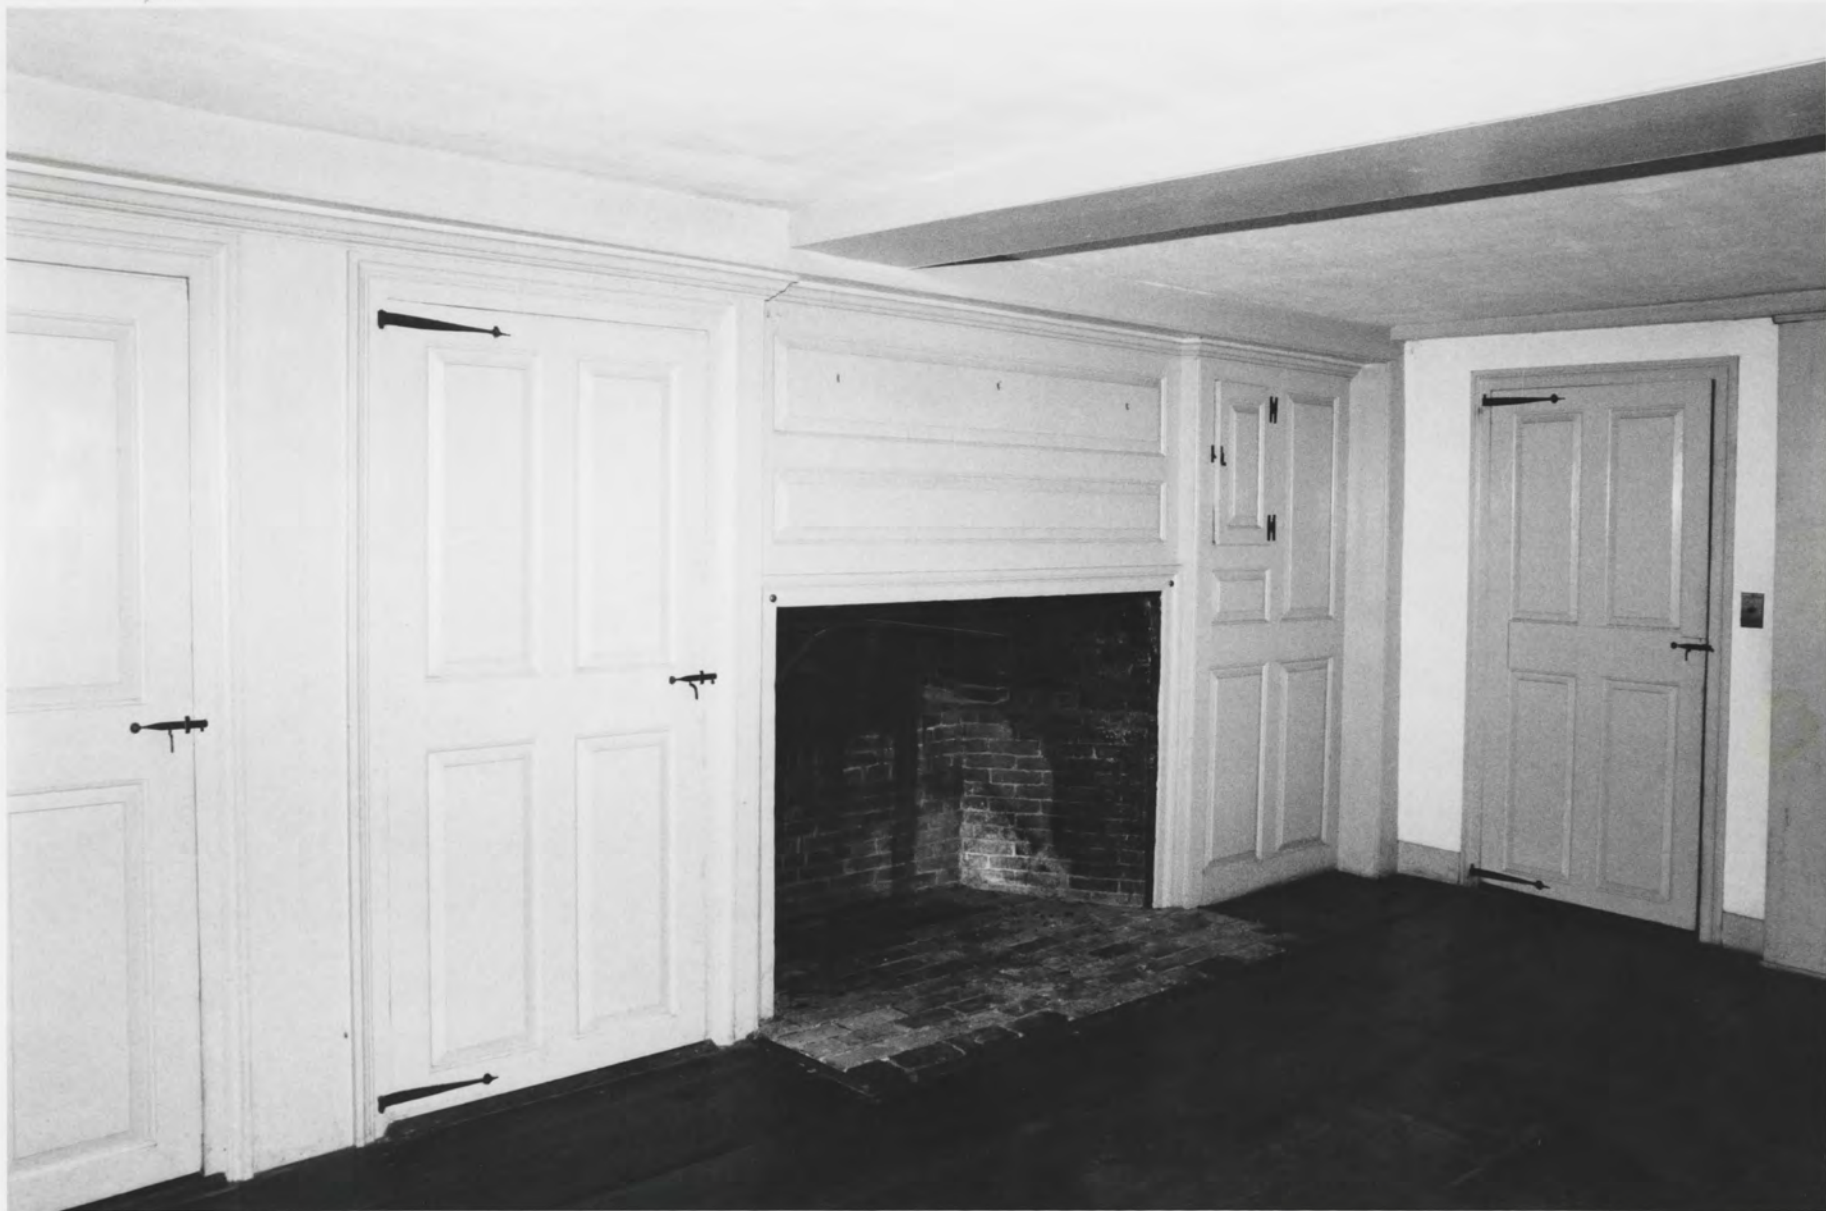
3. HILDRETH - ROBBINS HOUSE  
CHENNSFORD, MA

The **southeast first-story room**, (Photo #3) originally a kitchen and later a dining room, is a much smaller room—11' 4" wide, with a summer beam that is 15 ¾" wide. The firebox, which has been reduced in size by an added layer of bricks creating the present angled side walls, still has the opening of the bake oven in its rear wall. In this room the entire fireplace wall is a composition of late 18<sup>th</sup>-century raised-field paneling. Two long horizontal panels fill the wall above the fireplace, and a multi-paneled, two-range section north of the chimney incorporates a small, high cabinet with a single-paneled door. Two 4-panel doors are located south of the chimney—one leading to the front entry, the other to a china closet that occupies the location of the former cellar stairs. A crown molding of the same profile as that in the southwest room runs the length of the fireplace wall.

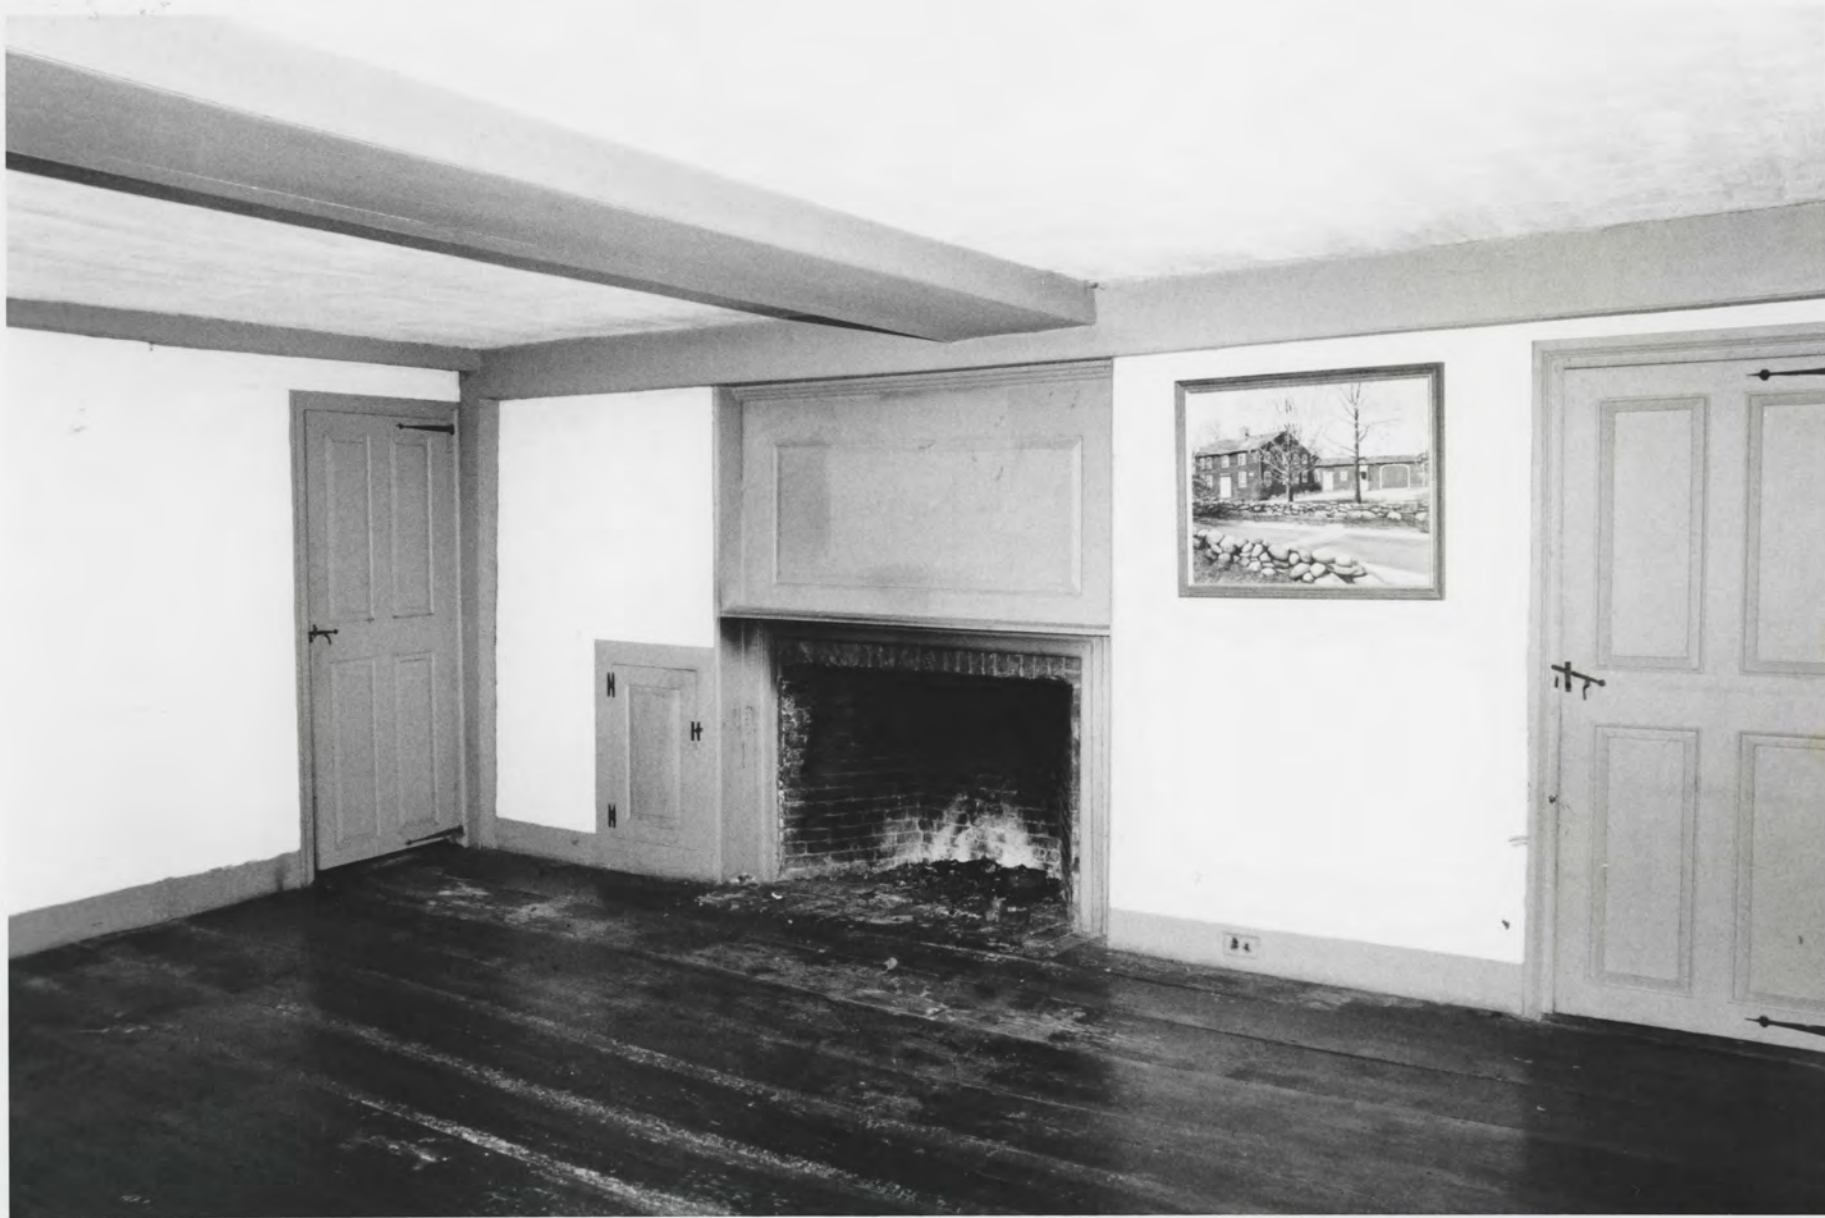
4. HUDROTH-ROBBINS HOUSE  
CHOLMSFORD, MA

The **southwest first-story room** (Photo #4) is quite large—15' wide, with a summer beam (including casing) that is 21½" wide. The slightly recessed fireplace has a molded surround and an overmantel consisting of a single large raised-field panel. A crown molding trims the upper edge of above the panel. A small cabinet with a paneled door located low in the wall just north of the fireplace appears to date to the 20<sup>th</sup> century.

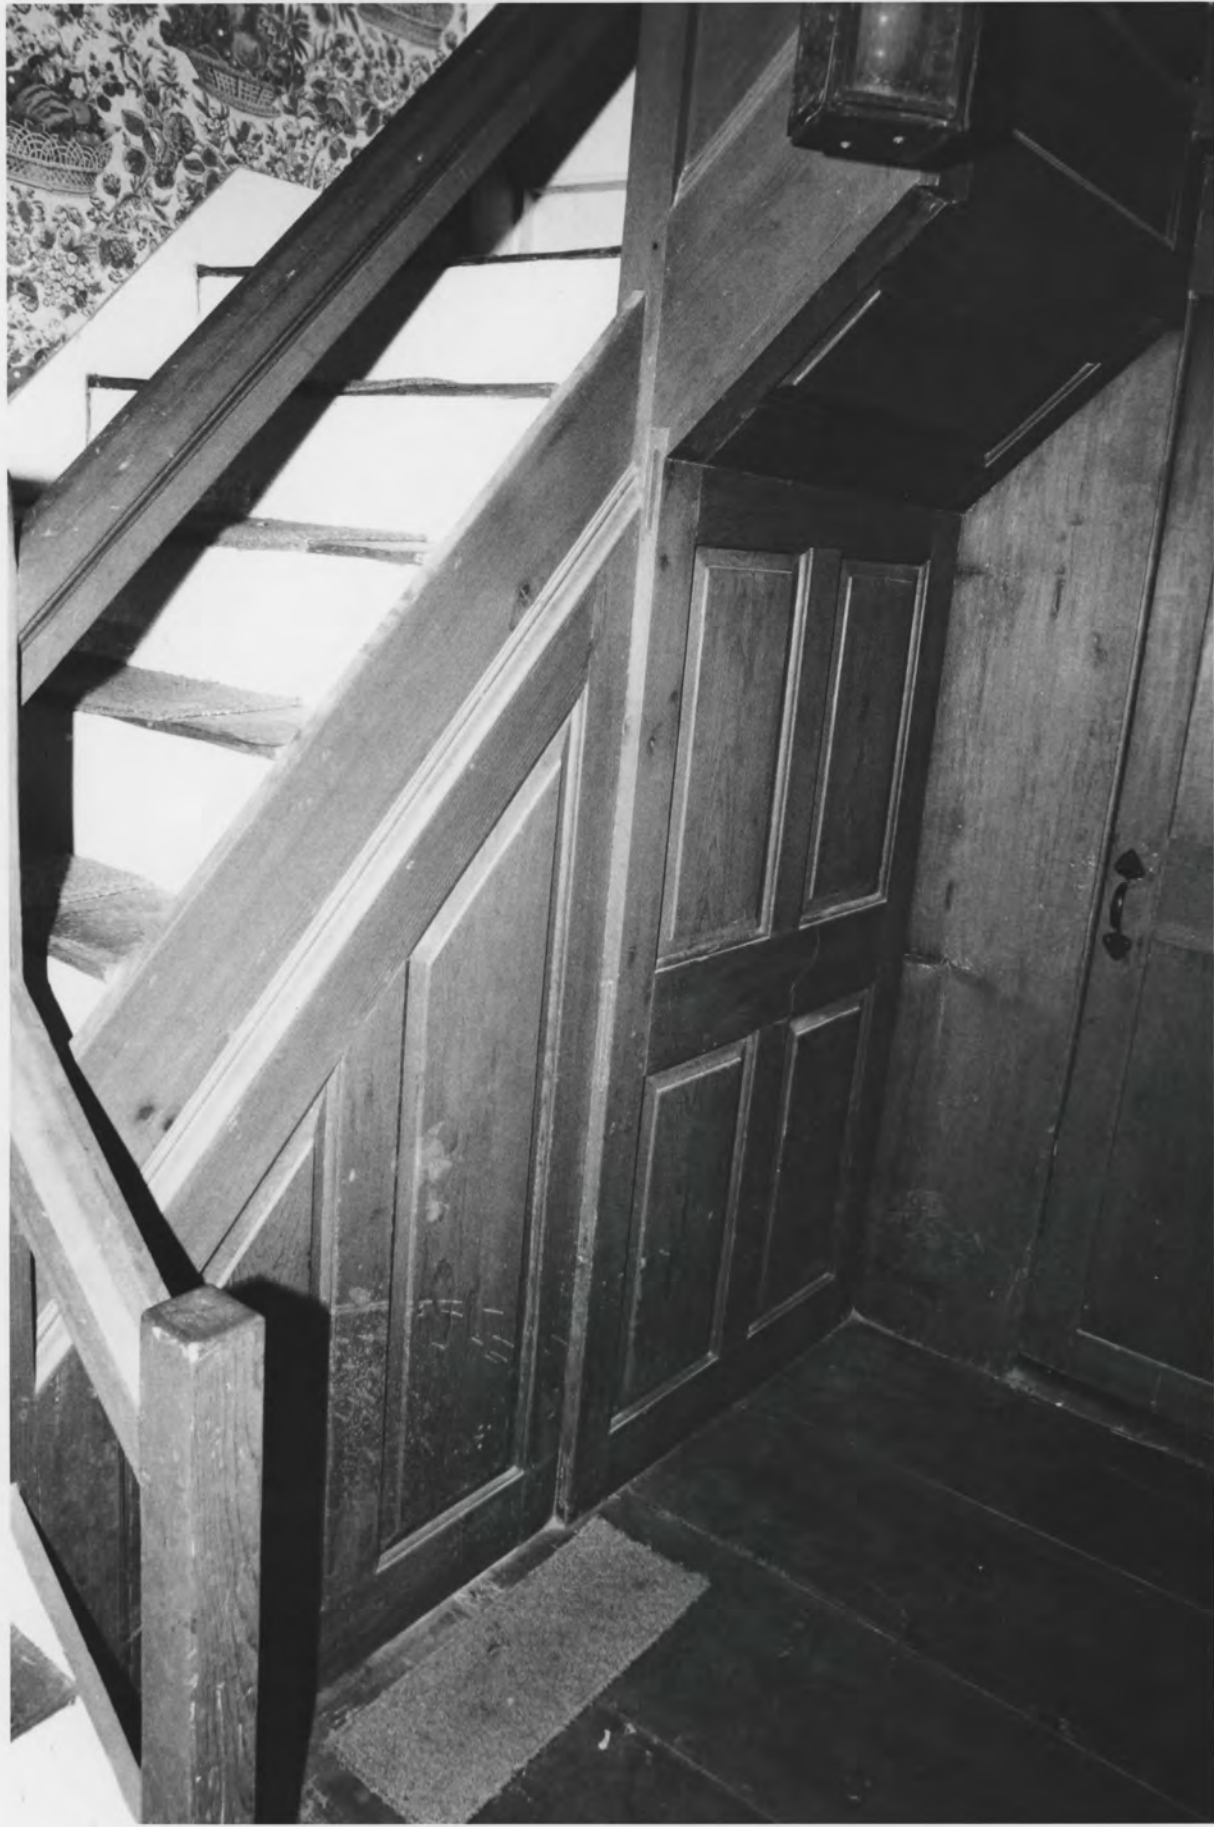
5 HILDETH-ROBBINS HOUSE  
CHAMSTED, MA

The **lobby entrance** (Photo #5), where the closed-string three-run staircase has 3"-square newel posts and molded rails without balusters, displays two types of woodwork: raised-field paneling against the stairs, and the back side of the feather-edge sheathing of the southwest first-story room's fireplace wall.

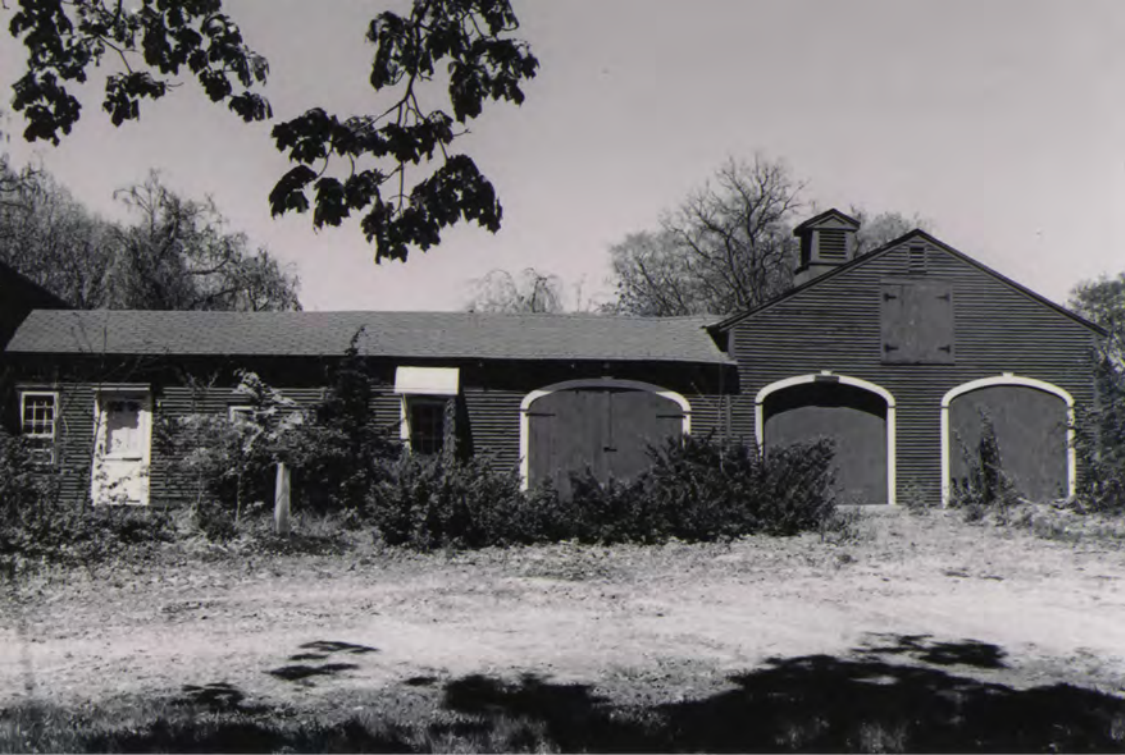
6 HILDRETH · ROBBINS HOUSE  
CHILMARK FORD, MA

The gable-front, clapboarded barn or stable/carriagehouse (Photo #6) that abuts the east end of the ell stands over a full-height, fieldstone cellar story. Although the cellar appears to be original, most or all of the upper portion of the structure was entirely rebuilt in the late 1950s or 1960s. (The original barn may have been higher, and is likely to have had a roof with a steeper pitch than exists today.) The barn façade has two elliptical-arched openings that mimic the one in the ell to their west, but they have taller,

The entire northeast ell (Photos # 6, 8, and 9) is most likely a former 19<sup>th</sup>-century rear kitchen and is a conversion of typical 19<sup>th</sup>-century attached line of sheds—is over 40 feet long. Since the ground slopes down to the rear, much of the ell stands over a full-height cellar accessible from the north. While much of the frame of the ell probably dates to the 19<sup>th</sup> century, this section of the building has been considerably altered, and the exposed rafter ends at the front edge of its shallow-gabled roof indicate that a major rebuilding took place here in the 20<sup>th</sup> century. Comparison with a photograph taken in 1955 shows that the fenestration of the south front wall has been rearranged somewhat since that time, and that the front wall of the attached barn has since been brought forward to occupy the same plane as that of the ell. A 9/6 window and a narrow 6-panel door (with bullseye glass in the top two panels) at the west end of the ell façade presently occupy the same positions as a door and window shown in the photograph; a window opening east of the door may have existed at that time, as well. The multi-light and panel mid 20<sup>th</sup>-century door in the wall further east, however, takes the place of a former window shown in the 1955 image. East of the latter door, a broad, keystone, elliptical-arched doorway appears to occupy the position of the 19<sup>th</sup>-century carriage opening. It retains a pair of non-functioning vertical-board doors mounted on what appear to be reproduction strap hinges.

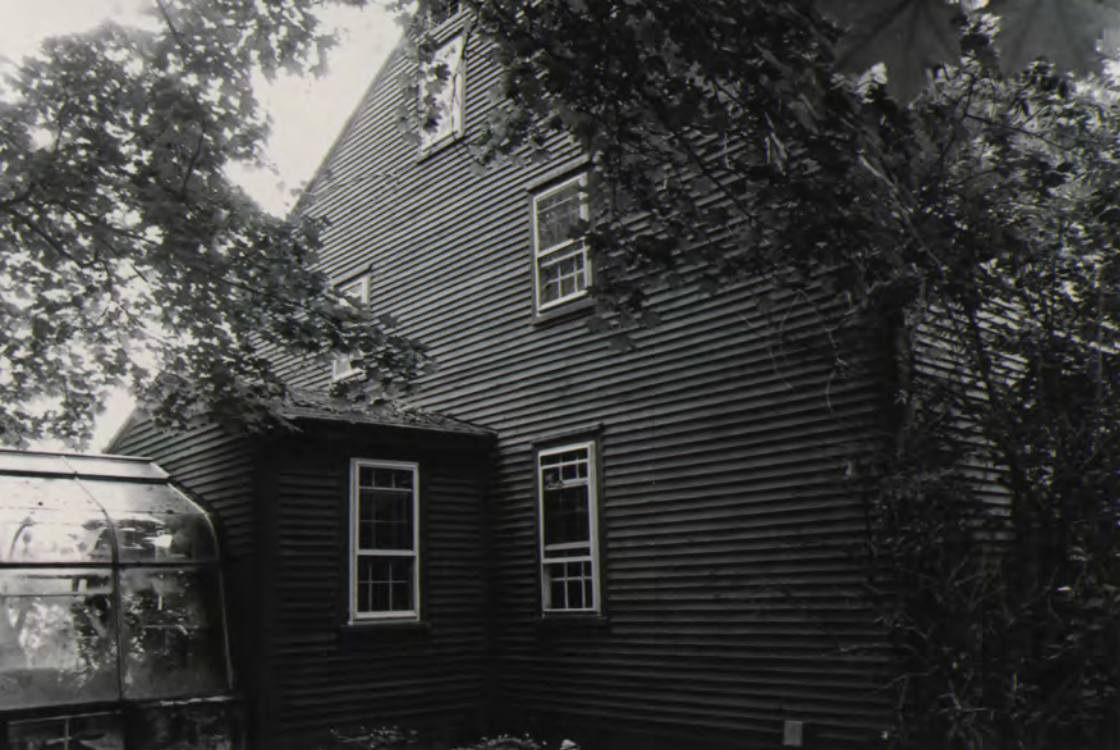
7 HILDRETH - ROBBINS HOUSE  
CHOLINSTON, MA

The west elevation of the main block (Photo #7) has only two windows at the second story, with one 6/6 under the gable peak at attic level. At the first story, there is one 9/6 window in the south part of the main wall. The south and north walls of the later west entry bay each have a single 9/6 window. The west wall of the entry bay, presently sheltered by an attached gambrel-roofed greenhouse, is sheathed with clapboard and vertical board and has a centered 15-light wood and glass French door.

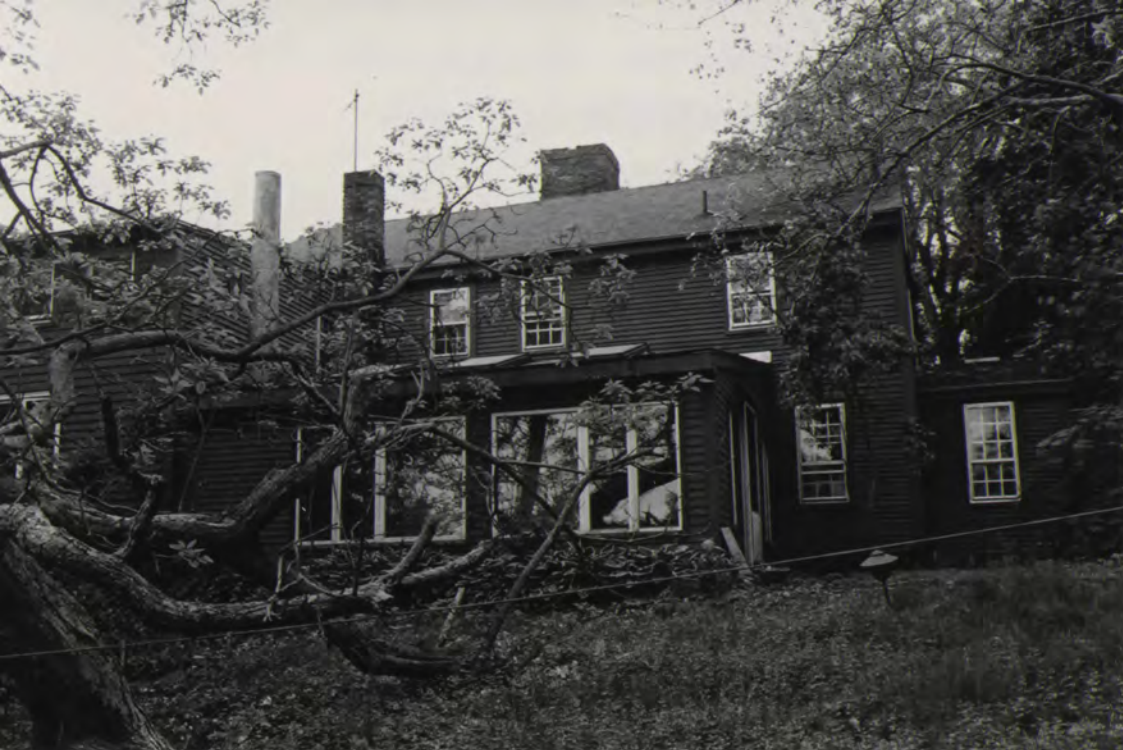
8

The north, rear elevation (Photo #8) is the most altered side of the main block. Most of the first story there is covered by the clapboarded, shed-roofed sunroom added in the 1960s or 1970s, and by the west end of the northeast ell, which overlaps the easternmost nine feet of the main house wall. All the window sash in the main wall—three windows at the second story, and one 9/6 at the west end of the first—are modern, and some occupy 20<sup>th</sup>-century openings. The windows along the length of the northeast ell, including a bank of four casements toward the west end, are also all of mid- and late 20<sup>th</sup>-century vintage (Photo #9).

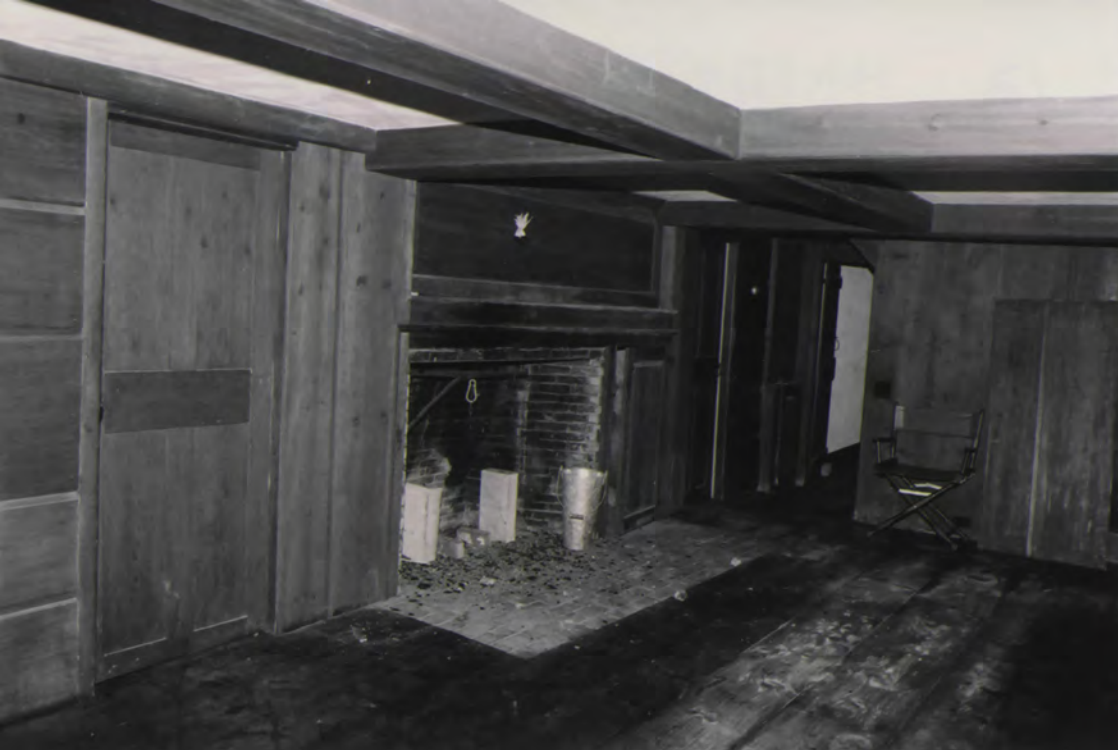
12 HILDRETH - ROBBINS HOUSE  
CHUMSFORD, MA

now consists of one broad room behind and northeast of the chimney, (most of which would have constituted the later 18<sup>th</sup>-century **leanto kitchen**—Photo #12) an enclosed stairway to its west, and west of that, a small room that was fitted up as a **pantry** in the 20<sup>th</sup> century (Photo #13). It is likely that the leanto originally housed just the kitchen and a first-story bedroom to its west, and that the bedroom was later reduced in size by the building of the stairs to the rear second-story space after the leanto was raised to a full two stories. The stairway is enclosed on both sides with late feather-edge/bead-and-bevel boards of a type characteristic of the Federal period. Compared to the feather-edge sheathing in the front part of the house which has the bolder ovolo molding typical of the mid-18<sup>th</sup> century, the paneling here is instead finished on one edge with a very narrow bead.

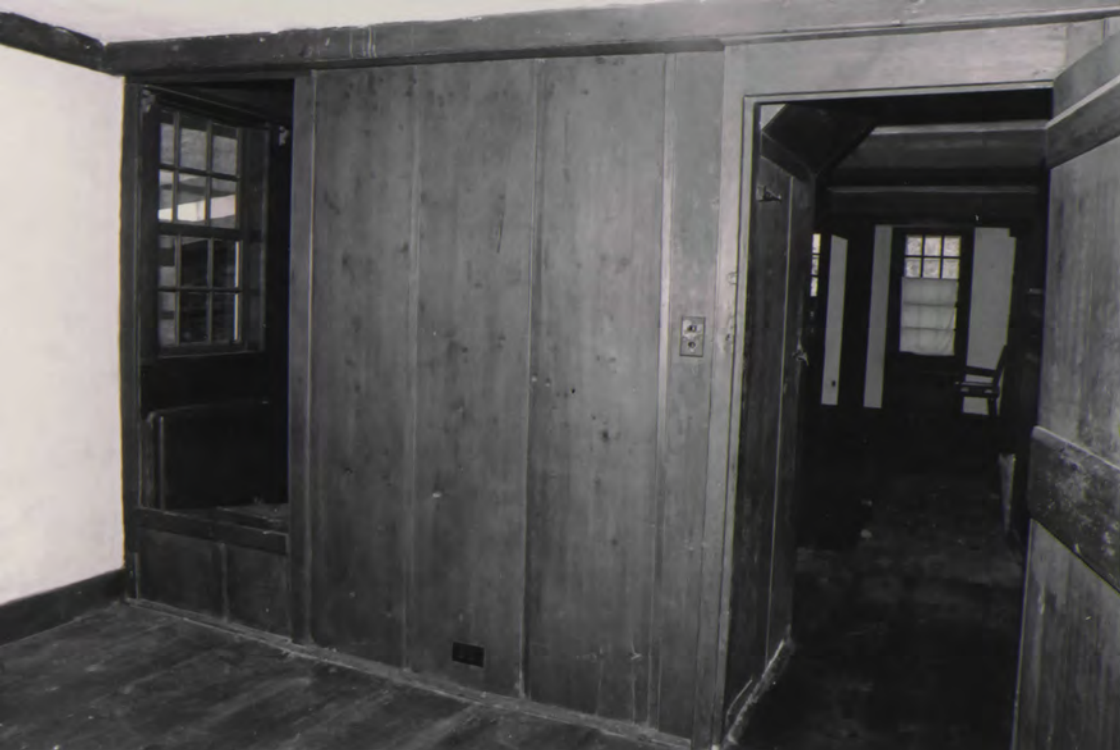
13 HILDRETH - ROBBINS HOUSE  
CITRUSFORD, MT

The **pantry** (former bedroom) (Photo #13) west of the stairs is a small space, with one large built-in pantry cabinet along its west wall dating to the 1950s or 1960s. Attached to the west wall of the pantry, (the exterior wall of the main block) is the small one-story, mid 20<sup>th</sup>-century **west entry bay**. Its front part houses a small lavatory. The walls of the rear space, an entry hall or mudroom, are covered in a combination of modern pine boards and 19<sup>th</sup>-century feather-edge sheathing, the latter possibly reused from the wall of the kitchen passage that was taken down. The floorboards of this space also may have been relocated from elsewhere in the house.

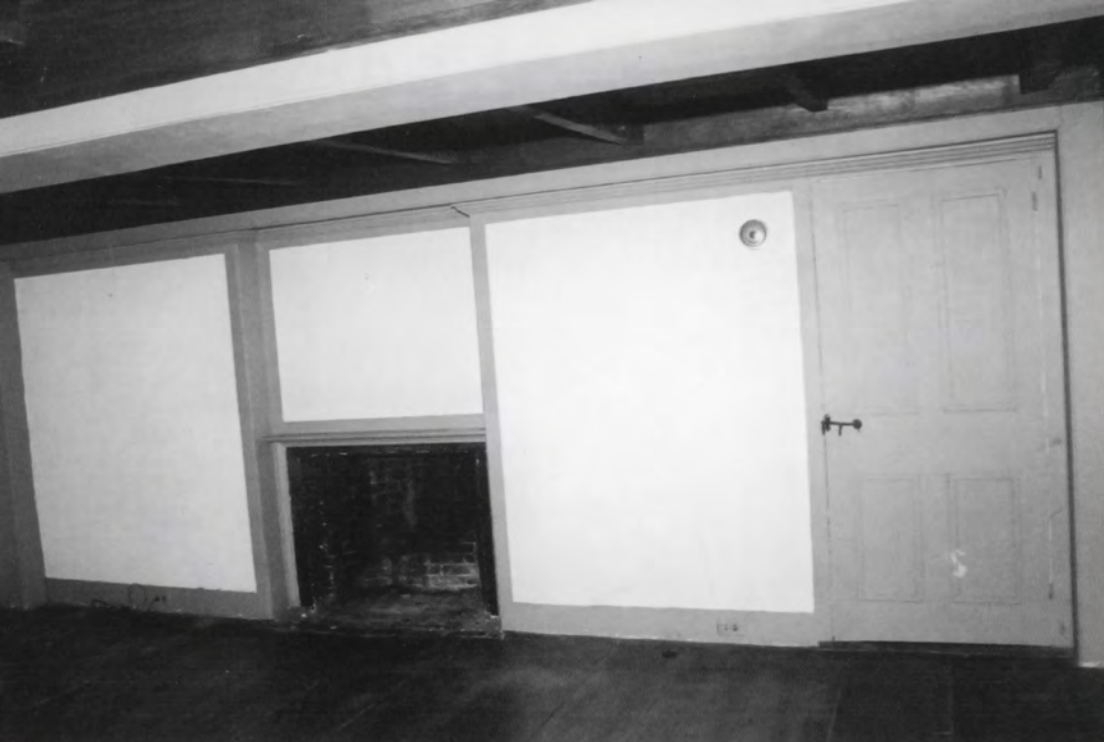
15

The **southwest chamber** (Photo #15) was clearly the most formal bedroom in the house. It has a more elaborately molded fireplace surround than the other chamber, a narrow mantel shelf, and a full crown molding below the chimney girt running the length of the fireplace wall. In about 1960, the summer beam was rebuilt and the plaster ceiling was taken down. In the process, some chalk graffiti in three places on the frame was revealed. Clearly written on two of the joists are the words "Sarah Hildreth, her hand." (Photo #16). While the doors in this room are hung on later hinges, the pintles for earlier strap hinges are still in place in the jamb for the door to the stairhall/entry.

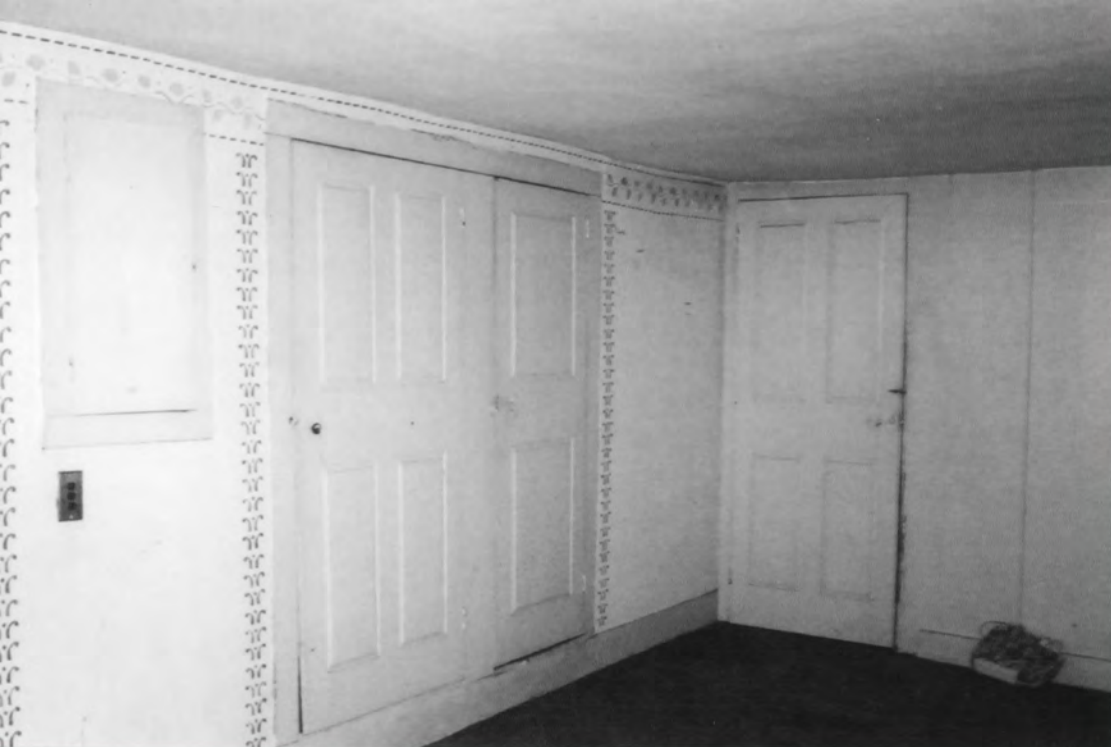
17

When the rear of the house was raised to a full two stories, a spacious **rear chamber** was created above the former leanto kitchen below (Photo #17). It appears that this room was unheated, as there is no visible evidence of a second-story fireplace in the back of the chimney. Instead, three paneled doors are located in the room's south wall—a 4-panel door that opens into the southeast chamber, another to a shallow closet, and a 2-panel door to its west opening onto the attic stairs. A small cabinet is located in the upper part of the wall between the closet and the east door. This large chamber extends from the east
