National Register of Historic Places Registration Form

Historic name:	Carroll C	County Infirmary		
Other names/site	number:	Carroll Manor,	Carroll County Home	
Name of related	multiple prop	erty listing:		
County H	Iomes in India	ana		
(Enter "N/A" if p	property is not	t part of a multip	le property listing

Street & number: 6409 W. 100 North					
City or town: <u>Delphi</u>	State: Indiana	County:Carroll			
Not For Publication:	Vicinity: X

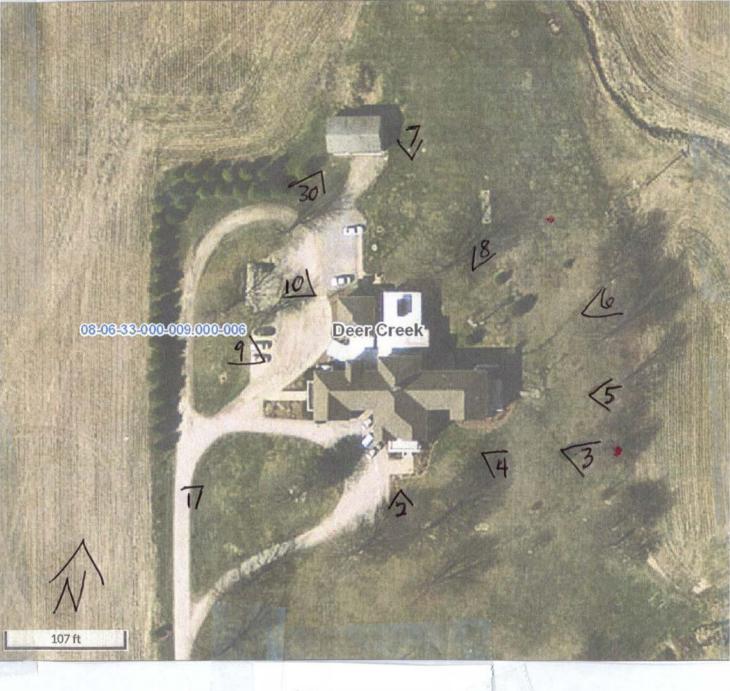
CARROLL COUNTY INFIRMARY 6409 W. 100 NORTH DELPHI, CARROLL COUNTY, INDIANA

Photo Locations for Exterior and Site Plan Original Photo by Beacon Schneider Corporation (Not to Scale)

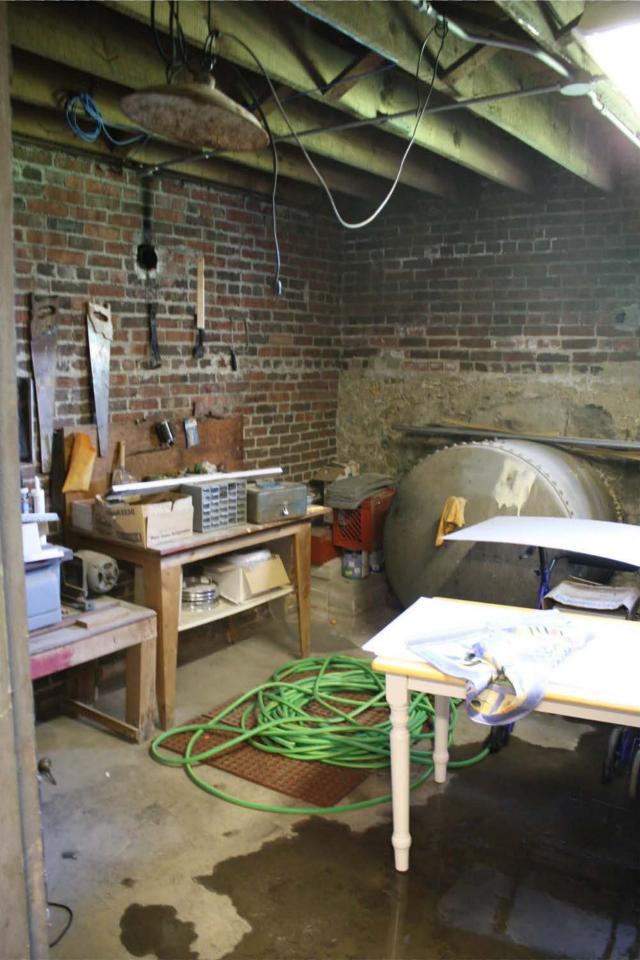
29 of 30: August 25, 2016—View of west and north walls of double room in northeast corner, basement of women's wing, showing one of large metal tanks sunken into the foundation. Facing northwest.
