Site No. BV-04-488

Utah State Historical Society
Historic Preservation Research Office
Structure/Site Information Form

Street Address: 595 North 100 West

Original Owner: John Black, House (Research in RA) Construction Date: c. 1910

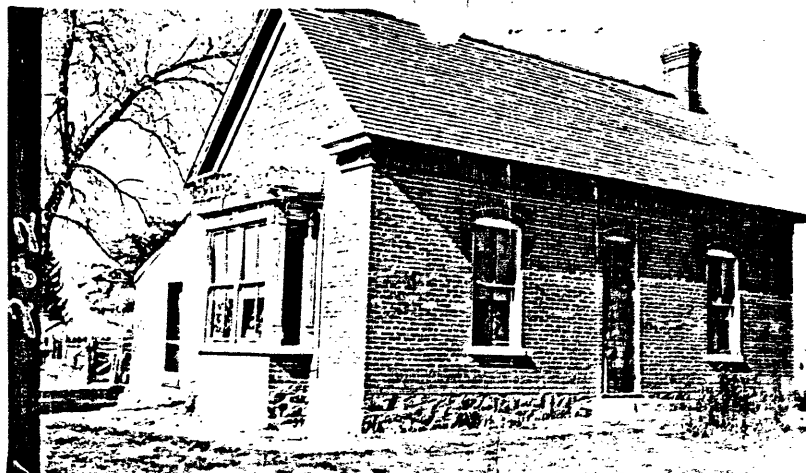
595 North 100 West
BEAVER, UTAH
1933 TAX PHOTO

The original portion of this home consists of a two room cottage with a hall and parlor plan. It is 1 1/2 stories tall and has a steeply pitched roof. There is one end-wall chimney and the front facade has three piercings, all of which are arranged with bilateral symmetry. Over the windows and doors there are decorative voussoir/pendant motifs in brick. There is a black rock foundation and the house displays excellent masonry work, a characteristic of Alexander Boyter's. The south facade has a rectangular bay window on it, with decorative, mill-run wooden molding. On top of the bay window is some decorative wrought iron roof cresting, the only such example this researcher has yet discovered in Beaver. The eaves are trimmed with a broad wooden cornice and it makes a boxed return in both gable ends. There have been some incompatible additions made on the house but they are fortunately on the rear and are therefore not highly visible from the front facade.
