IMPORTANT: USE IN CONJUNCTION WITH THE GREEN INVENTORY RECORD FORM FOR RECORDING HISTORIC STRUCTURES AND DISTRICTS. USE SEPARATELY FOR RECORDING STRUCTURES LOCATED WITHIN DISTRICT BOUNDARIES.

Beshoar, Barron B. Out of the Depths. Denver: World Press Inc., 1942, p. 27
 Records of the Congregational Church.
 Cramer, Anne. "Historic Congregational Church is Today's Library." Lafayette News, 31 December 1980, Vol. 7, #41, p. 8
Lafayette Leader, 11 October 1918.
Lafayette Leader, 1 November 1918.
Lafayette Leader, 10 February 1923.

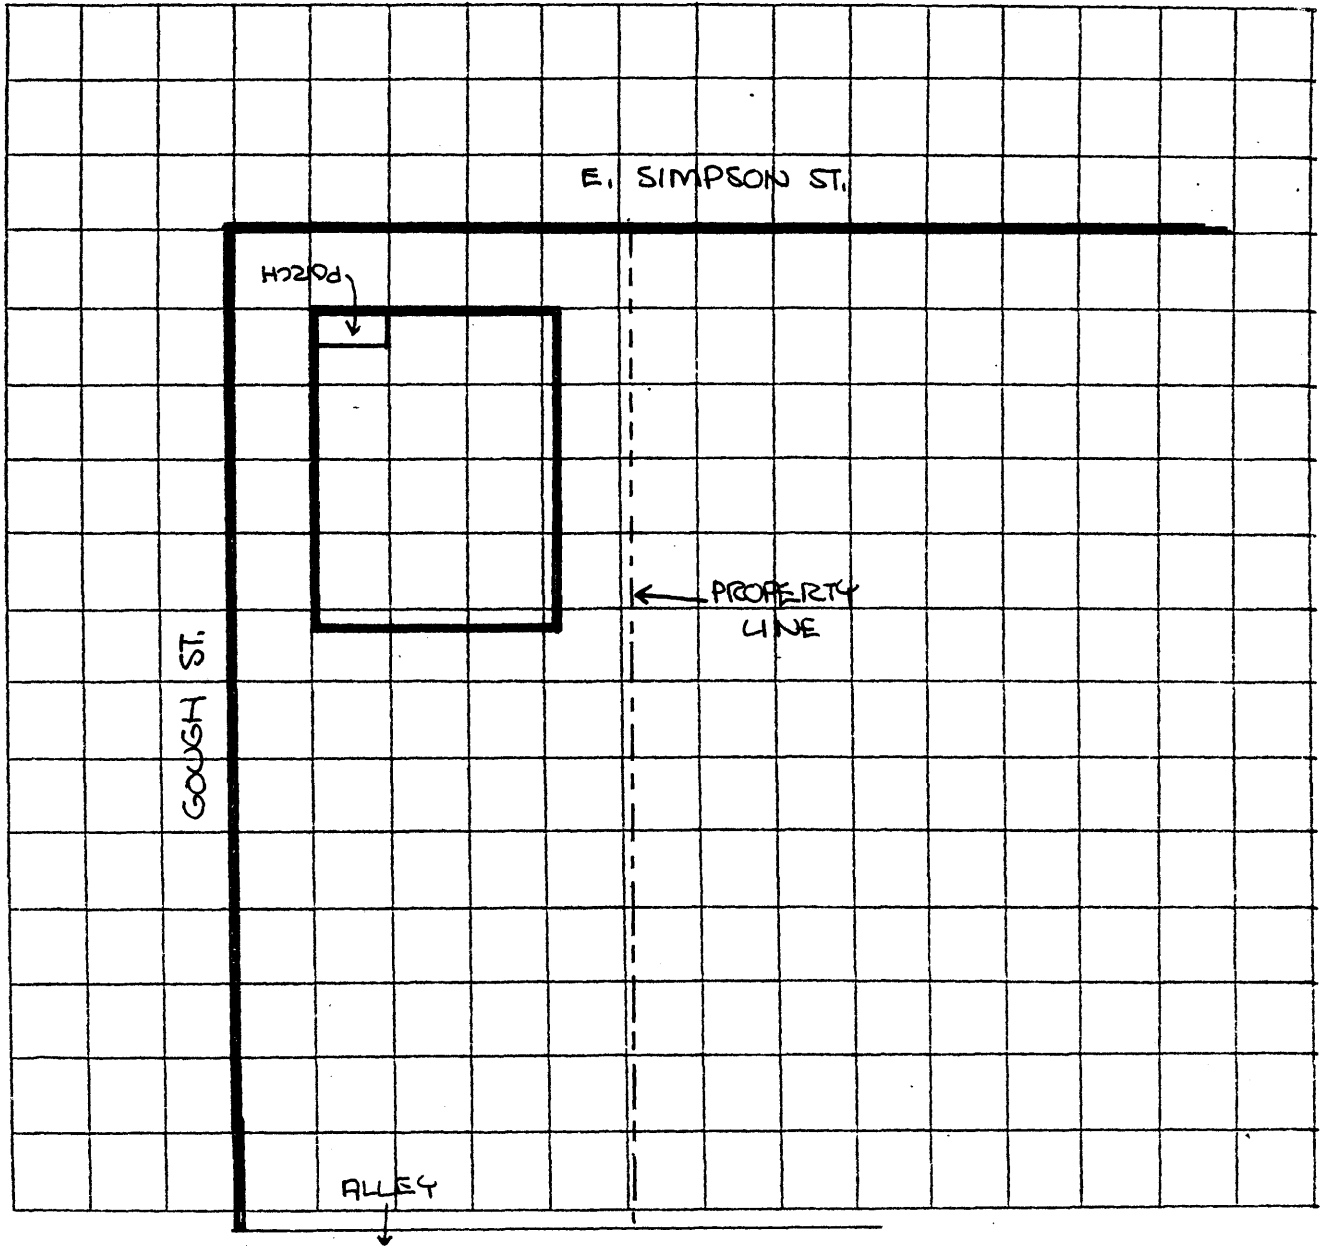
26)Recorder Affiliation Community Services Collaborative 27)Phone No. 442-3601

V. SKETCH MAP: Map all features and show the boundaries of the resources. Show all major topographic features, permanent modern features, and vegetation zones as appropriate. Give names of features, streets and addresses if known. Provide scale, key and direction.
