National Register of Historic Places Registration Form

historic name Eastlake Farmers Co-Operative Elevator Company
other names/site number Colorado Milling and Elevator Company; Denver Elevators Company; Eastlake Grain & Feed; 5AM.1445

street & number 126th Avenue and Claude Court not for publication
city or town Thornton vicinity
state Colorado code CO County Adams code 001 zip code 80241

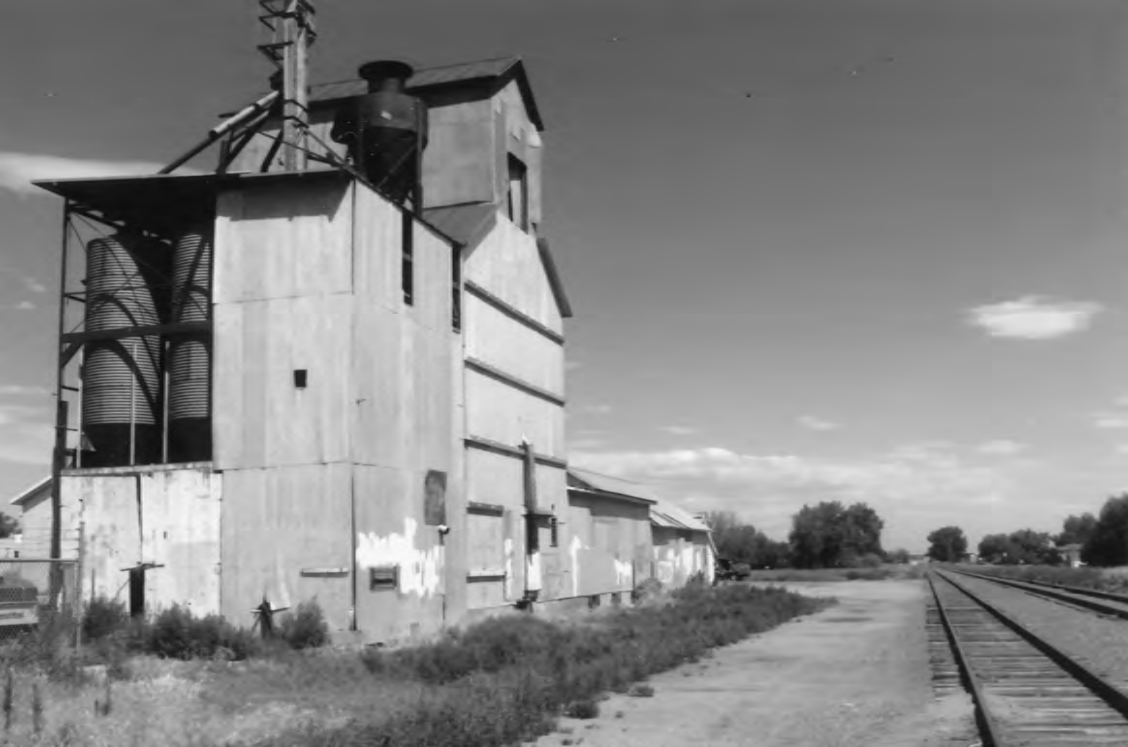
2

MAIN ELEVATOR STRUCTURE, 1920 (Contributing) (Photographs 2, 3, 4, 5, 7)

Composed of three adjoining, but distinct, sections comprising an irregular rectangular plan oriented lengthwise on a north-south axis paralleling the railroad tracks, the Farmers Co-Operative Grain Elevator is a complex structure measuring 142' north to south and 50' from east to west at its widest point. The resource is functionally a country elevator of studded (as opposed to cribbed) construction. Stud construction is alternately known as frame or balloon-frame construction. In contrast to terminal elevators, country elevators served as local receiving elevators, receiving grain directly from farmers, and from whence raw product was transferred to a terminal elevator in Denver for shipment or sale. Engineer Robert Dunbar constructed the first recognized structure of its type in Buffalo, New York in 1843, although elevators only became widespread subsequent to the Civil War with the build-up of a concentrated rail system (Brown).

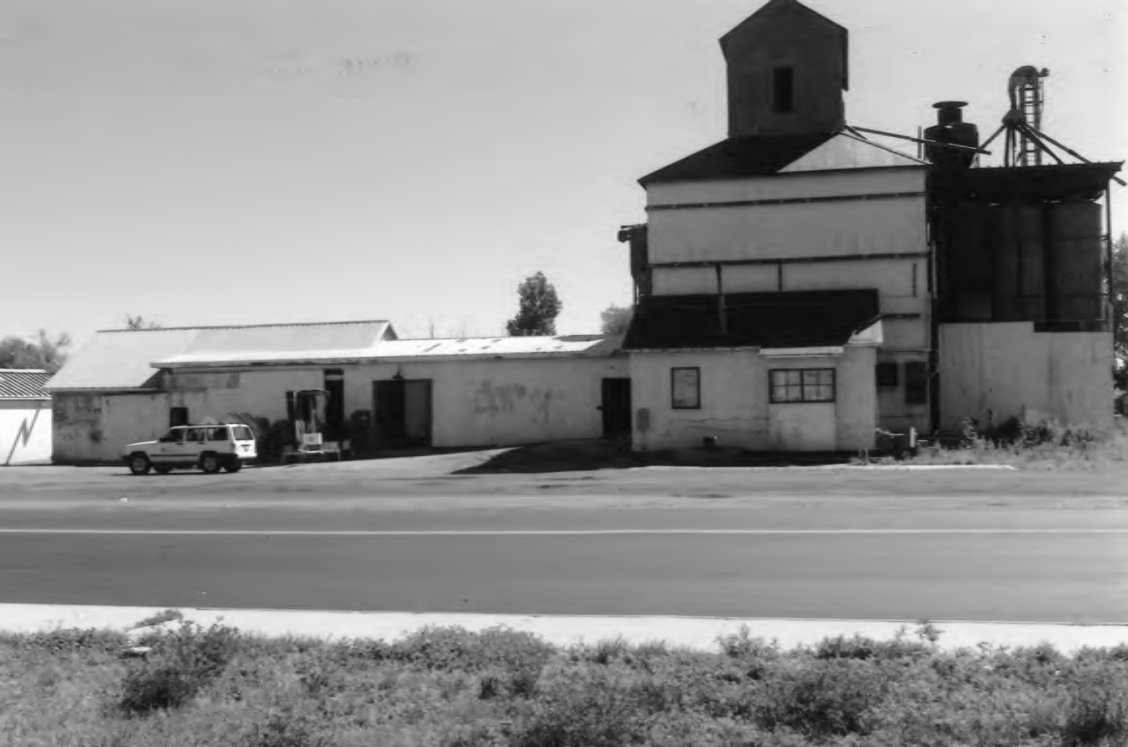
5 AM. 1445
Eastlake Farmers Co-operative Grain Elevator
Adams County, Colorado

Warehouse, ca. 1920 (Photograph 3)

As evidenced by the solidity of the reinforced concrete foundation, the white pine wood floor of the warehouse was engineered to withstand the bulk storage of thousands of pounds of grain. Timber-frame construction with wood plank and weatherboard walls made for an inexpensive, yet sturdy, storage space. Although much of the original equipment housed in the warehouse has been removed, a small portable scale for weighing sacks of grain remains. Metal supports and the baffled downspout from a grain mixer, powered by a small exterior-mounted engine, is still affixed to the roof of the 1920s portion of the warehouse. This early portion of the warehouse was built about 3' above grade to allow for the easy loading of grain-filled gunny sacks onto flatbed trucks. This also permitted a full basement, which still houses the rusting remains of the water pumps and valves that attached to early steam engines powering the operation's grain augers and the circa-1930s Kritzer overhead space heater, before electrical upgrades made steam obsolete. A steam pipe dressed in asbestos extends the length of the warehouse, continuing to the concrete block outbuilding just to the north. Later portions of the warehouse are of basic utilitarian construction; either slab-on-grade or barn-style, with wood walls clad in sheet metal. Vandals have stripped the entire building of the copper wiring and other salvageable metals.

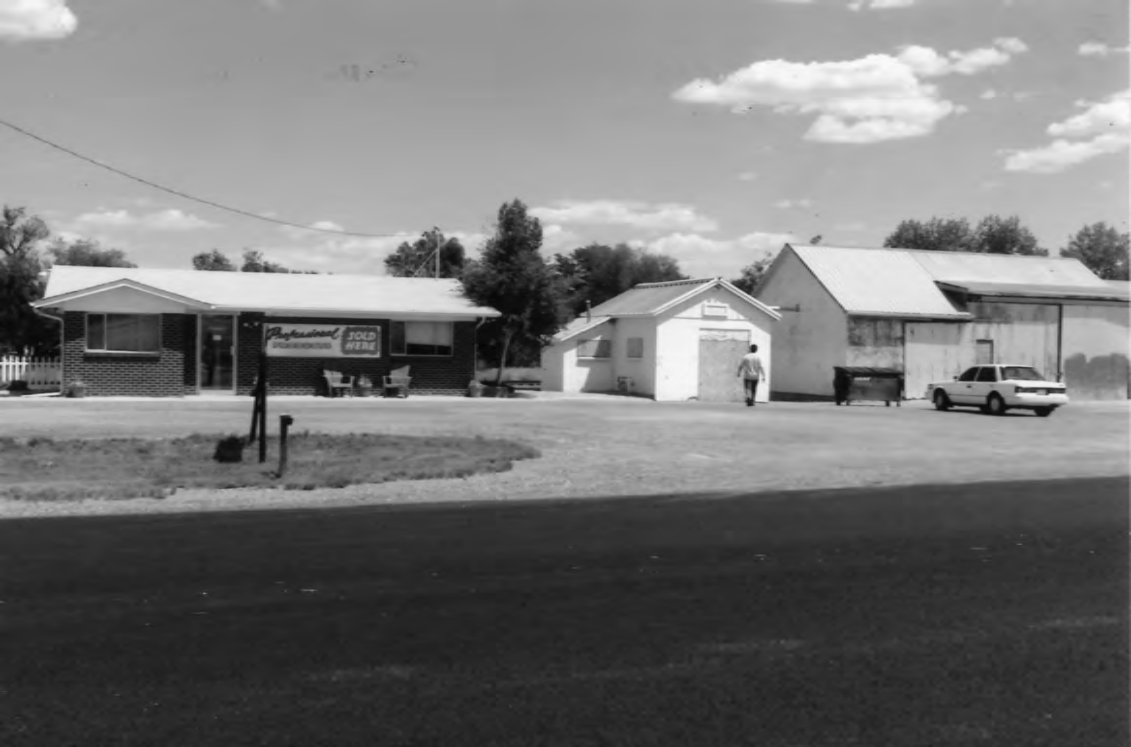
11

Scale House and Sales Office, 1965 (Photographs 11, 13)

The larger outbuilding was purpose-built in 1965 just north of the machine shop in response to operational constraints posed by the physical location of the old, undersized truck scale and sales office, which was attached to the grain elevator's west elevation. This 900-square-foot brick building, which became the new sales office and scale house for a larger 780-square-foot truck scale capable of weighing semi-trailer trucks, is, according to oral histories, a modified Perl-Mack home. This outbuilding served expanding operations at the Farmers Co-Operative Grain Elevator well, allowing management to repurpose the original office and truck scale to further operational efficiency at the elevator. After remaining vacant for a time, the building has been repurposed as a hair salon and beauty parlor.

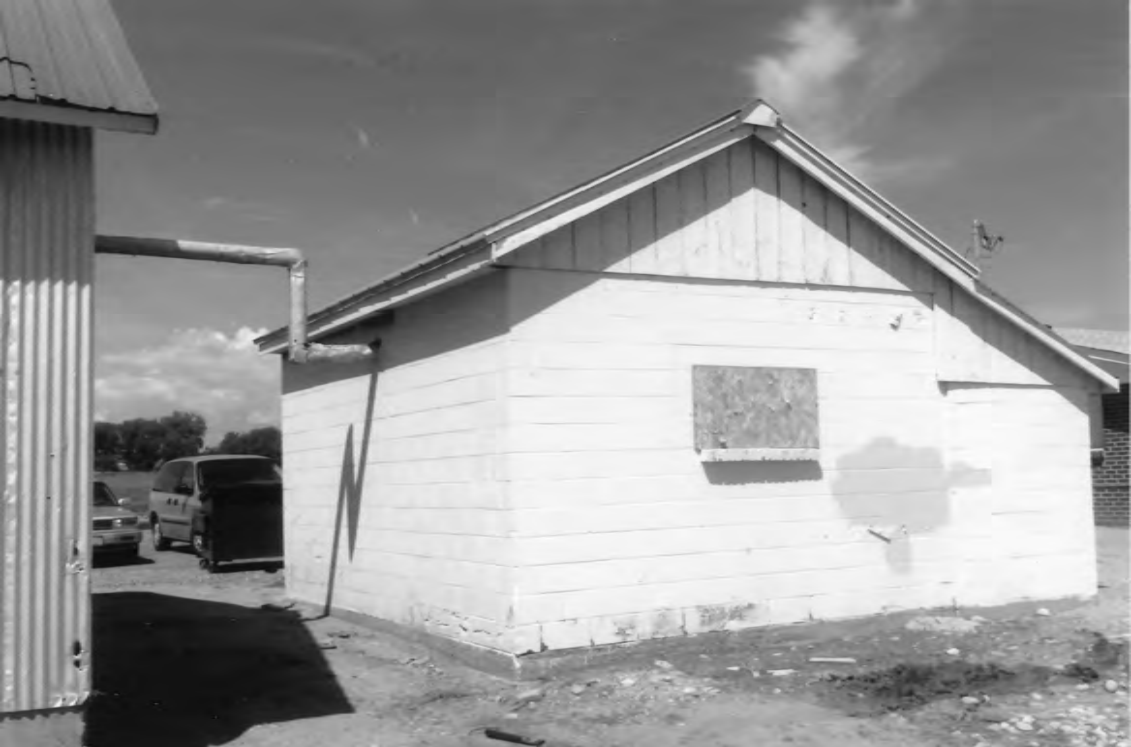
12

Machine Shop/Tool Shed, 1962 (Photograph 12)

Built in 1962, the smaller of the two outbuildings is a single-story, 280-square-foot concrete block building built on a concrete slab-on-grade foundation and surmounted by a front-gable roof. Concrete block was a logical building material choice, as it is both sturdy and inexpensive. Fireproof, it also prevented wayward sparks escaping the metal shop from accidentally igniting the highly flammable grain dust in the nearby warehouse and elevator. Initially used as a storage shed for the grain operations tools, air compressor, welding equipment, and other implements, this utilitarian building also housed upgraded electrical circuitry for the entire operation. More importantly, the building also served as an on-site

machine shop. Construction resulted in significant cost savings as machinery repairs could thereafter be completed on site.

Long since removed, evidence of wood-framed service doors and the remnants of three circa-1950s aluminum-framed slider windows remain atop a single row of corbelled brick which forms an exterior sill. A window was included in each of the building's elevations except to the south, nearest the warehouse, as additional insurance against fire. A 48-square-foot concrete block addition on the north elevation housed a bathroom, shower and sink. At the time of this circa-1960s addition, the building was retrofitted with natural gas, as evidenced by cuts in the concrete floor and the extant meter found on the north side of the building. A small ribbon of concrete sidewalk connects this small outbuilding with a later outbuilding to the north, suggesting that the building may have also served in a limited role as a small office in the early 1960s.
