National Register of Historic Places Registration Form

historic name Lake Vernon Snow Survey Shelter
other names/site number Lake Vernon Cabin, Lake Vernon Patrol Cabin, Yosemite National Park Building No. MA2450

Lake Vernon Snow Survey Shelter

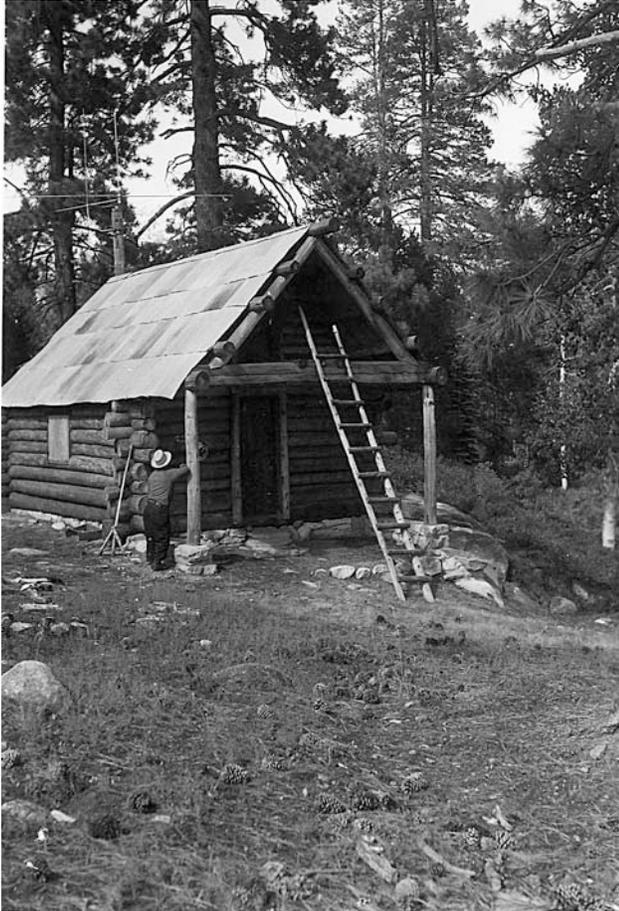
Historic Photo #1. Lake Vernon Shelter, 1952. Photographer: unknown
Yosemite National Park, Division of Facilities Management
Building Files, Folder "Lake Vernon Cabin". El Portal, CA.

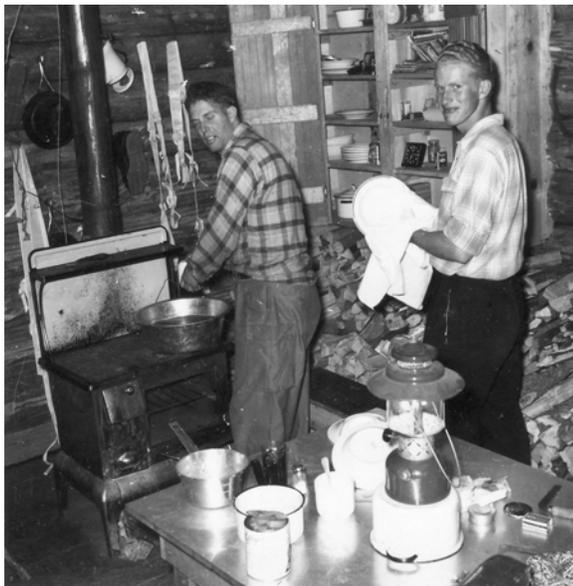
Historic Photo #2. Snow surveyors cooking in Lake Vernon shelter, camera facing south-east, c. 1950. Photographer: unknown. Photo: Don Paulsen Collection, California Department of Water Resources, 1416 9th Street, Sacramento, CA .
