KENTUCKY HISTORIC RESOURCES
Individual Inventory Form

Resource # 115
Shelby County

1. Name of Resource: Newton House

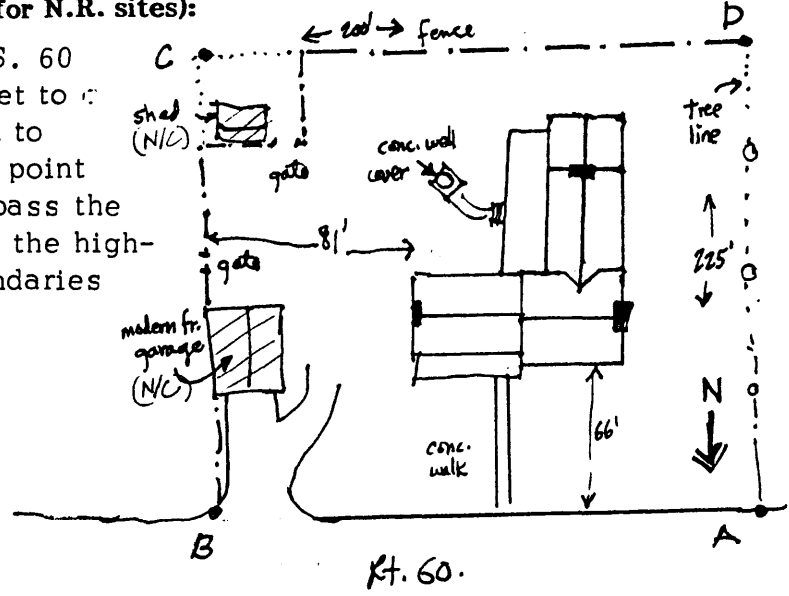
Site Plan (and boundary description and justification for N.R. sites):

Beginning at point A, proceeding east along U.S. 60 200 feet, thence south along a fenceline 225 feet to point C, thence west along a fenceline 200 feet to point D, thence 225 feet along a tree line to the point of origin. The boundaries were chosen to encompass the house and its domestic-related space defined by the highway fences, and a treeline. Included in the boundaries are a non-contributing frame garage and shed.

Point A is in the northwestern corner of the yard, is on the southern edge of US 60, and is 91 feet west of the west edge of the walk.

NOT TO SCALE

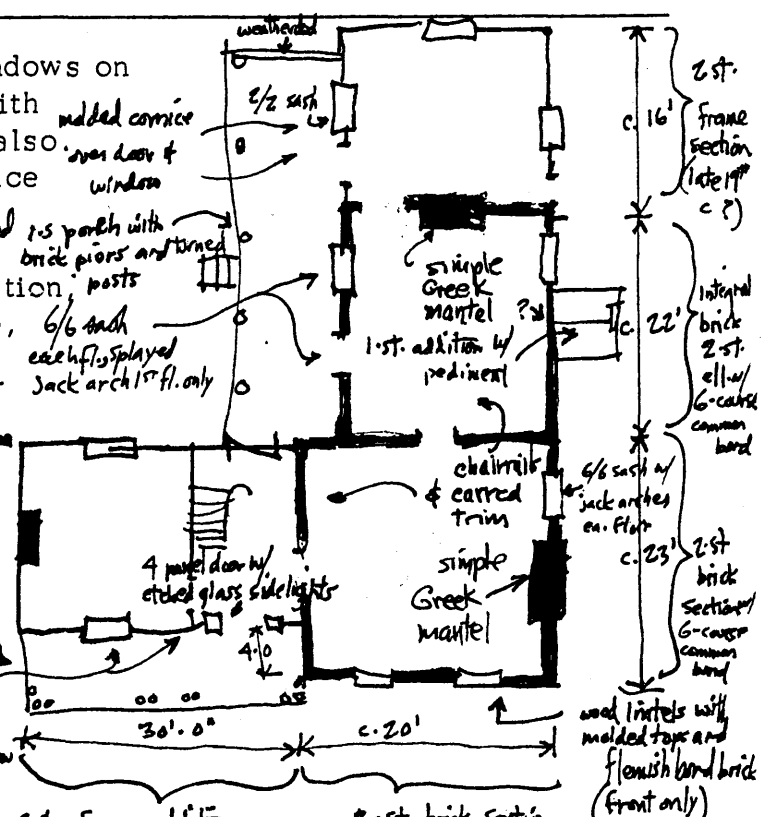
Description and House Plan:

Frame section has stone found; built in gutters

2-story brick house of unclear original form. 2 windows on principal facade (north) in each floor are treated with molded wood lintels. Flemish bond brick on north also. Slightly projecting chimney on west end. Box cornice with molded bed and crown of late shape. Frieze board returns at ends of wall. Unbeaded tapered rake board in each gable end, stone foundation. Brick 2-story integral ell to south w/lower roofline, back arches, 6/6 sashes throughout. Early blinds. 2nd floor windows on ell have no jack arches. 6-course common bond brick. Frame two-story. Adding to east added in late 19th century, creating apparent center-passage plan. Bracketted cornice w/undulating dentil cornice. 6/6 sash and door with etched glass in sidelights and transom all have shallow pediment cornice on 1st floor & orig. blinds.

Door in 2nd floor over main entry door. Small caps on corner boards. 1-story shed-roofed porch with sawn brackets and frieze is supported by paired slender posts. Stone foundation throughout wing. Small interior brick chimney. Frame addition extending ell to south dates from late 19th or early 20th century. The 2-story wing has built-in gutters, 2/2 sash with molded cornices. One-story porch with turned posts along east side of both sections of ell.

Interior: Greek eared trim in brick section, also chairrailing both rooms. Simple Greek Revival mantels in both rooms first floor
