HISTORIC RESOURCES INVENTORY
BUILDING AND STRUCTURES

IDENTIFICATION	1. BUILDING NAME (Common) <u>Private Residence</u> (Historic) <u>Isaac Hoadley House</u>
	2. TOWN CITY <u>Branford</u> VILLAGE _____ COUNTY <u>New Haven</u>
	3. STREET AND NUMBER (and/or location) <u>9 Totoket Road</u> Map G7, Block 3, Lot 7; 1.5 acres
	4. OWNER(S) <u>Bryna L. Scherr</u> <input type="checkbox"/> Public <input checked="" type="checkbox"/> Private
	5. USE (Present) <u>One-Family Dwelling</u> (Historic) <u>Same</u>
	6. ACCESSIBILITY TO PUBLIC: EXTERIOR VISIBLE FROM PUBLIC ROAD <input checked="" type="checkbox"/> Yes <input type="checkbox"/> No INTERIOR ACCESSIBLE <input type="checkbox"/> Yes <input checked="" type="checkbox"/> No IF YES, EXPLAIN _____

DESCRIPTION	7. STYLE OF BUILDING <u>New England Colonial/Greek Revival Additions</u> DATE OF CONSTRUCTION <u>c.1757</u>
	8. MATERIAL(S) (Indicate use or location when appropriate) <input checked="" type="checkbox"/> Clapboard N. <input type="checkbox"/> Asbestos Siding <input type="checkbox"/> Brick <input type="checkbox"/> Other (Specify) _____ <input checked="" type="checkbox"/> Wood Shingle <input type="checkbox"/> Asphalt Siding <input type="checkb

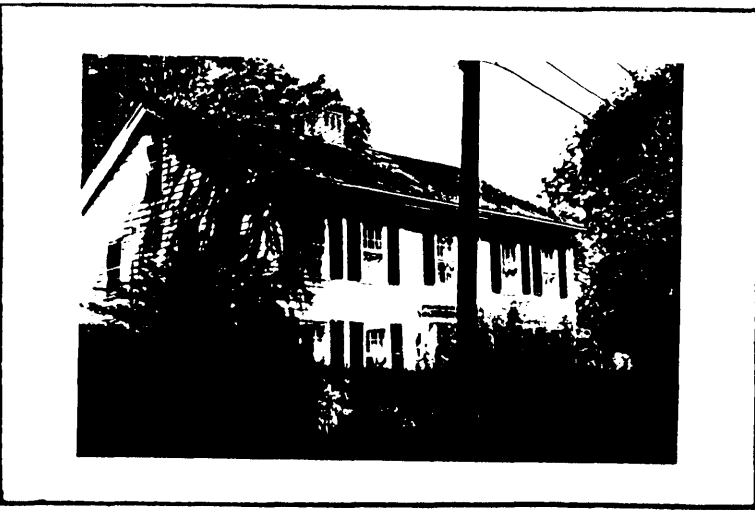
17. OTHER NOTABLE FEATURES OF BUILDING OR SITE (interior and/or exterior)
 Constructed on a nearly-square plan with its ridge parallel to the street, this structure has a shallow-pitched roof (less than 8:12) with cornice returns and a brick, center chimney which straddles the ridge. The house has a five-bay, nine-window facade with six-over-six sash and a center entry featuring sidelights, Doric pilasters and a three-part entablature with dentil moldings below the cornice. While the street facade and south elevation retain their wood-shingle oversiding, the north and west elevations have been restored using clapboard.

PHOTOGRAPHER: Jane P. Bouley
 DATE: July, 1984
 VIEW: East & South Elevs.
 NEGATIVE ON FILE: CHC-File 2 Neg 7A
