United States Department of the Interior National Park Service National Register of Historic Places Registration Form

historic name McIntire Ranch

other names/site number Los Ojos / 5CN793

McIntire Ranch
Conejos County, CO

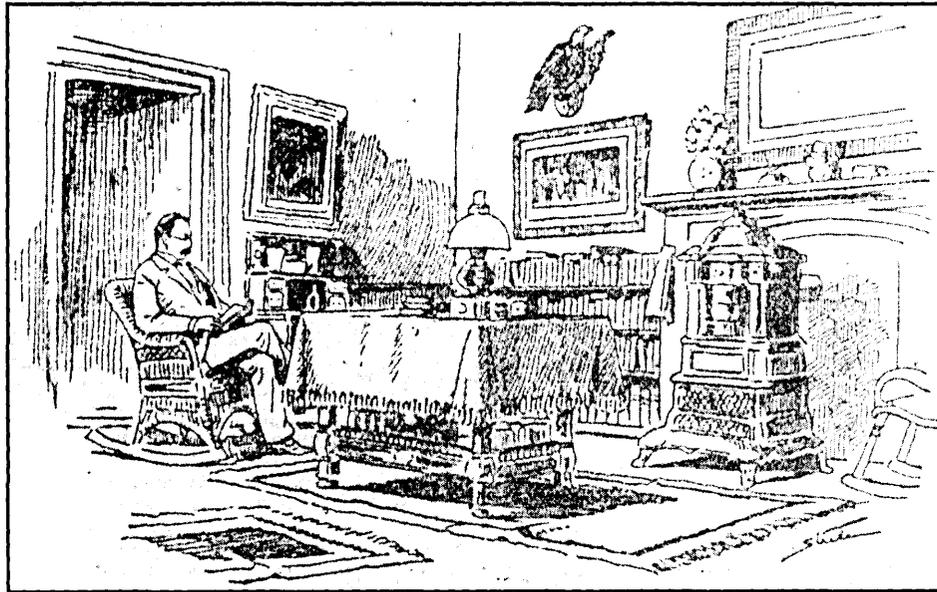
Figure 3. Artist's rendition of the interior of the main house (Building 1).

The third fireplace was on the east side of the house near the northeast corner of the structure. Currently, very little remains of the fireplace except the inner hearth, a scatter of hand-made bricks, and a few fire bricks. The inner hearth is made of 3-in.-thick concrete poured below the sub floor that measures 1½-ft.-long and 2½-ft.-wide. The majority of the bricks are hand-made in a mold with a sand-struck surface (Gurcke 1987). Fire bricks were also identified among the fireplace remains with the word "SAVAGE" embossed on one surface. The Savage name was used by more than one fire brick manufacturer; however, the dates of operation for the companies suggest that the brick may have been manufactured by the Ashland Fire Brick Company of Kentucky between 1892 and 1913 (Gurcke 1987:292).

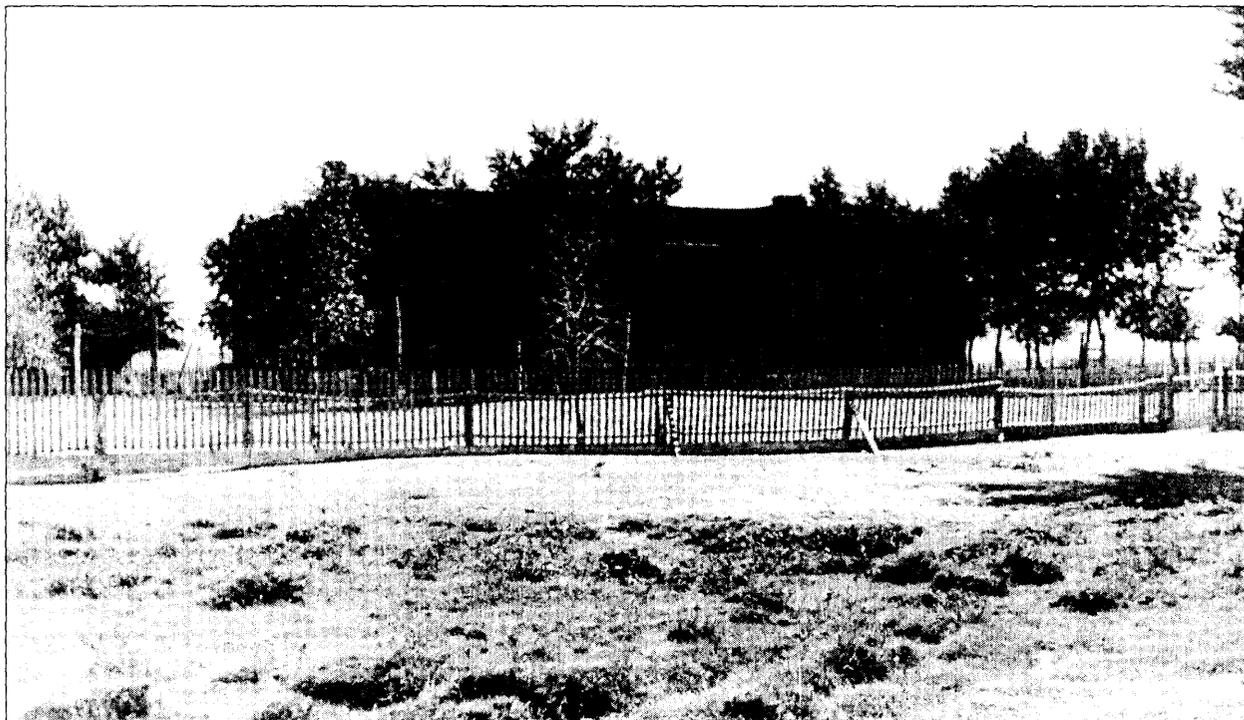
Figure 4. Photograph of Main House at the McIntire Ranch ca. 1890.

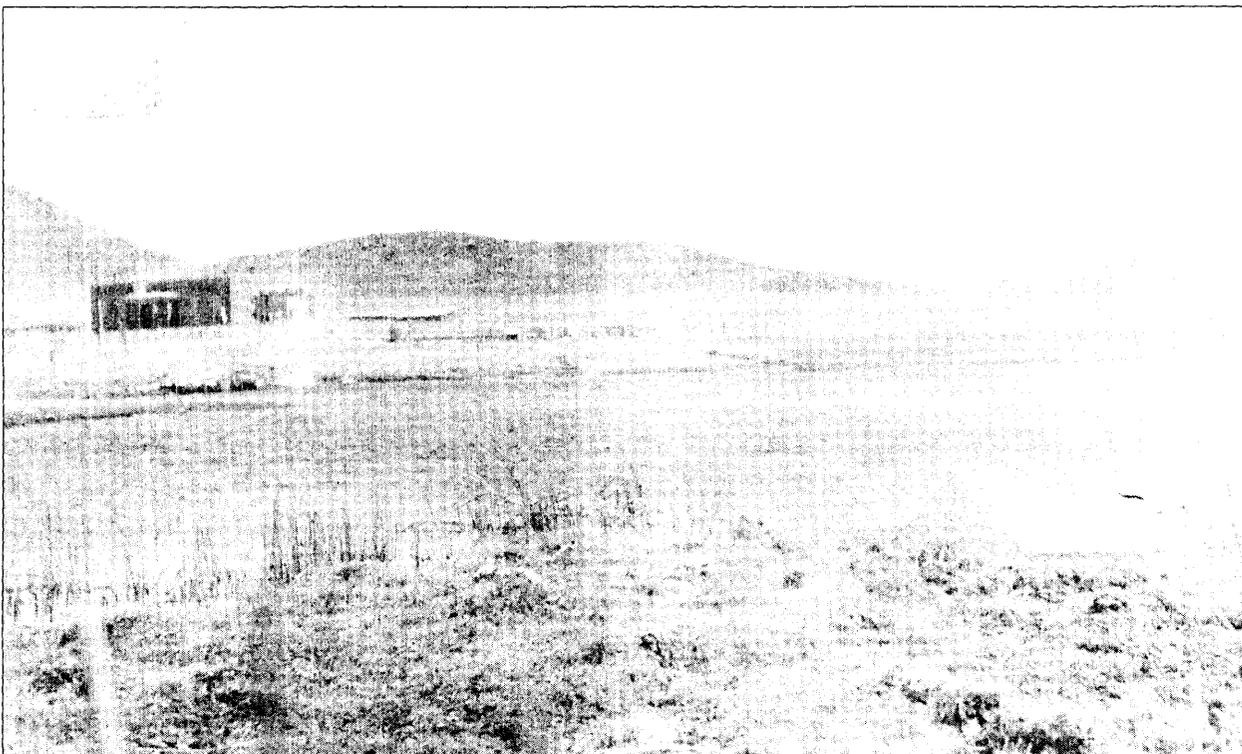
Figure 5. Photograph of the McIntire Ranch ca. 1880.

The building is visible in a circa 1880 photograph at the rear of the McIntire house (Figure 5). The photograph shows that the building had a shed roof that sloped westward. Unfortunately, no other construction details are visible. The lack of adobe block remains or adobe melt suggests that the building was built of wood that was later salvaged. The simple foundation construction suggests that the building was built on, or very near to the ground surface. Based on this type of construction, the building may have had a limited importance, such as a stable, animal or tack shed. It is conceivable that the building was part of a stable. The 1894 *Rocky Mountain News* article about the ranch reported that the road to the ranch approached the rear of the house, making the building represented by Foundation 1 an ideal location for a stable where a wagon and necessary tack could be kept.
