National Register of Historic Places Registration Form

Historic name: Monument Lake Park Building and Hatchery Complex

Other names/site number: 5LA.12777

City or town: Weston State: CO County: Las Animas (071)

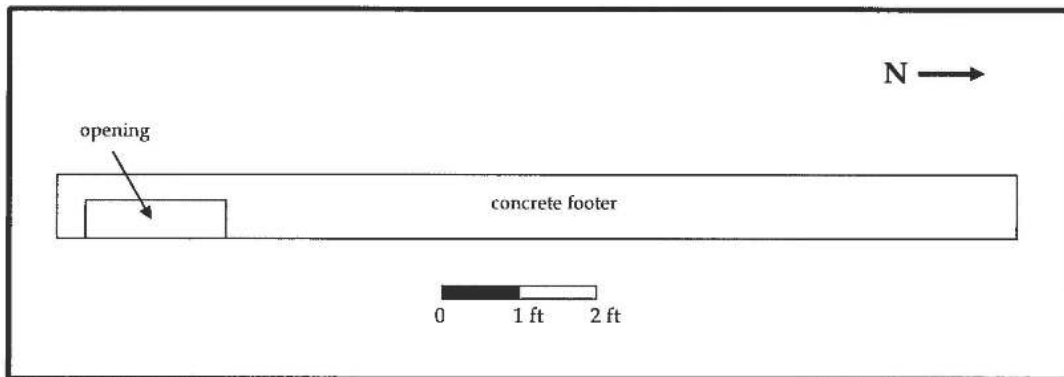
Site 1 – Profile of Foundation 1.
From Anthony & Associates, Historical Archaeology Component Form, 8/31/2012

Site 1 is a small poured concrete foundation located approximately 60' north of the zoo enclosures. The foundation is an "L" shaped footer that projects 11" above the current grade and measures approximately 12' x 5'. It is oriented on a northwest-southeast axis. Its actual date of construction and original use is unknown, however, it was constructed prior to the hatchery closure in 1959. Additional archaeological investigation of this feature may be warranted, as its original function is unknown.

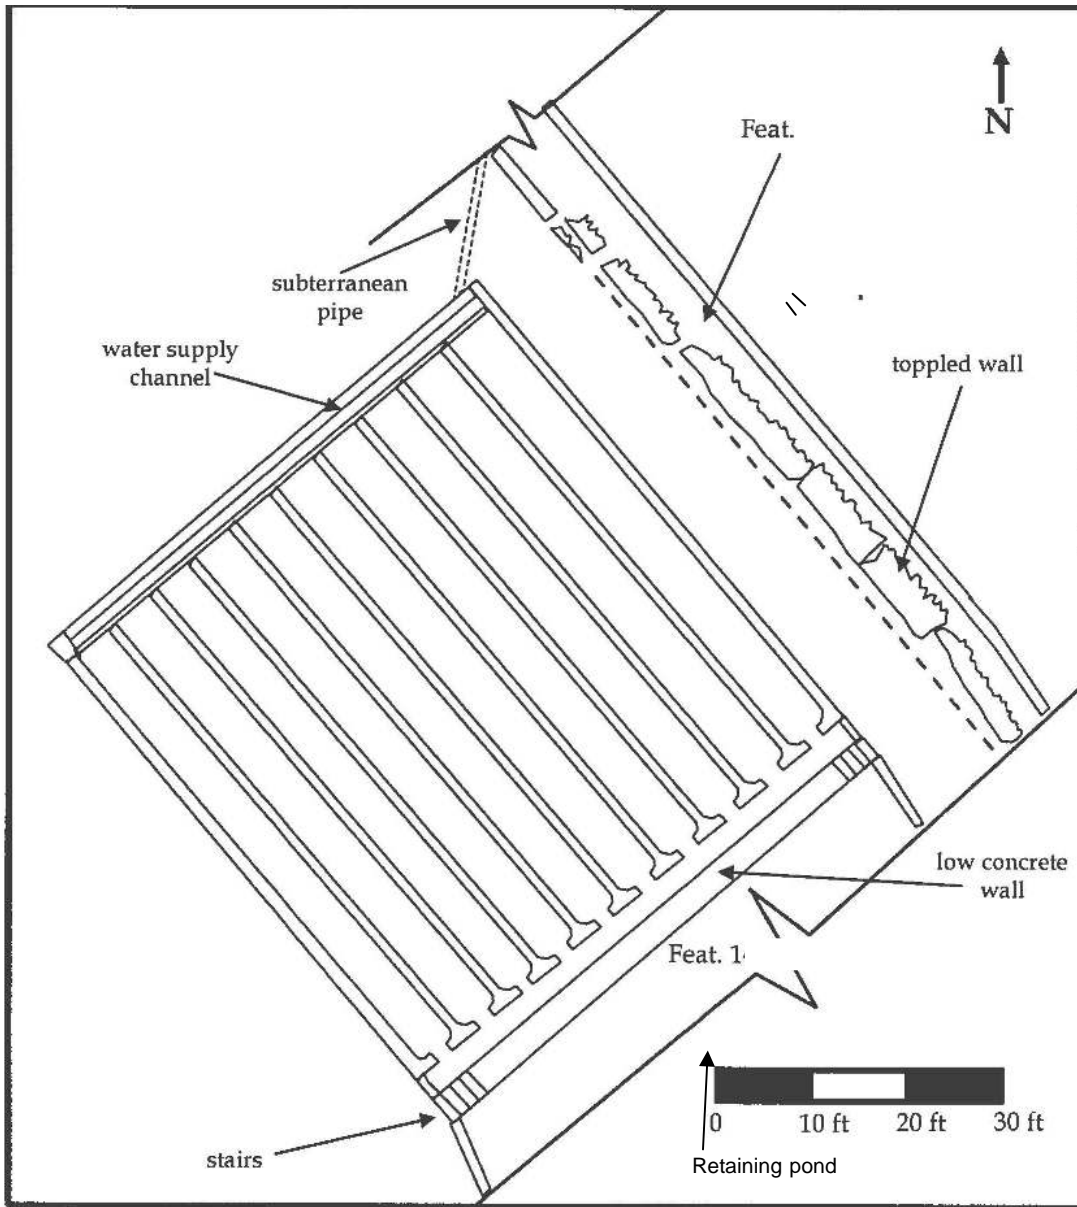
Structure 11 – Plan view of Raceway Pond.
From Anthony & Associates,
Historical Archaeology Component Form, 8/31/2012

Structure 5 is a sunken, rectangular raceway pond measuring 60' x 65' and oriented on a northwest-southeast axis. Built in 1937 with CCC labor, the IWL paid for construction materials. The raceway pond featured a continuous flow-through of water to prevent the build-up of waste, thereby allowing a maximum density of fish stock to occupy the channels. The raceway's narrow channels prevent fish from swimming in circles, an action that causes waste and debris to collect in the center of the channel.

The raceway channel walls are constructed of wire-reinforced concrete. Channel walls are 8" thick and 2' tall at the north end, and 3' tall at the south end of the pond. The walls extend approximately 60' and end in gated openings. Most of the raceway walls are in good condition, however, some exhibit evidence of spalling. The raceway pond extends another 5' to the south beyond the end of the raceway channel walls. A set of concrete steps on the east and west perimeter walls delineate a poured concrete lip that spans the pond east to west and provides a boundary from the raceway to the retaining pond. The concrete steps and lip are in poor condition. As the fish hatchery has not been operational since 1959, the pond has been abandoned since.

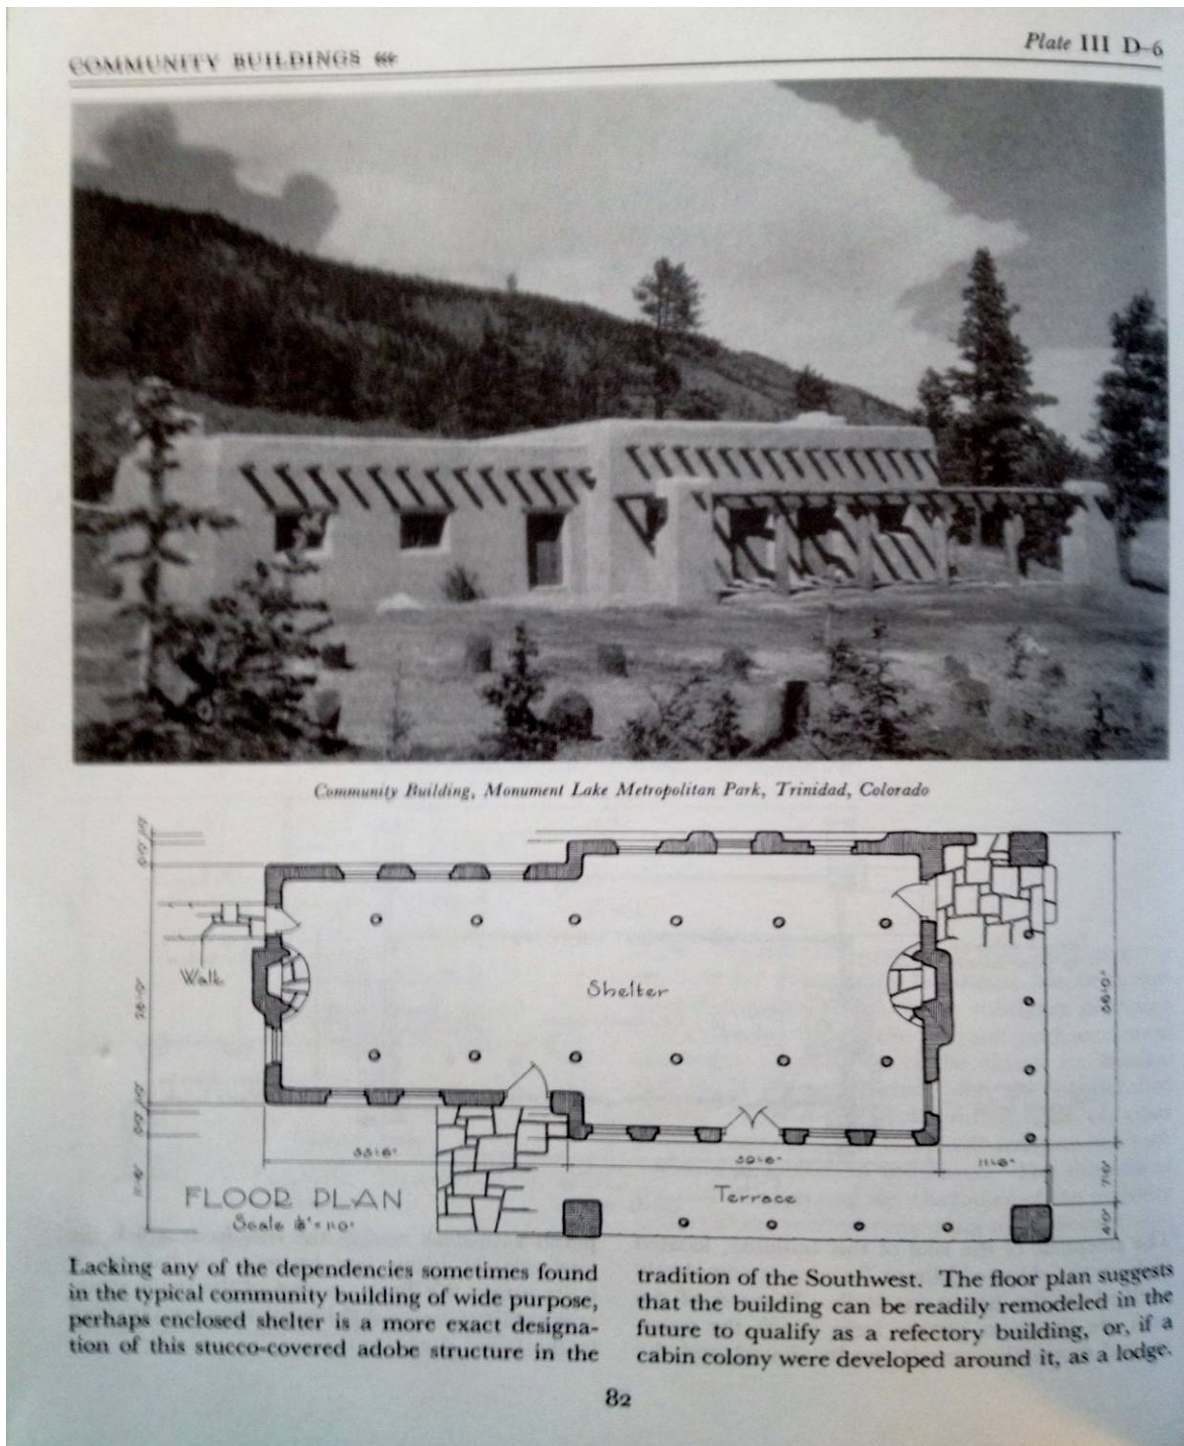
Figure 4: Photo and Floor Plan of Community Building at Monument Lake Metropolitan Park (Building 1 – Kendall House), 1935

Although the individual architect responsible for the design of Kendall House is unknown, the building was important enough to be featured in Part III of Albert H. Good's *Park and Recreation Structures*. Good was an architectural consultant to the National Park Service in the 1930s and 1940s and his pattern books, published between 1935 and 1938, highlighted the best buildings from what was dubbed the "Golden Age of Rustic Design." "Monument Lake Metropolitan Park's Community Building" was one of only seven community buildings nationwide highlighted by Good. Good stated in his preface, "The most completely satisfying subjects included herein are so, not as a result of chance, but because training, imagination, effort, and skill are conjoined to create and fashion a pleasing structure or facility appropriate to a particular setting."¹¹ The simplicity of the design and the continued functionality of the Kendall House is a lasting tribute to those who designed and built it – and to the government programs that supported their endeavors.
