### **National Register of Historic Places Registration Form**

1. Name of Property	
historic name Cashier'	
other names/site number	_
2. Location	
street & number Bayshore Center at Bivalve, 2800 High Street	not for publication
city or town Commercial Township	vicinity
state New Jersey code NJ county Cumberland code 011	zip code08349

Ex-schooner CASHIER, official number 5286, was constructed as a two-masted Delaware Bay oyster schooner with a clipper bow. She was built in Cedarville, New Jersey, by Milton Duffield, and was launched in 1849. She had a high topmast, which extended above the mainmast and her masts had sharp rakes or angles to them. Her registered length is 54.2 feet, breadth 17.3 feet, depth 4.2 feet, gross tonnage 19 and net tonnage 9. CASHIER received her first engine, shaft and propeller in 1916 and by 1938, her centerboard trunk, one mast (out of two) and rigging were removed. Her now removed engine was a 471 Detroit Diesel with 3½ to 1 reduction. CASHIER's deck cabin had a pilothouse built on top. In 1973, 3 feet of her traditional schooner stern was cut off due to rot, making it into a square stern. CASHIER is currently sunk in a boat slip between wharves M an

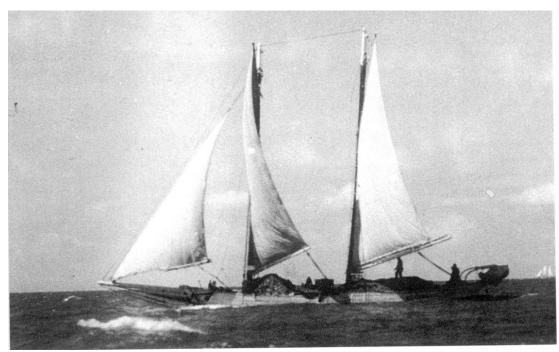
**Historic Photograph #3:** CASHIER, dredging under sail.

The introduction of the oyster dredge, though decidedly a factor in the ability of the oystermen to increase their catch was not the primary impetus for the efficiency and eventual success of the Delaware Bay oyster industry – this was provided by the railroads. In the 1830's the soon to be bustling town of Port Norris had a total of eight dwellings. Its principle function was the shipping of cordwood and lumber. Following the construction of the railroad lines to the mouth of the Maurice River in Bivalve (Port Norris's waterfront section) in the 1870's and 1880's Port Norris' population jumped to 885 and twenty years later it was up to 1800. Bivalve quickly supplanted Philadelphia as the shipping point for Delaware Bay oysters. Most of the vessels traditionally harvesting oysters from various tributaries along the bayshore started using Bivalve as their homeport – at least during the harvest season during the fall and winter months. <sup>11</sup> [Photos 1,3]

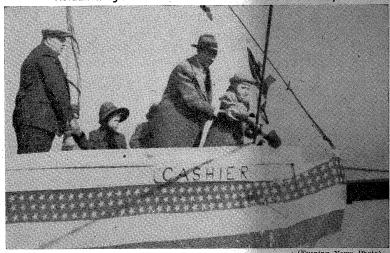
Historic Photograph #5: Relaunching of CASHIER, 1949.

Assisted by her father Carl Reed, little Sarah Jane Reed breaks the customary bottle over the prow of the cyster boat Cashier on the 100th anniversary of its launching at Cedarville in 1849. Assisting in the ceremiony which took place yesterday at the Delaware Bay Ship Building Corp. Yard, at Leesburg, are John L. Reed, Jean Esther Reed and behind his father is Carl John Reed.

The Cashier was relaunched yesterday with appropriate ceremony at the Delaware Bay Shipbuilding Company at Leesburg where she was converted in 1945 in such a way as to enable her on the oyster business.

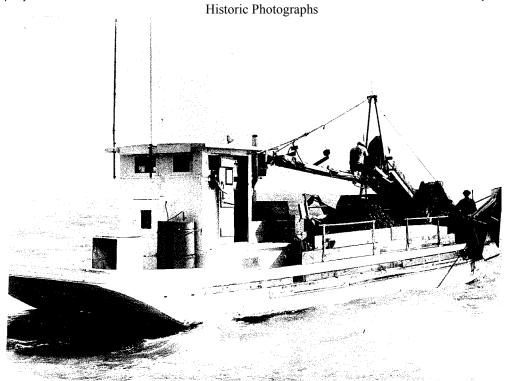
**Historic Photograph #15:** CASHIER, pre-1973. Note traditional schooner stern. Prior to removal of three feet.

McConnell took CASHIER to a shipyard in Dorchester, and pursued an extensive course of repairs. The stern of a schooner is susceptible to rot, and the condition of CASHIER'S stern led the owner to cut off about 3 feet, yielding the square stern appearance she has today. Such stern shortening was a common practice for the longest-lived of the schooners. In 1971, out of a sailing oyster dredge fleet that once numbered in excess of 500 boats, no sail-powered dredgers survived, and only 45 demasted engine-powered schooners, including CASHIER, remained on the Maurice River (The major concentration on the Bay), and only half of these still worked the oyster beds. By 1984, 35 to 40 oyster schooner worked in the Delaware Bay fleet; by 2014, this number was reduced to 12. McConnell sold CASHIER to Bob Robbins, another local oysterman, late in 1993.

- 14. Photographer: unknown. Date Photographed: pre-1973
  Description of Photograph(s) and number: Oyster Dredge Boat CASHIER
- 15. Photographer: unknown. Date Photographed: pre-1973
  Description of Photograph(s) and number: Oyster Dredge Boat CASHIER. Note traditional schooner stern. Prior to removal of three feet.

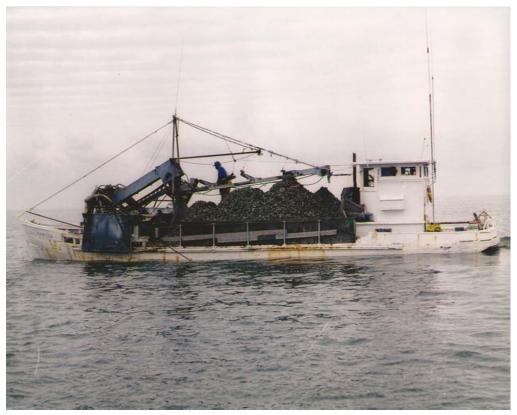
**Historic Photograph #16:** CASHIER, dredging under power, 1980s. Note conveyor belts and machinery on deck and square stern.

Dredging Equipment – The foundation and attachments for the now-removed dredging equipment remain. Mid-ships even with the aft end of the bow deck rail, there is a square metal platform (36 inches by 36 inches) bolted to the deck. From this platform protrudes several bolts for dredge winches and an oyster conveyor. The conveyor took the oysters forward to a mechanical culler. [Hist. Photos 13,14,15,16]

- 16. Photographer: unknown. Date Photographed: pre-1973
  Description of Photograph(s) and number: Oyster Dredge Boat CASHIER, dredging under power, 1980s. Note conveyor belts and machinery on deck and square stern.
