National Register of Historic Places  
Registration Form

historic name Oak Grove Farm

other names/site number Lovell House

street & number 410 Exchange Street

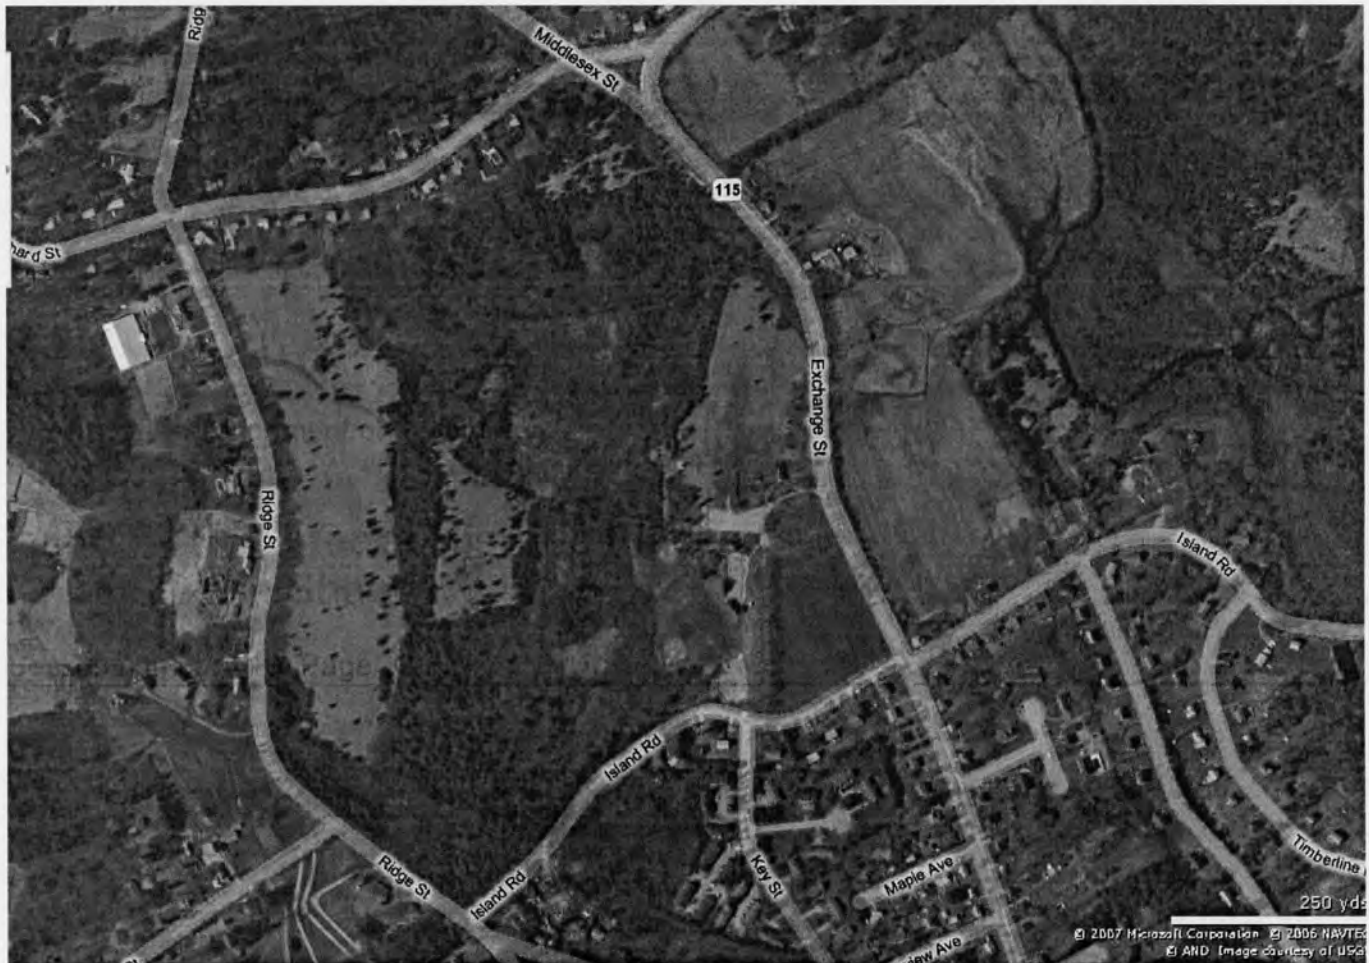
Aerial View of Oak Grove Farm, bordered by the rear lot lines of dwellings along the southern side of Orchard Street on the north, Island Road on the south, Exchange Street on the east and Ridge Street on the west.

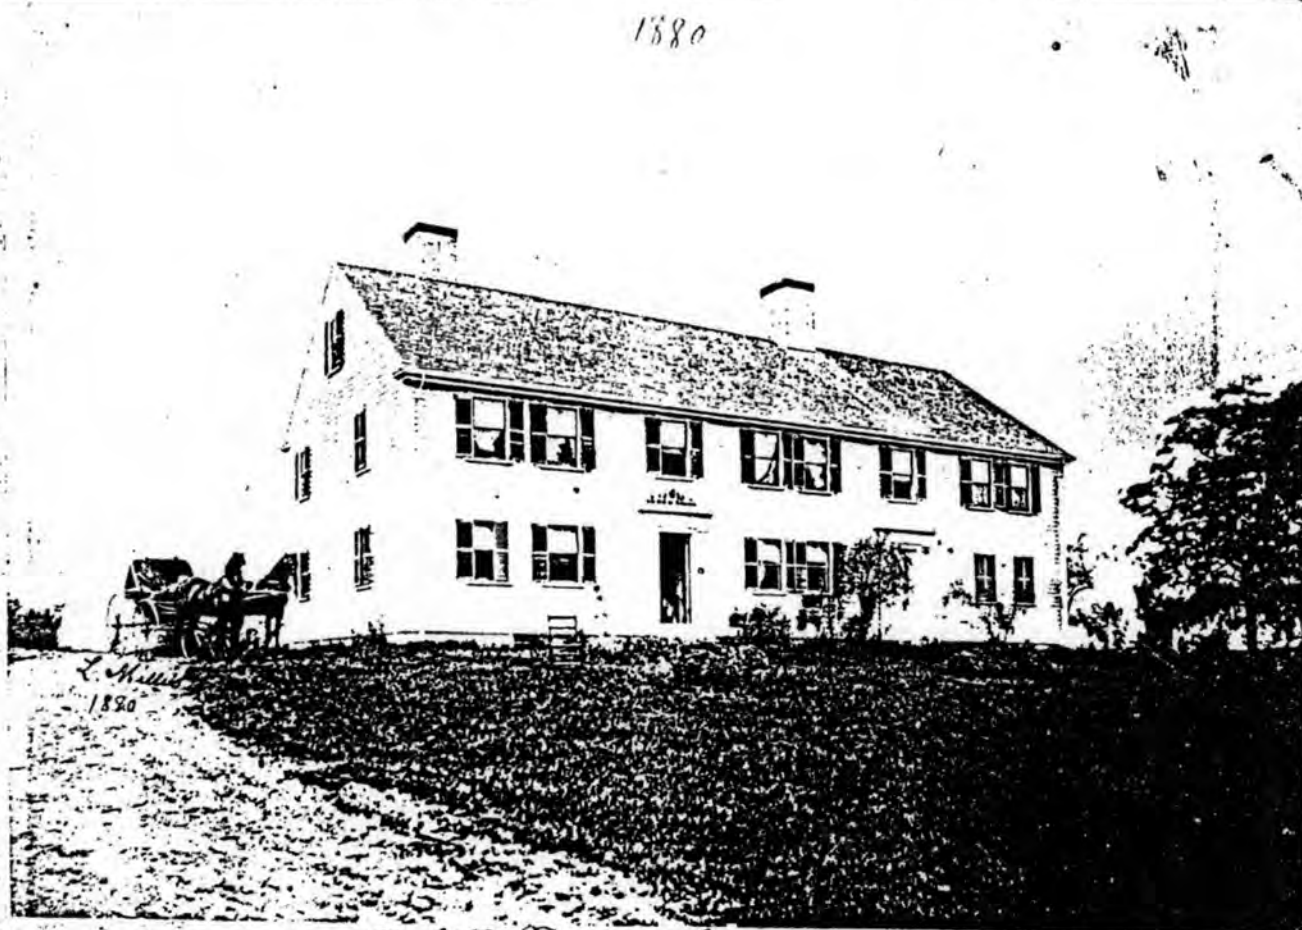
*O.G.F. Farm House 1880 E. Midway Road*

The **Lovell-Oak Grove Farm House [Photo #1]** was developed in three phases. Evidence that has helped historians to understand the three phases are an 1880 photograph of the eight-bay house, an 1890 bird's-eye view of Oak Grove Farm Buildings, and architectural clues, particularly on the interior. In addition, the house had deteriorated while vacant for several years before it was taken over by the town and substantially rehabilitated in 1984. Existing fabric provided clues for the way in which to restore the house.

The rear ell has three exposed sides. Most of the windows on each elevation have 6/6 replacement sash set in flat, unadorned frames. These windows are likely to have had 2/2 sash or 1/1 (see 1880 photograph), like the rest of the windows, when the ell was constructed ca. 1884. When the town acquired the property, most windows were boarded up with plywood. On the north side facing into the angle formed by the main house and the rear ell, there are three second-story windows in the first, third, and fifth bays. An exception to the 6/6 sash is seen on the north elevation of the rear ell. A large, modern, three-part, first-story window is composed of a central picture window flanked by 2/2 sash. Under this window there once was a small addition, probably two stories high, projecting from the rear ell foundation wall. The foundation of this small addition is evidence of its location; the footprint is seen on an 1893 plan of land of Oak Grove Farm, and the roof line is visible in the 1890 bird's-eye view of "Oak Grove Farm Buildings."

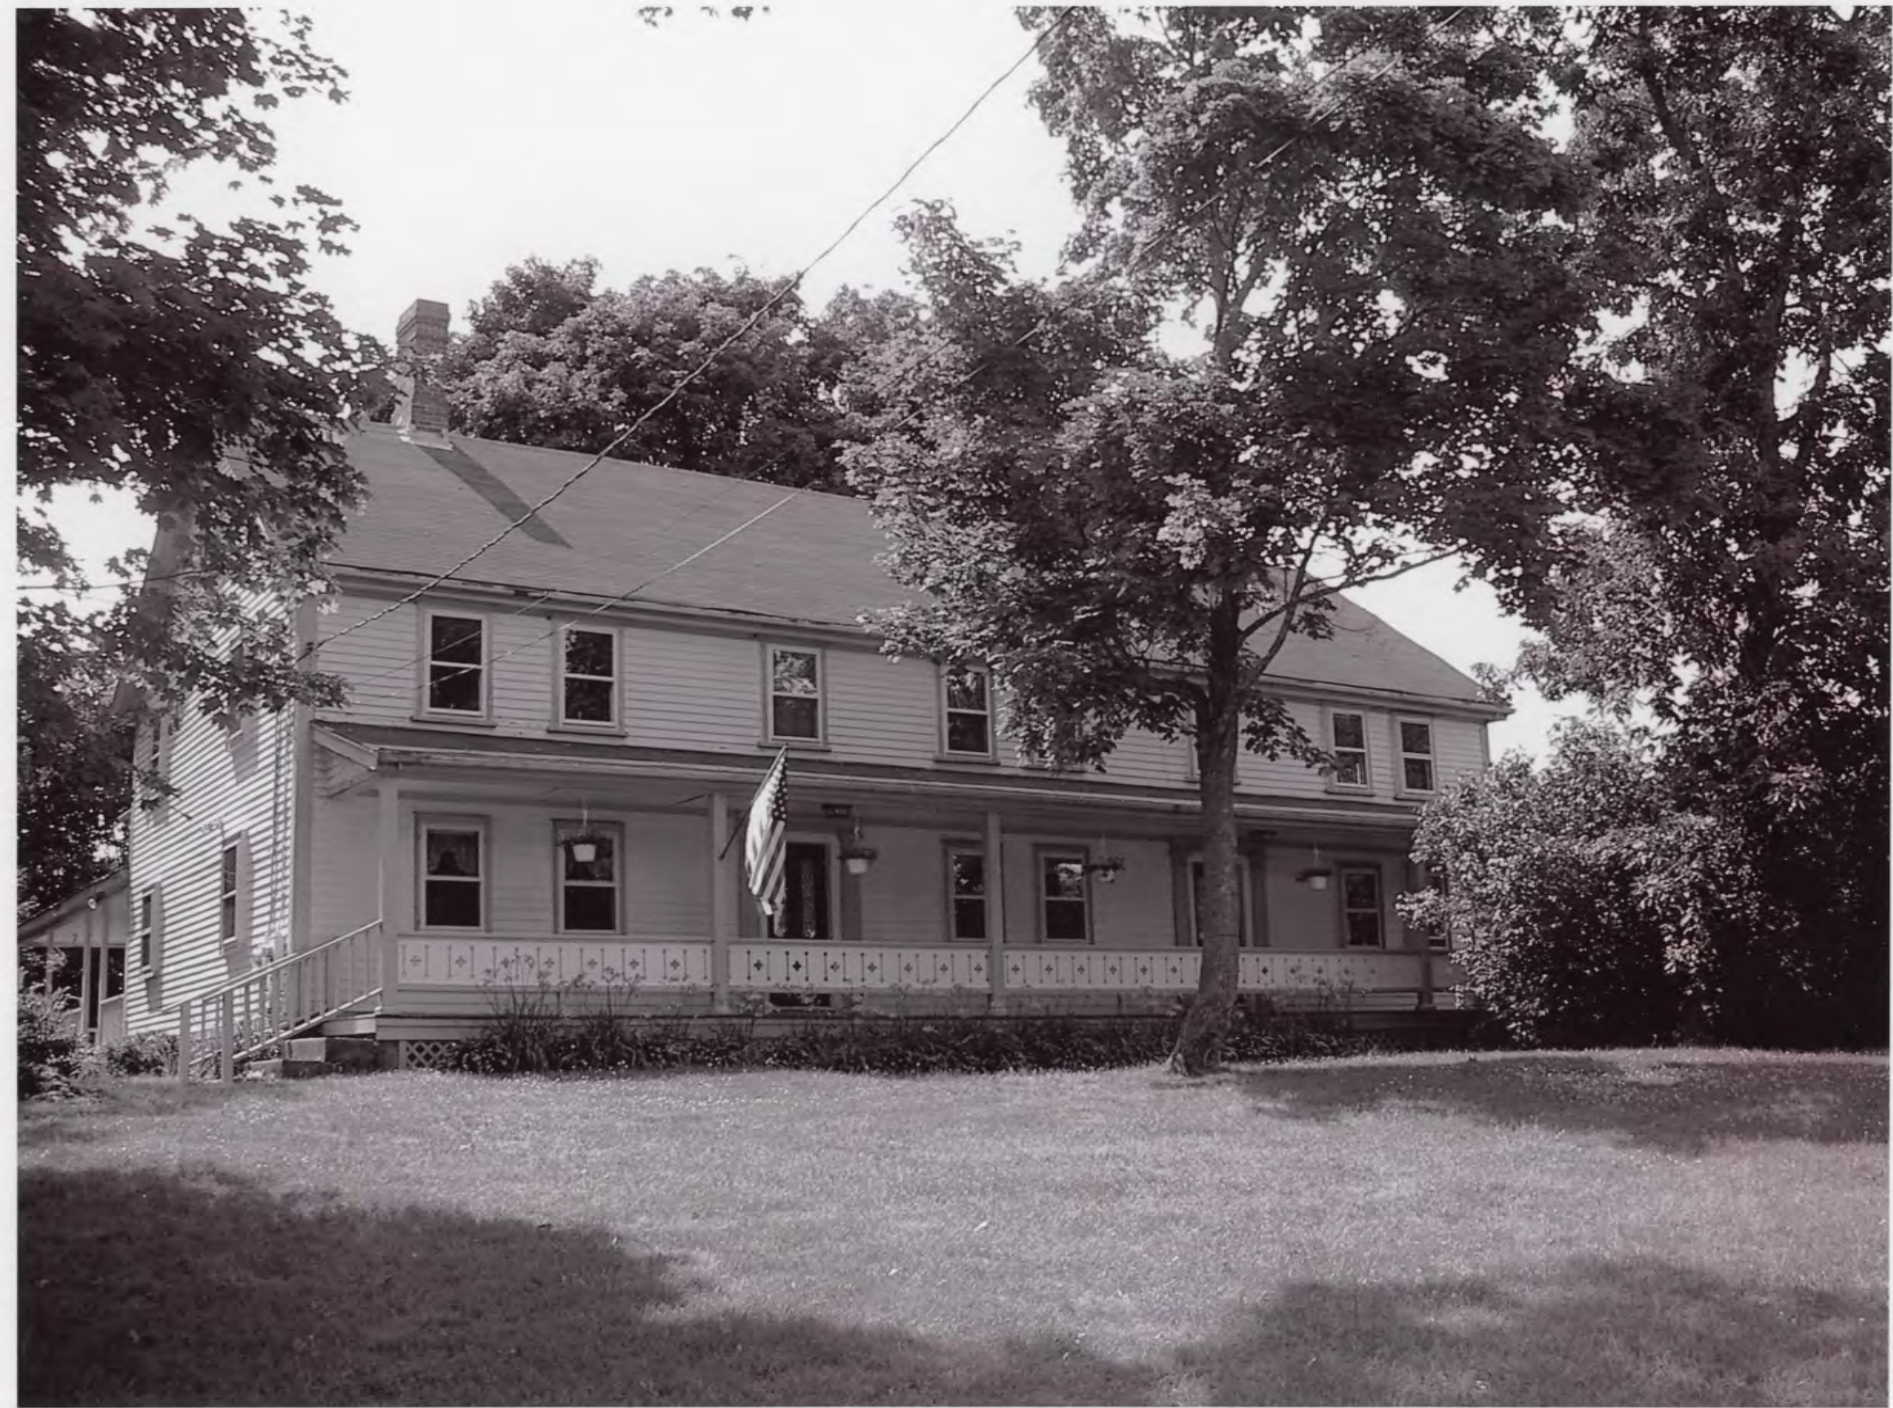
Photo #1

Main (east) facade looking west, northwest

The original house appears to have been a five-bay, center-chimney, early 18<sup>th</sup>-century building comprising the five northernmost bays of the main façade. The center chimney was removed ca. 1884. The second phase, which likely dates to the second quarter of the 19<sup>th</sup> century, is a three-bay lateral addition that extended the main block to the south, making it the present 8 bays wide. Phase three is the rear ell, which was added behind the 19<sup>th</sup>-century part of the house in 1884. A full-length porch across the main eight-bay façade dates to ca. 1883-1884, and a full-width porch that runs along the south elevation of the rear ell was probably built at the same time as the rear ell.

The 2½-story, wood-clapboard farmhouse is situated on a slight knoll that slopes away from the northwest corner of the house. The foundation under the original part of the house is random-sized fieldstones, with added mortar on the north end where the exposed foundation is 3 to 5 ½ feet high. A granite block foundation is under the three-bay, 19<sup>th</sup>-century lateral addition on the south end. The foundation of the 1884 rear ell consists of fieldstone, mortar, and some brick. The land on which the rear ell sits slopes away from the main block, so that the exposed fieldstone foundation is gradually higher from east to west. The west end of the rear ell is carried by a section of brick foundation, which is nearly a full story above grade. The land behind the house and along the north side of the rear ell slopes away from the front of the building so that exterior cellar entries are cut into the high foundation walls. One is located in the rear elevation (the northwest end) in the original section and one is centered on the west gable end of the rear ell. **[Photo #2]**

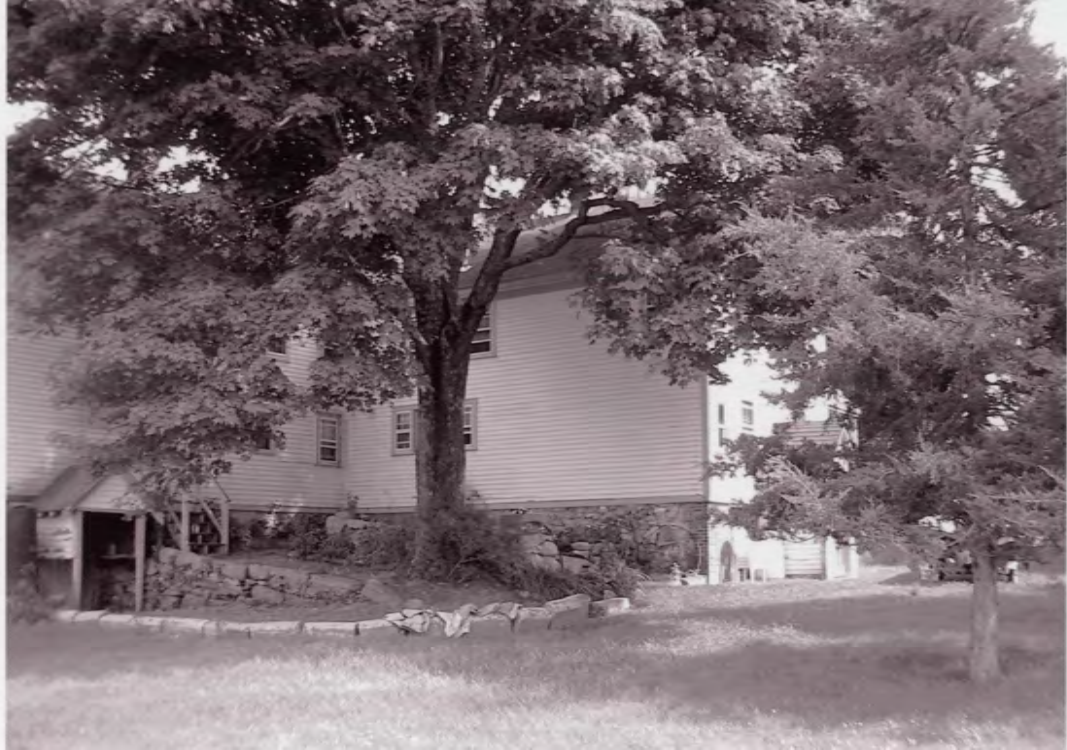
June 2007  
Bear Elevation, Near Ell Looking SW  
Photo #2

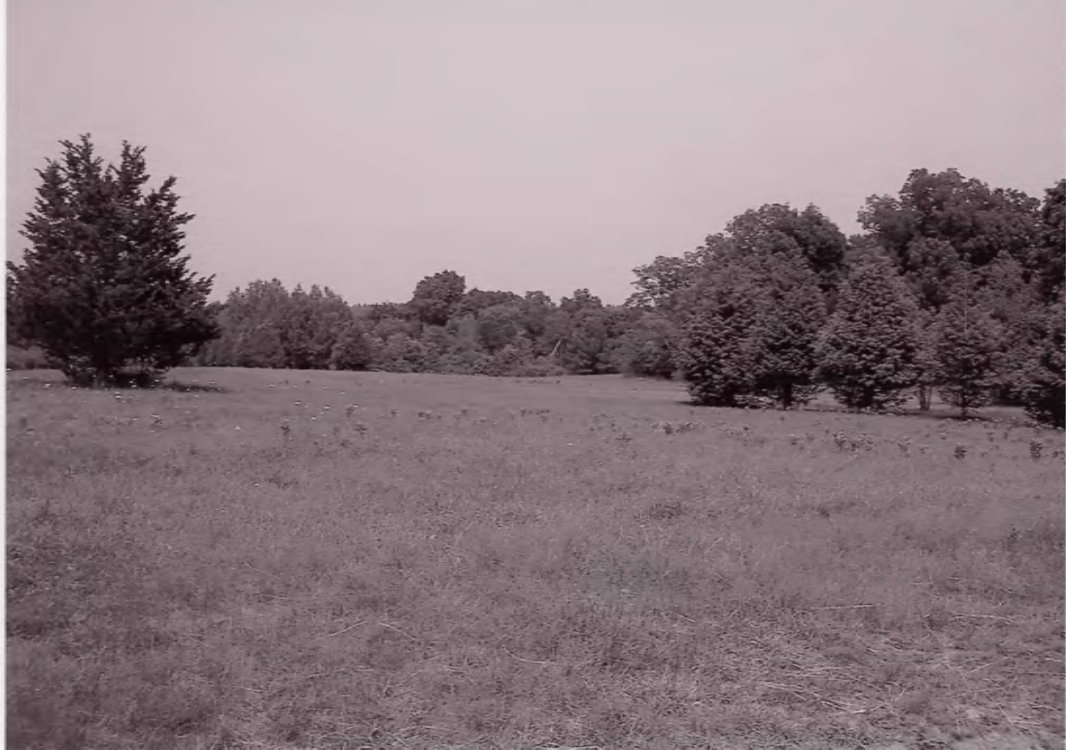
Meadow Behind house looking NW  
Photo #4

due to creation of building lots on this northern boundary, the stone wall is no longer on the Oak Grove Farm parcel. The **site of a dairy complex [Photo #4]**, which once contained large barns and other farm structures, is directly behind the house (west) and the parking area noted below. Acres of **agricultural fields** and meadows are intact and continue to be farmed.

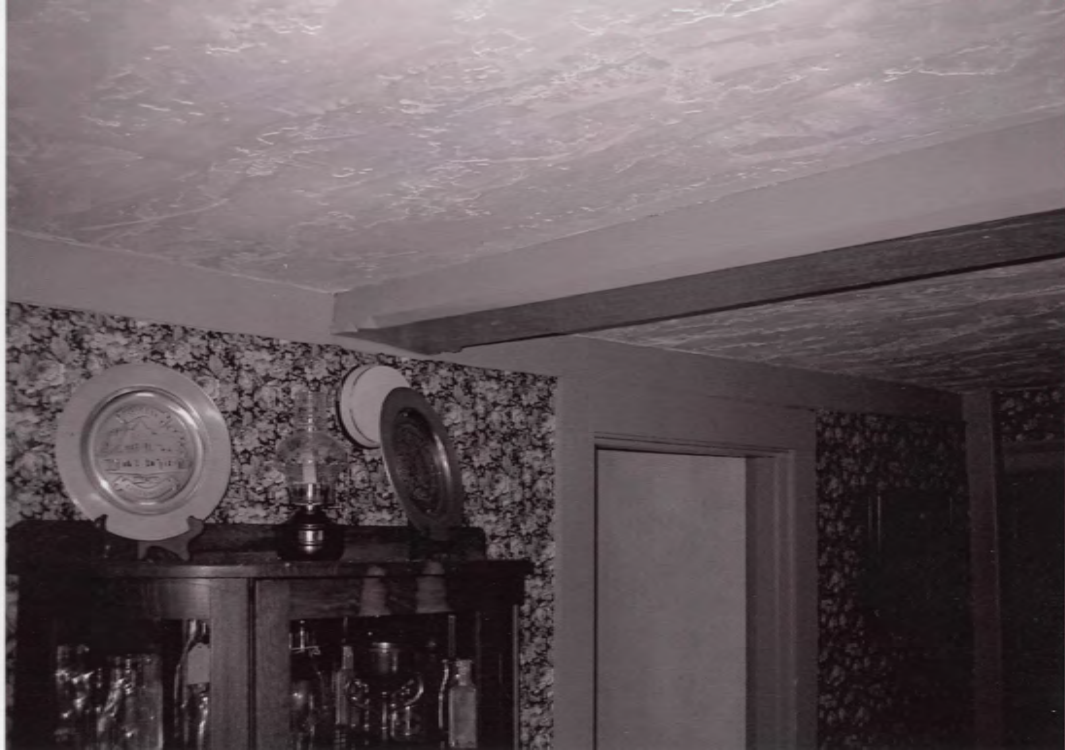
North plaster - summer beams w/ chandelier  
Photo # 5

Readily visible evidence in the earliest section of the house suggests an original construction date in the first or early second quarter of the 18<sup>th</sup> century. If sufficient suitable sampling locations are present, dendrochronological dating might provide a more precise date. Of interest is the presence of exposed, decoratively carved, chamfered and beaded framing members. The north parlor summer beam has chamfers that end in well-defined stops [**Photo #5**]. In the south parlor and north chamber, summer beams are beaded, and beaded corner posts, girts, and plates are present in both the parlors and the chambers. There is no evidence that three exposed decorated summer beams were ever cased, although the summer beam in the south bed chamber is boxed.

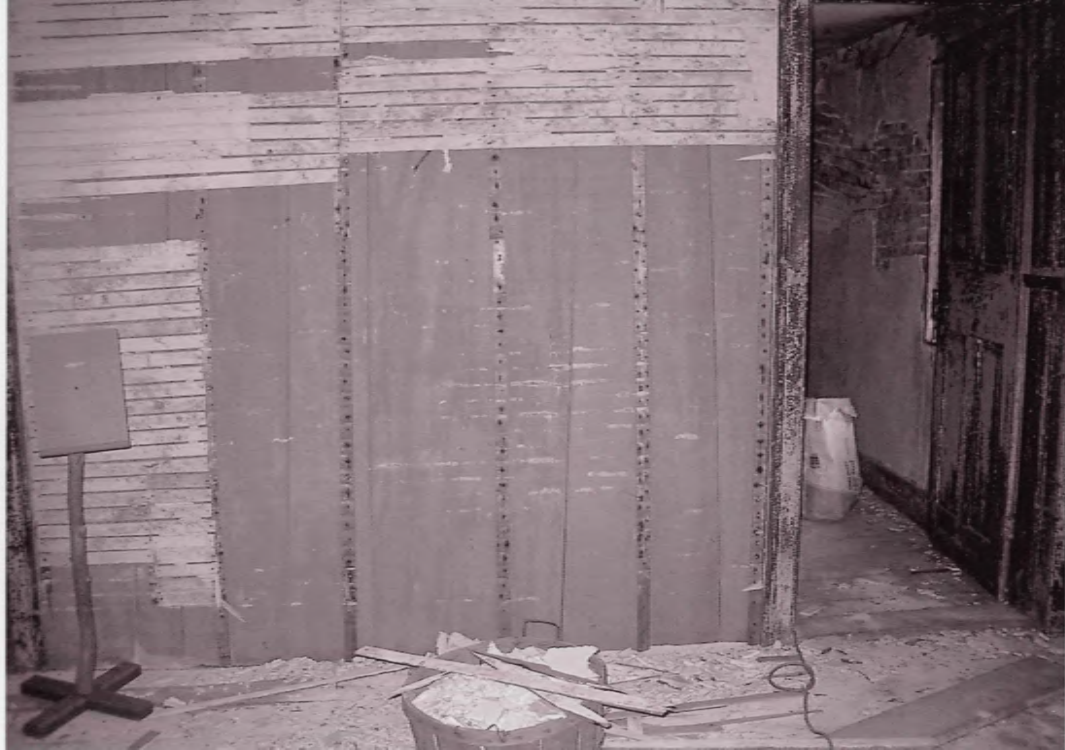
photo # 6

pre 2007  
North chamber - vertical board wall  
behind lath

Original vertical plank walls have been found behind the lath and plaster in the north chamber, and in the small room behind the north chamber. Removal of part of the lath and plaster has exposed vertical beaded board walls [**Photo #6**]. Some of the plaster had failed due to water and fire damage and some had been removed for unknown reasons; thus, there are large sections of exposed vertical plank walls, which are believed to exist also in the north parlor below this chamber; however, there has been no investigation in that room.
