Town Gloucester. 009

Address 189 Concord Street

Historic Name Ella Proctor Herrick House

INVENTORY FORM CONTINUATION SHEET

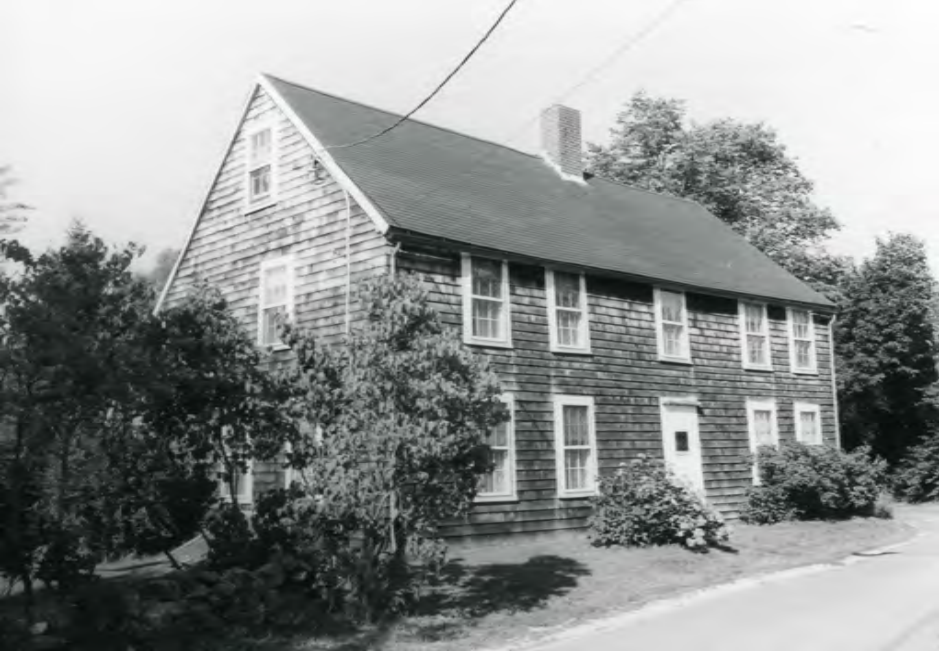
1st Period Buildings of E. Ma, MA 26:02

main view of house  
1985

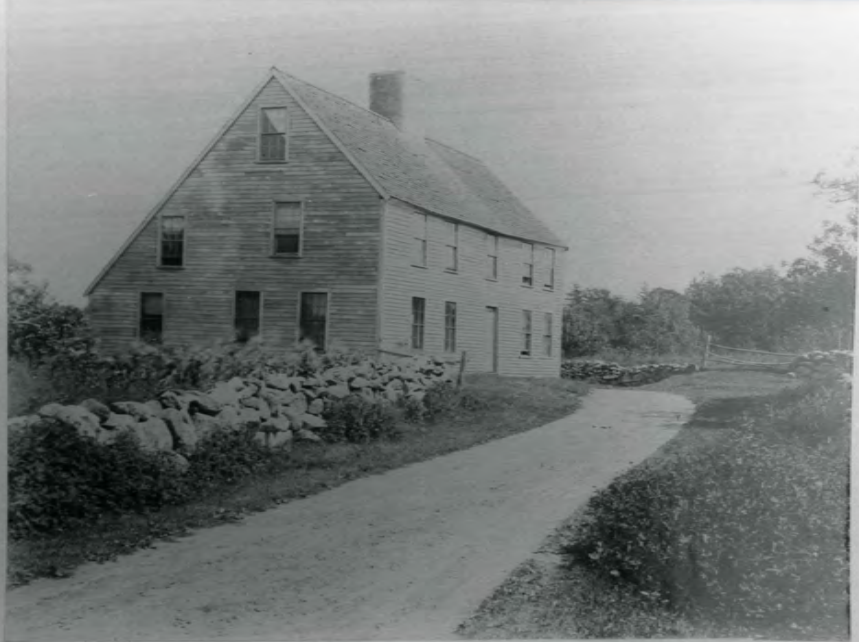
- 26-2 main view of house
- 30-17 Rear post of right hand addition at junction with old part. New plate resting on post and extending under the beam of original house (See photo 30-16 for comparison)
- 25-34 Detail: summer beam left-hand room
- 26-4 historic photograph
- 30-20 Doorway to rear, original room. Arched head support is framed into studs on either side

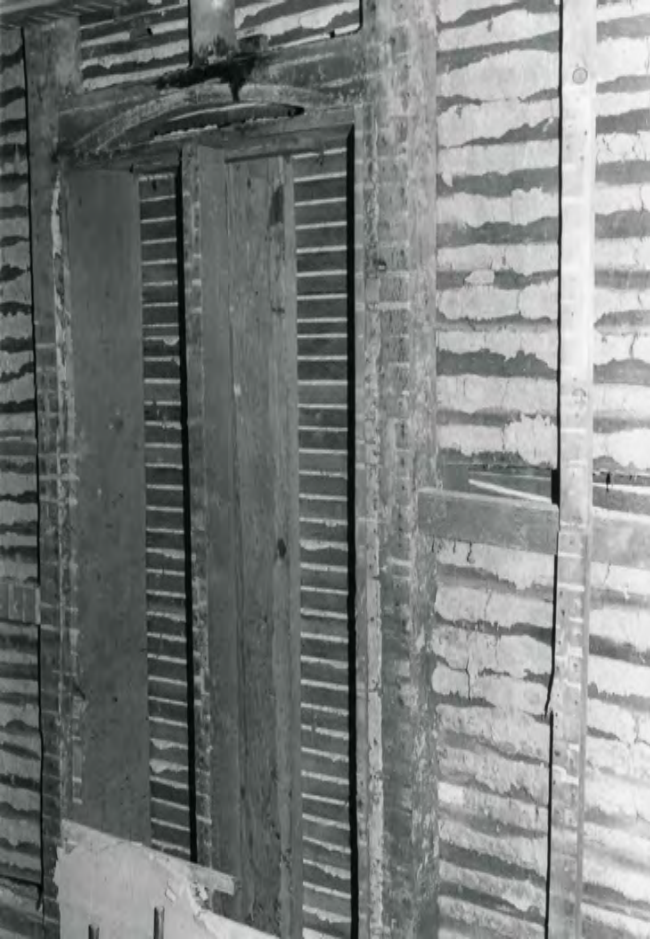
30:20

The segmentally arched door head in the original rear wall of the left hand room is a rare surviving example of decorative First Period carpentry work. Segmentally arched doors are known in only one or two other examples in the study area.

Gloucester, MA  
Ella Proctor Thaxter Hb.  
189 Concord Street  
Doorway to rear,  
original room  
1985

First Period features are seen in the left hand rooms and attic. In the left hand room, the longitudinal summer beam, the only framing member exposed, has 1 3/4" wide quarter-round chamfers, flat collars and concave taper stops. The room also retains at least one wall of original clay plaster, heavily whitewashed, in which an original arched doorway has recently been uncovered (see photo). The doorway in the rear wall has a segmentally arched head which is let into the studs on either side.

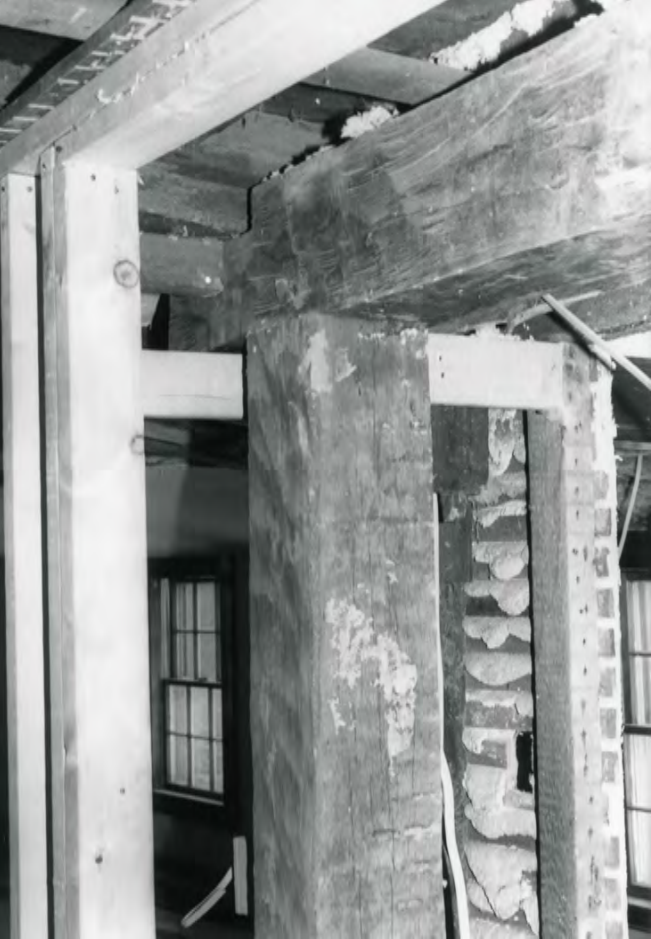
30:17

Gloucester, Tr  
Ella Proctor Thacker Tr  
189 Concord Street  
rear post of right  
hand addition at  
junction with old part.  
1985

Finishes have recently been removed from the right hand chamber in the portion of the house added in the 18th century. There is clear evidence that the unchamfered summer tie beam was exposed and whitewashed for a time before being boxed, while the rest of the ceiling was plastered from the beginning. Current renovations have also allowed examination of the interesting method of joining the 17th and 18th century portions of the house at the rear plate. The newer plate laps under the original end tie beam inside of the original corner post, and is supported by its own post. This creates a strong junction, but means that the plates of the old and the new portions of the house are not aligned.

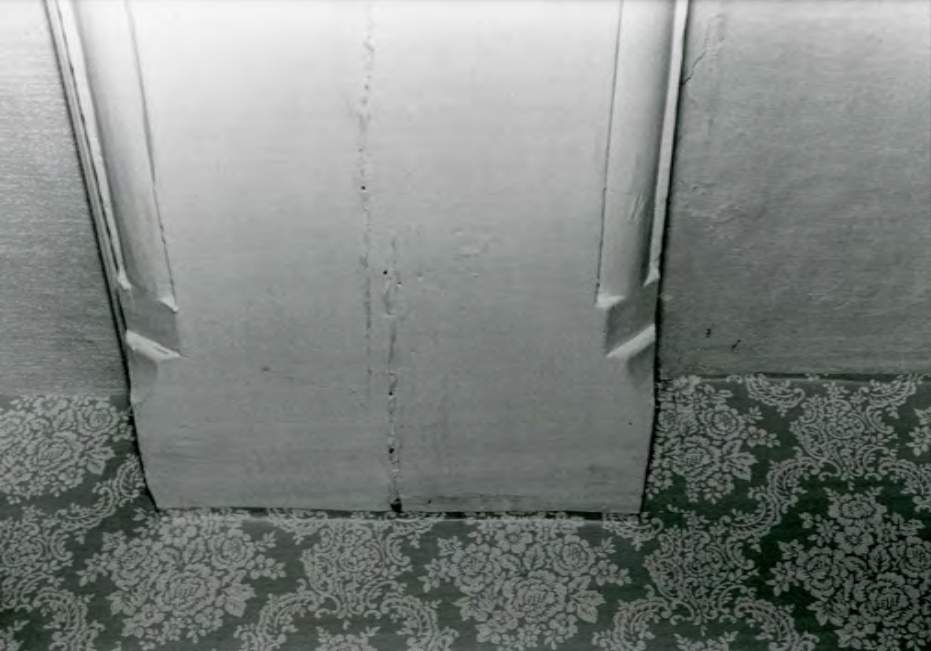
25:34

Gloucester, MA  
Ella Proctor Hennick House  
189 Concord Street  
Detail: Summer beam  
1985
